The Role of Channel Armoring with Gabions on Channel Adjustments on the Zealand River, New Hampshire

Douglas M. Thompson, Leah S.
Puklin and Anna E. Marshall

Connecticut College

2014 Gabion Assessment

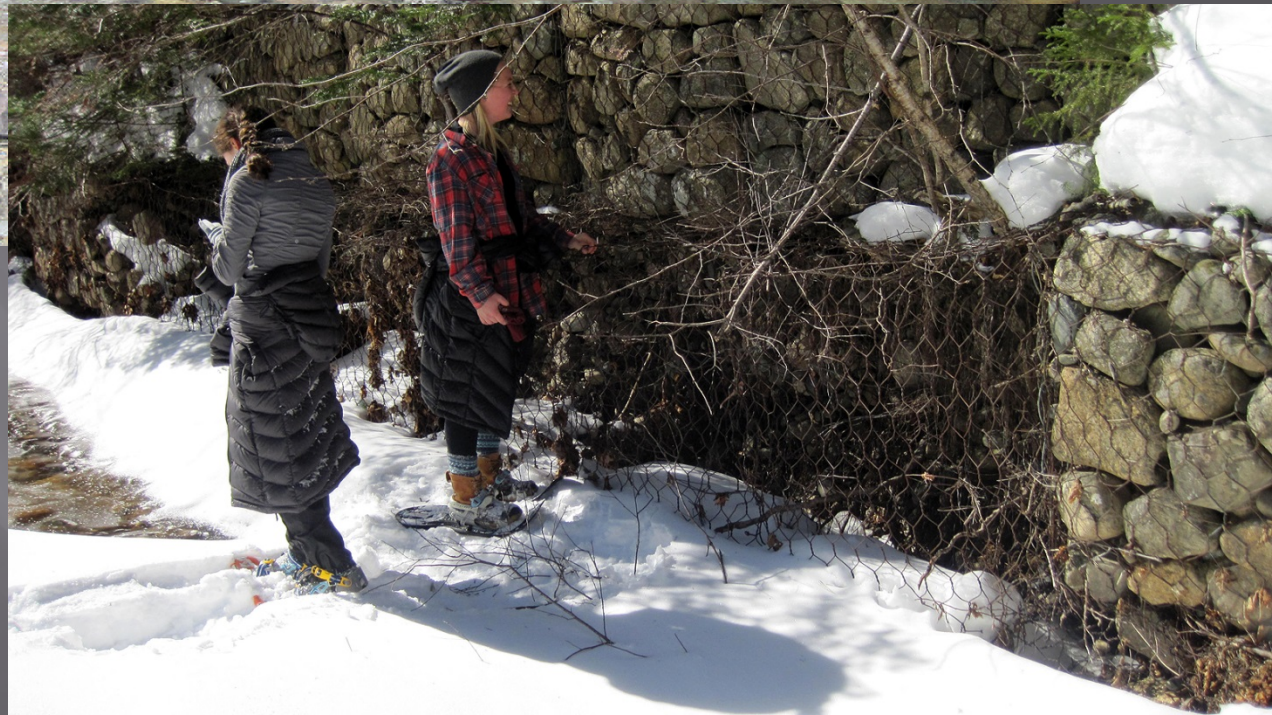
Failed

<50% Full

>50% Broken Wires

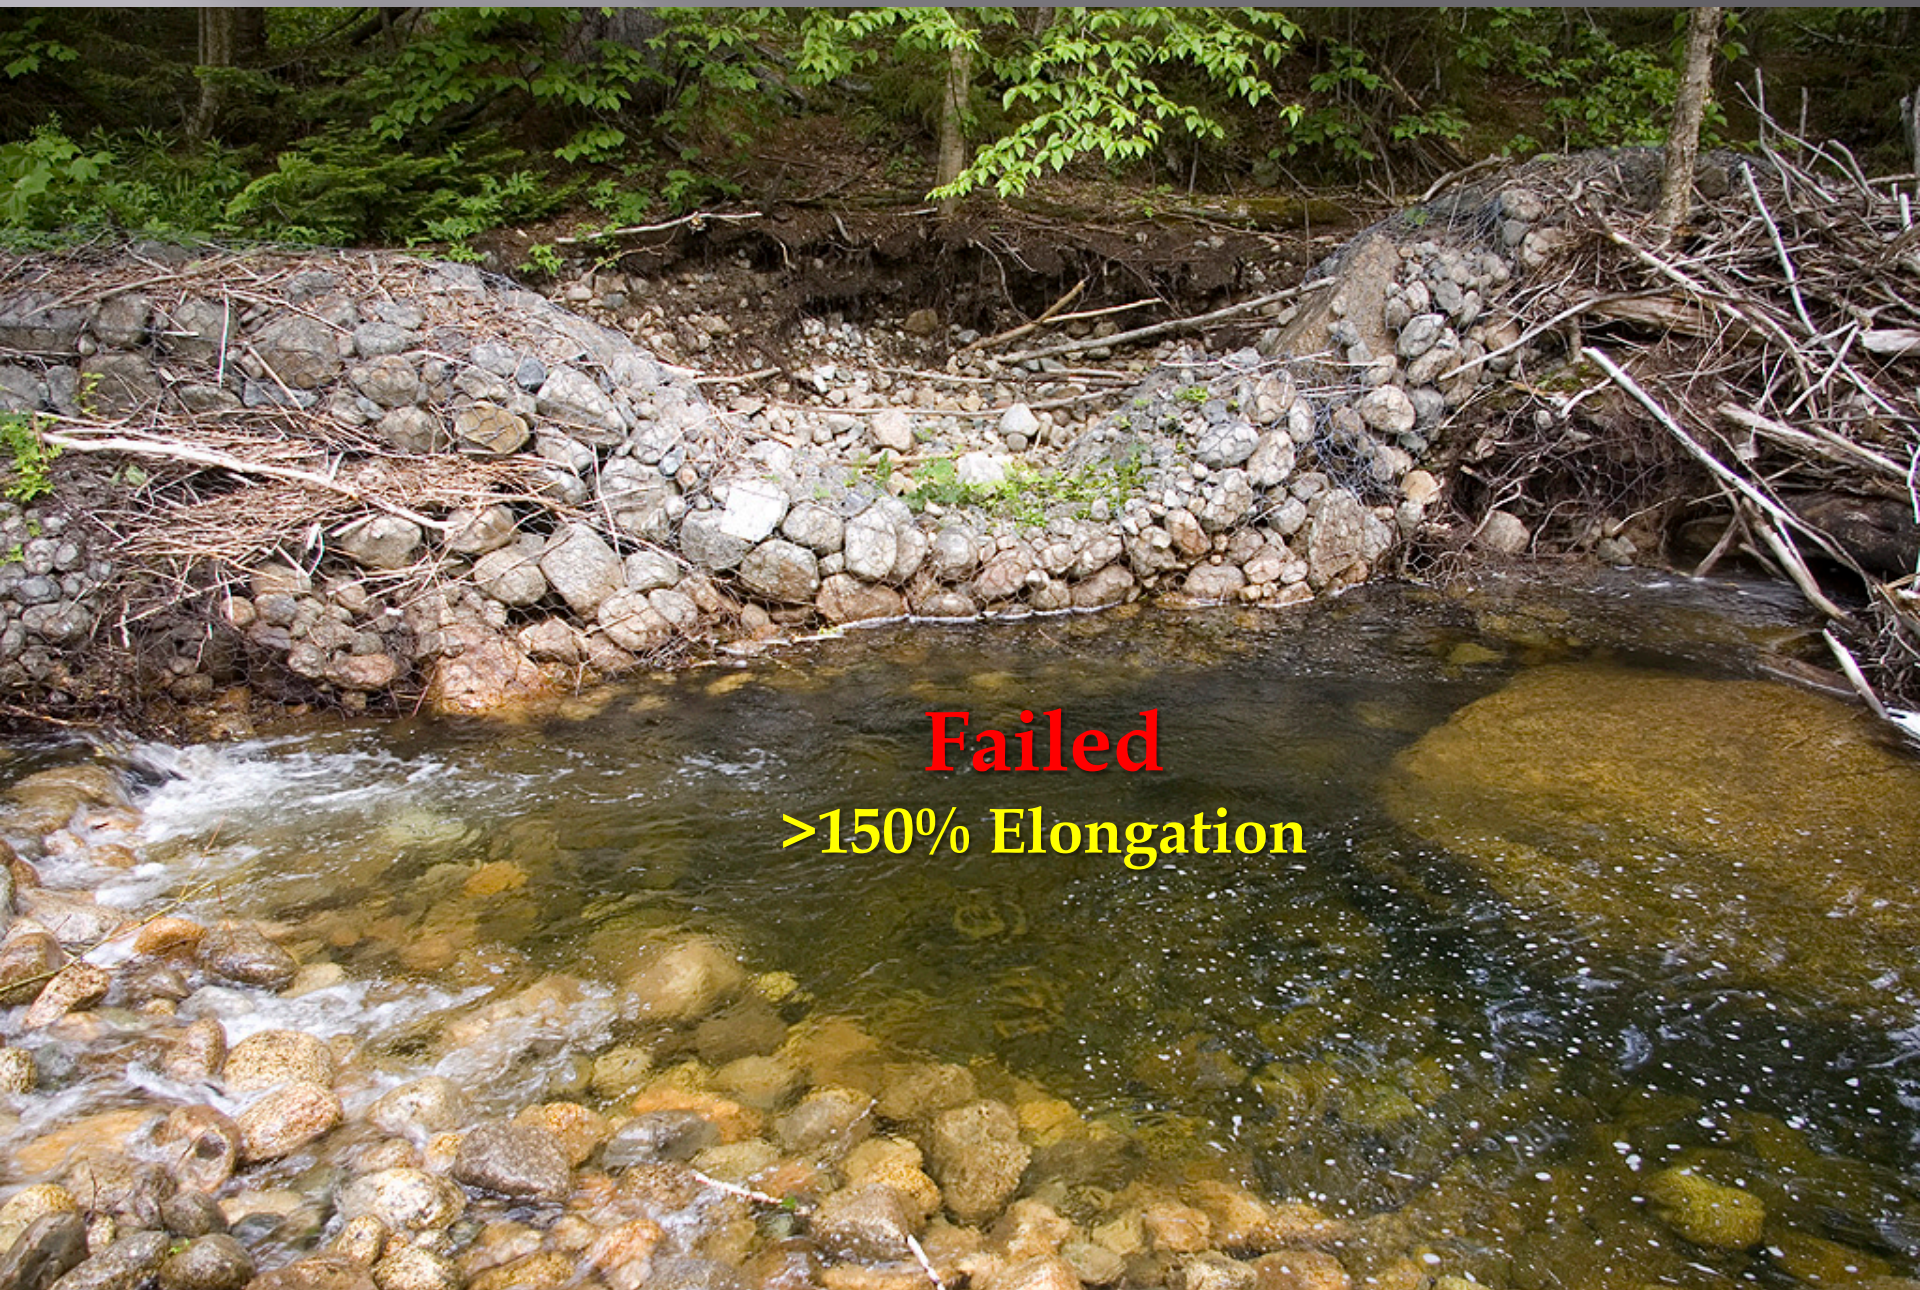
Failed
Tilting >30°

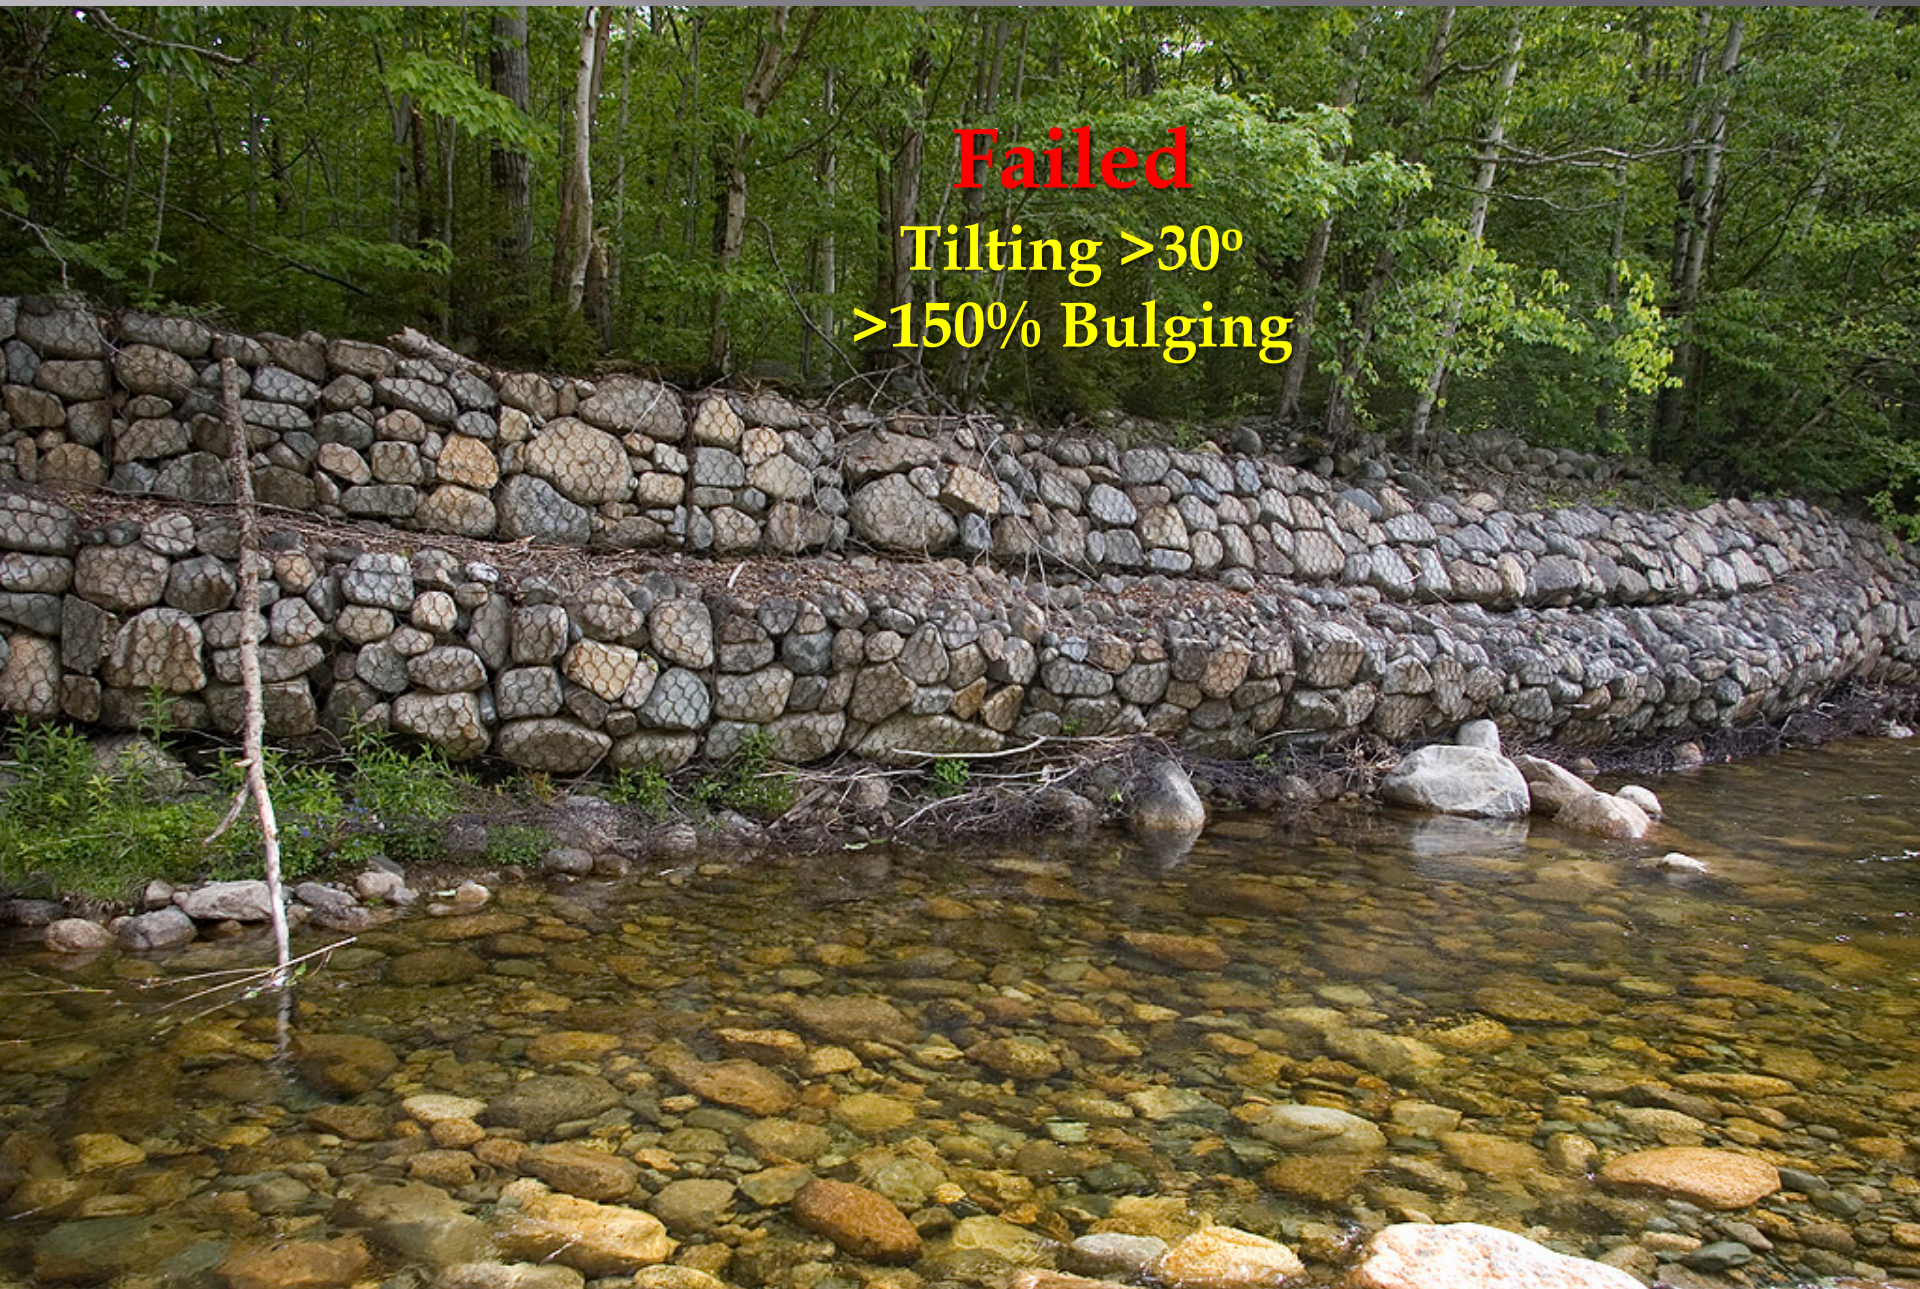
Failed
>150% Elongation

Failed
Tilting $>30^\circ$
 $>150\%$ Bulging

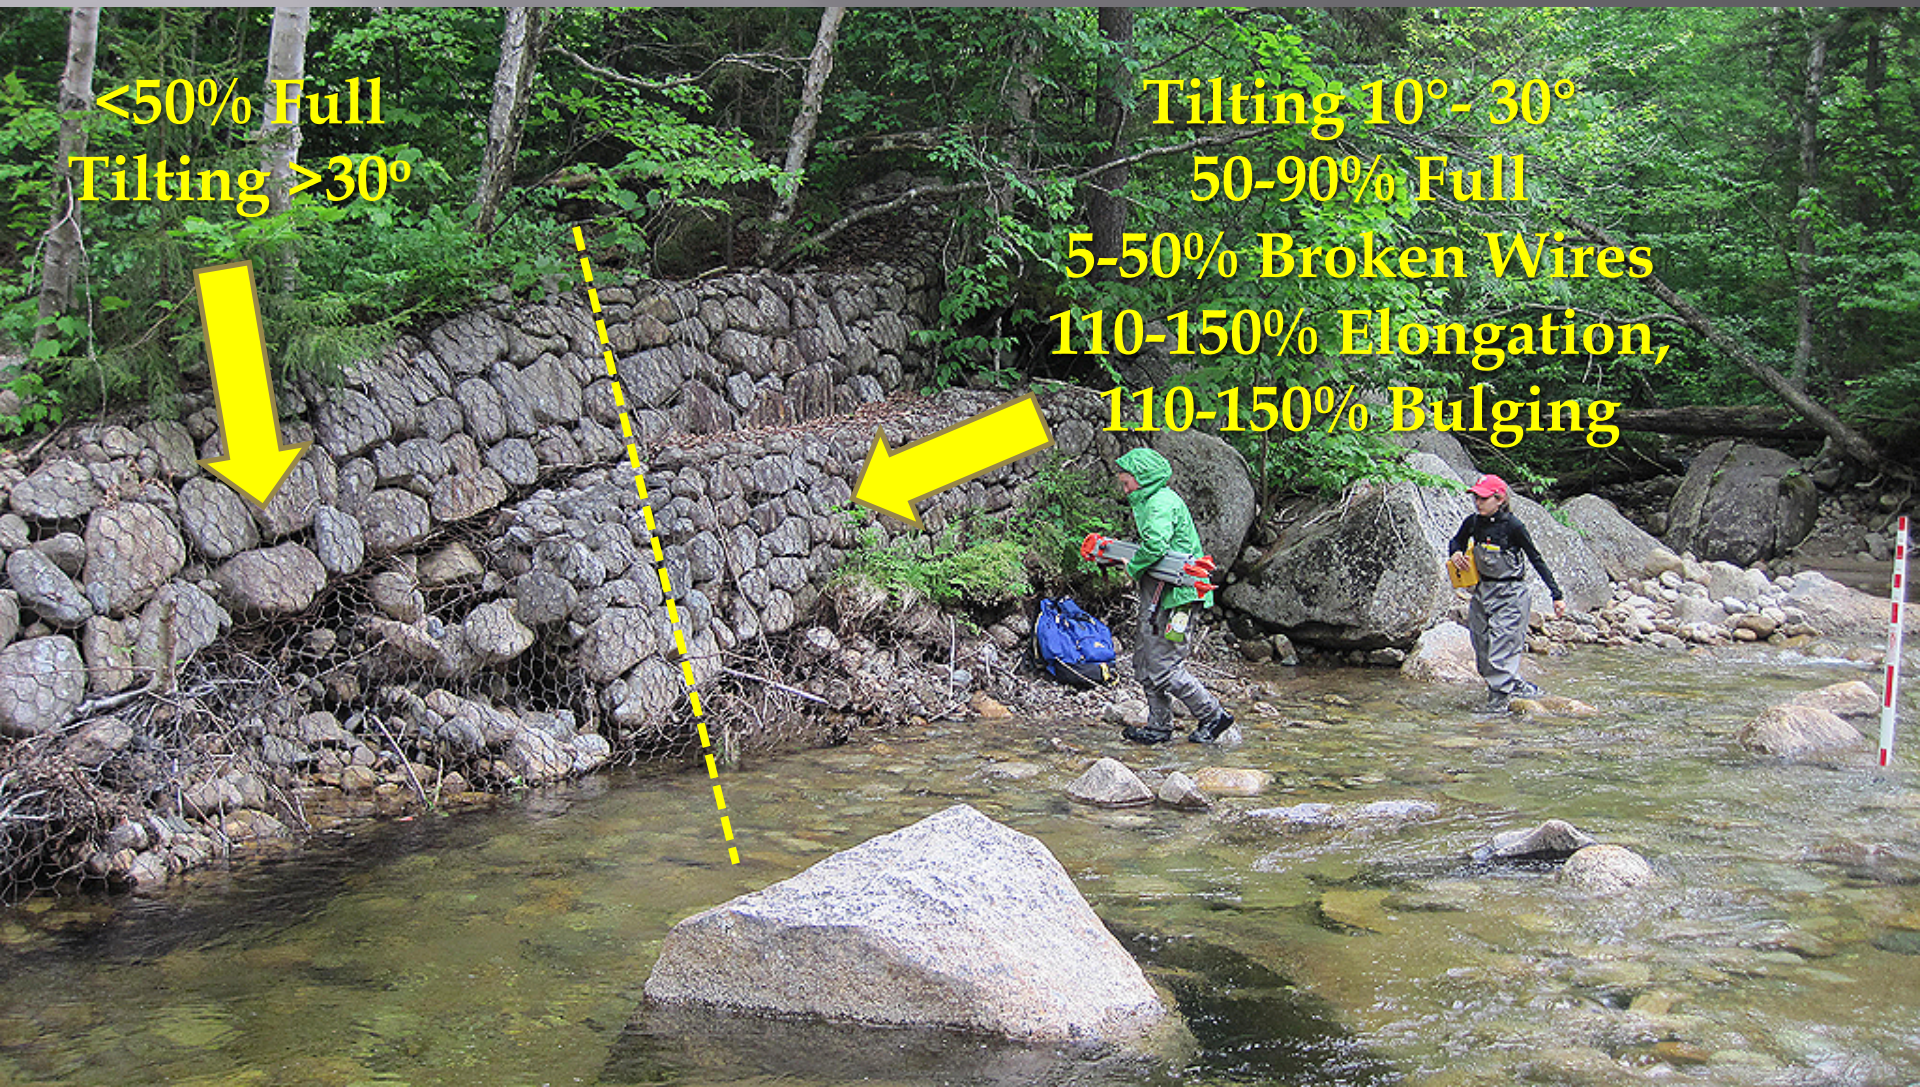
Failed

Damaged

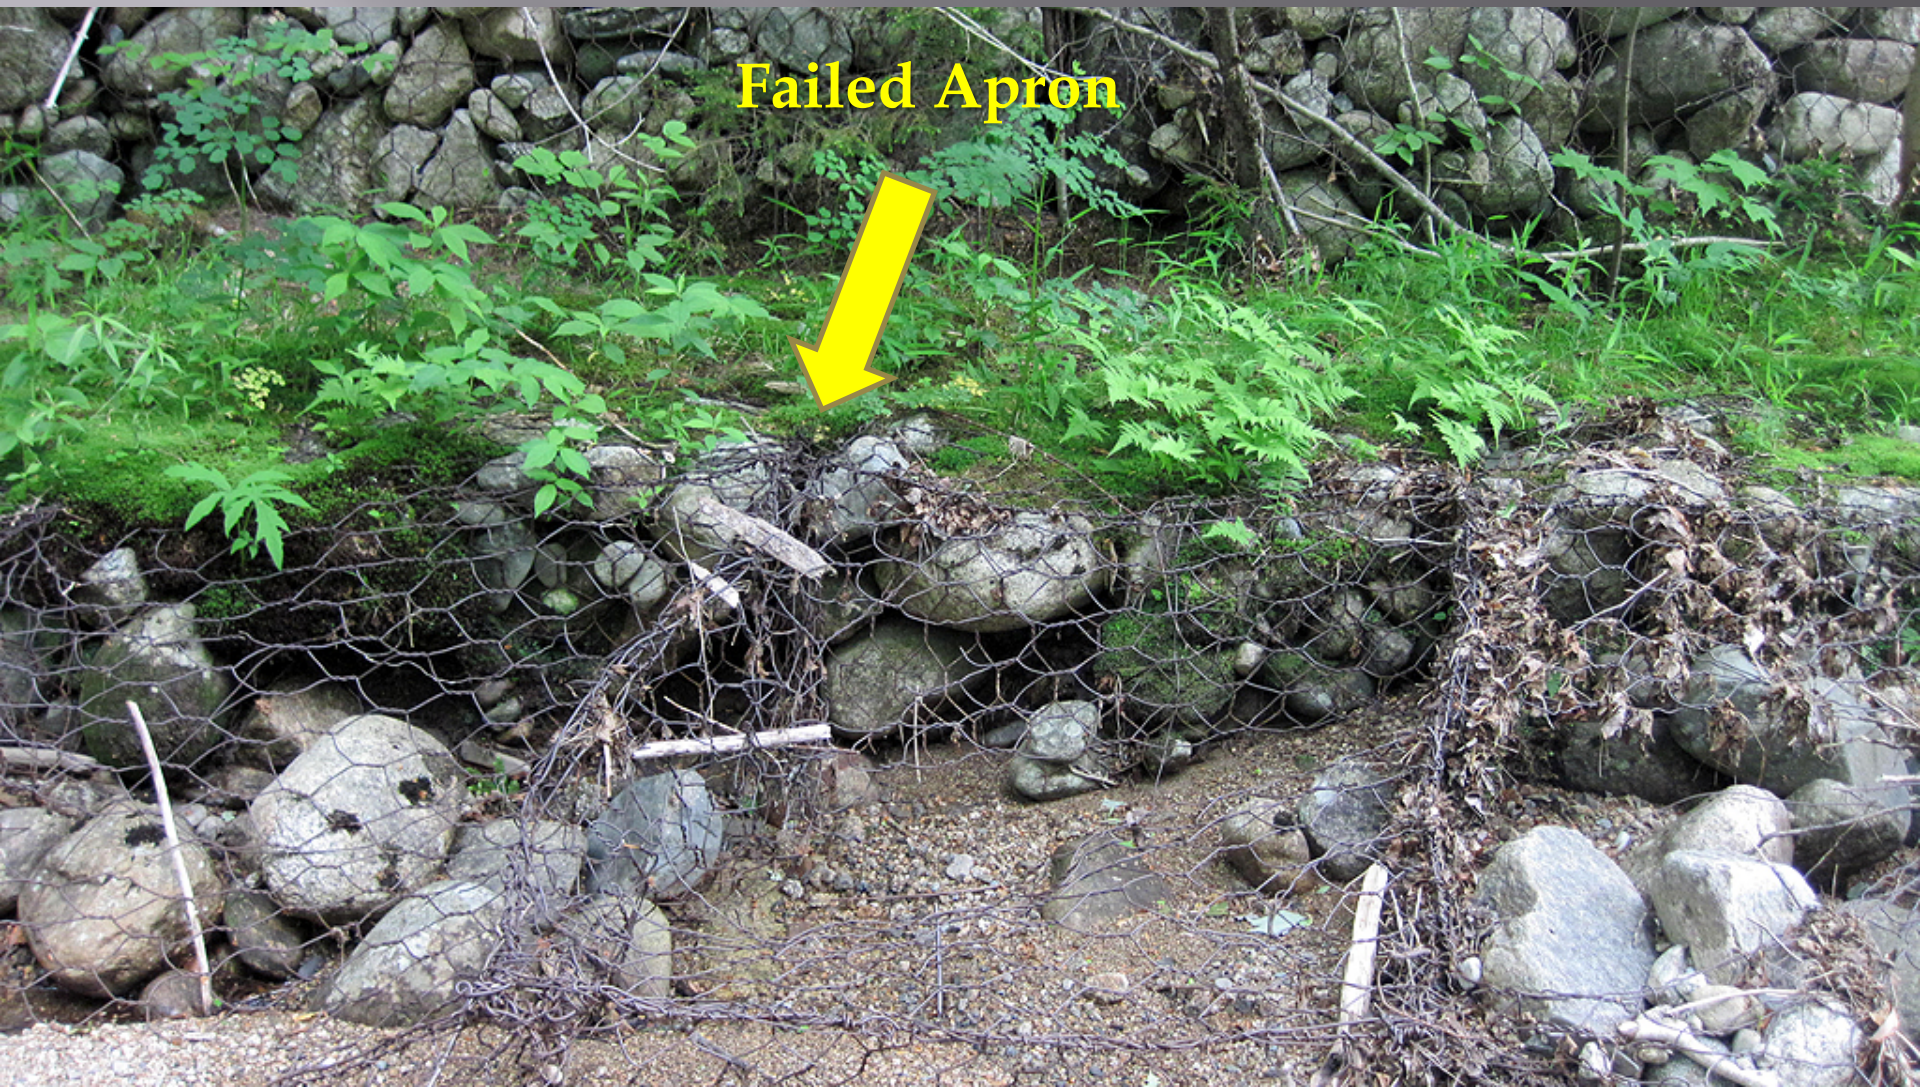
Damaged

Failed Apron

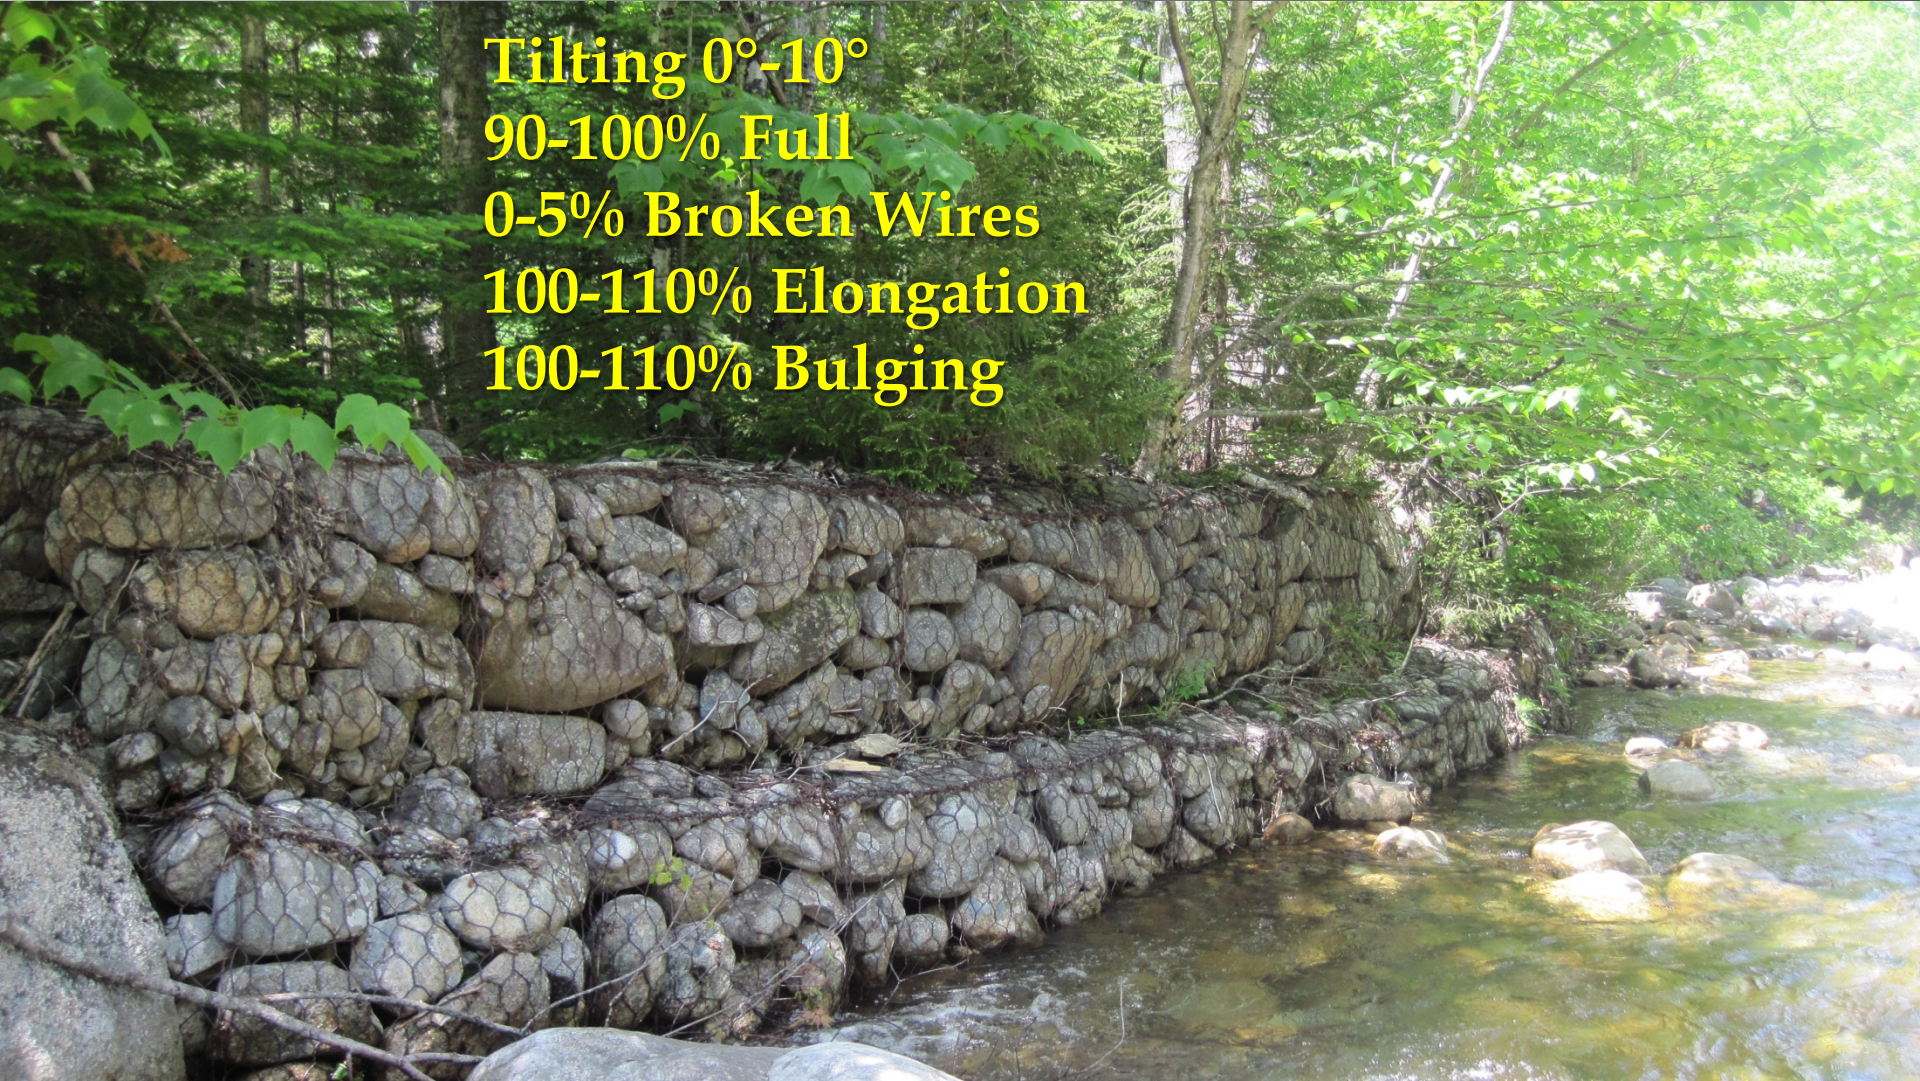
Intact

**Tilting 0°-10°
90-100% Full
0-5% Broken Wires
100-110% Elongation
100-110% Bulging**

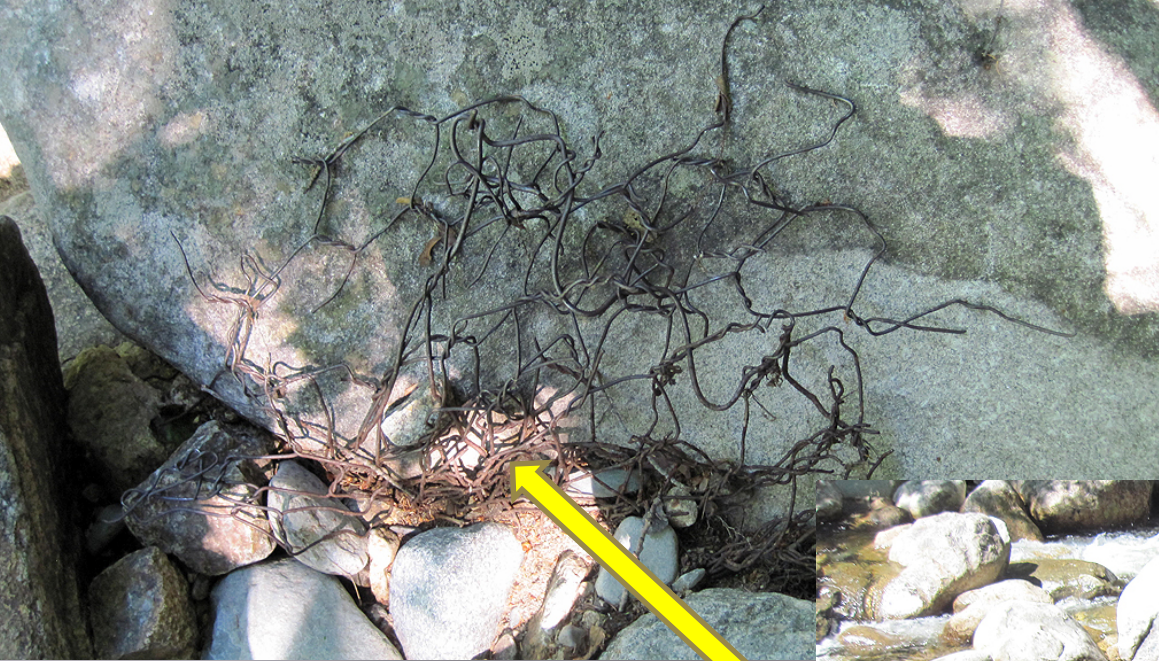
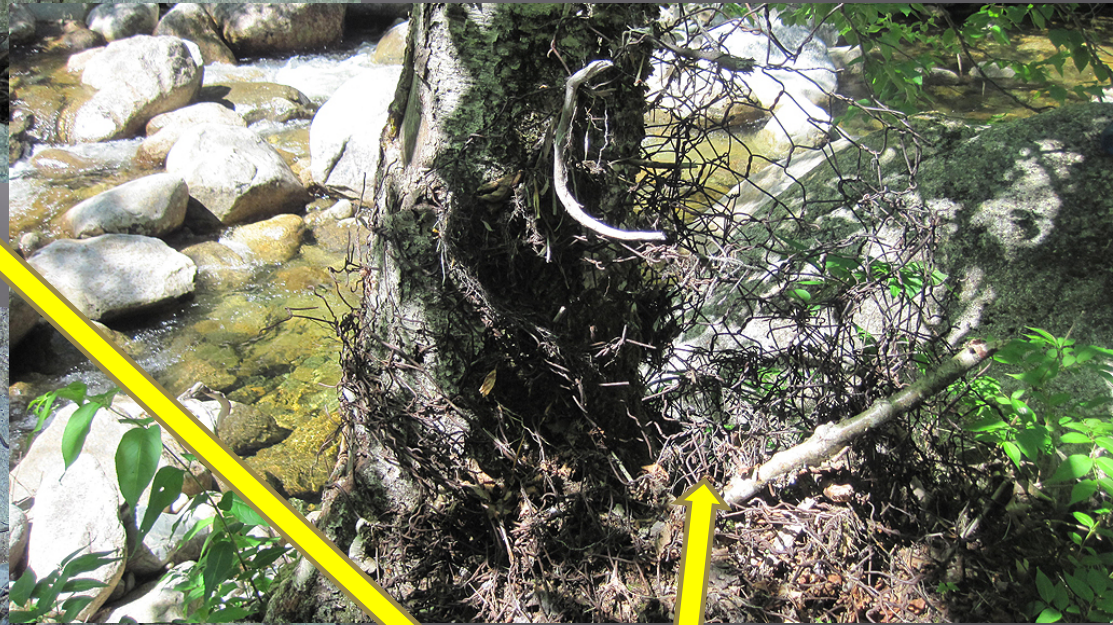
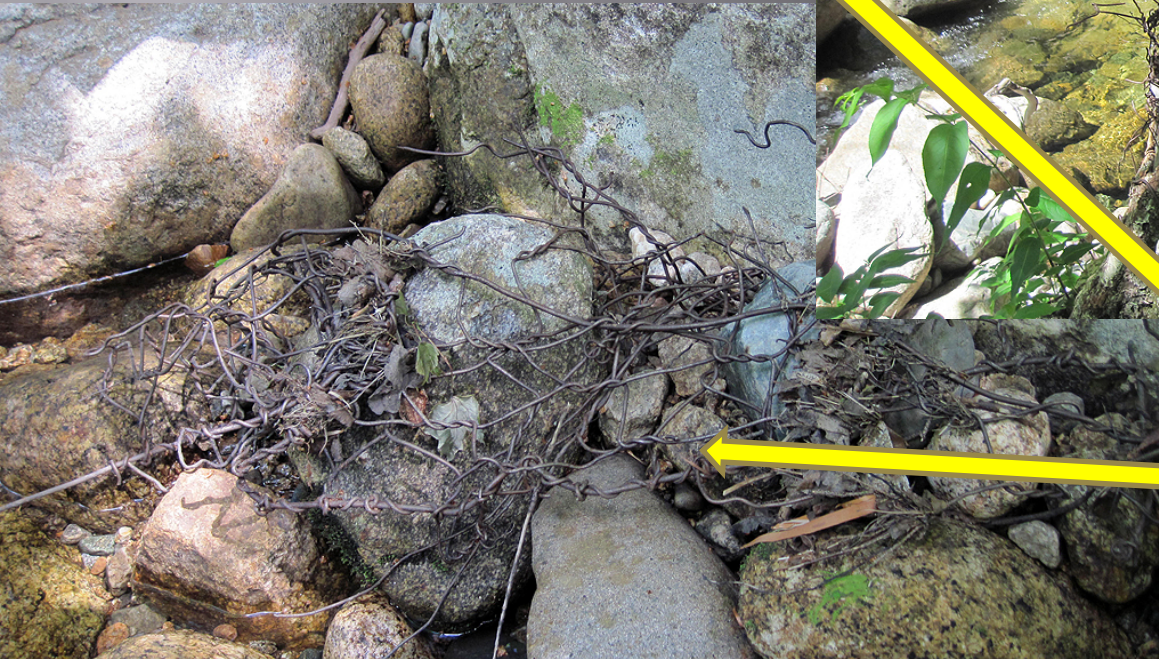
Upper
Reach

wire from
failed sills?

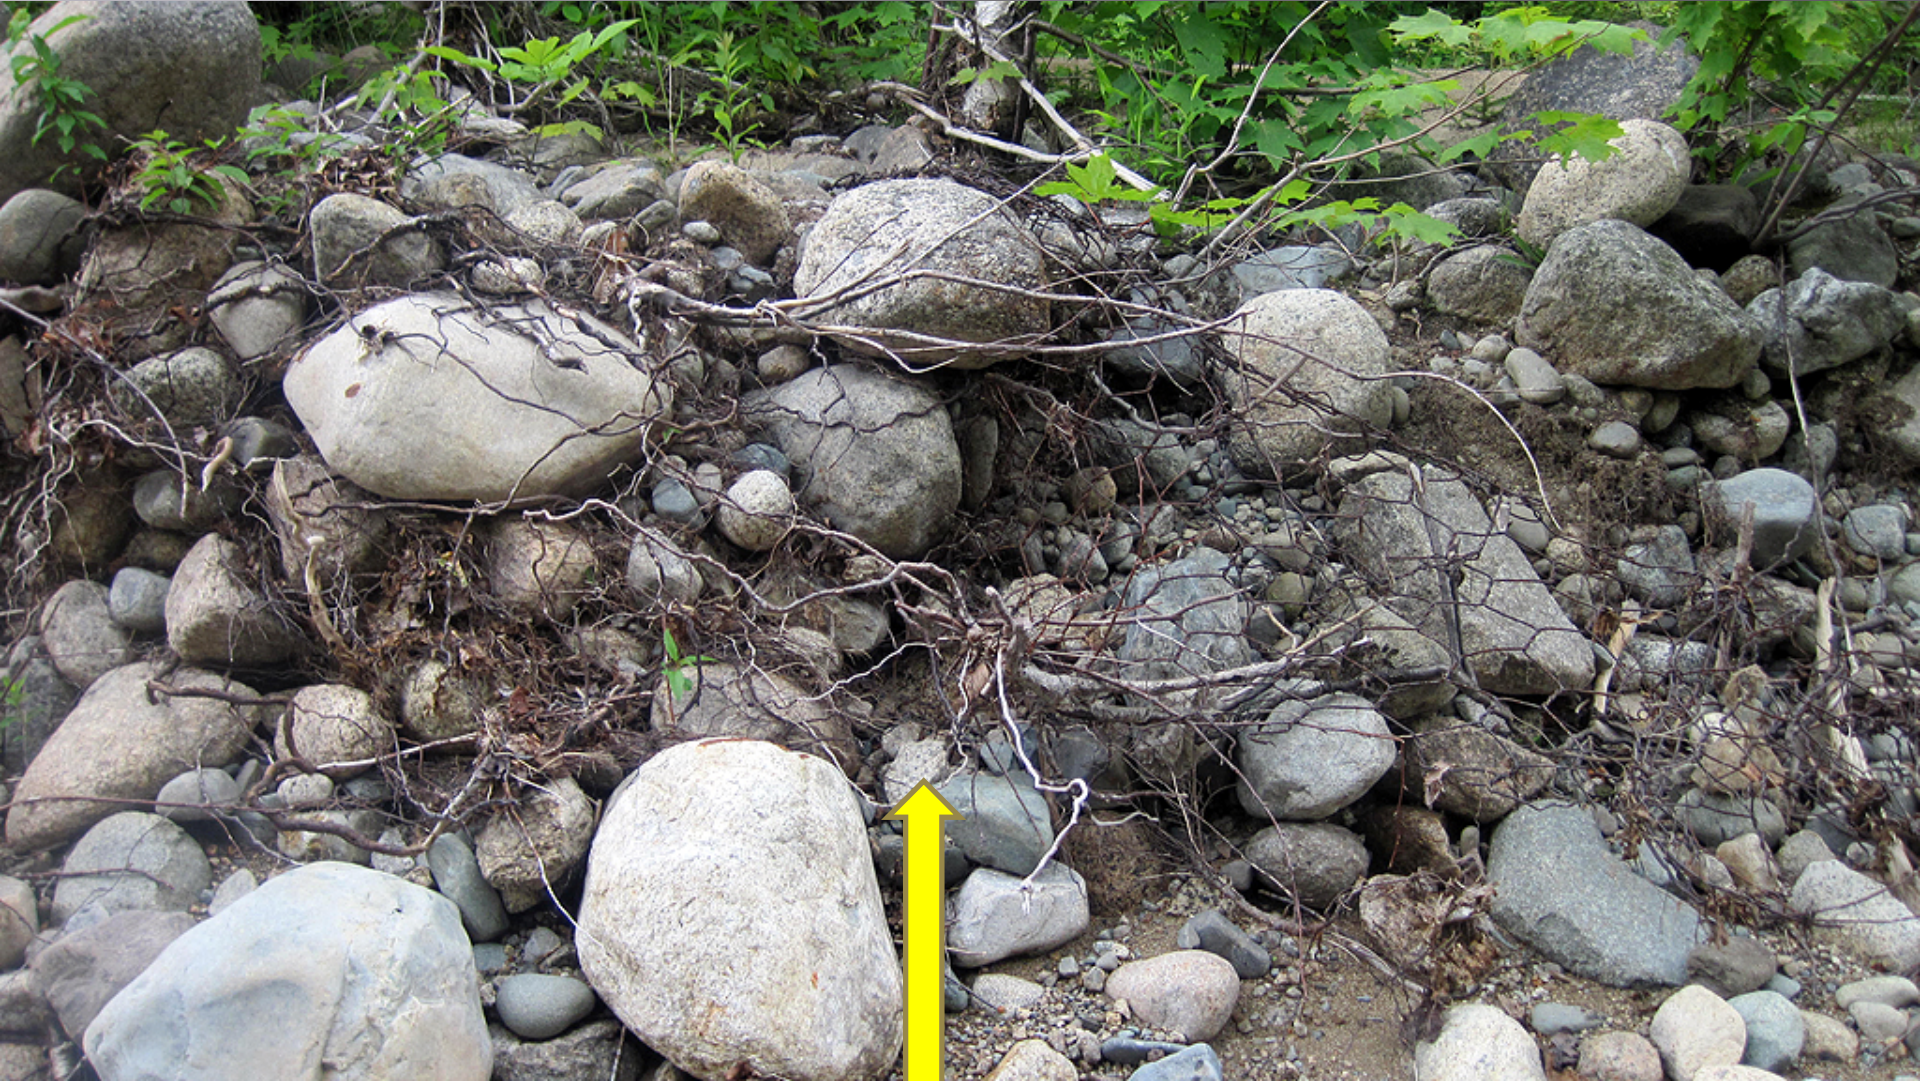
Middle Reach

damaged sills

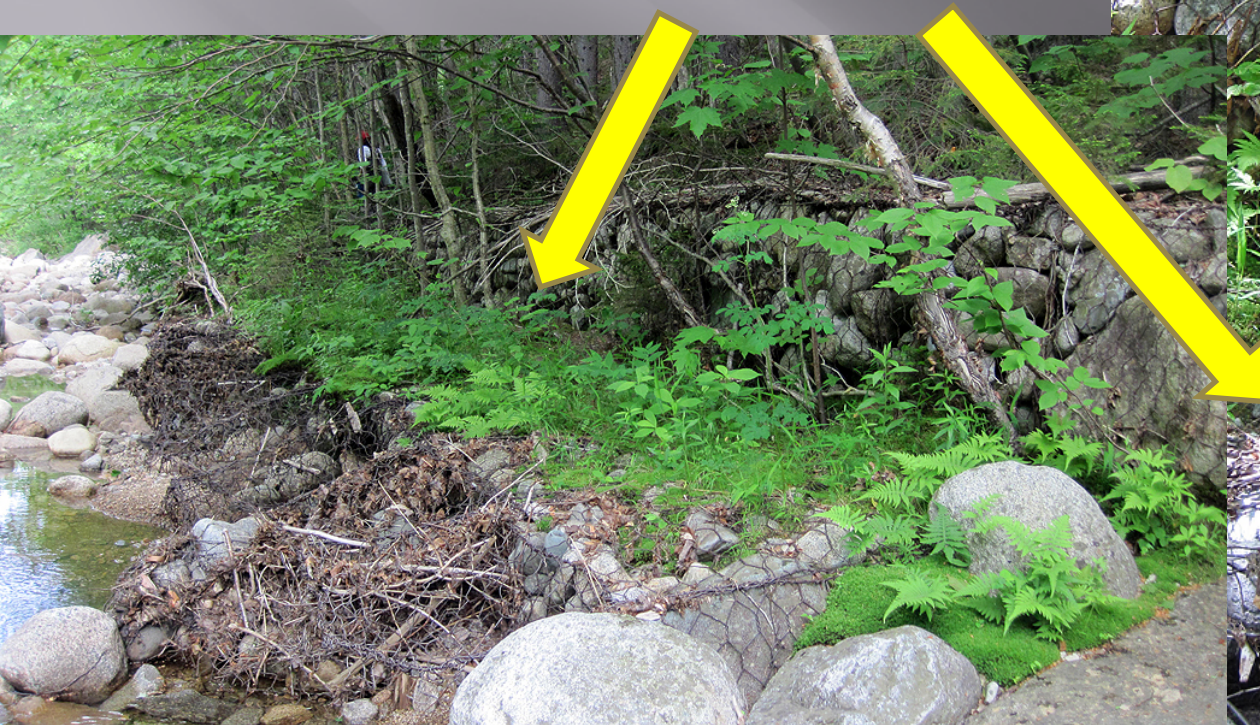
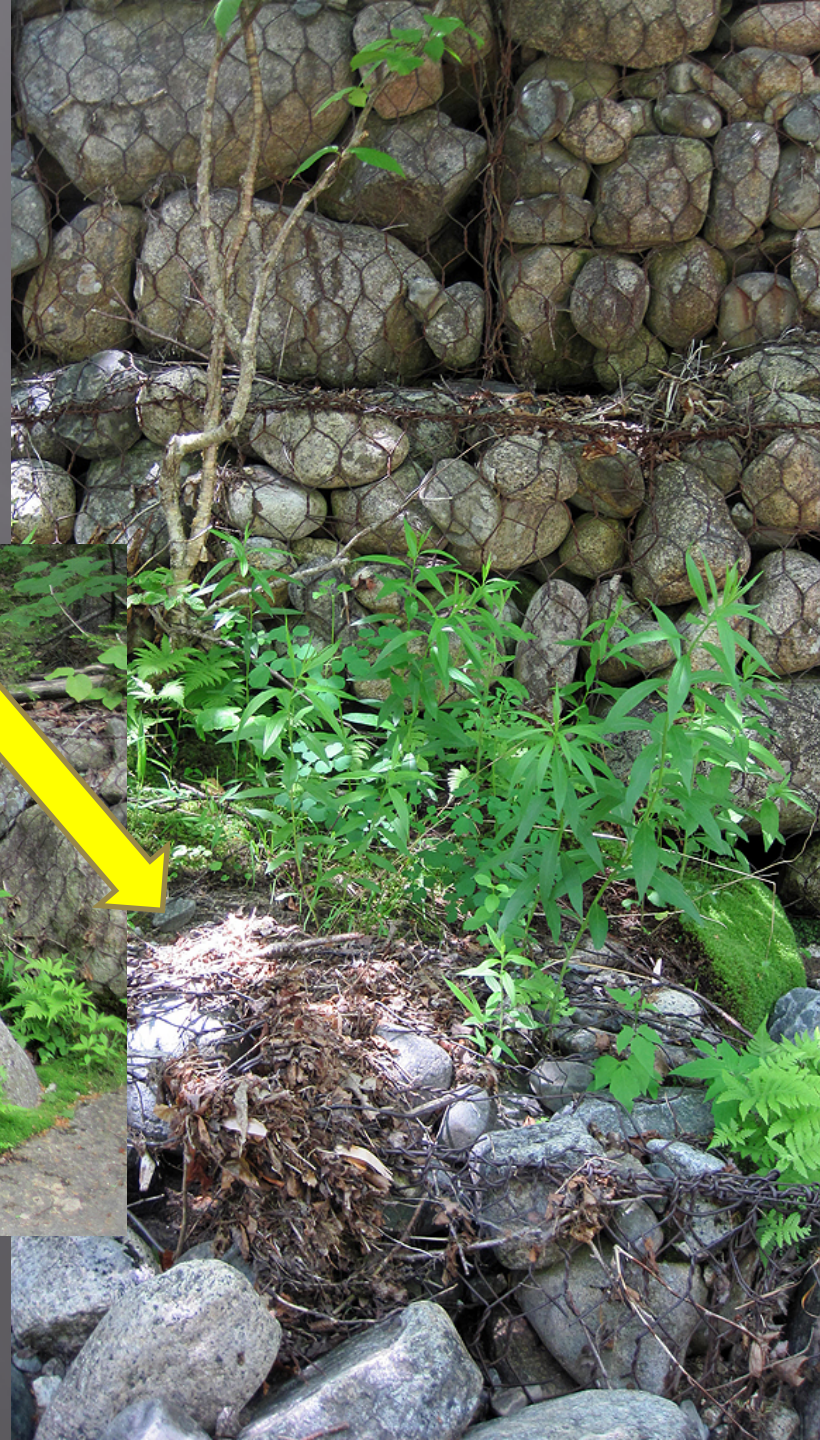
Middle Reach

exposed aprons

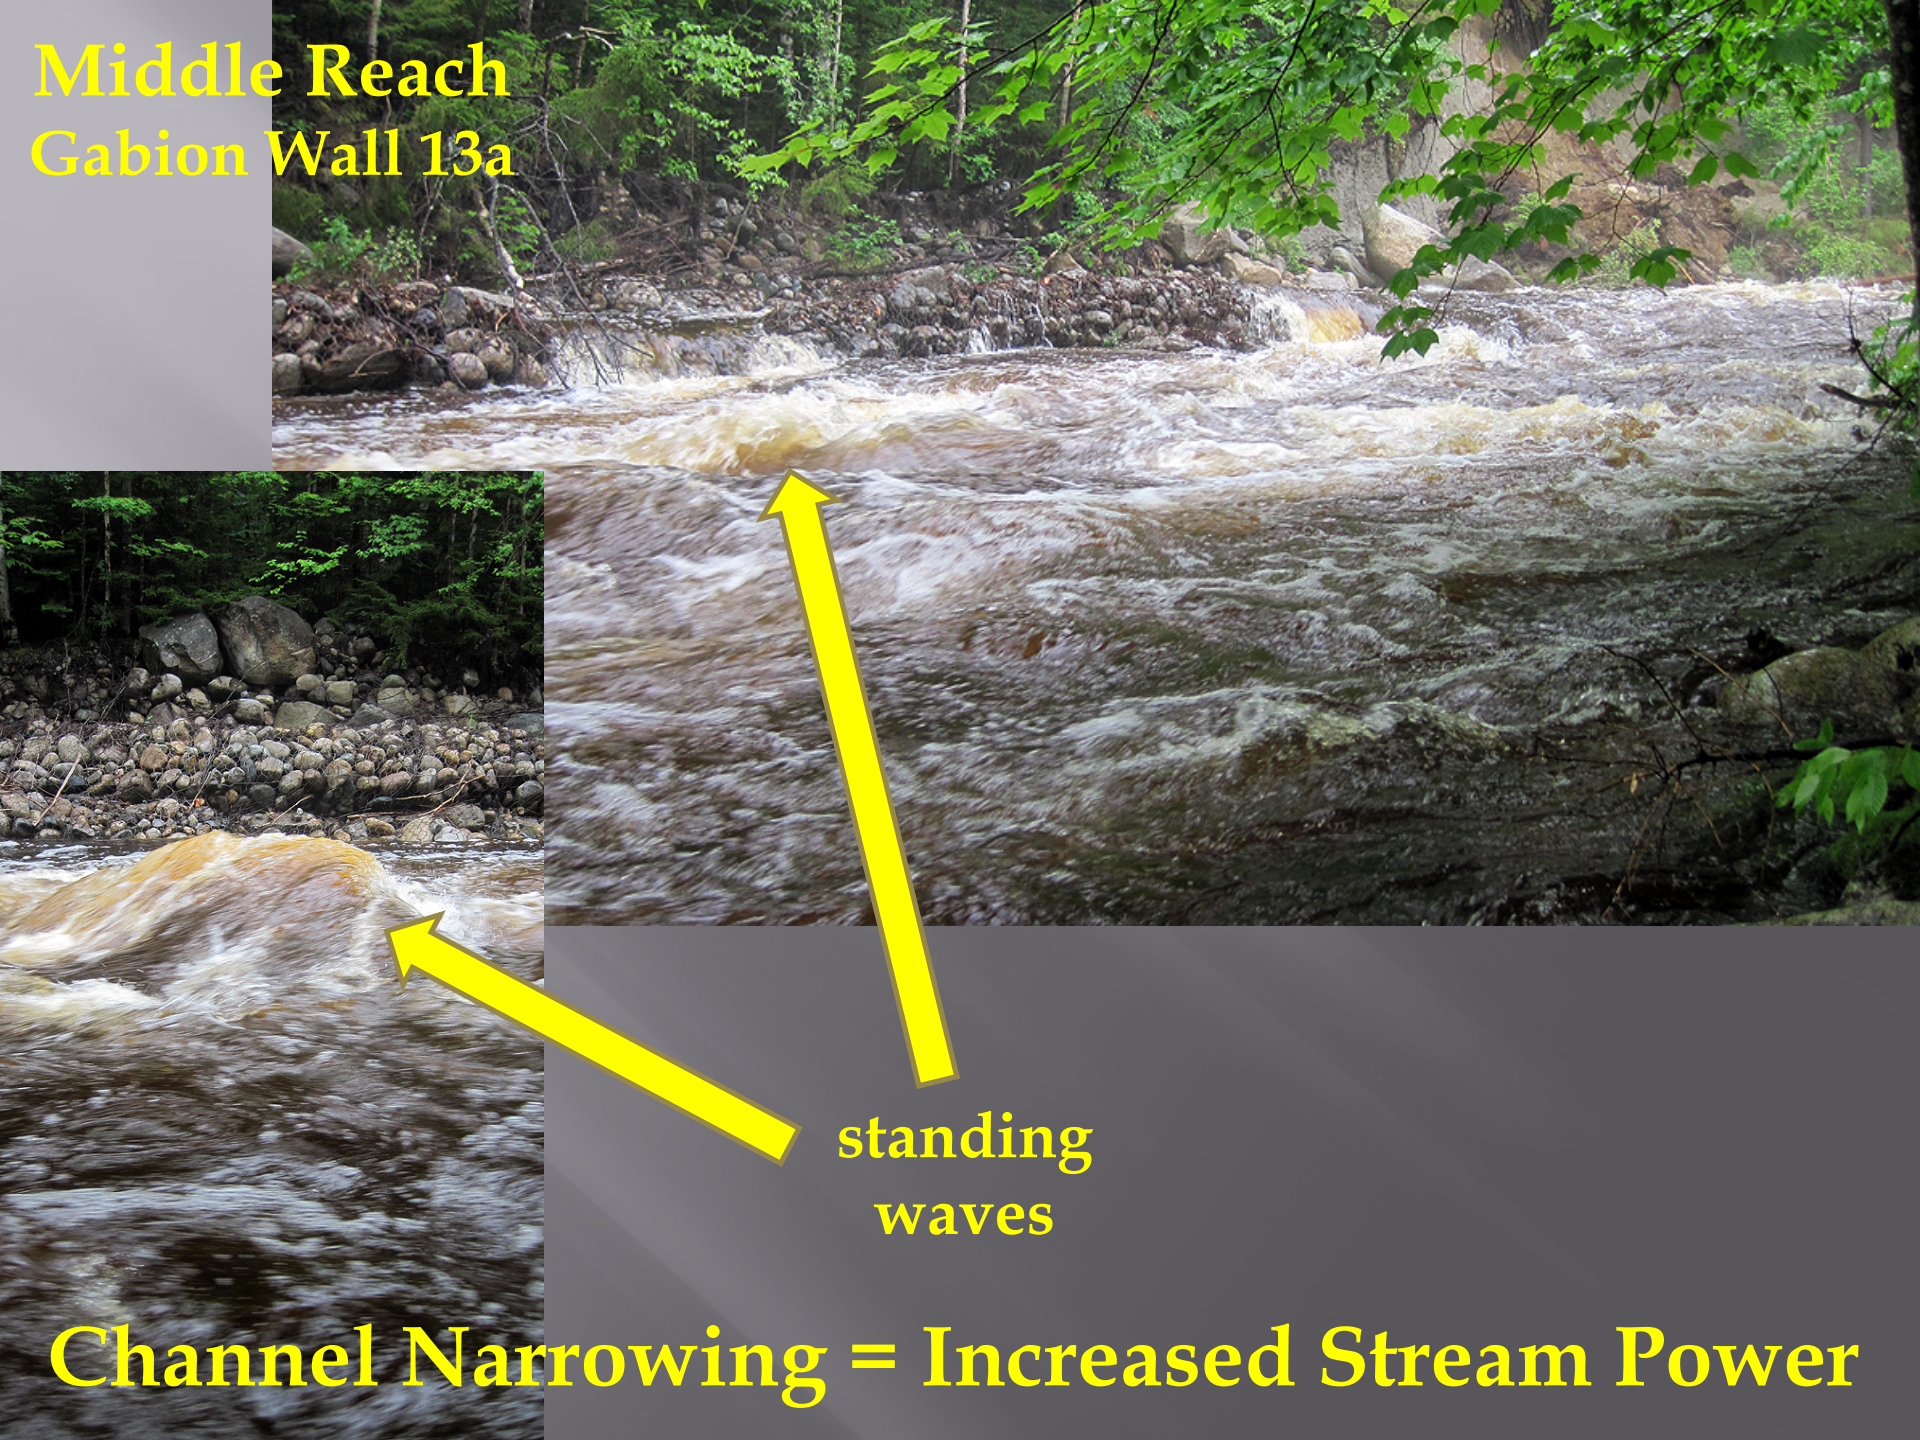
Middle Reach Gabion Wall 13a

standing
waves

Channel Narrowing = Increased Stream Power
