The Role of Channel Armoring with Gabions on Channel Adjustments on the Zealand River, New Hampshire

Douglas M. Thompson, Leah S.
Puklin and Anna E. Marshall

Connecticut College

2014 Gabion Assessment

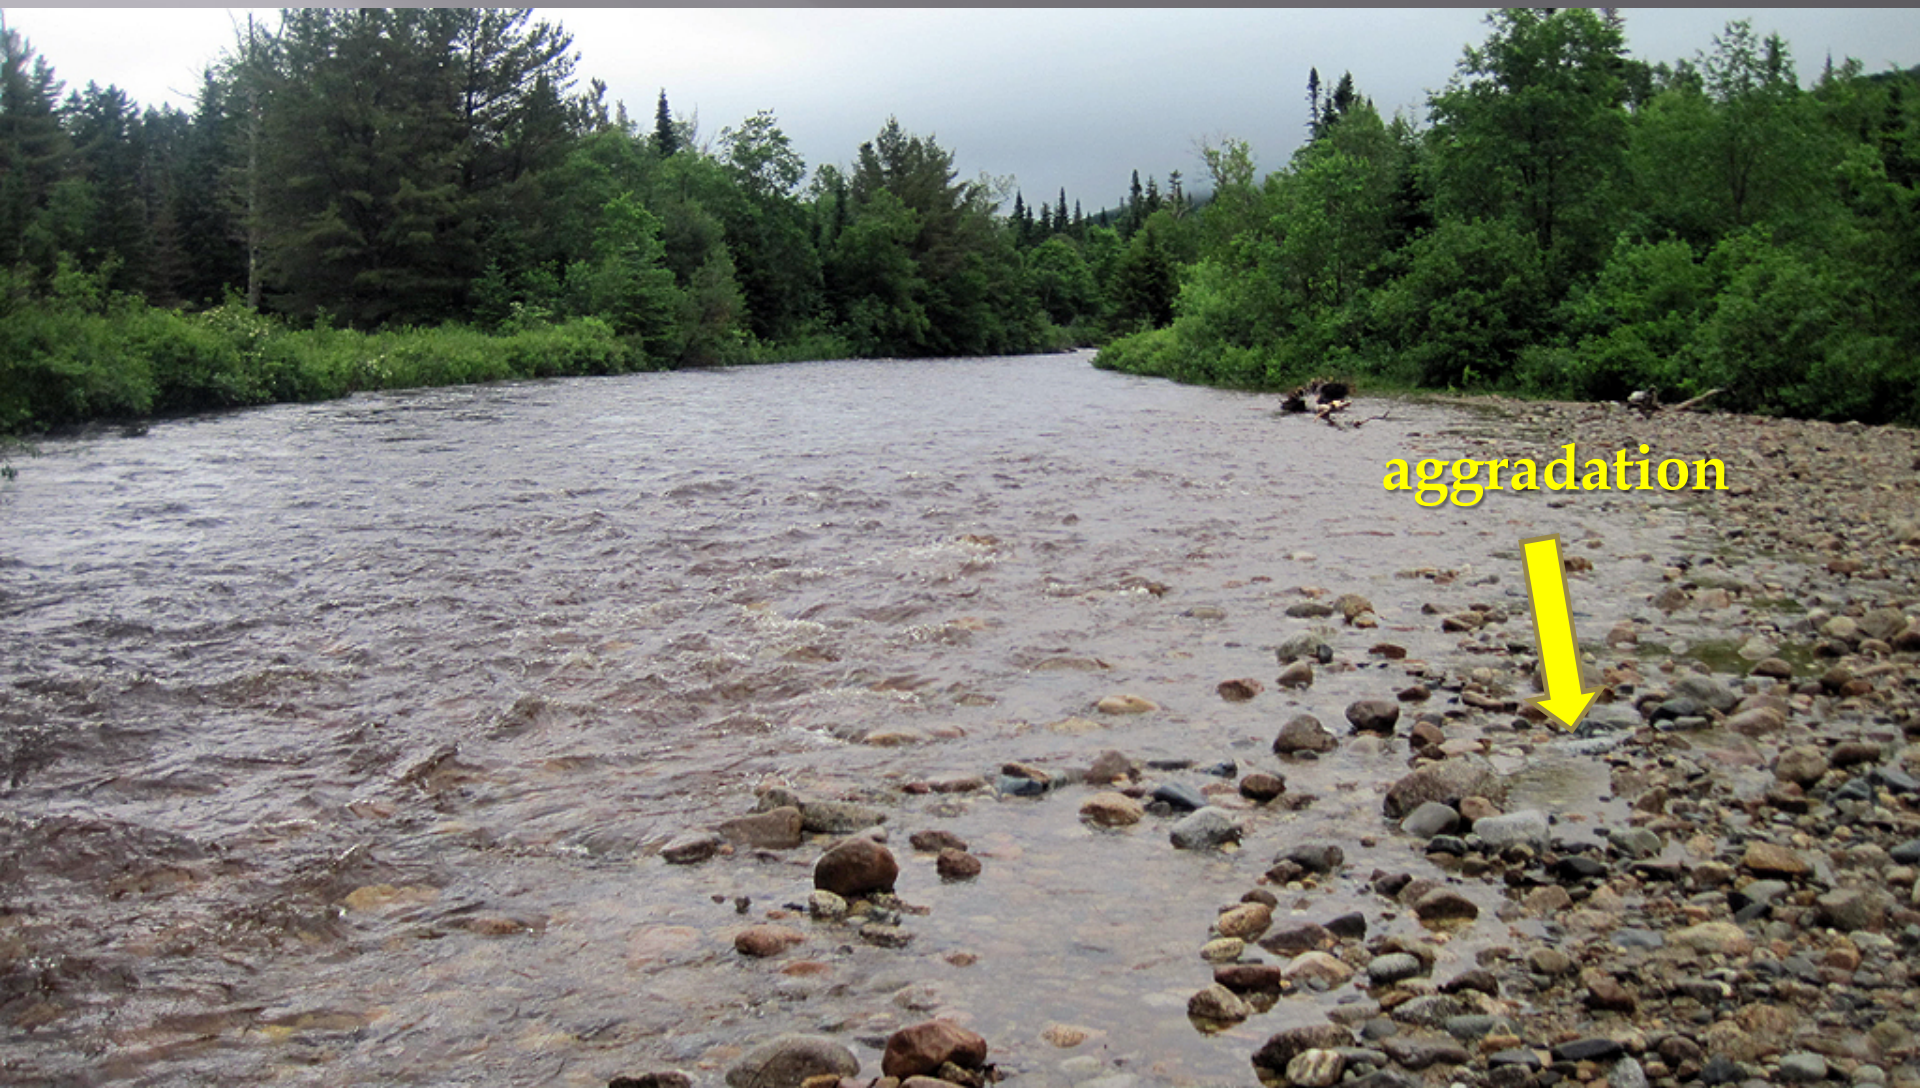
aggradation

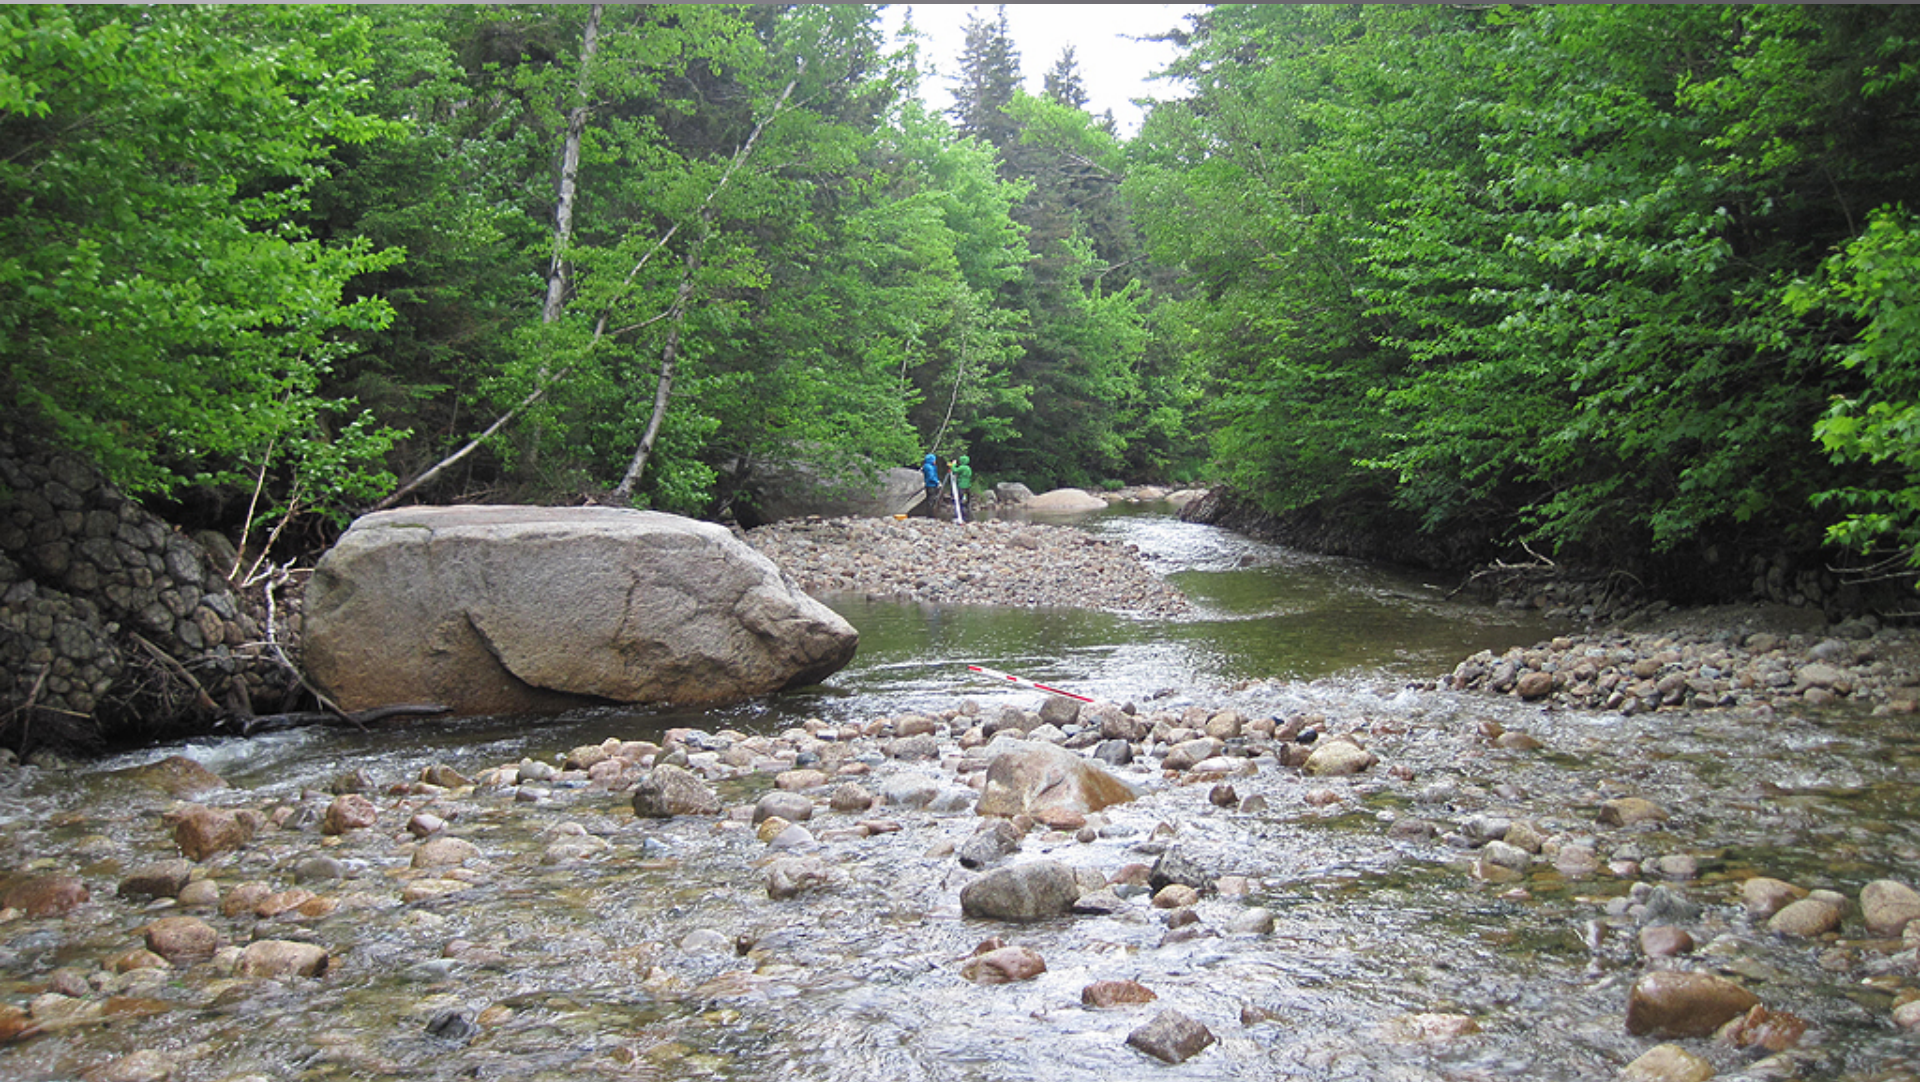
Continuing Concerns

Increased Stream Power

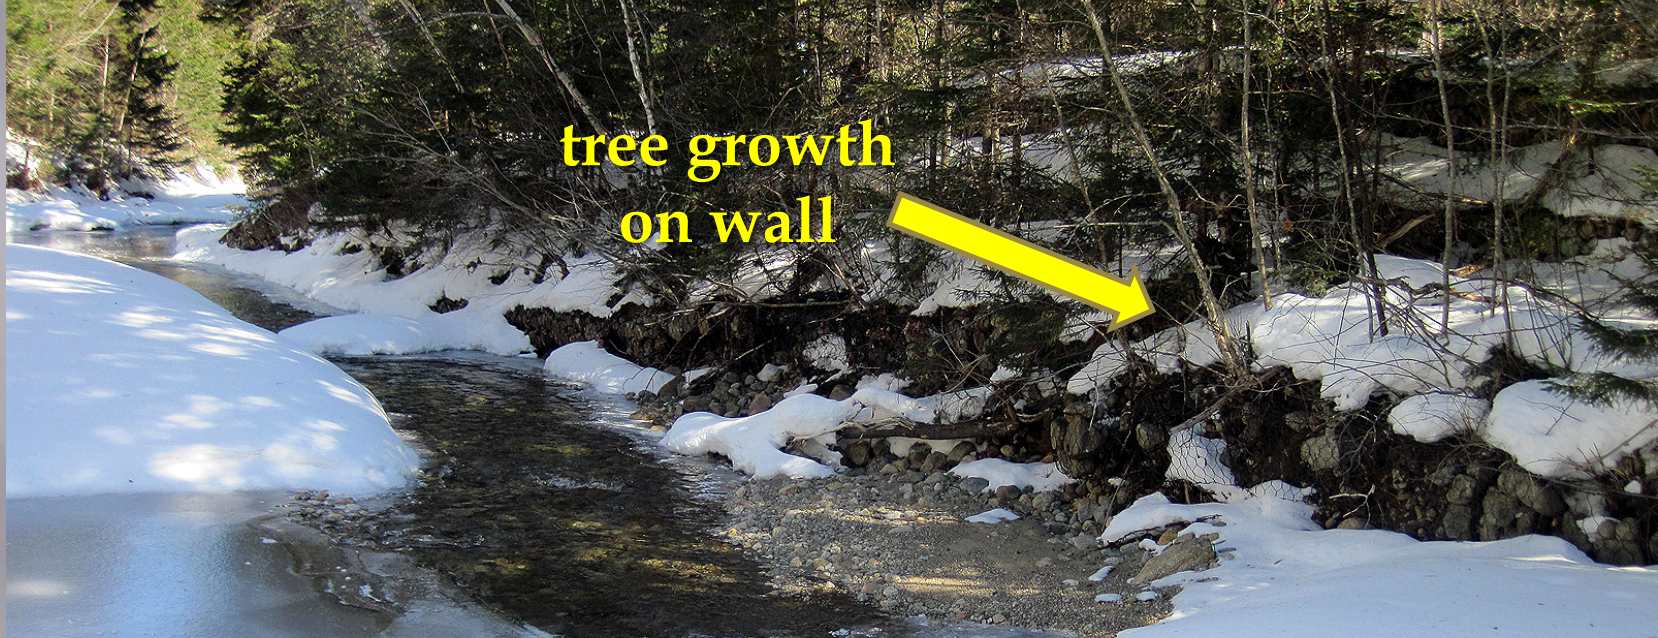
tree growth
on wall

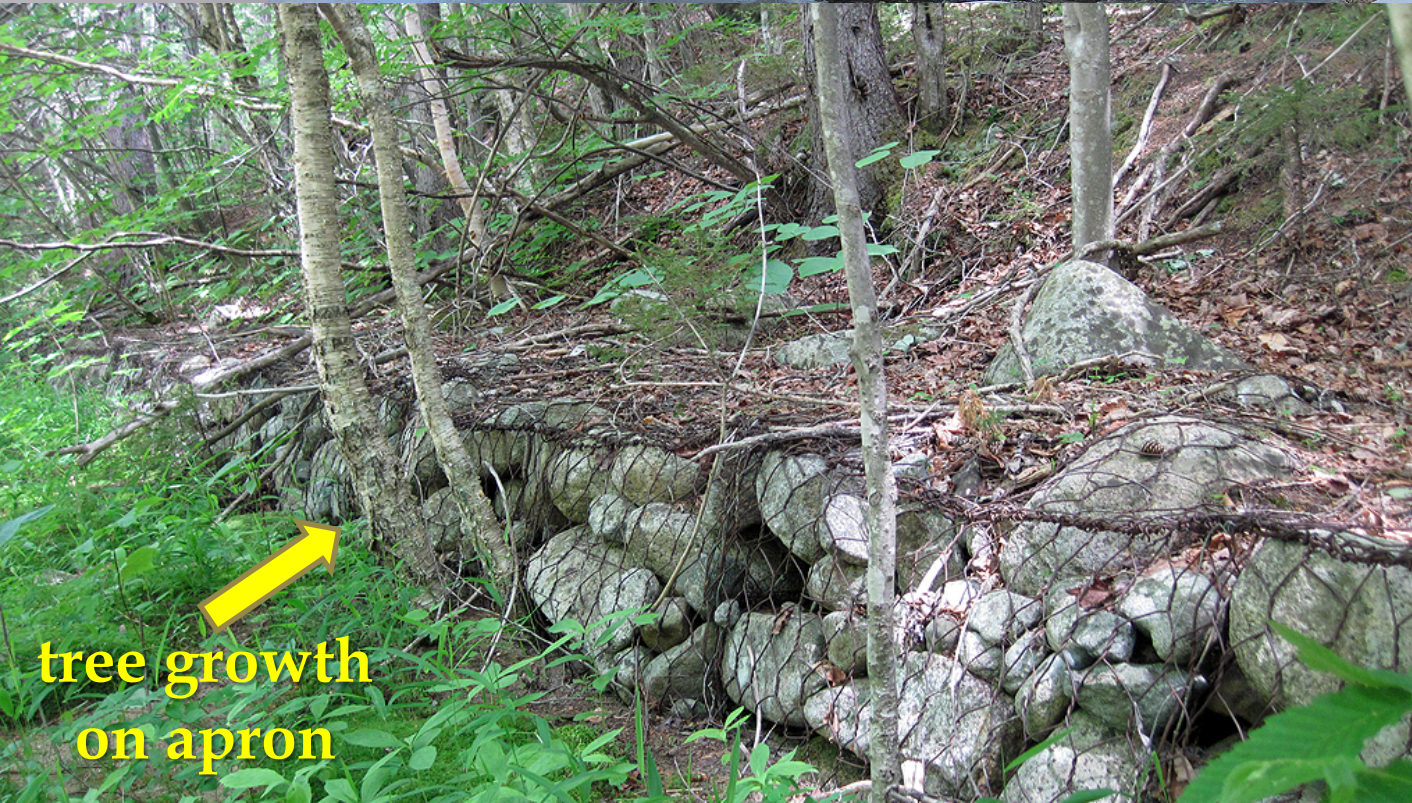
tree growth
on apron

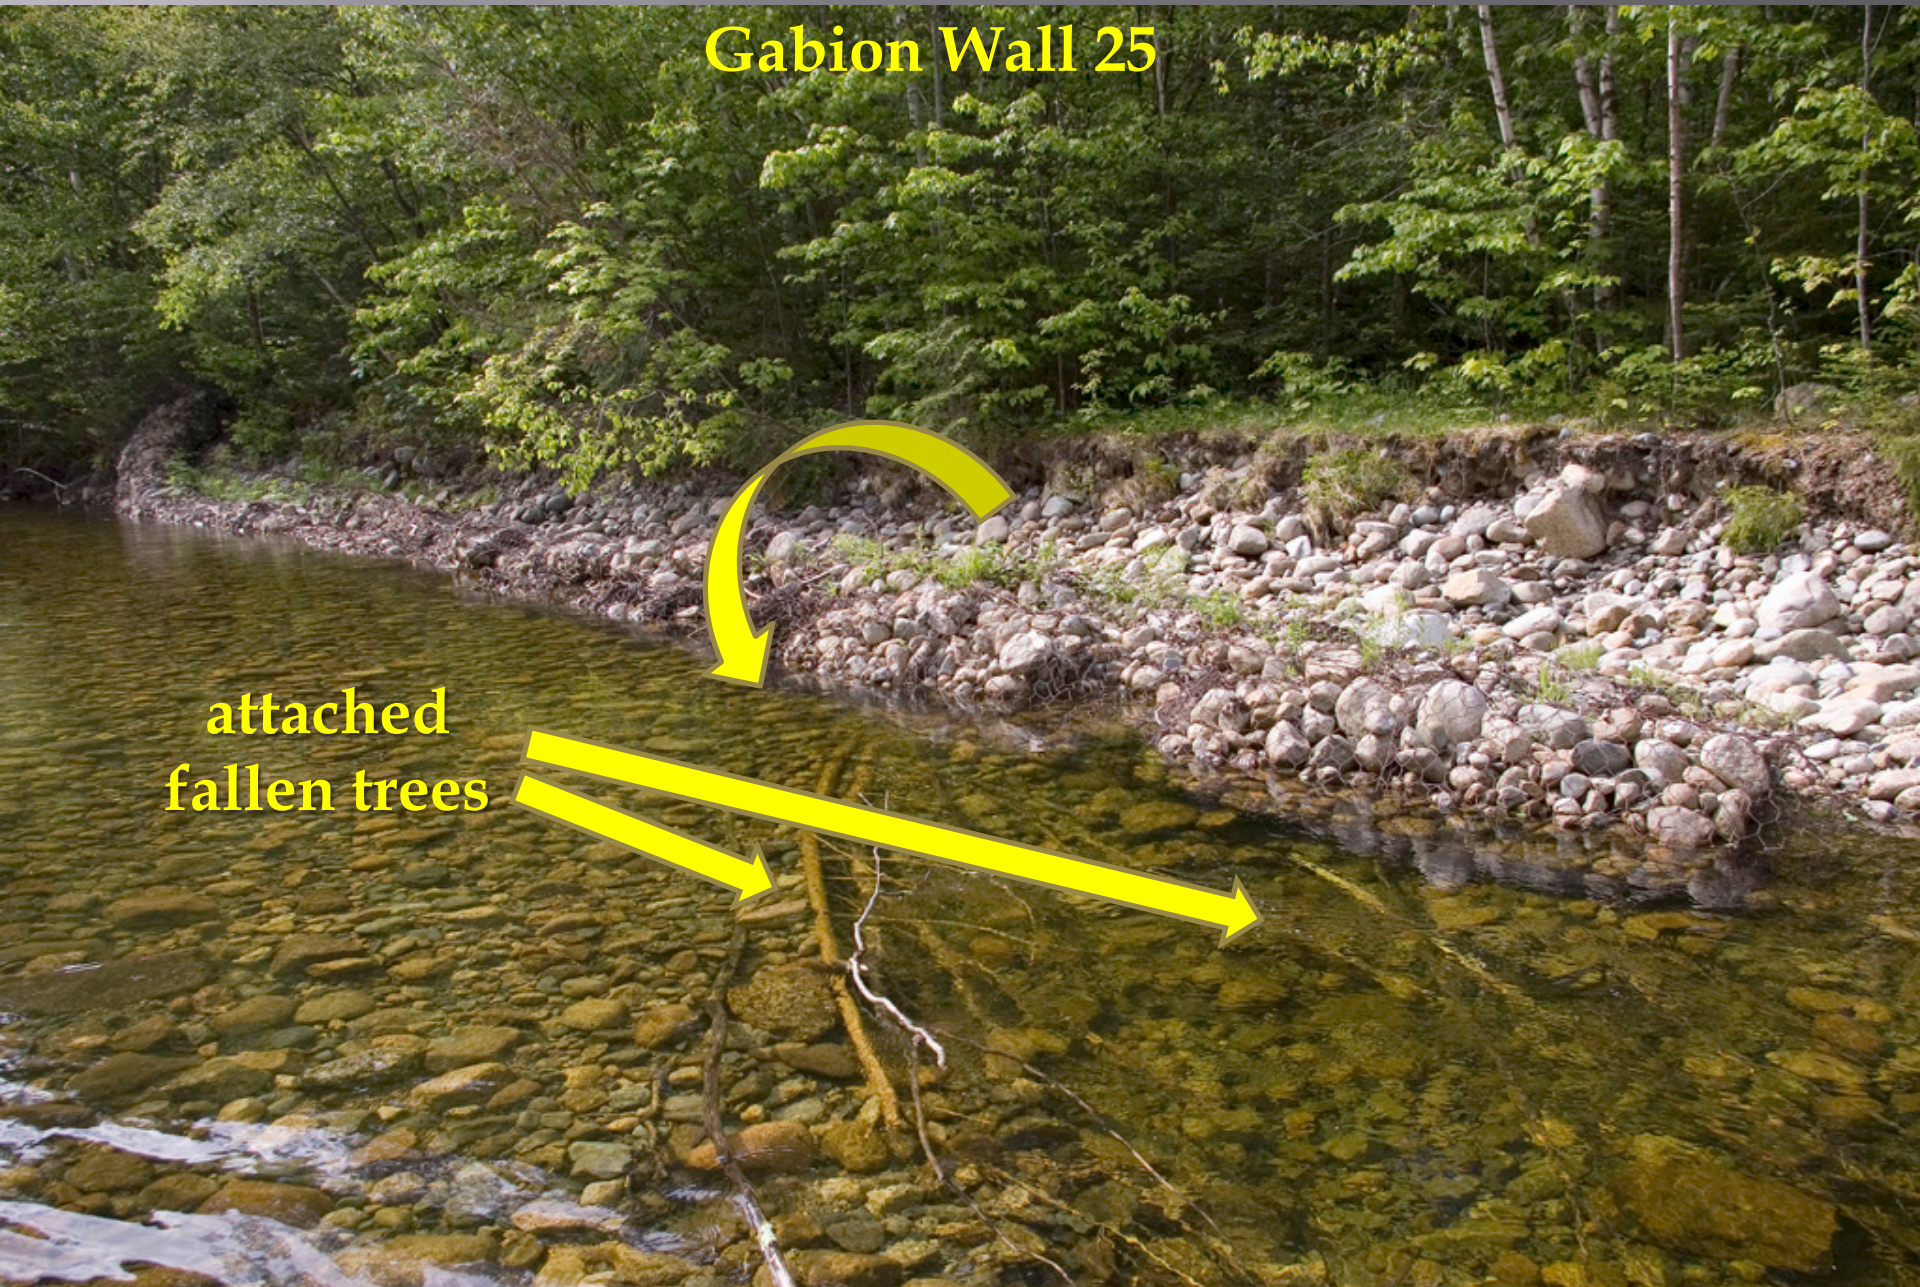
Lower Reach Gabion Wall 25

attached
fallen trees
