Paper No. 299-12, [T150. Advances in Understanding Processes at or Near the Groundwater–Surface Water Interface](#)

25 September 2019: GSA Annual Meeting in Phoenix, Arizona, USA – 2019, Geological Society of America *Abstracts with Programs*. Vol. 51, No. 5

AN ENGINEERING GEOLOGICAL ANATOMY OF THE PADMA RIVER BANK FAILURE AND EROSION, 2018: A CASE STUDY OF NARIA BANK SECTION, BANGLADESH

This presentation is on last year's (2018) river erosion along Padma R, near Naria with possibilities of preparation of engineering geological maps and database.

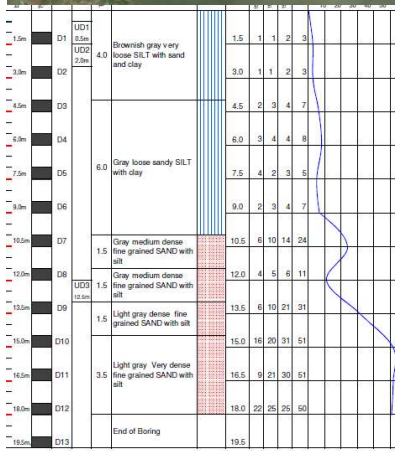
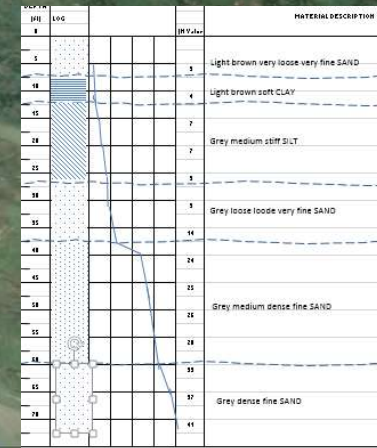
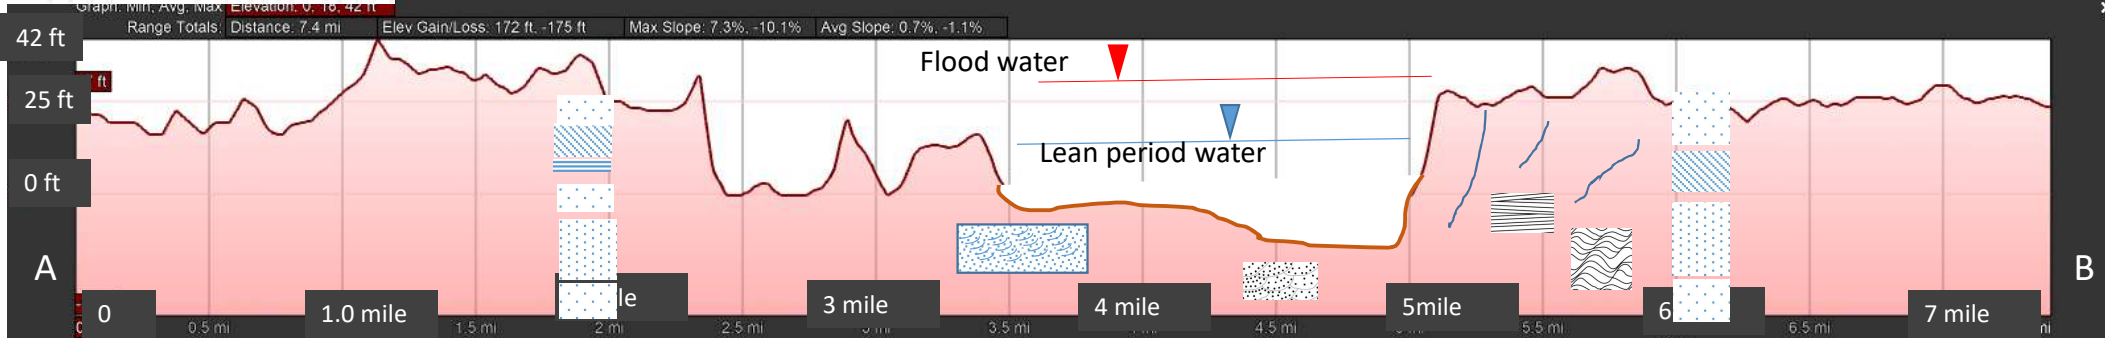
The exposed bank materials

Top soil: 2-3 ft:

Brownish gray loamy soil or plough soil, mostly moist to dry, moderately permeable, fractured, Contains rootlets and perforations.

Below topsoil:

Sand: Gray and light gray, fine with medium, highly micaceous, laminated with fine silt, cross bedded, mostly rounded quartz, loose sand.

Alternating cross-bedded silt and micaceous fine sand of very high dilatancy and low angle of friction due to presence of micaceous sand.

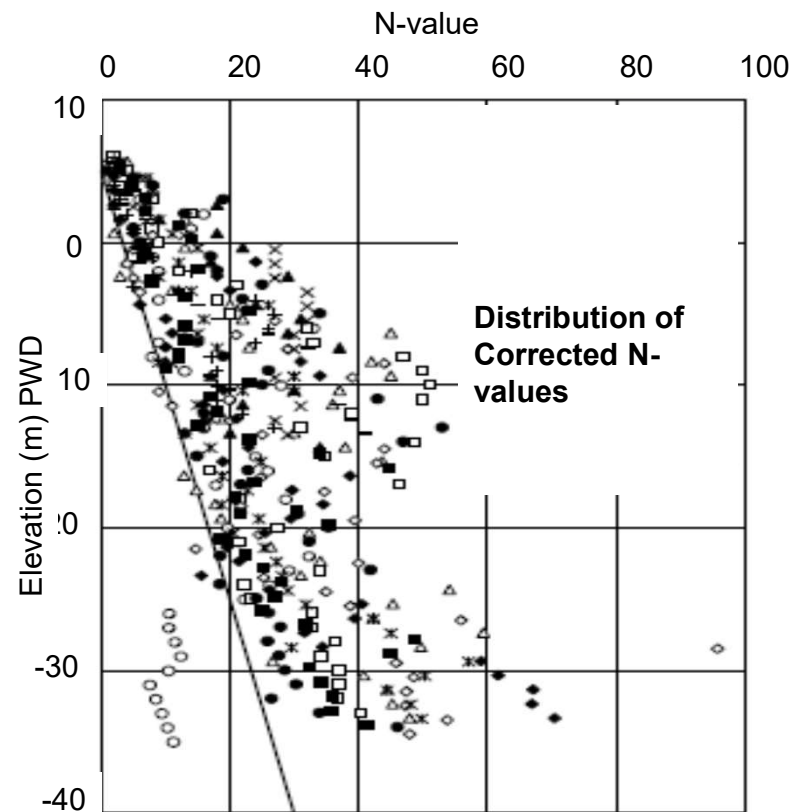
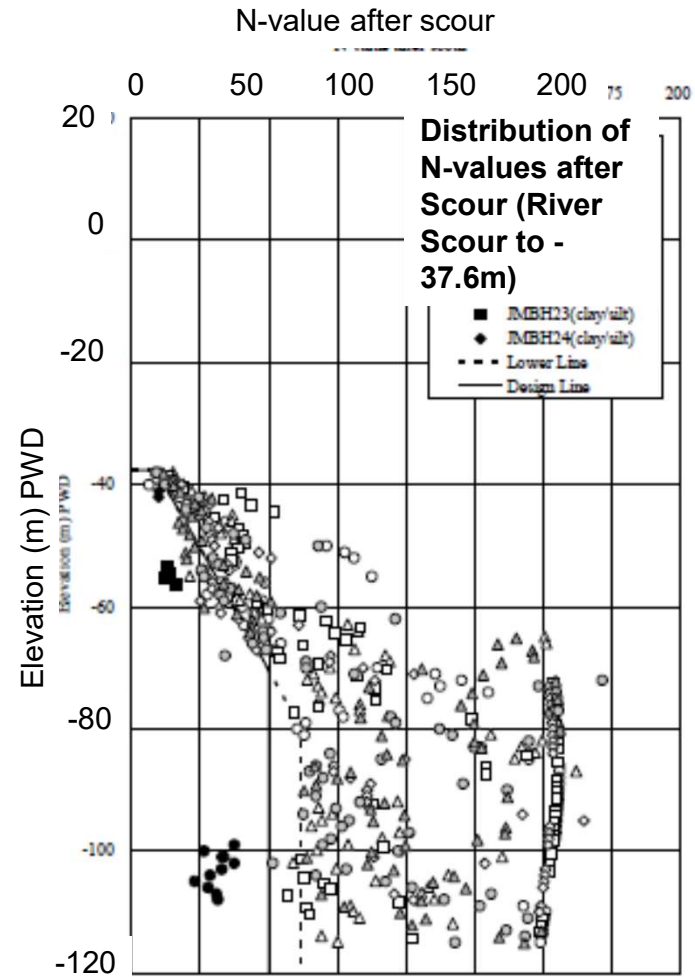
Geotechnical Characteristics

RIVER BED CONFIGURATION -The deep trenches form along right bank and render the ground increasingly more vulnerable to subaqueous slope failure due to presence of thick (~200 ft.)

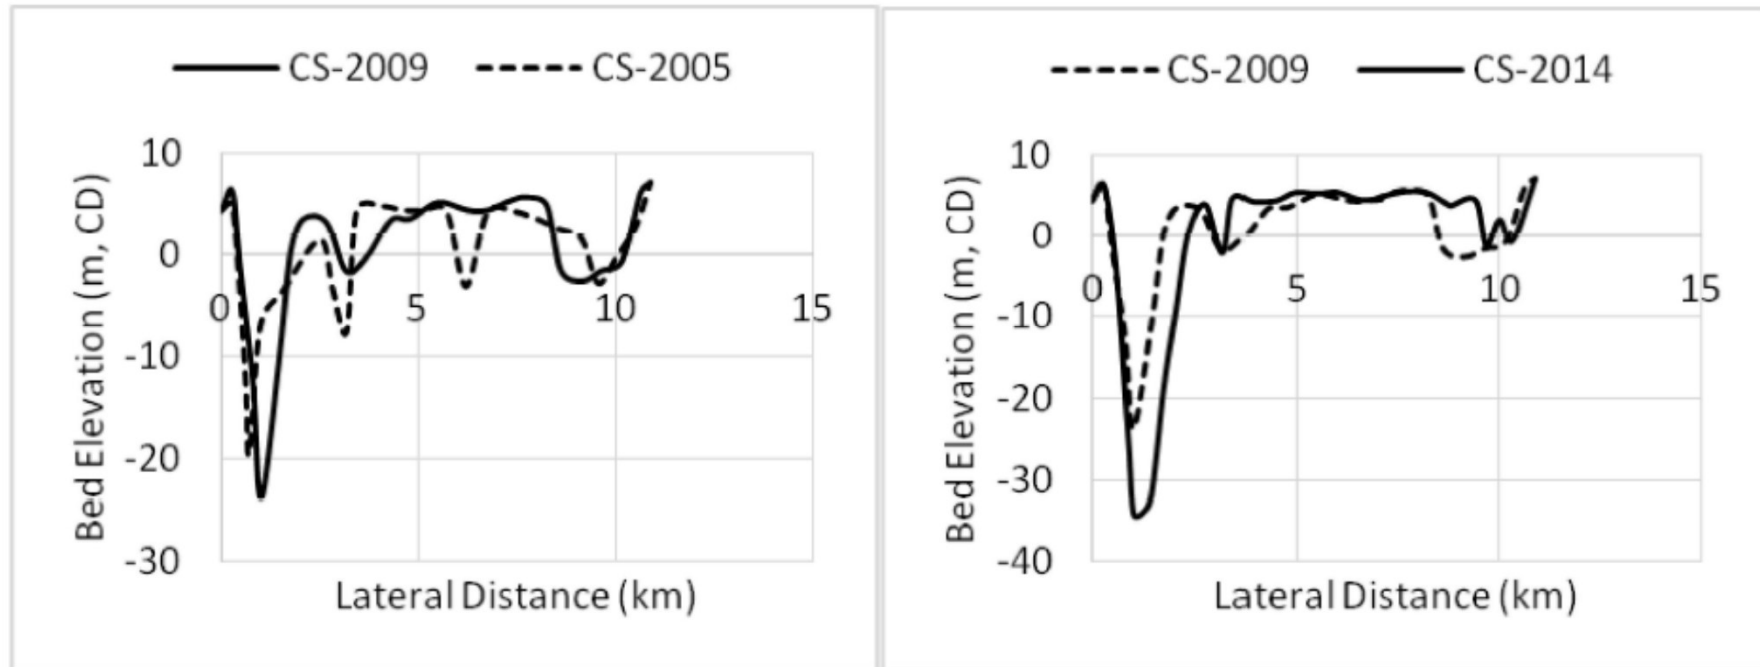
A typical cross sectional variation of Padma River at Bauria BWDB Station between 1996 and 2014

An investigation by [Uddin, M J. et al \(2017\)](#) at Baruria Transit station showed a dynamic behavior and deep bed level variations.
