# ENGINEERING GEOLOGY'S ROLE IN REOPENING VERMONT'S TRANSPORTATION INFRASTRUCTURE IN RESPONSE TO CLIMATE CHANGE

*JAY R. SMEREKANICZ, P.G., C.P.G.  
SENIOR ENGINEERING GEOLOGIST  
SCARPTEC, INC.  
MONUMENT BEACH, MASSACHUSETTS  
[JAY@SCARPTEC.COM](mailto:JAY@SCARPTEC.COM)*

*VERMONT AGENCY OF TRANSPORTATION (VTRANS)  
HIGHWAY DIVISION | CONSTRUCTION & MATERIALS BUREAU  
GEOTECHNICAL ENGINEERING SECTION | GEOLOGY UNIT*

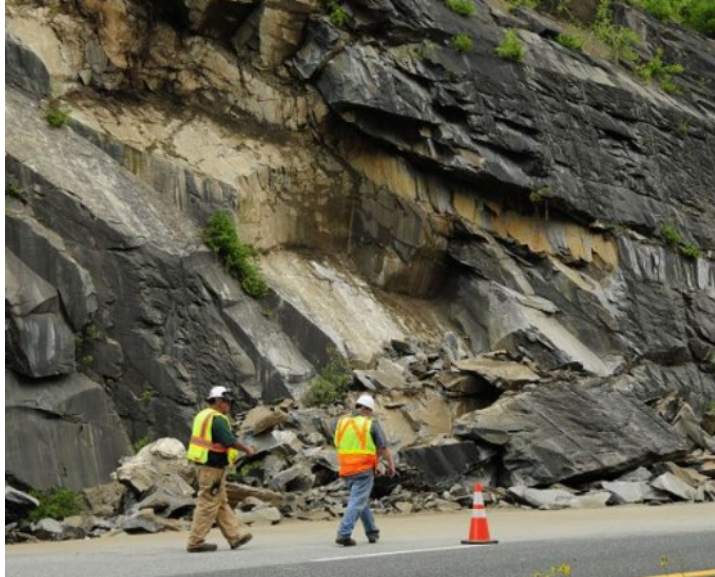
*Rockslide I-89 NB, Exit 6, Berlin, July 2012 – note metalimestone bed between phyllite/schist layers (Waits River Fm; VTrans)*

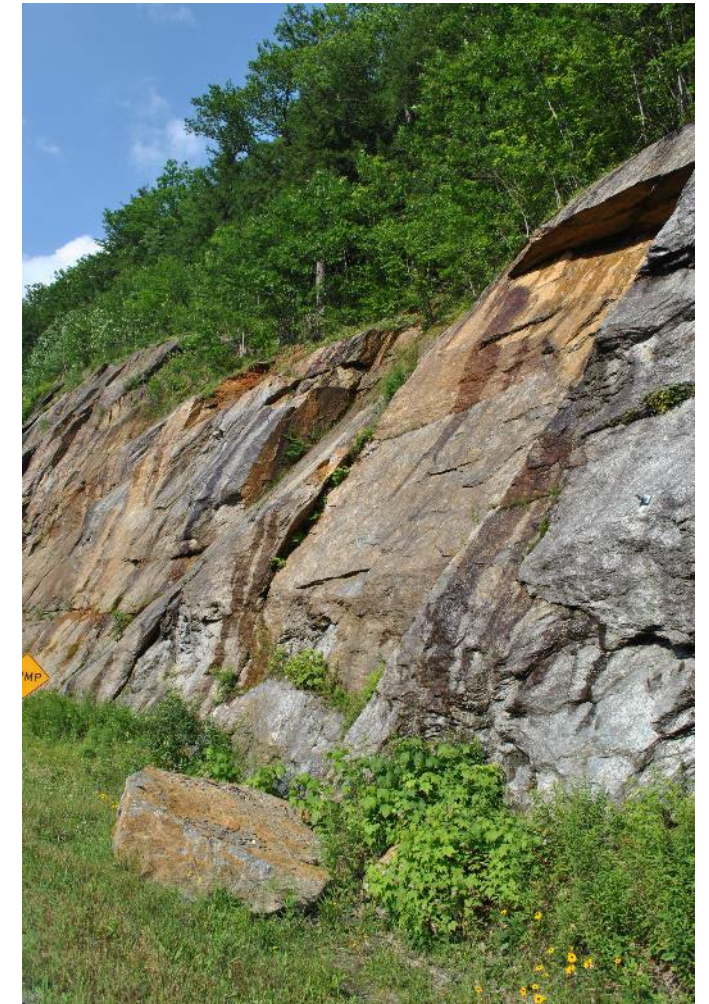
*Rock fall VT Rt 103 Chester – note wet/weathered foliation planes (Gassetts Schist; Golder WSP, 2023)*

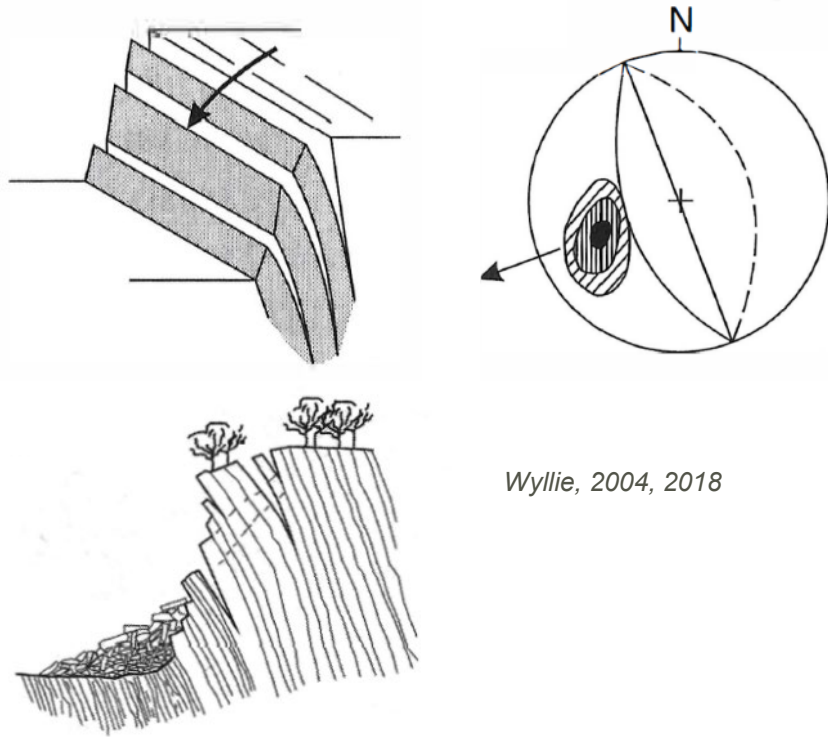
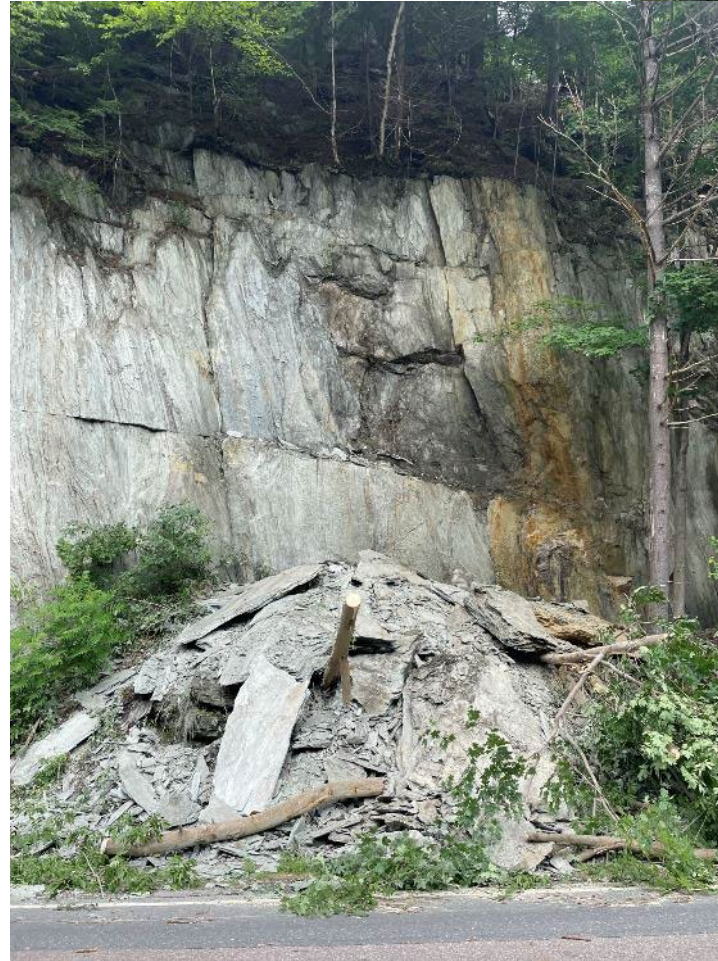
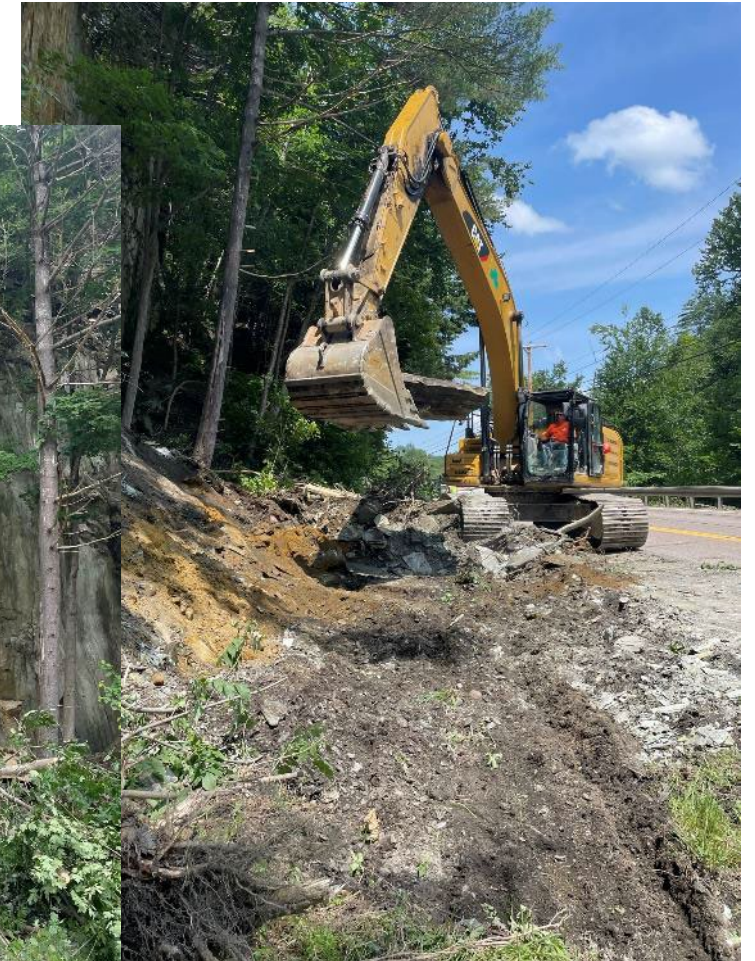
# Case History 1: VT Rt 12 Rockslide, Berlin

- Cause = Nearly vertical foliation on strike with roadway saturated from intense rainfall, lead to toppling
- Fairly common in VT

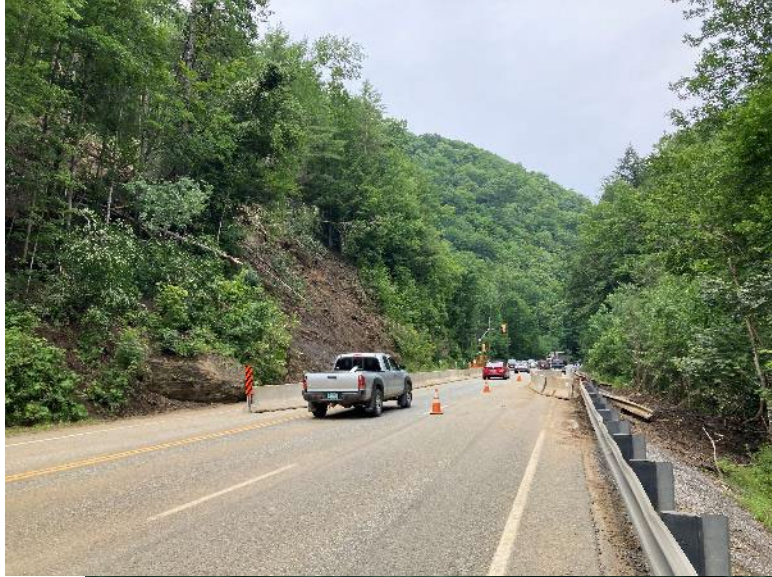
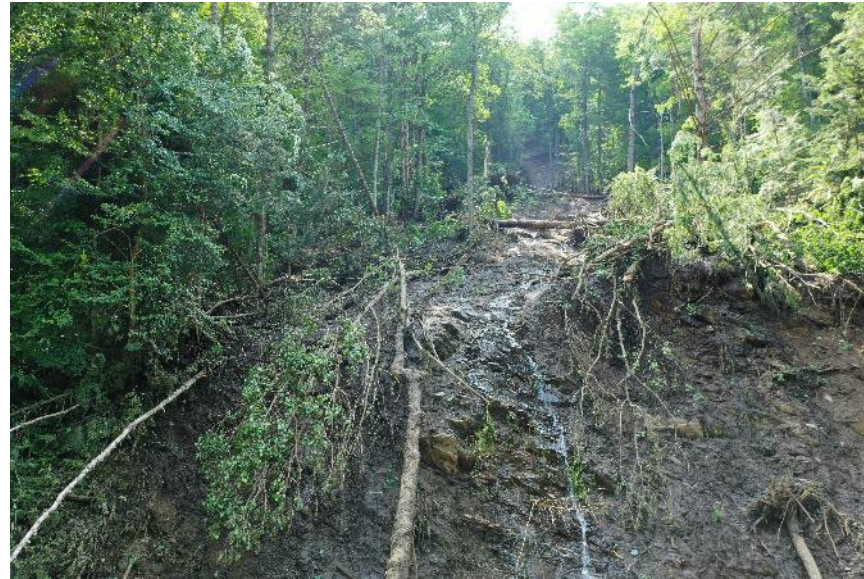
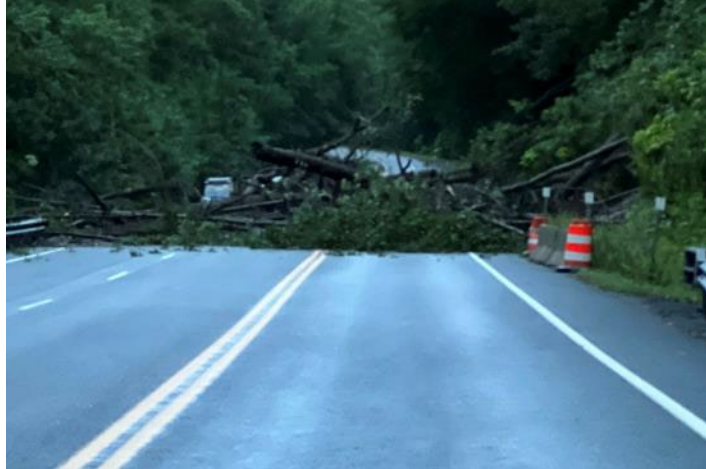
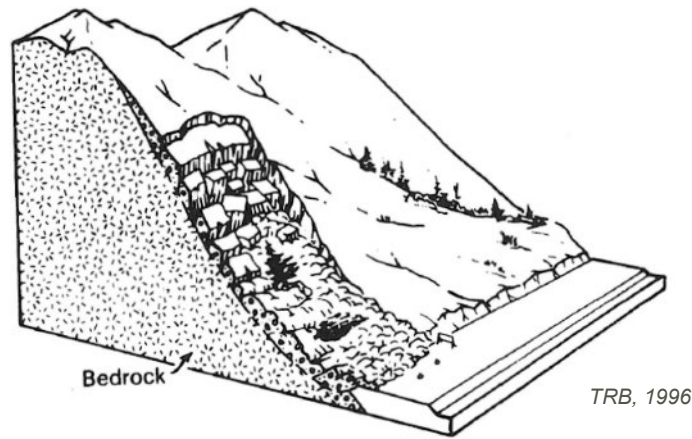
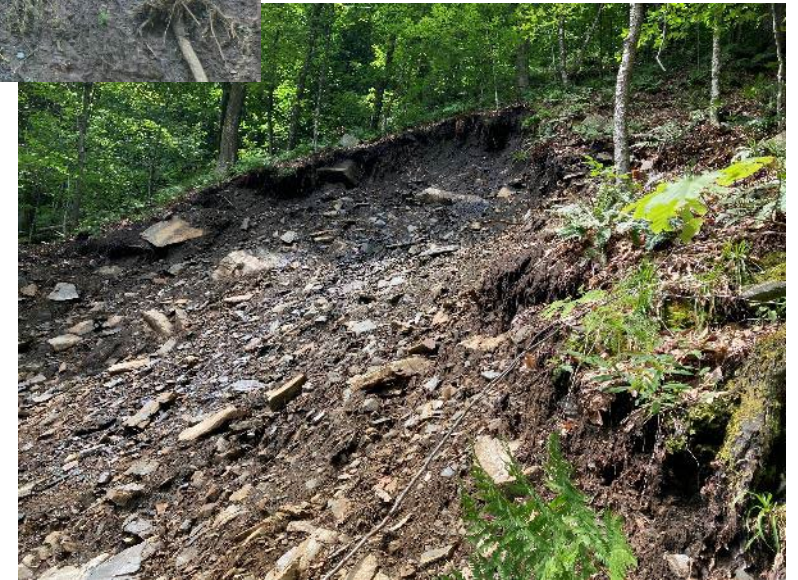
# Case History 2: VT Rt 103 Proctorsville Gulf Debris Flow, Chester

- “Gulf” (deep valley), steep slopes of forested/protected land, 3-lane road, outside of VTrans right-of-way, ~1,000 ft runout starting at +40° headslope
- July 10-11, 2023 rainfall event
- Bedrock geology complex (slate, phyllite, schist, gneiss, amphibolite – Ordovician Missisquoi & Silurian-Devonian Northfield Fms), overlain by thin mantle of colluvium developed from glacial till

- Natural event (?), possibly influenced by past foresting activity, uprooted trees from prior storms
- Scars of past similar events evident (LiDAR)
- 100’s of similar steep slopes with thin colluvium over bedrock

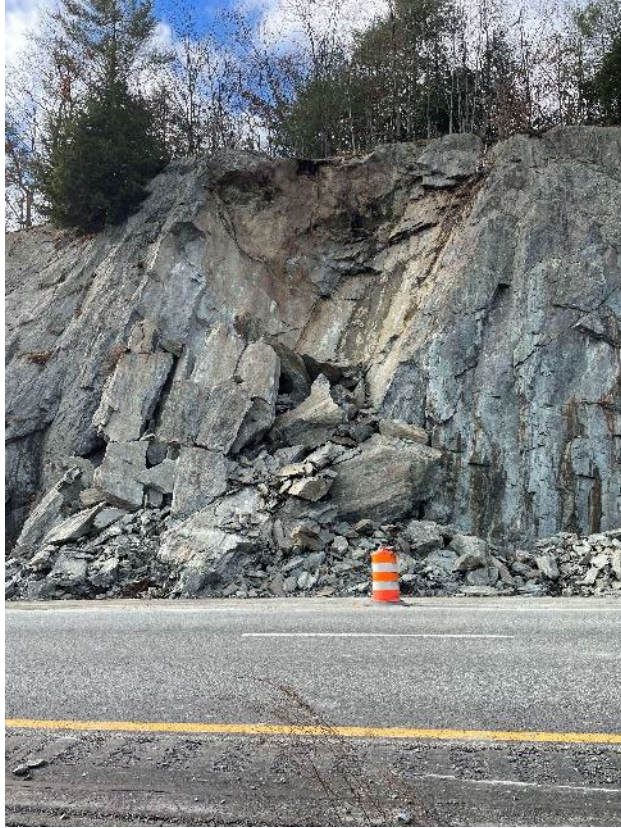
# Case History 3: I-91 MM67.25 SB Rockslide, Hartland

- Cause = wedge sliding due to ice-jacking
- Intersection of two joints, with line of intersection “daylighting” on rock face
- Emergency mitigation initiated to address large blocks in ditch and unstable overhang
- Mitigation = vegetation removal, scaling (removal of remaining loose rock), and securing overhang with rock dowels

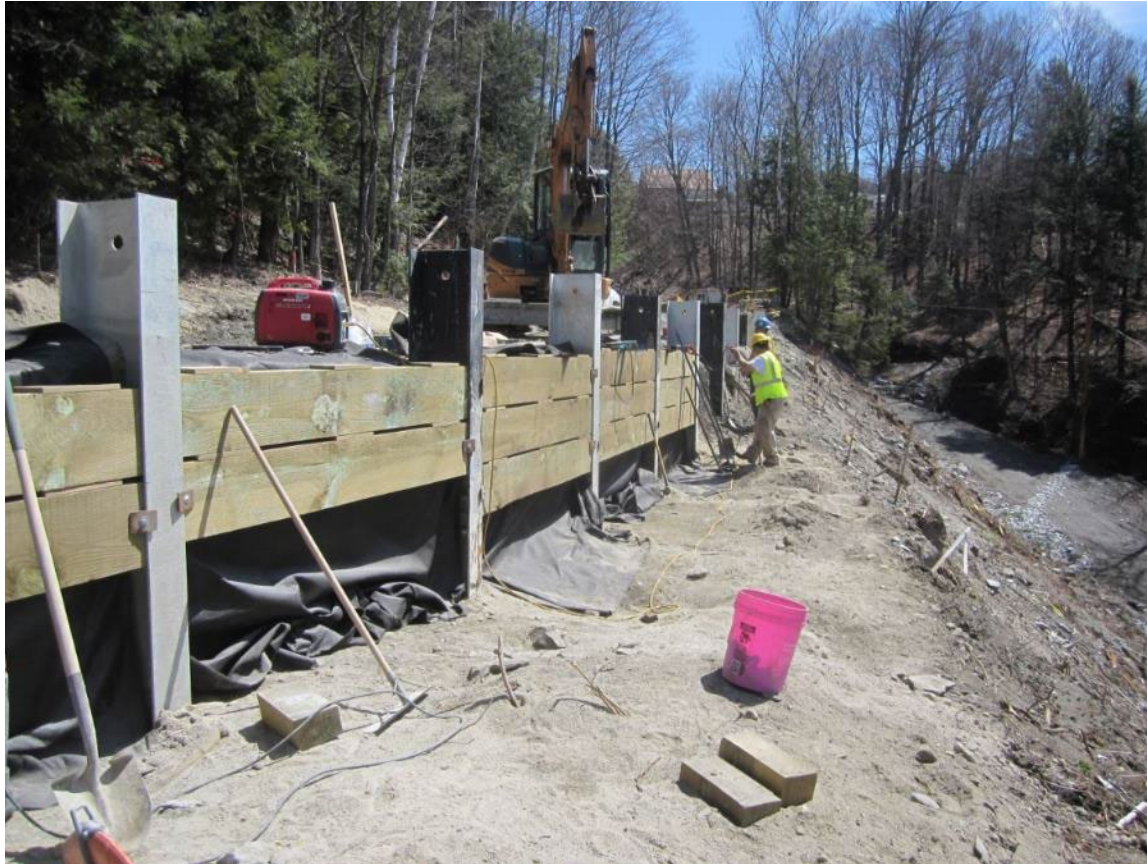
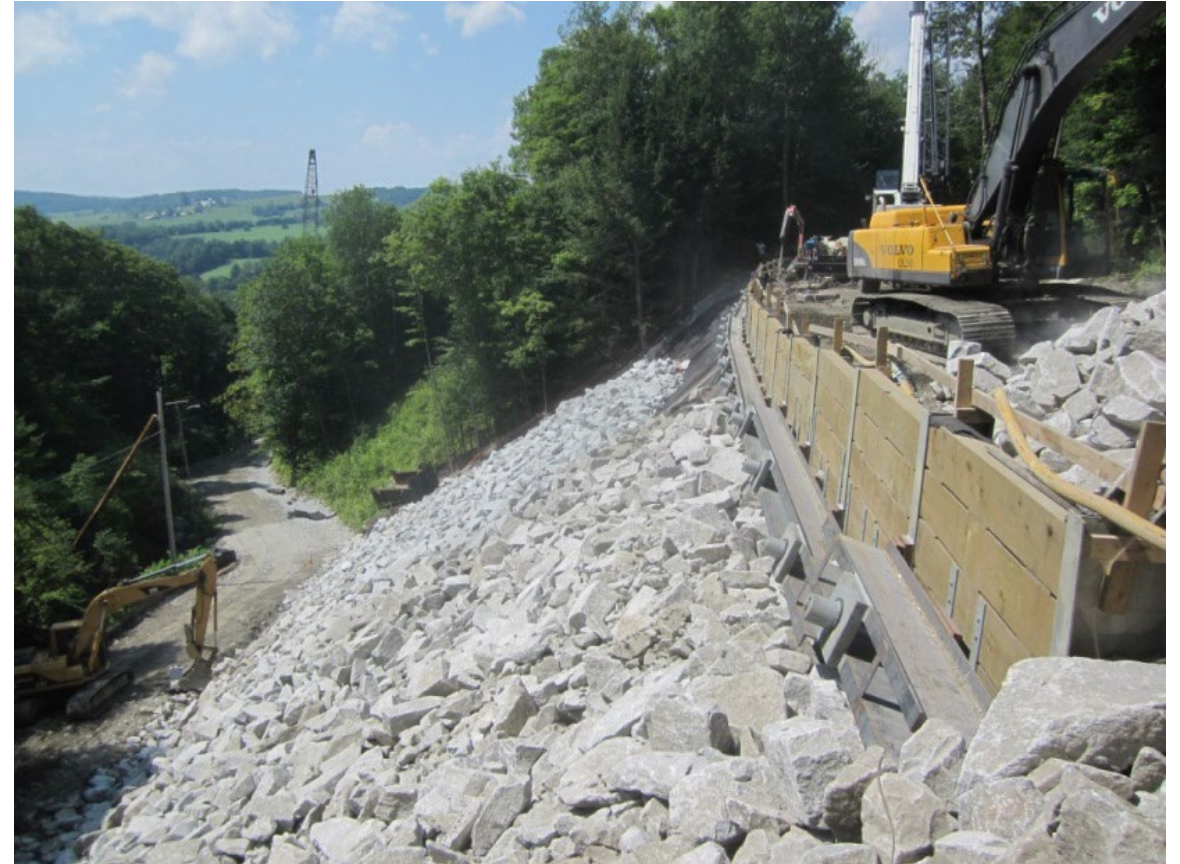
# Case History 4: Railroad Switchback Slope Failure, Barre

- State-owned railway servicing Rock of Ages granite quarry
- July 2011 heavy rains caused small landslide, with a small head scarp in railbed (~1 ft)
- Even a fraction of an inch movement will cause railways to shut down
- Geology consists of fill materials over glacial till/colluvium
- Cause = circular failure within unconsolidated materials

- Mitigation consisted of full slope repair, with tied-back retaining wall and rip rap slope armor (very \$\$\$)

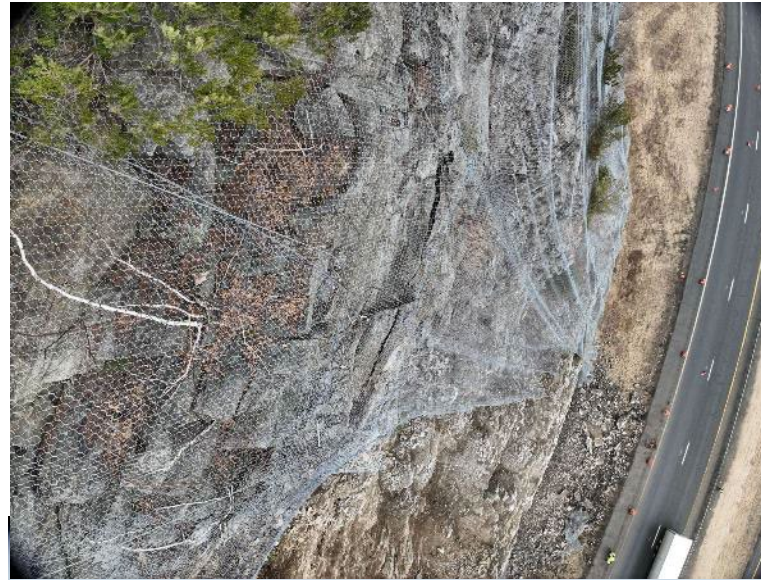
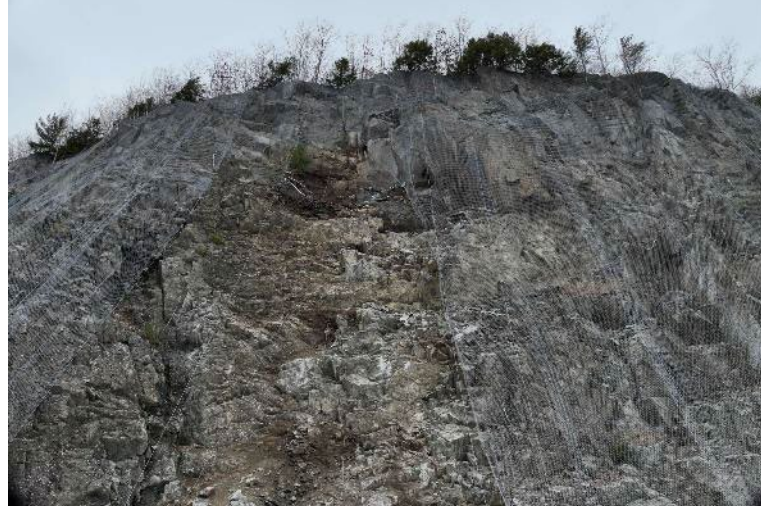
# Case History 5: I-91 MM92.6 SB Rockslide, Fairlee

- February 28, 2024 evening (*2<sup>nd</sup> biennial rockslide season*)
- Closed both directions of interstate due to rocks in road
- Very high and steep rock slope, +270 ft above roadway (“The Palisades”)
- Early Devonian Fairlee Pluton Quartz Monzonite (weakly foliated, highly fractured & faulted)
- VTrans last mitigated slope with rock removal, rock dowels and wire mesh in 1996, minor tears repaired 2022

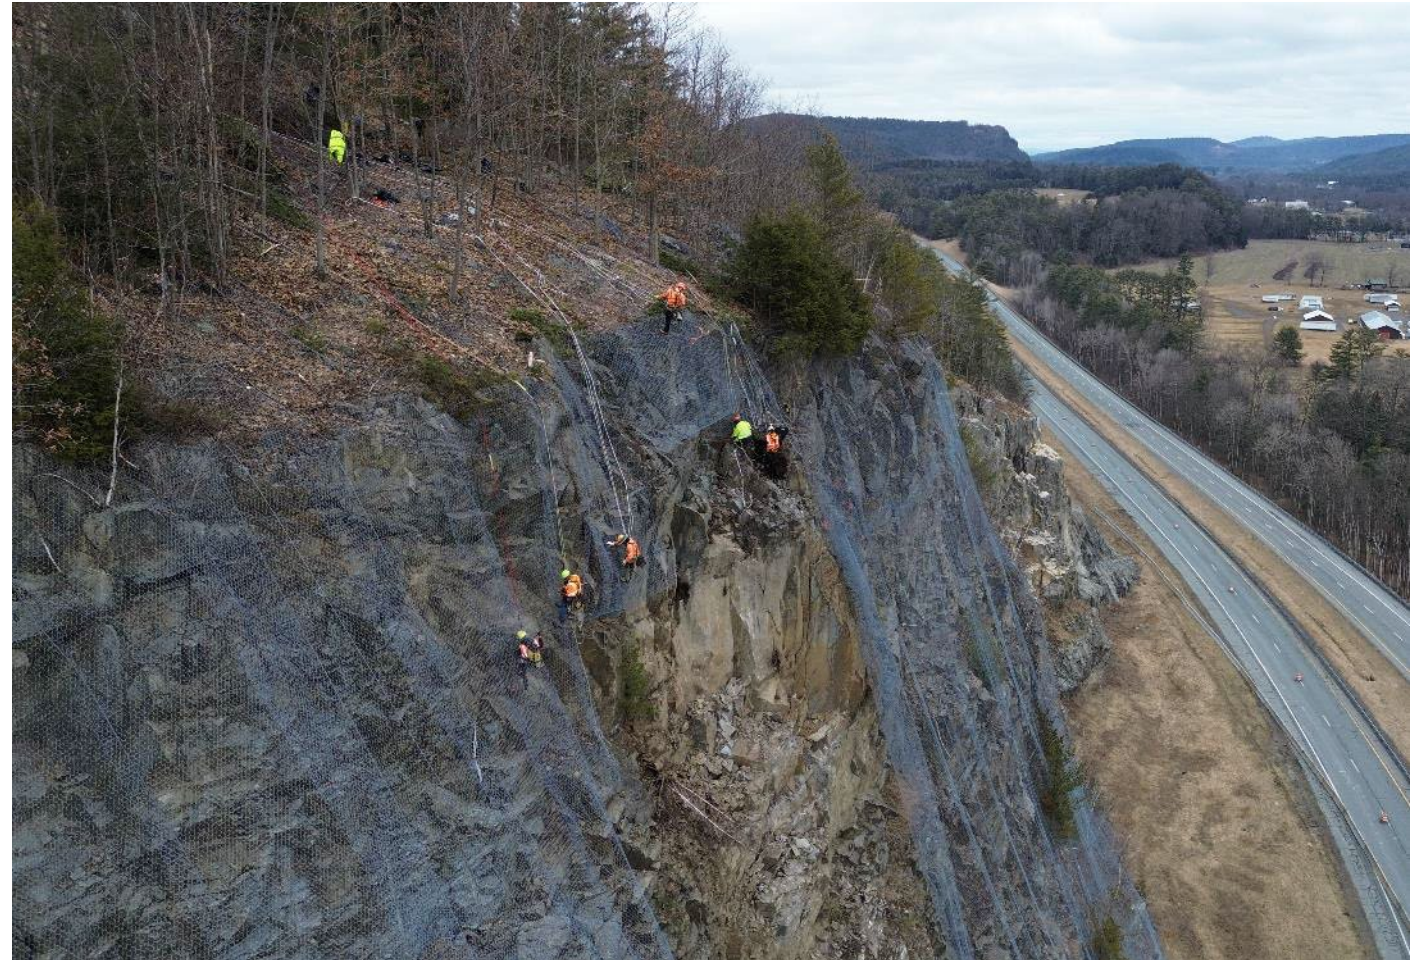
- Cause = toppling of large pillars, blocks and slabs exacerbated by melting of adfreeze (melting of ice acting as a temporary “glue” after ice jacking occurs)

- Emergency mitigation on going, consisting of scaling remaining loose rock and repair of draped mesh

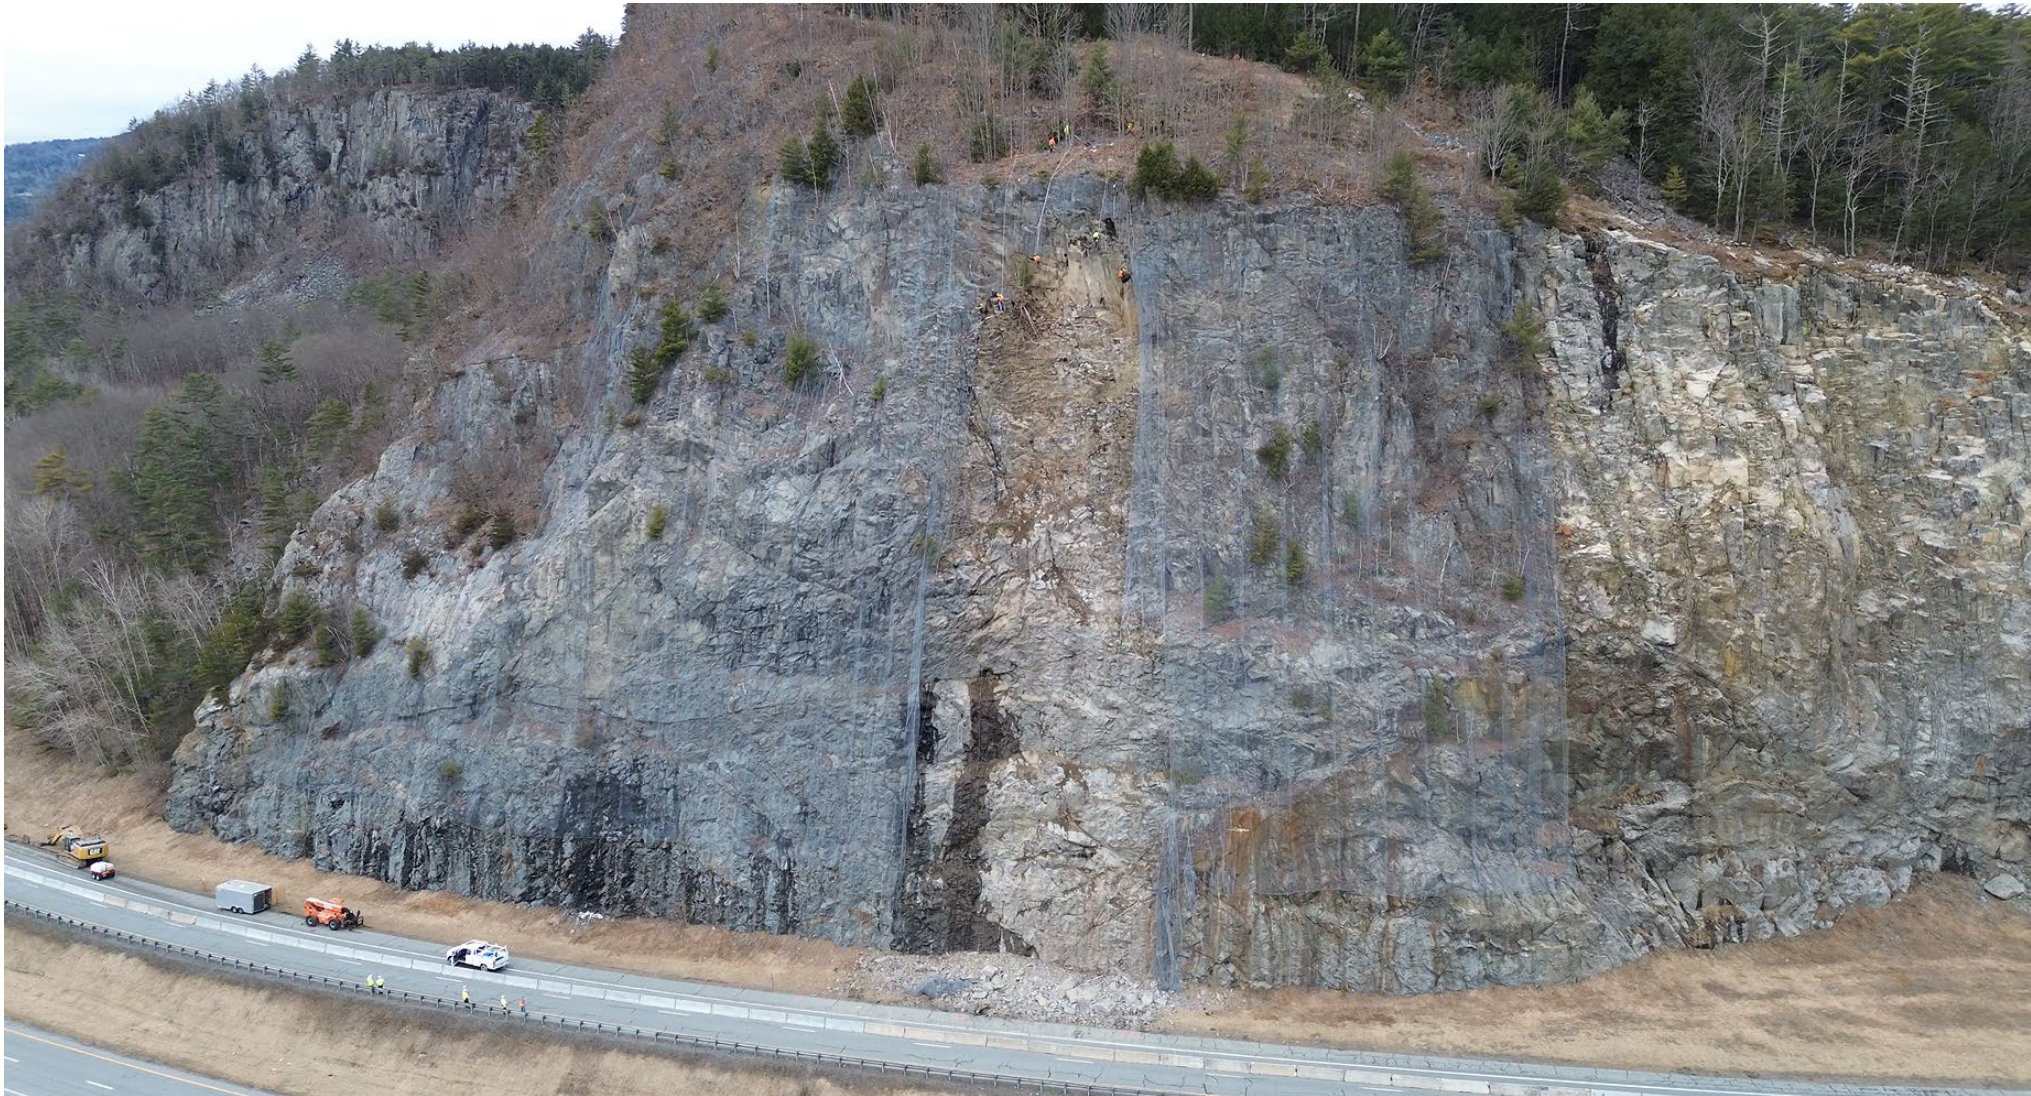
# Case History 5: I-91 MM92.6 SB Rockslide, Fairlee

- Numerous other areas identified behind mesh at risk of failing and overwhelm netting
- Intends to program and mitigate these 2025
