Identifying Groundwater Discharge Locations in Tidal Wetlands using Environmental Thermography at Prime Hook National Wildlife Refuge, Delaware, USA

Thomas E. McKenna Delaware Geological Survey, University of Delaware

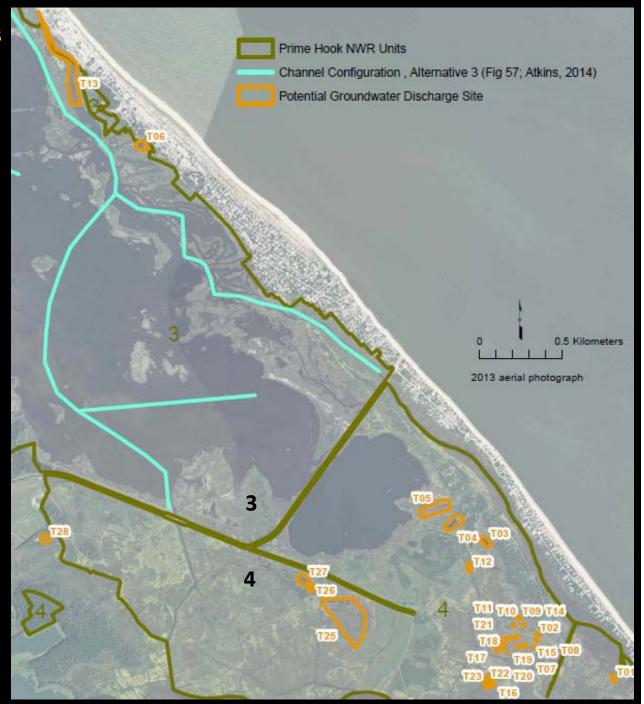
Locations of thermal anomalies (potential groundwater discharge sites)

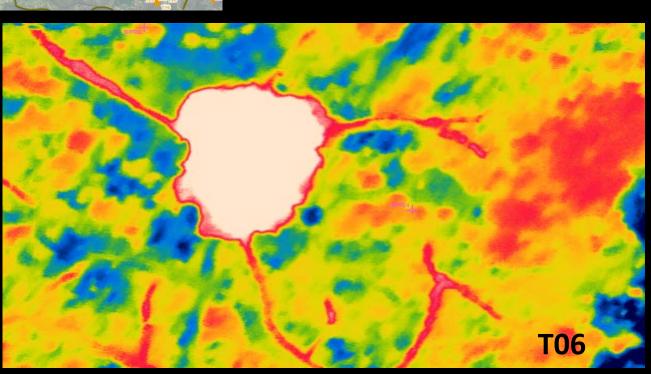
Thermal anomaly in eastern part of Unit 3 near Primehook Beach

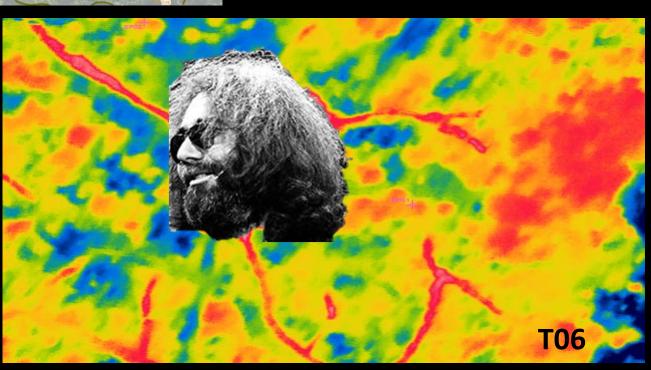
Thermal anomaly in eastern part of Unit 3 near Primehook Beach

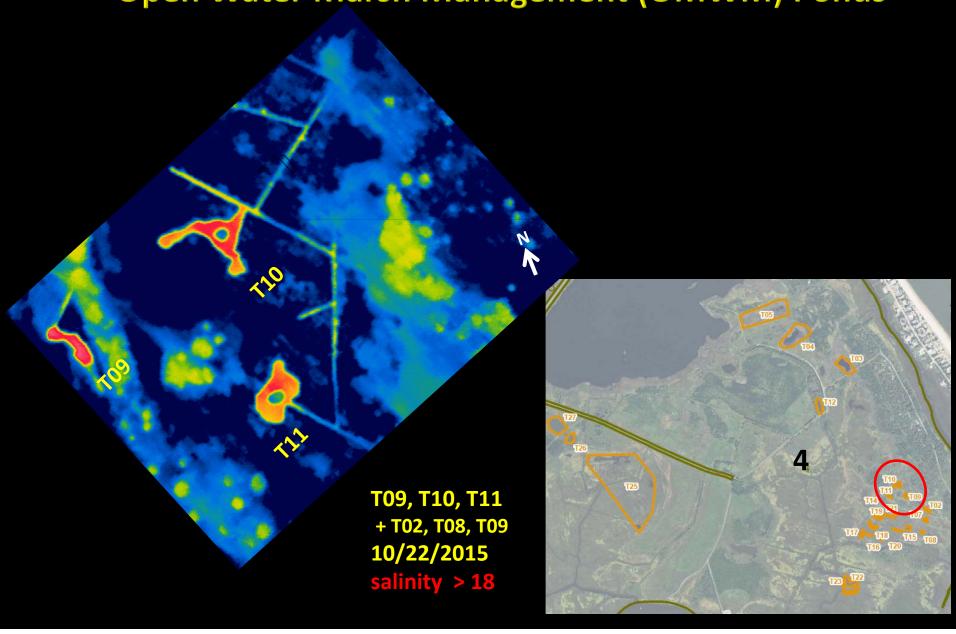
Thermal anomales in northeastern part of Unit 4 Open Water Marsh Management (OMWM) Ponds
