Electrical Resistivity Imaging (ERI) beneath Sinkholes and Suspect Sinks: Implications for Karst Risk Assessment in Clark County, Ohio

Michael J. Zaleha & Cole S. Benning

Department of Geology, Wittenberg University, Springfield, Ohio 45501-0720
mzaleha@wittenberg.edu

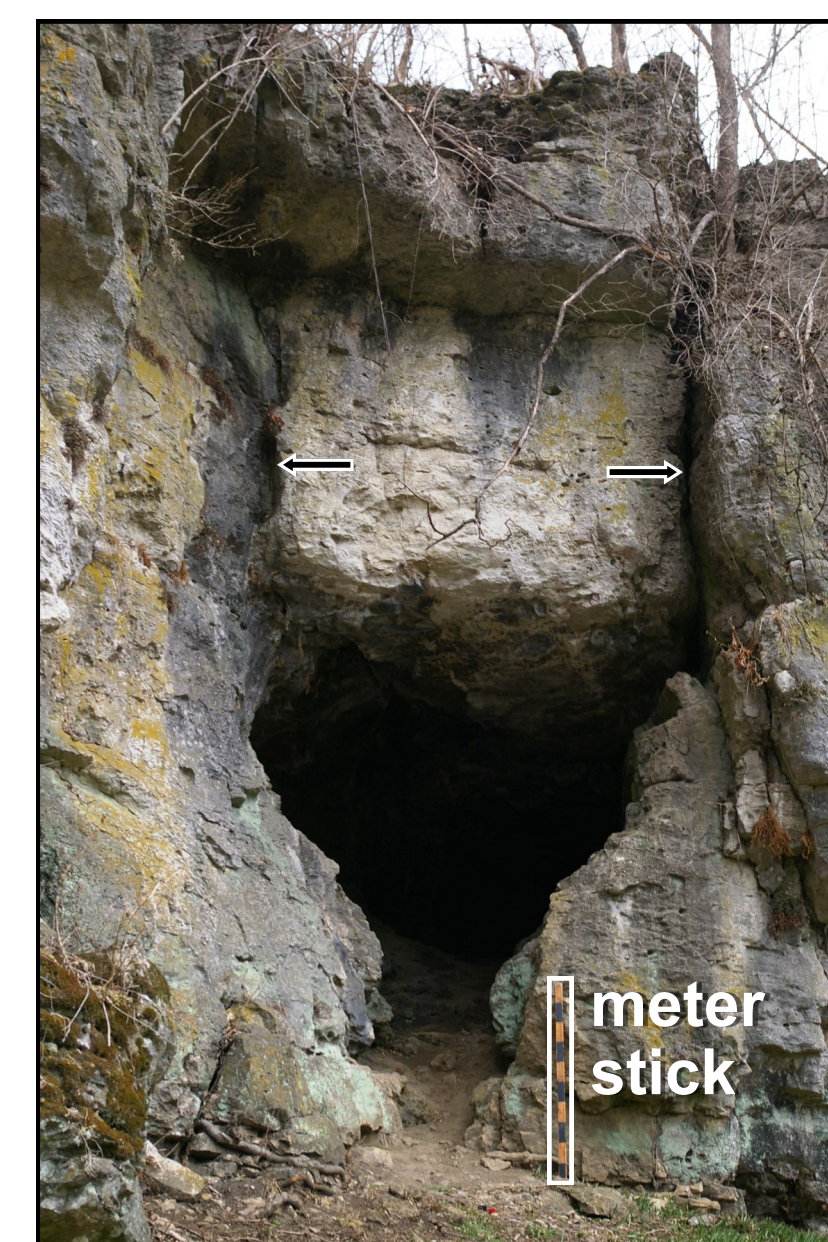
Solution void (cave) within the Cedarville Dolomite. Also note fractures (arrowed) along which the void has developed.

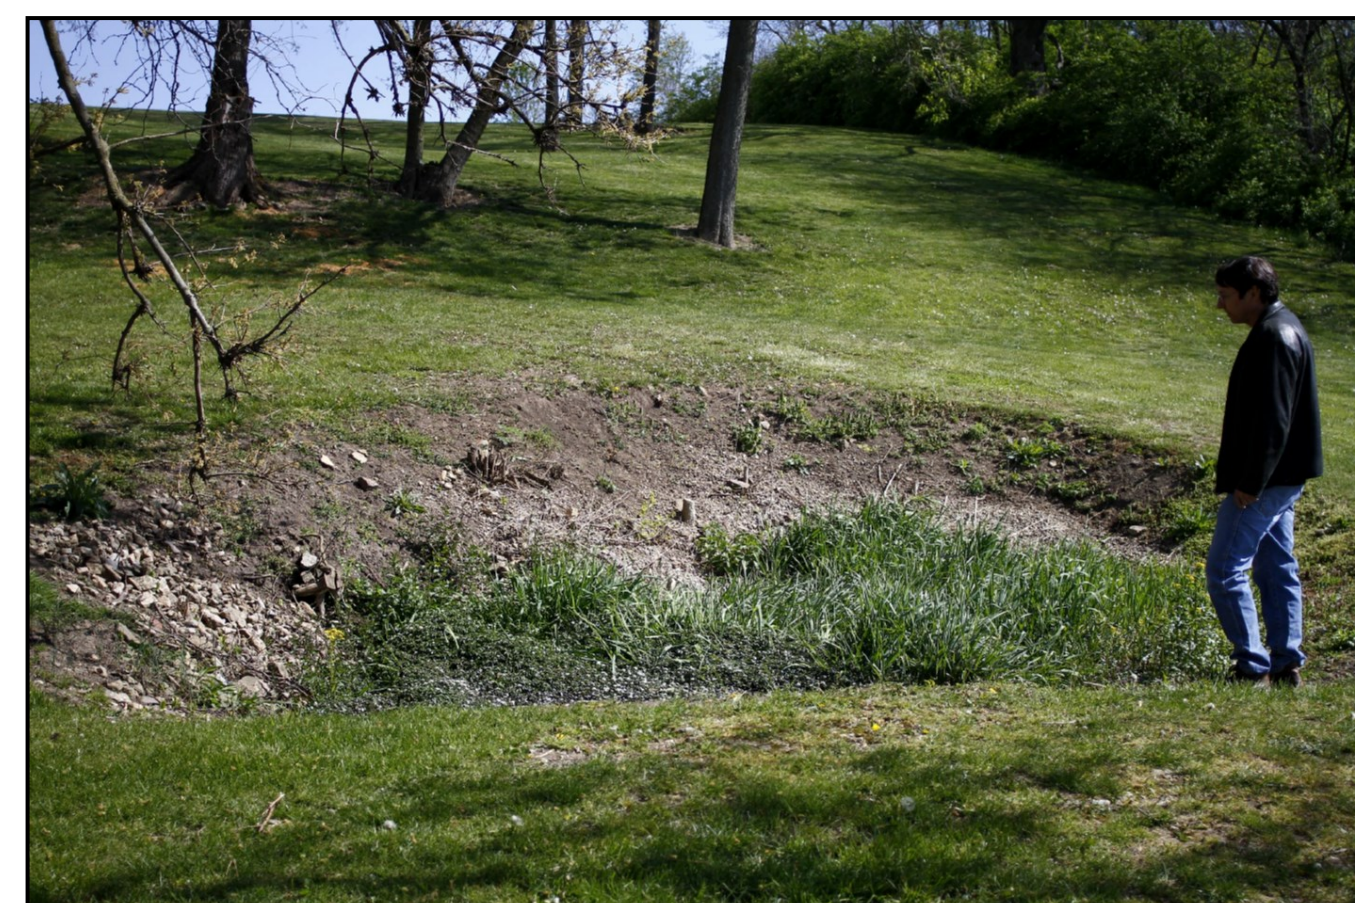
Sinkhole apparently due to collapse into a subsurface void comparable to that to the left (from Aden, 2012).

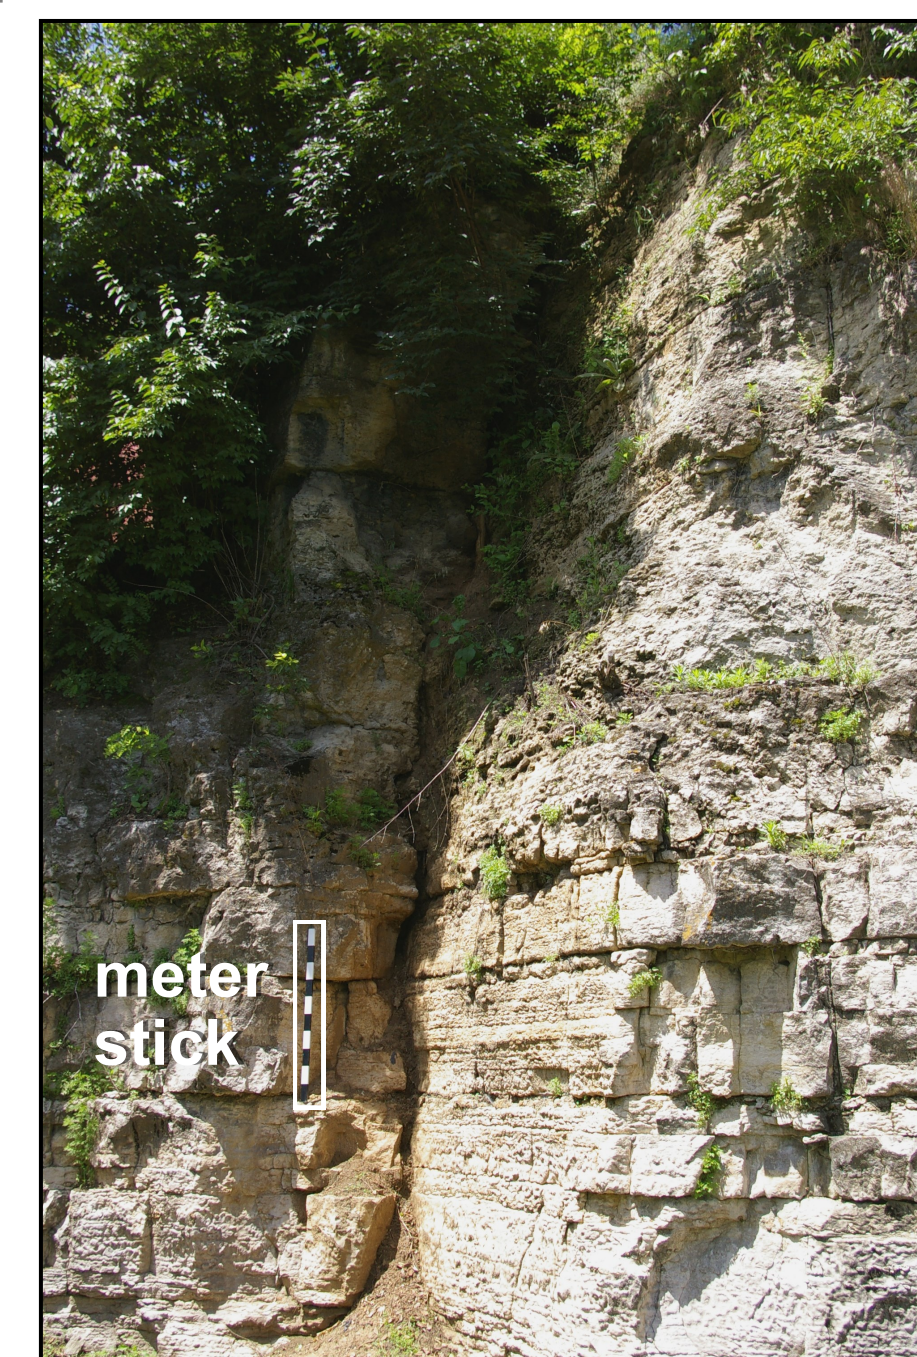
Solution-enlarged fracture (joint), common within the Cedarville Dolomite, filled with sediment. Such fractures are often associated with cover-collapse sinkholes.

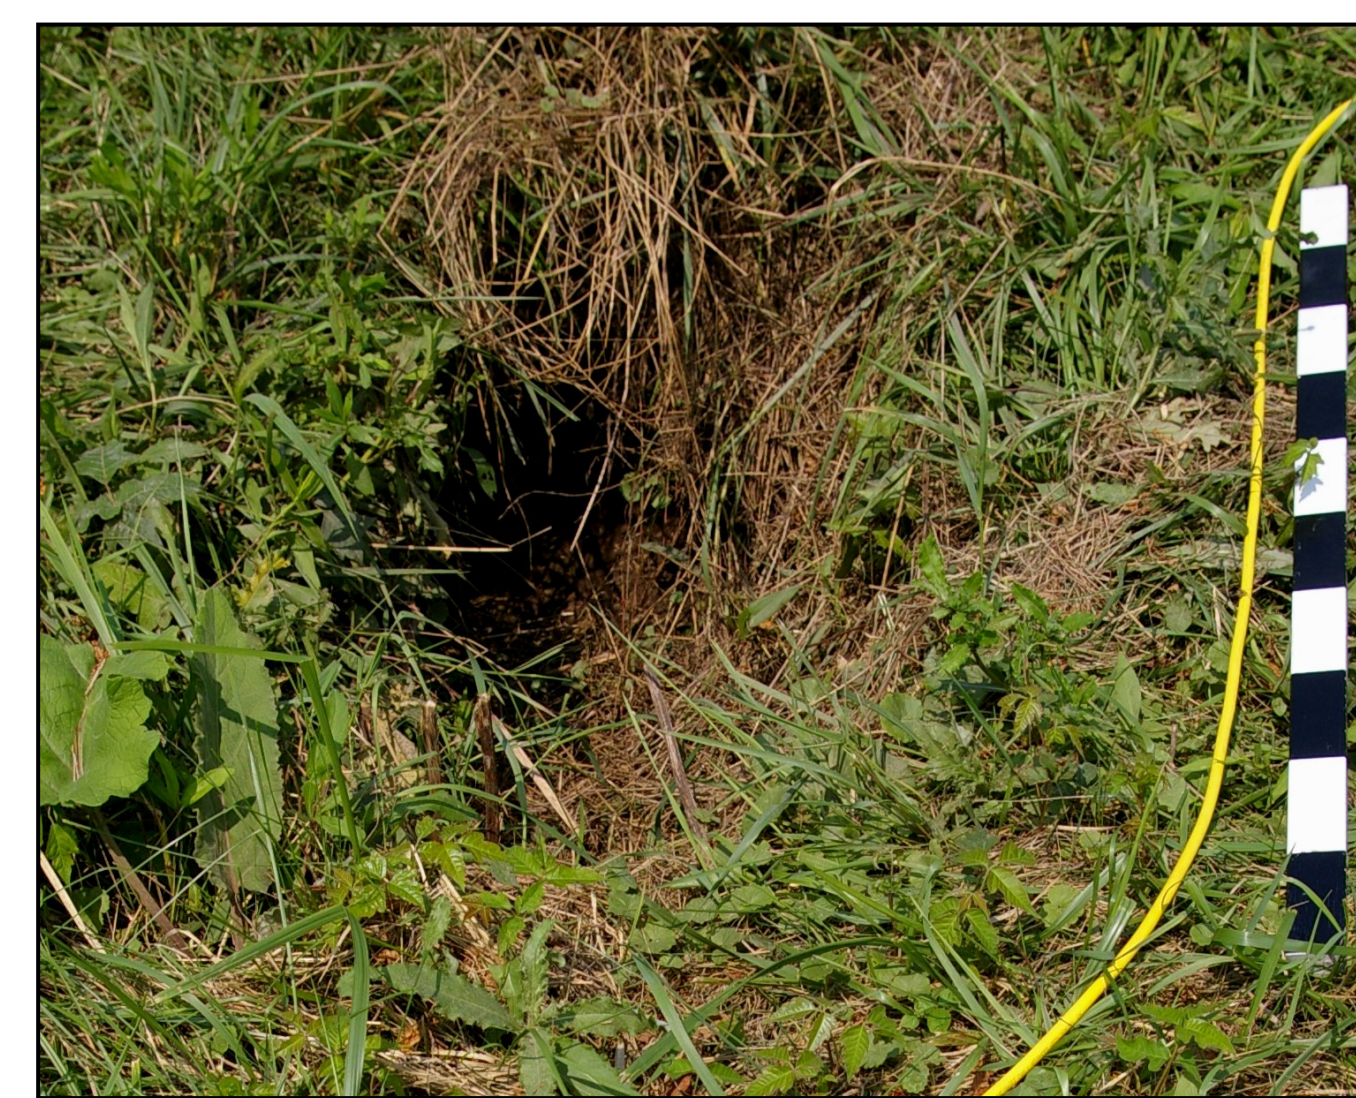
Examples of sinkholes at the Old Mill Road site. Sinkholes are typically ~1 m across, decimeters deep, and floored by sediment.

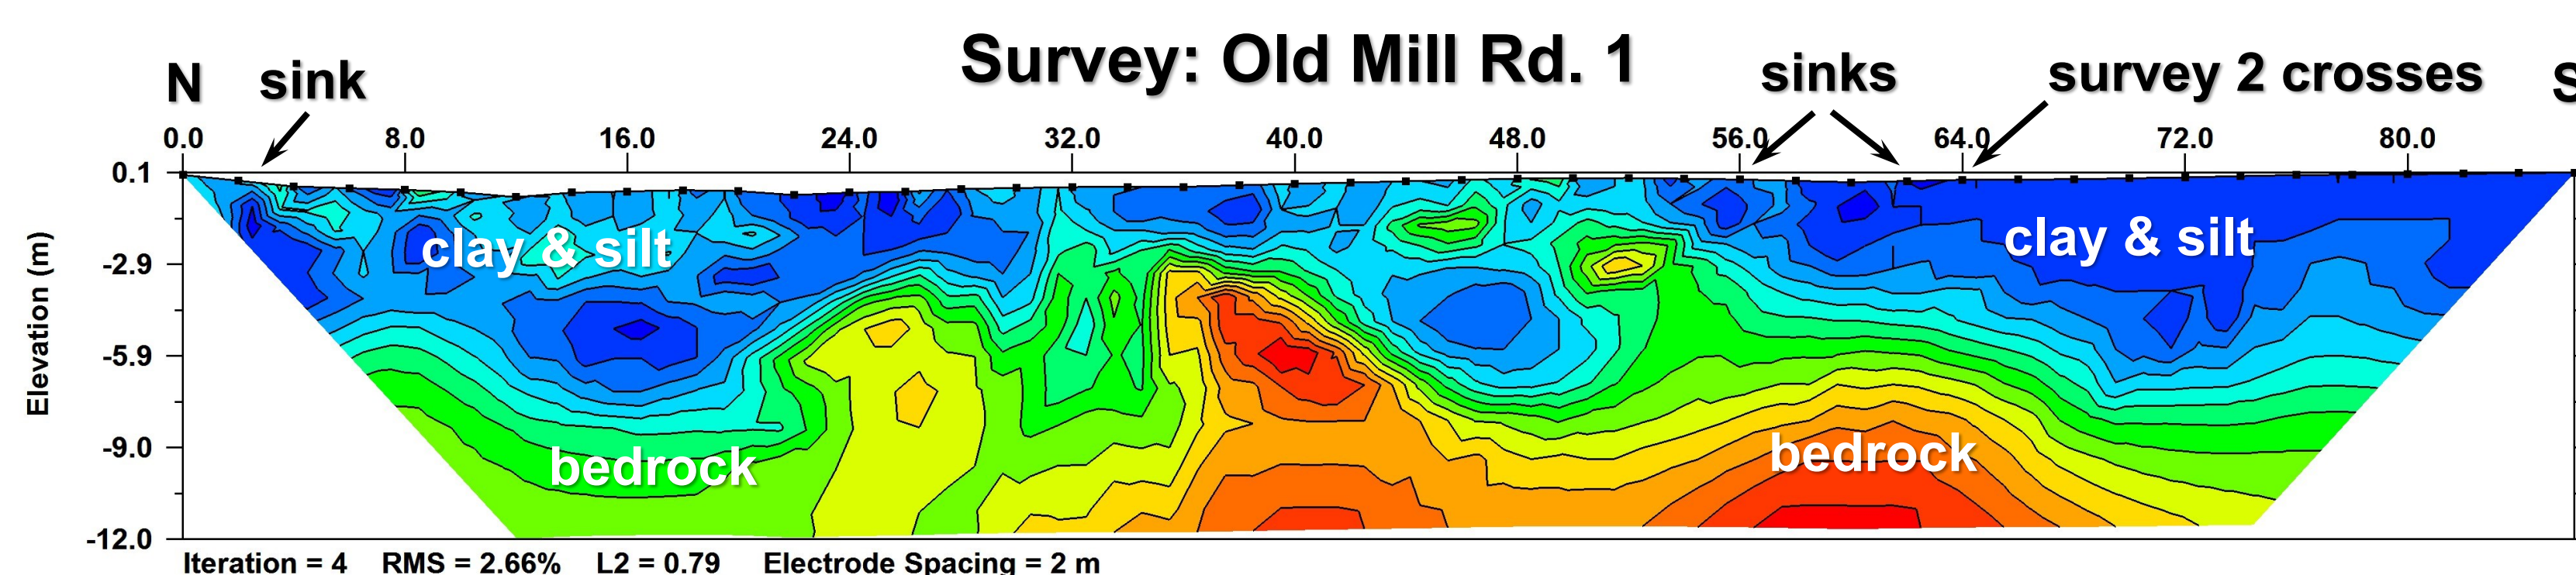
In this **ERI survey**, bedrock (the Cedarville Dolomite) is readily differentiated from the overlying sediment. Relief on the bedrock surface of decimeters to a few meters is apparent. No anomalies indicative of bedrock collapse are present beneath the sinks, suggesting that they formed by subsurface erosion and collapse of sediment associated with solution-enlarged fractures, similar to those apparent in outcrops.

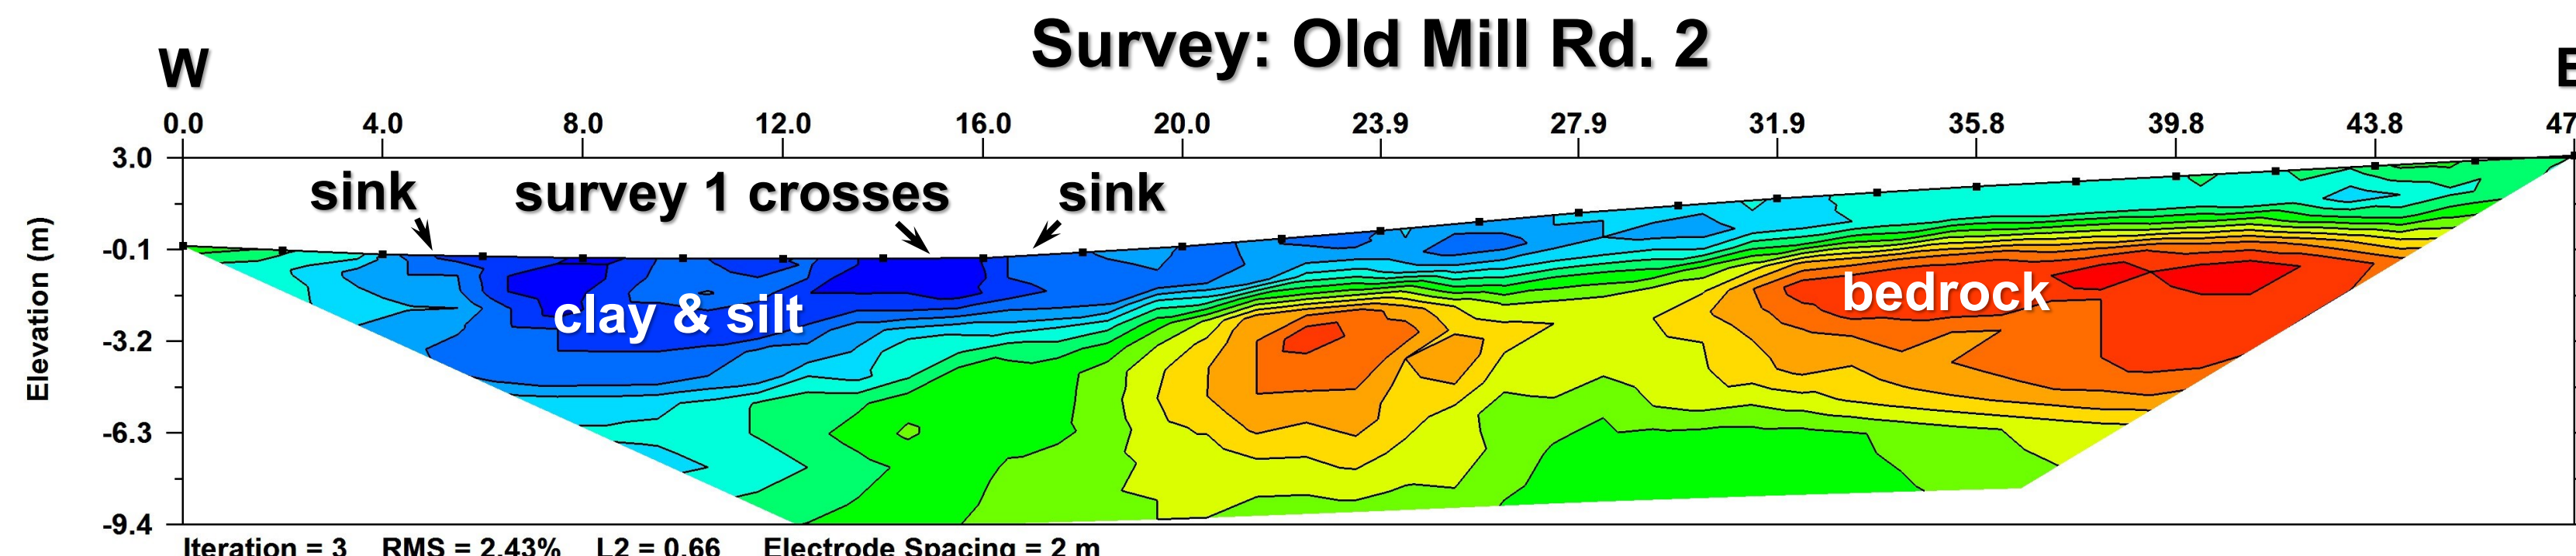
Sinkholes at the Old Mill Road site are likely **cover-collapse sinkholes**, formed by the above process (from Zhou et al., 2002), associated with subsurface water flow confined by bedrock topography of the dry drainage.

In this **ERI survey**, bedrock (the Cedarville Dolomite) is readily differentiated from the overlying sediment. Depth to bedrock on the ERI survey is consistent with that recorded on nearby well logs. The dry drainage is clearly controlled by bedrock topography. As in Survey 1, no anomalies indicative of bedrock collapse are present beneath the sinks, suggesting that they are cover-collapse sinkholes formed by the process outlined above.

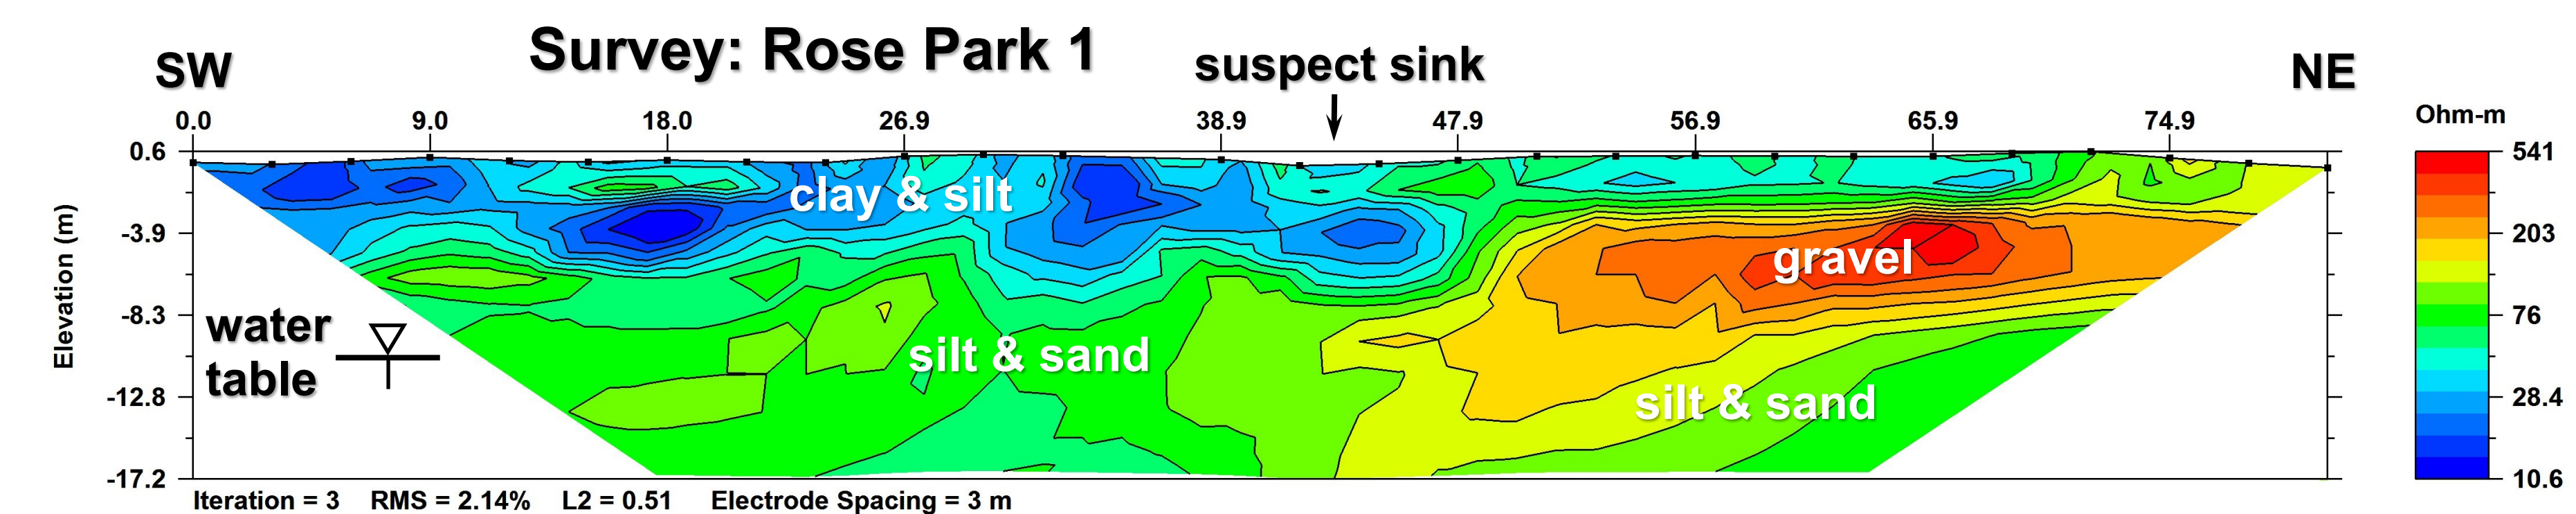
Bedrock was not intercepted in this survey, consistent with nearby well logs which indicate depth-to-bedrock in this area ≥ 18 m. Most karst features in Clark County occur where depth-to-bedrock is ≤ 8 m. It is unlikely that the **suspect sink** is related to any bedrock feature and, hence, is **not a sinkhole**. The depression does correspond with a change in the underlying sediment and may be the result of differential compaction or, more likely, a cultural feature (see historical aerial photo, below-right). Depth of water table is from a nearby well log.

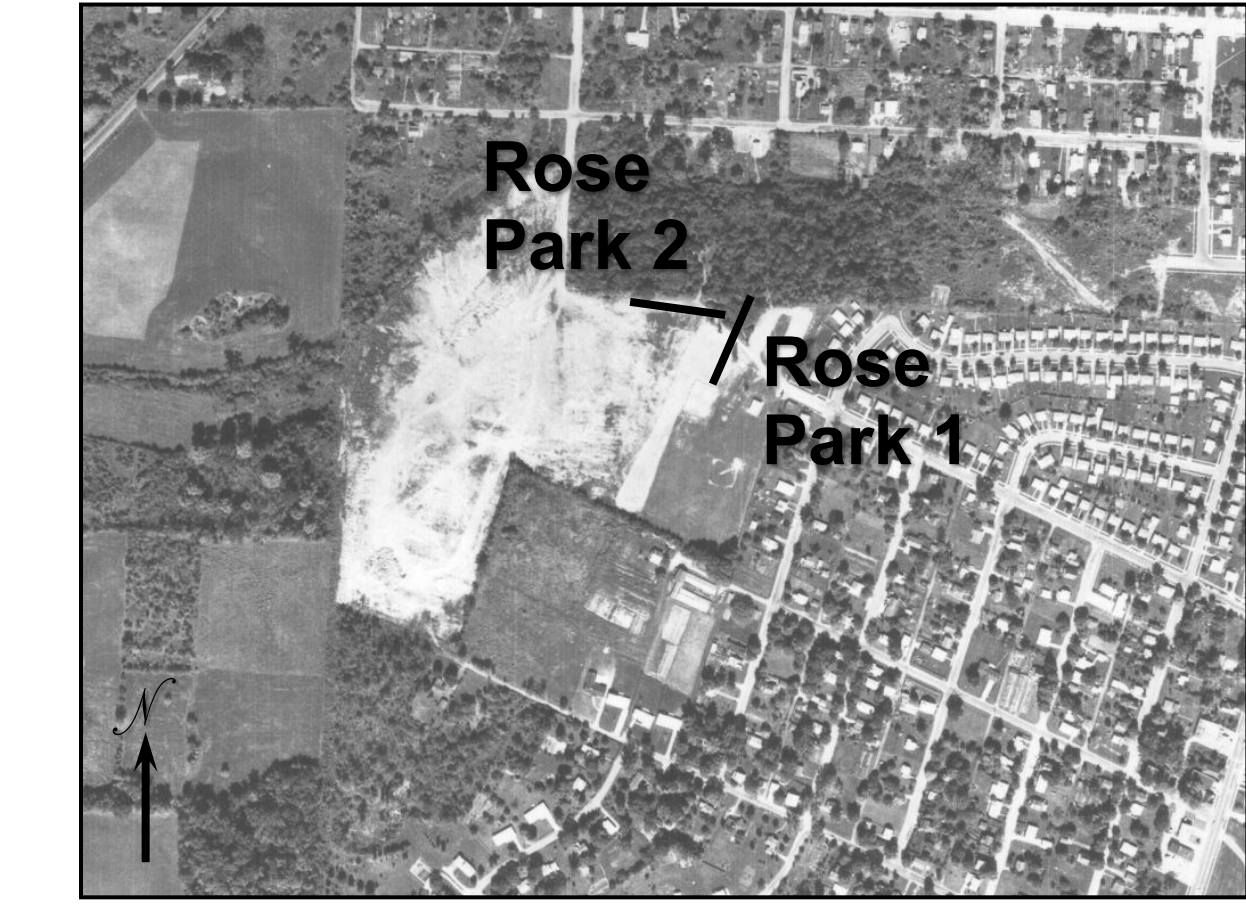
1968 aerial photo of the Rose Park site. The site is on the margin of an urban area and appears disrupted, suggesting that the suspect sinks are cultural features (e.g., decomposed, buried trash pits, such as plant debris; excavations) rather than sinkholes.

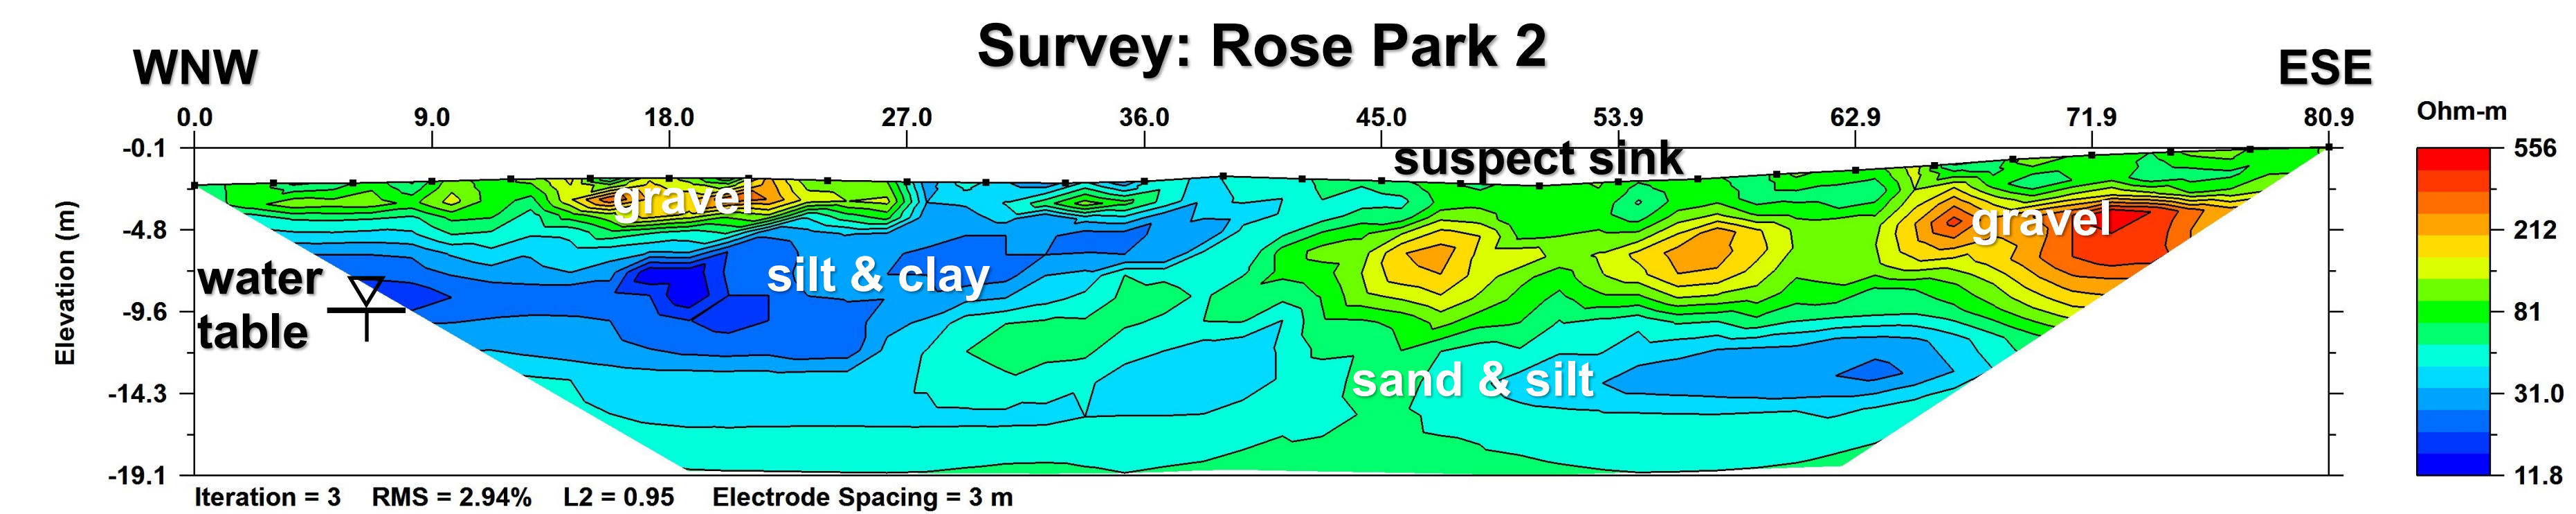
As in Survey 1, **bedrock was not intercepted**. The depression does correspond with a slight change in the underlying sediment and may be the result of differential compaction between two gravel lenses or, more likely, a cultural feature (see historical aerial photo, above-right). Depth of water table is from a nearby well log.
