Combating witchcraft beliefs by accessing and reconstructing the history of heavy rainfall-triggered landslides and related hazards in the Bamumbu region, south west Cameroon

Tangumonkem E.T., and GHOGOMU R. T

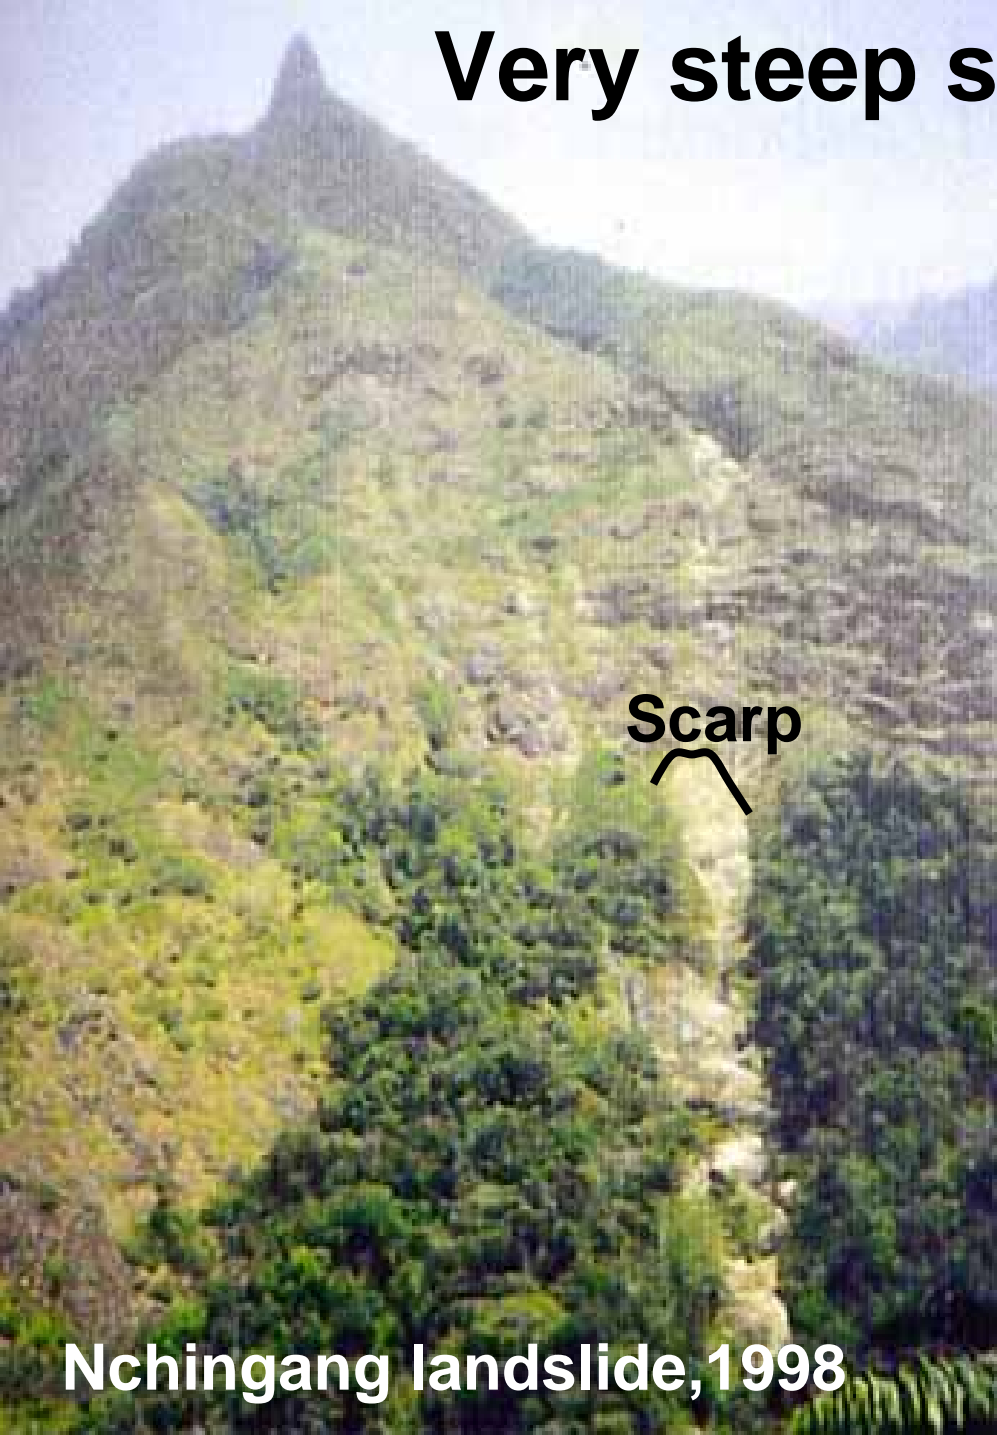
Very steep slopes

Nchingang landslide, 1998

- ❑ Step slopes approximately 15° - 85°
- Availability of loose sediments
- ❑ High rain fall
- ❑ Deforestation
- ❑ Poor agricultural practices for example the “ankara system”

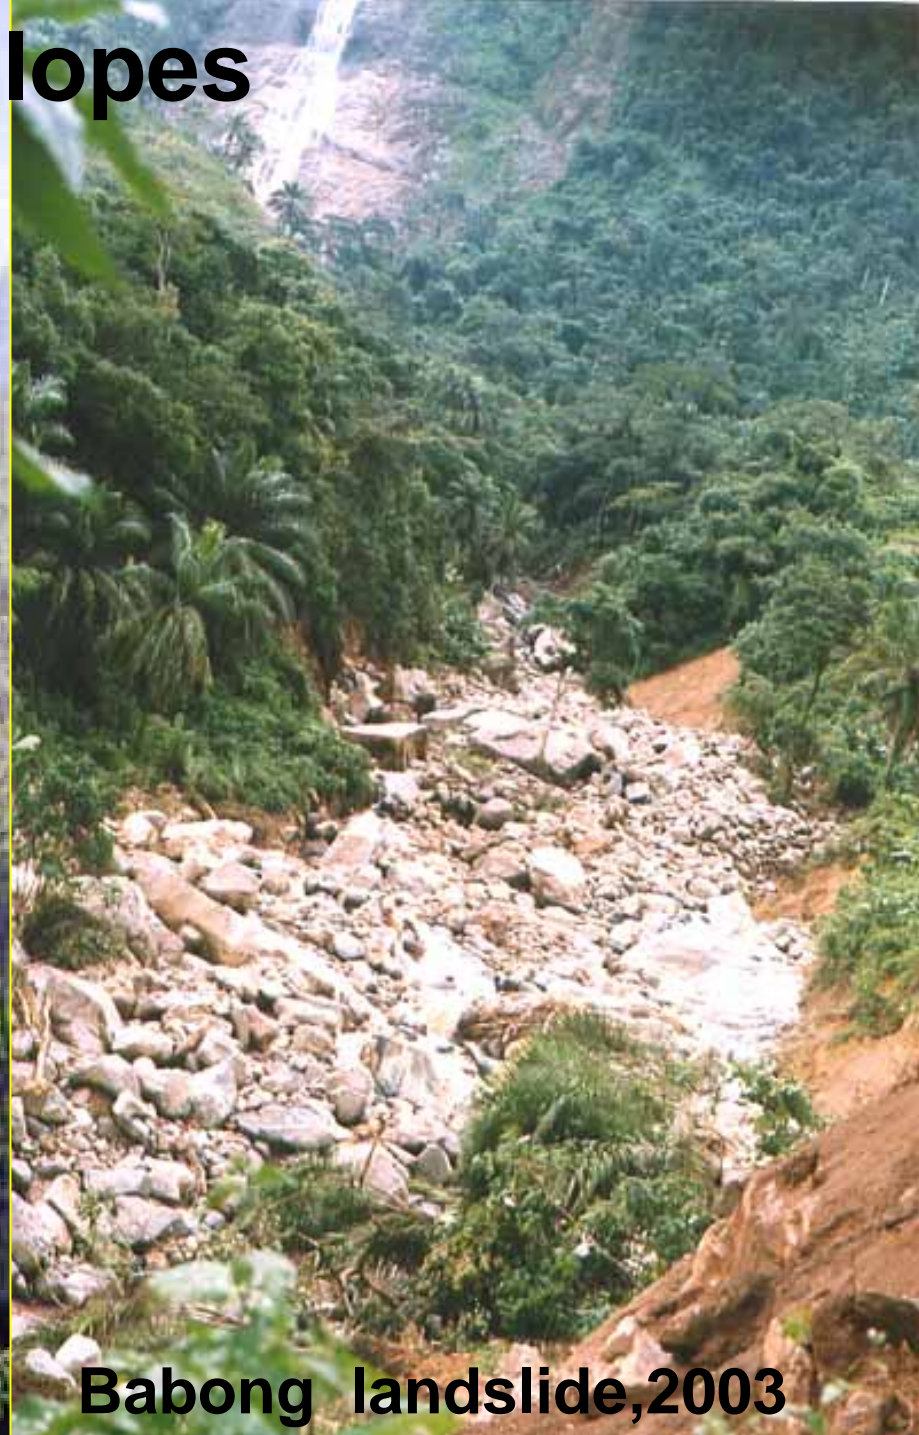
Babong landslide, 2003

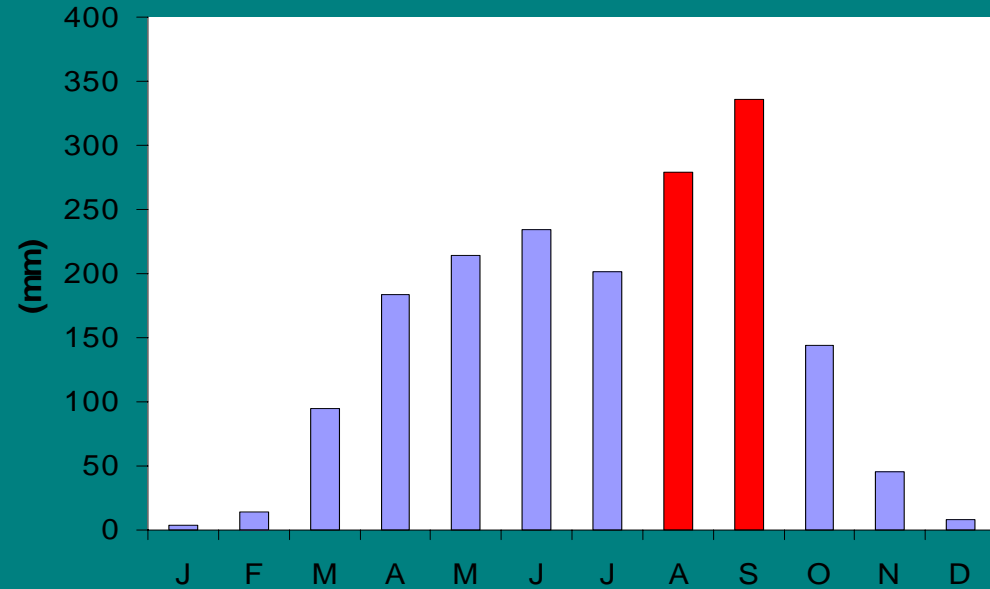
Mean Annual Rainfall Bamumbu Region,
Cameroon.

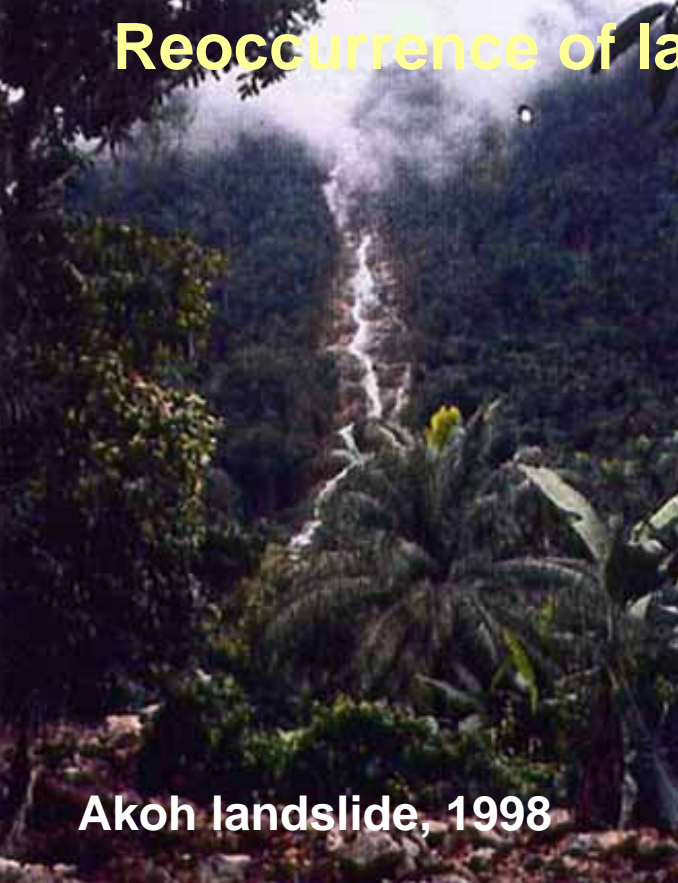
Reoccurrence of landslide on the same site

Akoh landslide, 1998

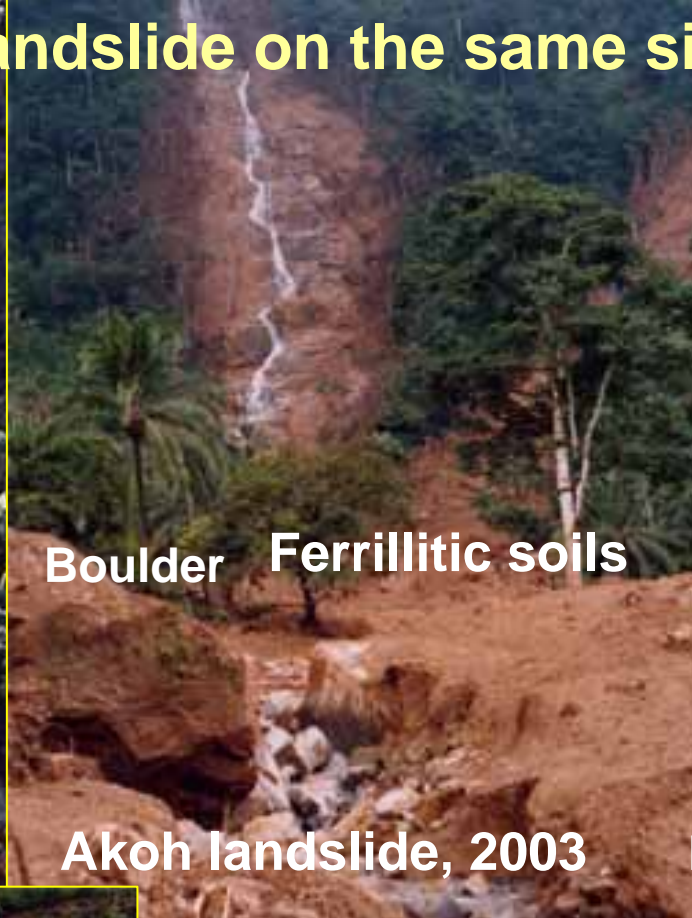
Boulder Ferrillitic soils

Akoh landslide, 2003

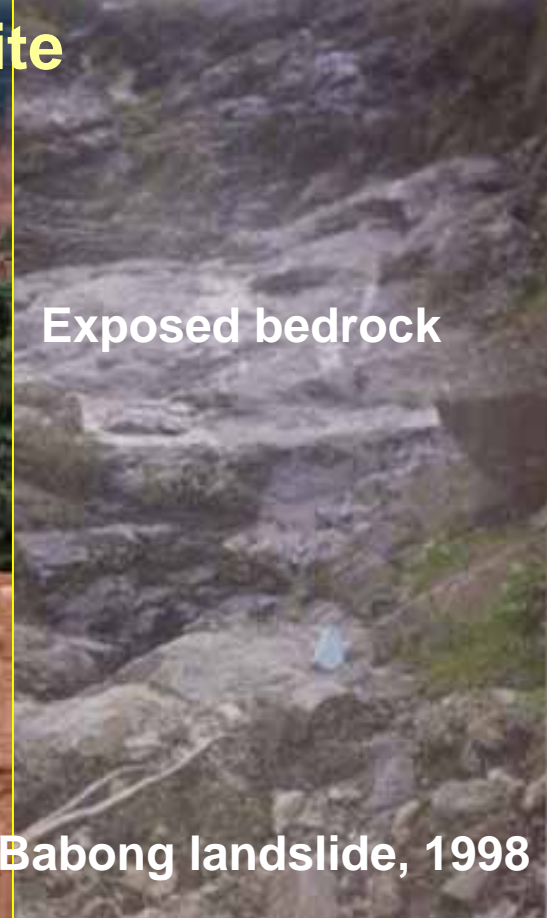
Exposed bedrock

Babong landslide, 1998

| Location & Relief | General Description | Geology | Materials deposited |
|--|---|--|--|
| <p>Close to the bottom of the caldera, 85% of the slope 60°-85°</p> | <p>Scarp 10m - 20m. Bed rock exposed at almost every site and streams are very common. Sides 10m - 15m deep. Length 10m -700m.</p> | <p>Weathered granites and trachytes. Ferrillitic soils and andosols, involved.</p> | <p>Boulders, rock particles, sand and silt 256mm-0.004mm, logs. Almost all the materials washed and deposited in the streams below and finally into river Meyi</p> |

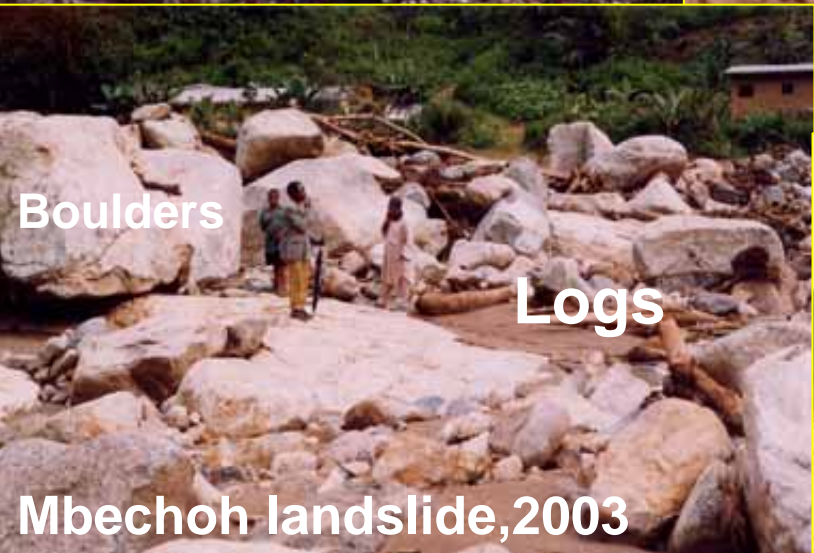
Boulders

Logs

Mbechoh landslide, 2003

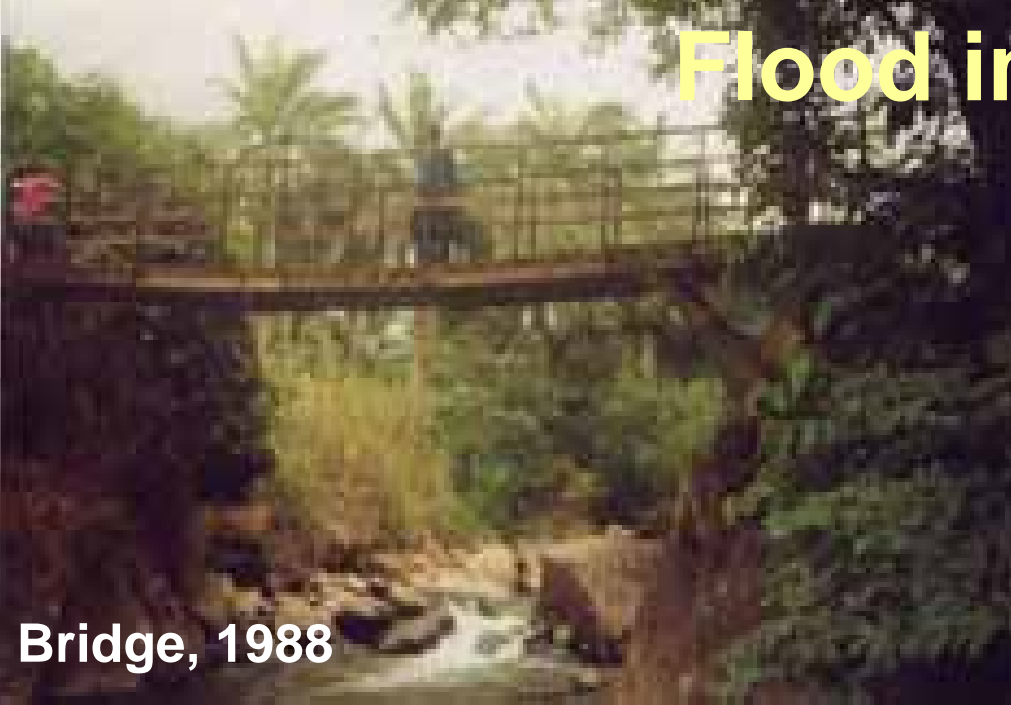
Bridge, 1988

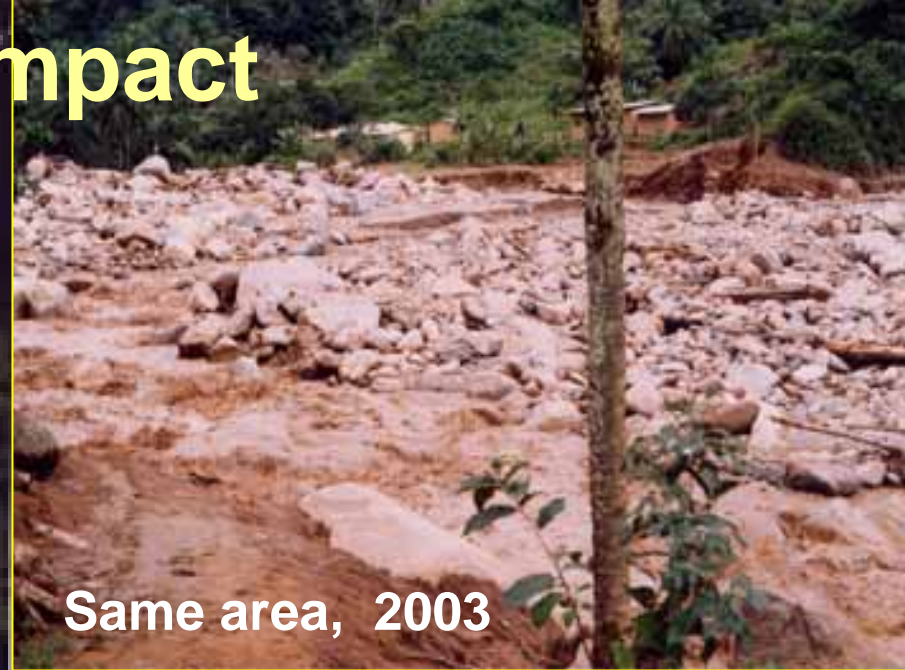
Same area, 2003

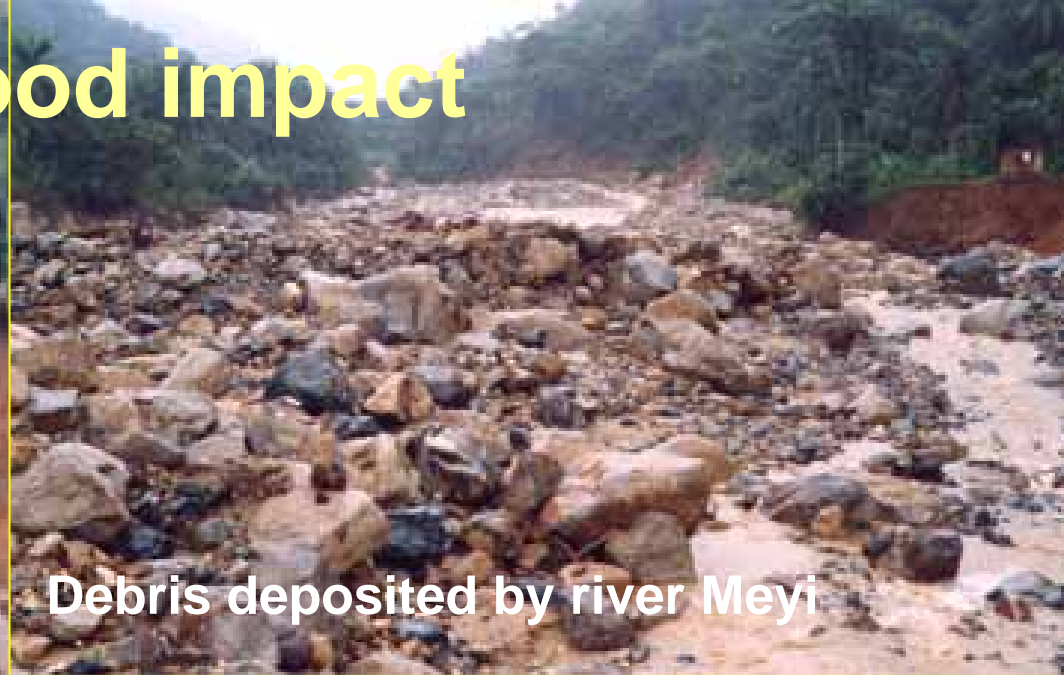
Debris deposited by river Meyi
