INFLUENCE OF COASTAL PLAIN CARBONATES ON RESERVOIR DEVELOPMENT: BIENVILLE NATIONAL FOREST, SMITH COUNTY, MISSISSIPPI

The study site is in south-central Mississippi in Paleogene/Neogene coastal plain deposits

The key question was if karst was a factor in dam and reservoir stability and function

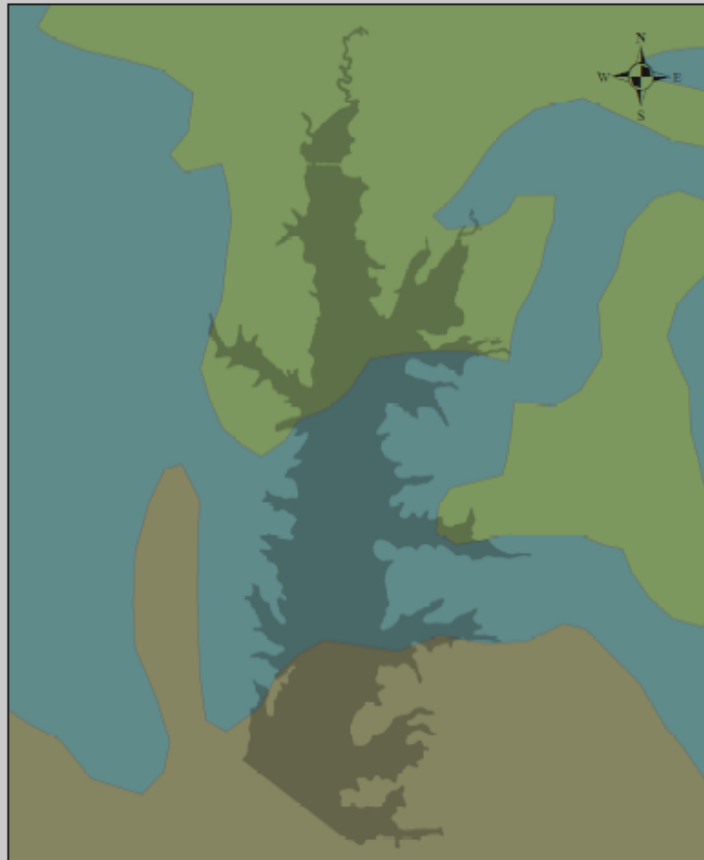
Surface Geology Map of Proposed Reservoir

CATAHOULA FORMATION
 VICKSBURG GROUP
 FOREST HILL FORMATION

Dip is SSW at 6.6m/km, with significant local variation.

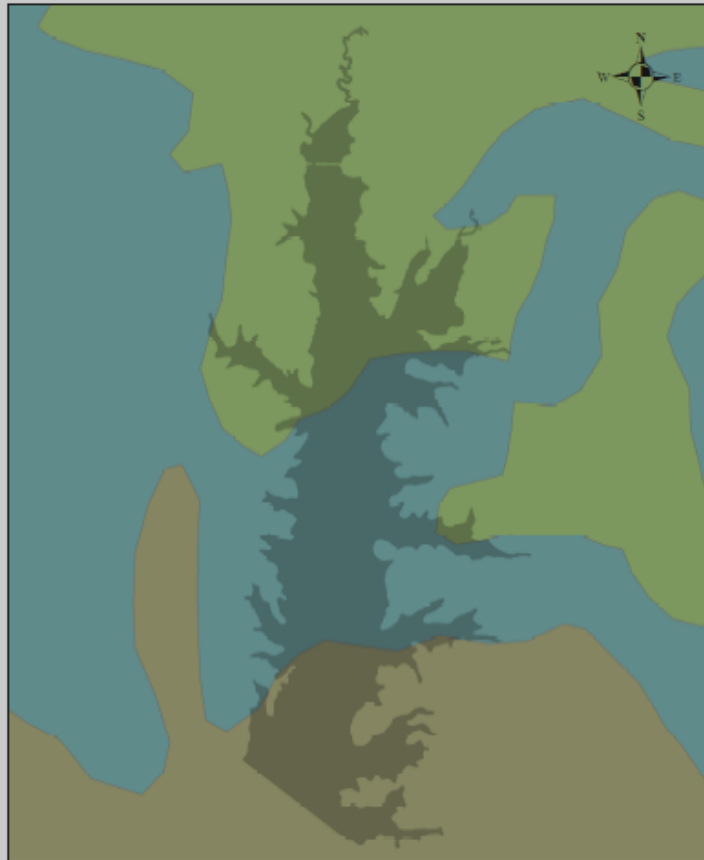
Surface Geology Map of Proposed Reservoir

CATAHOULA FORMATION
 VICKSBURG GROUP
 FOREST HILL FORMATION
 RESERVOIR FOOTPRINT

Dip is SSW at 6.6m/km, with significant local variation.

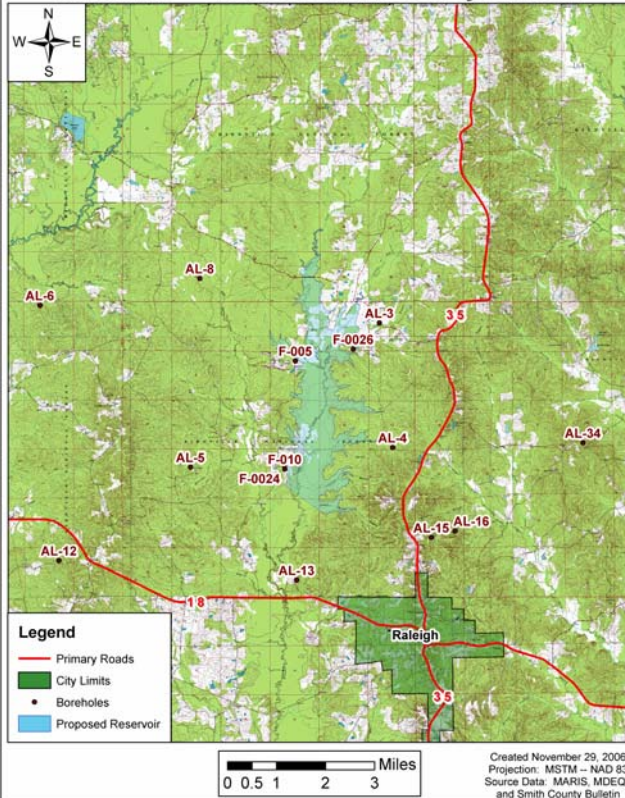
Boreholes --- MDEQ & Smith County Bulletin

Well logs from a variety of sources reported lost circulation and bit drops up to 2 m

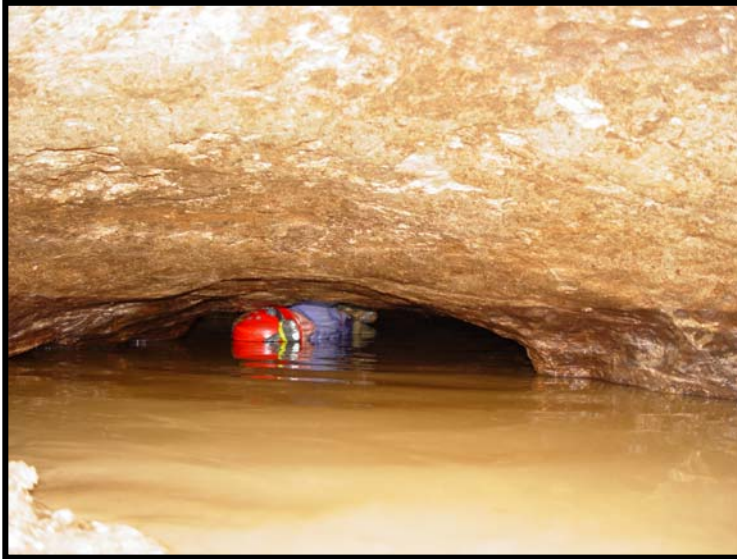
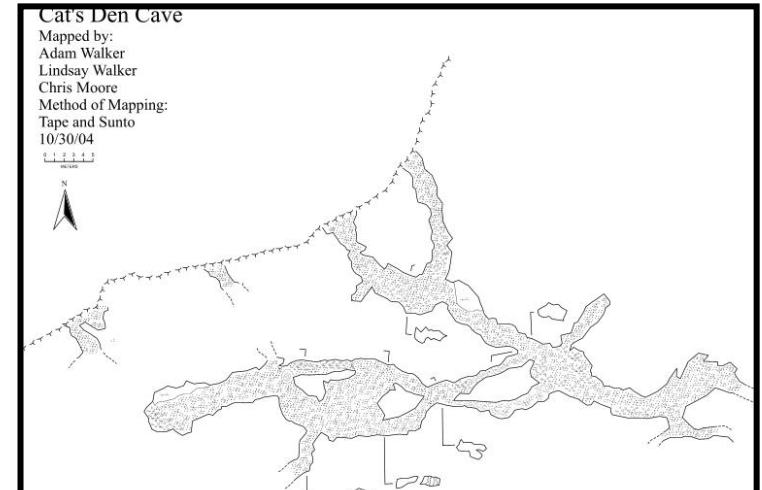
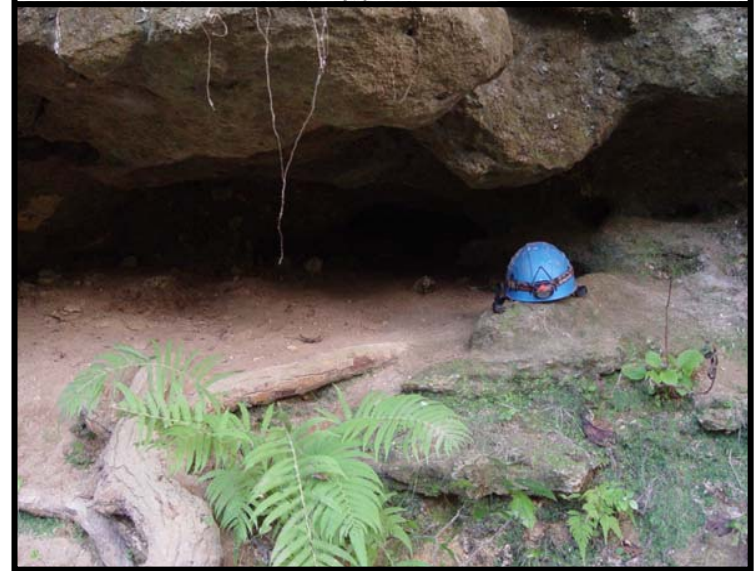
Active and abandoned karst conduits are found in the Glendon Limestone a few miles east of the reservoir site

Modern active flow

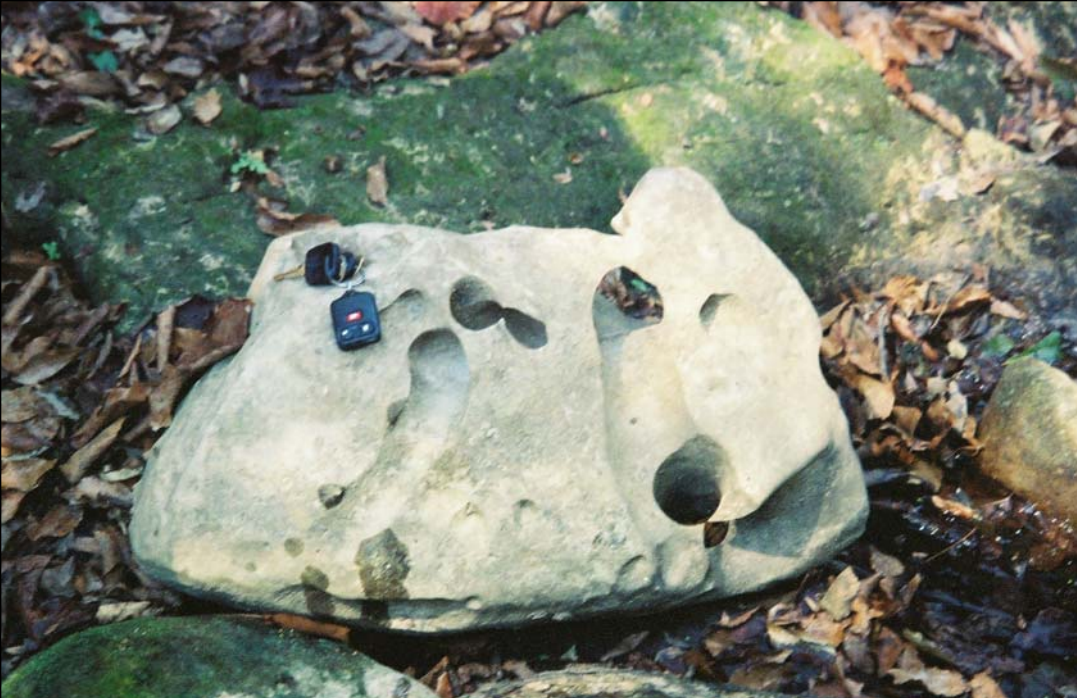
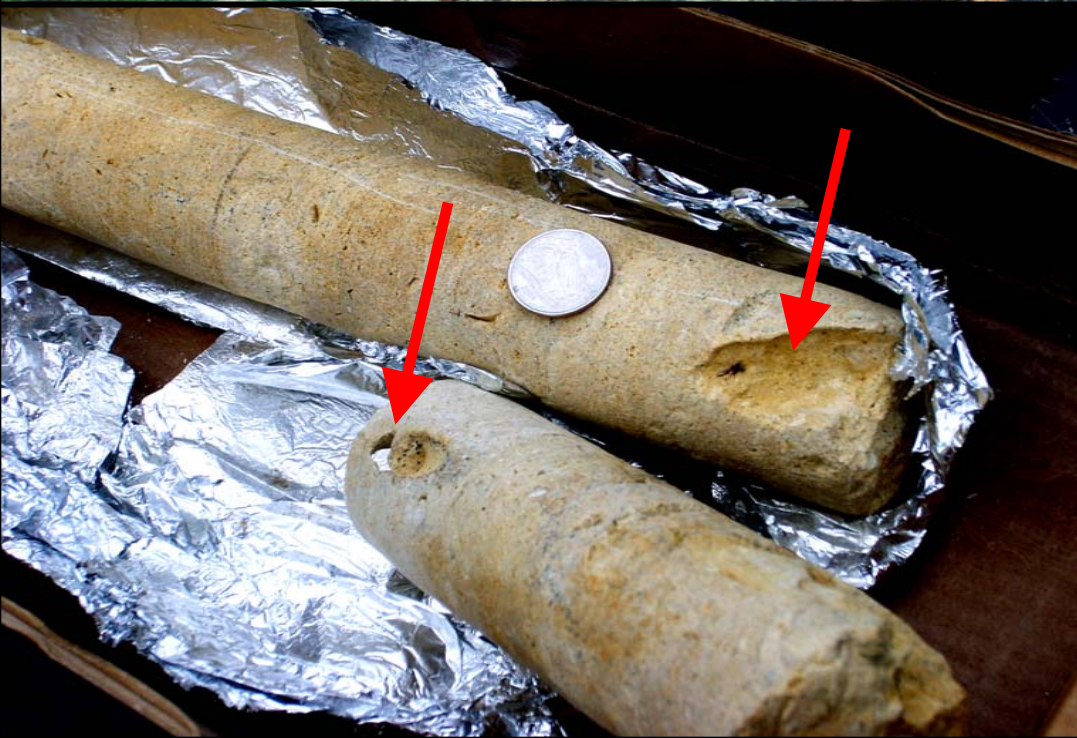
Valley wall paleo-flow

**Karst dissolution
in the Glendon
Limestone was
visible in outcrop
and in core.**

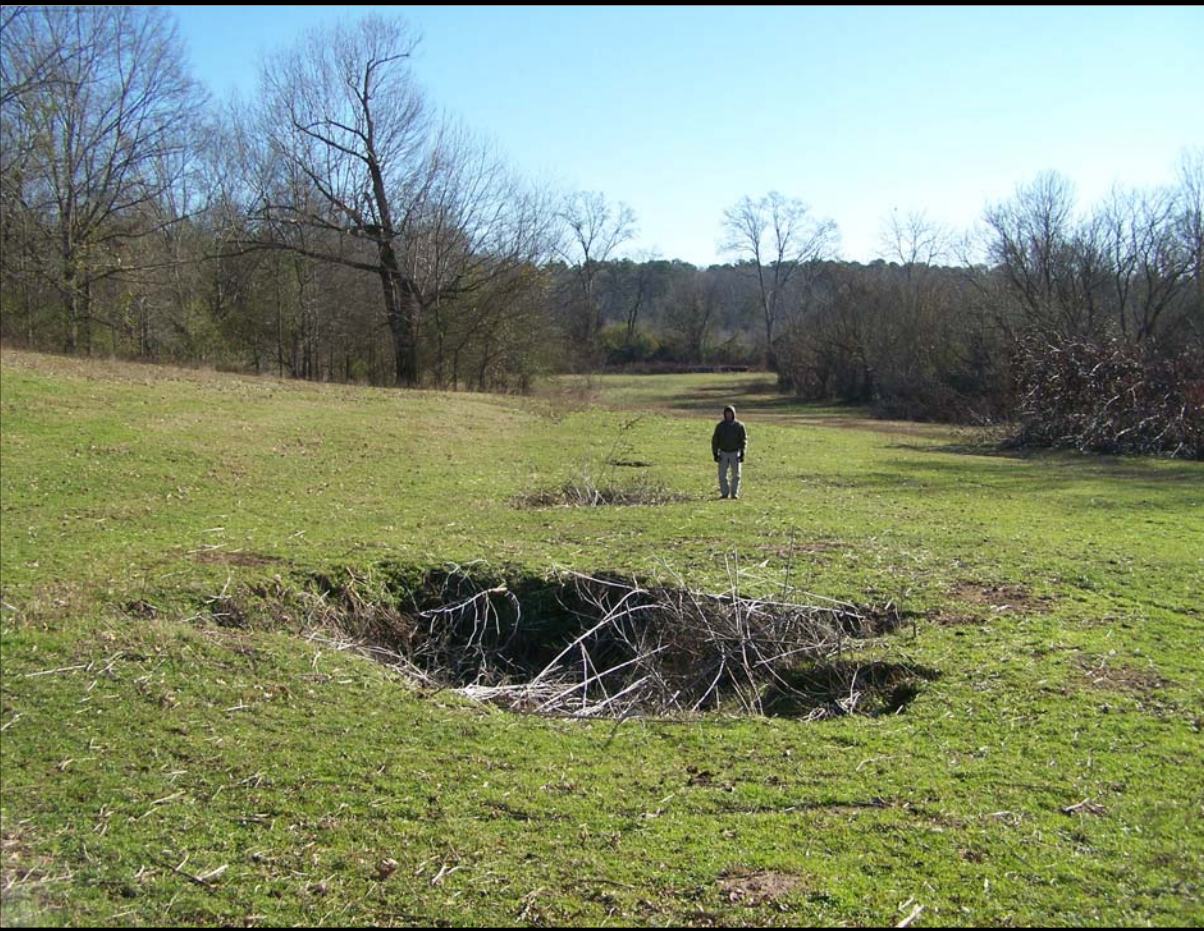
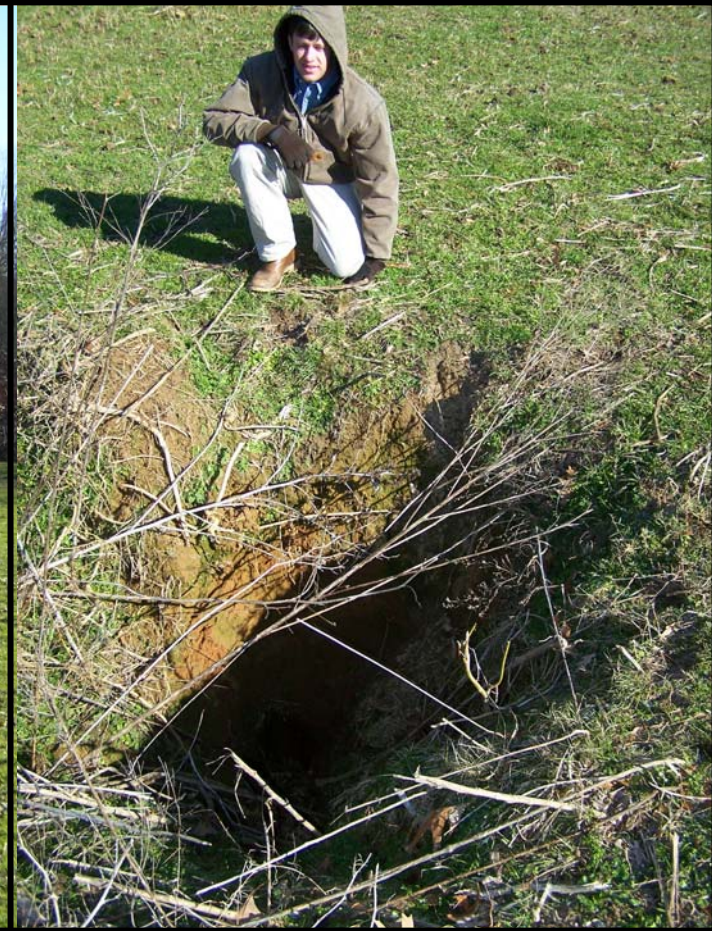
Field Reconnaissance found few actual karst features. The most dramatic were four cover collapse sinkholes in one pasture.

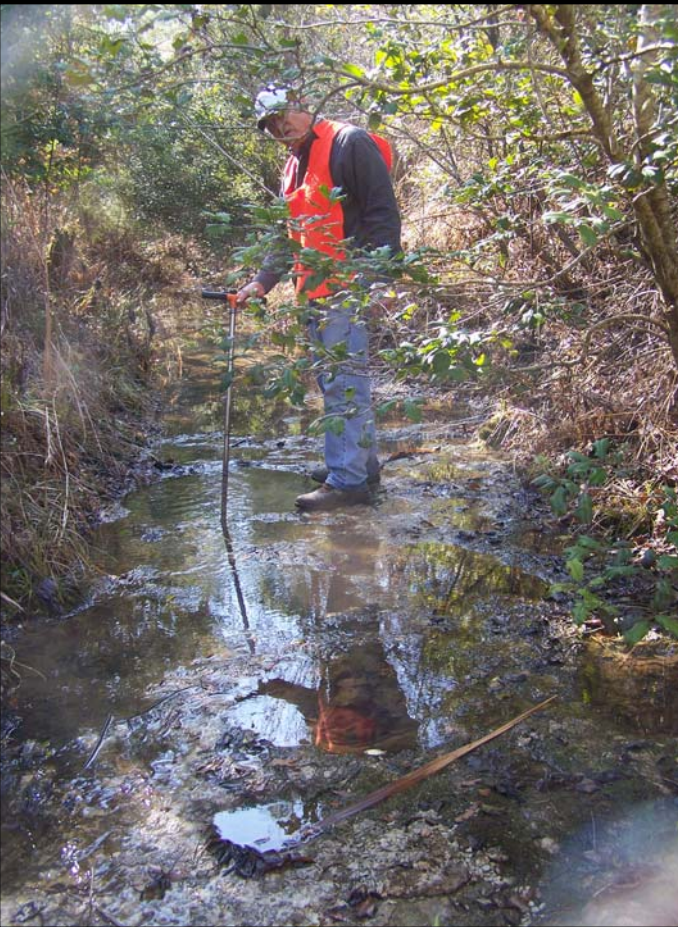
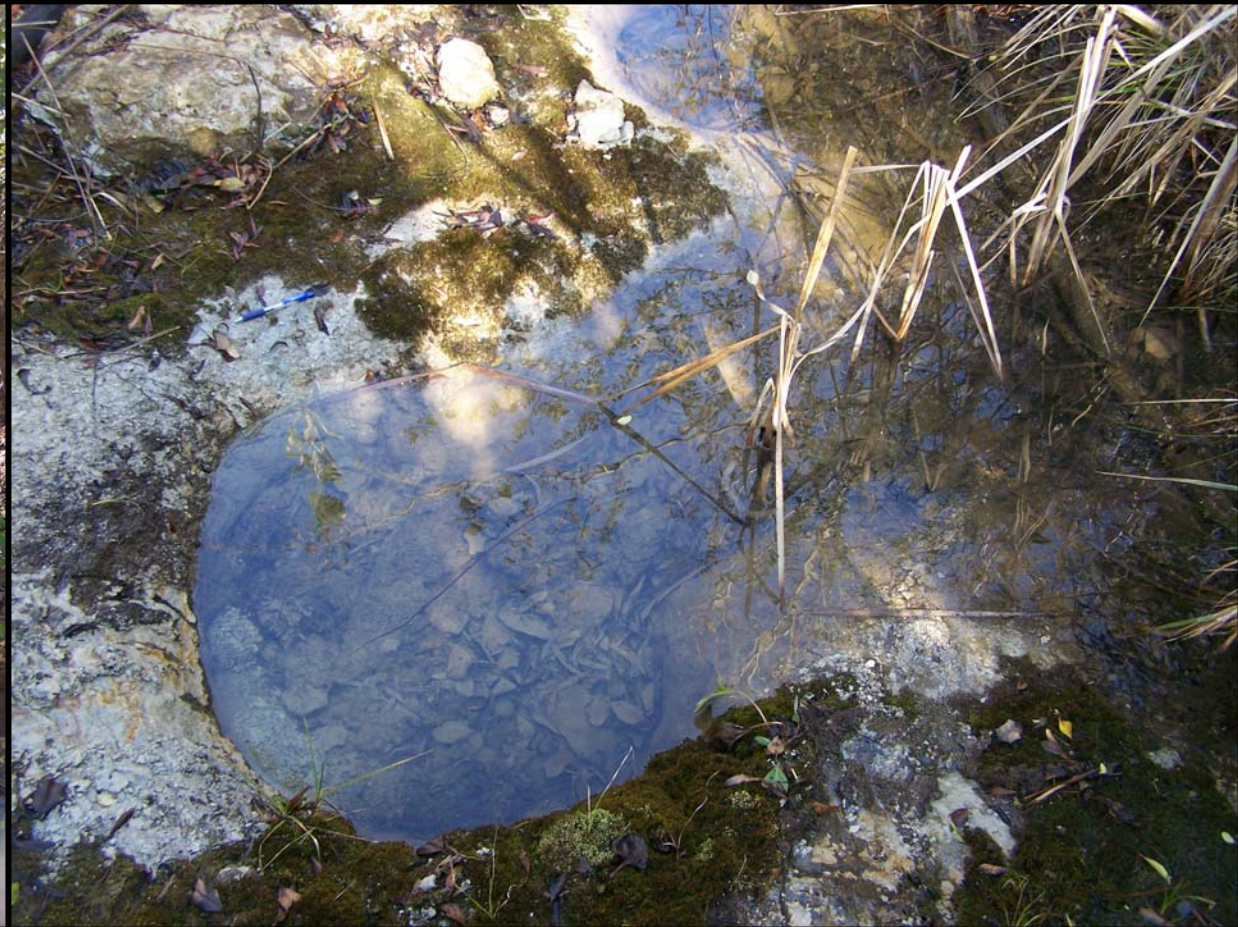
Tributaries crossing the Glendon Limestone displayed surface karren but did not sink.

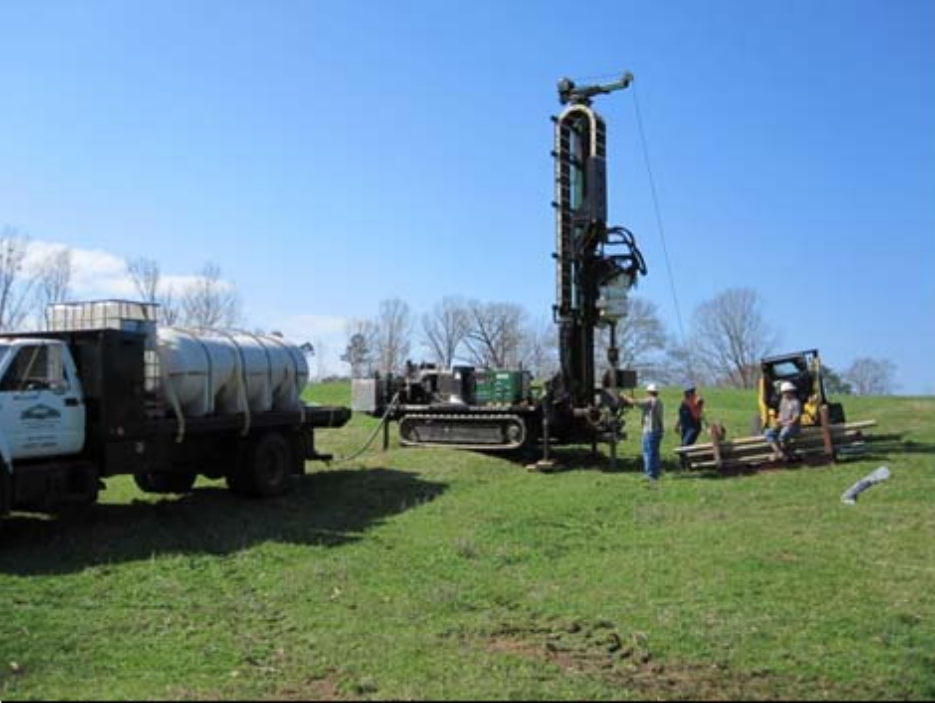
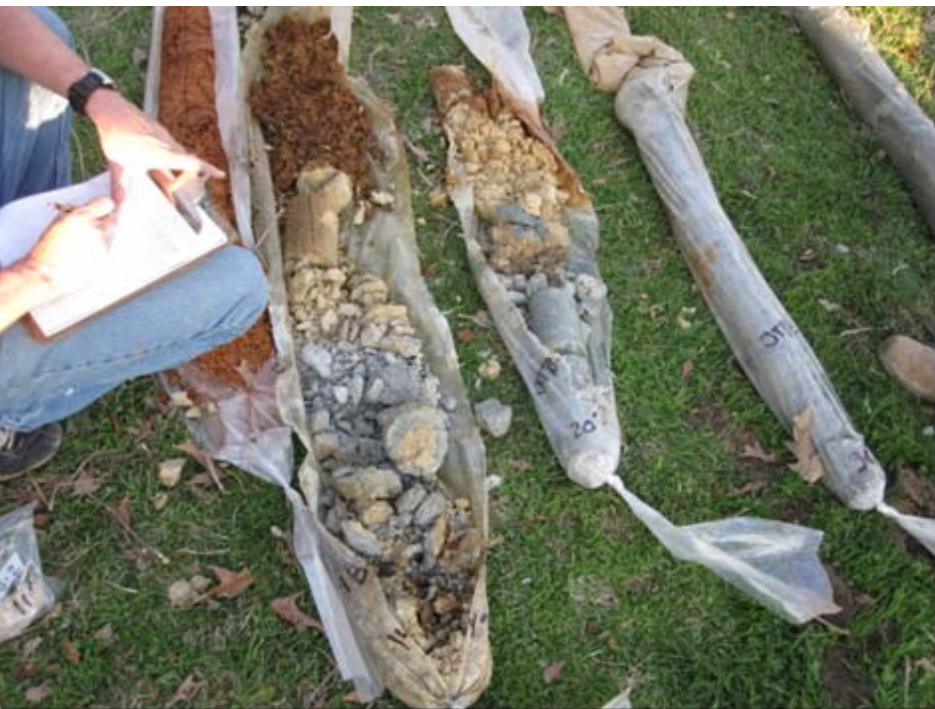
A sonic drilling rig was used to assess suspected karst features and anomalies

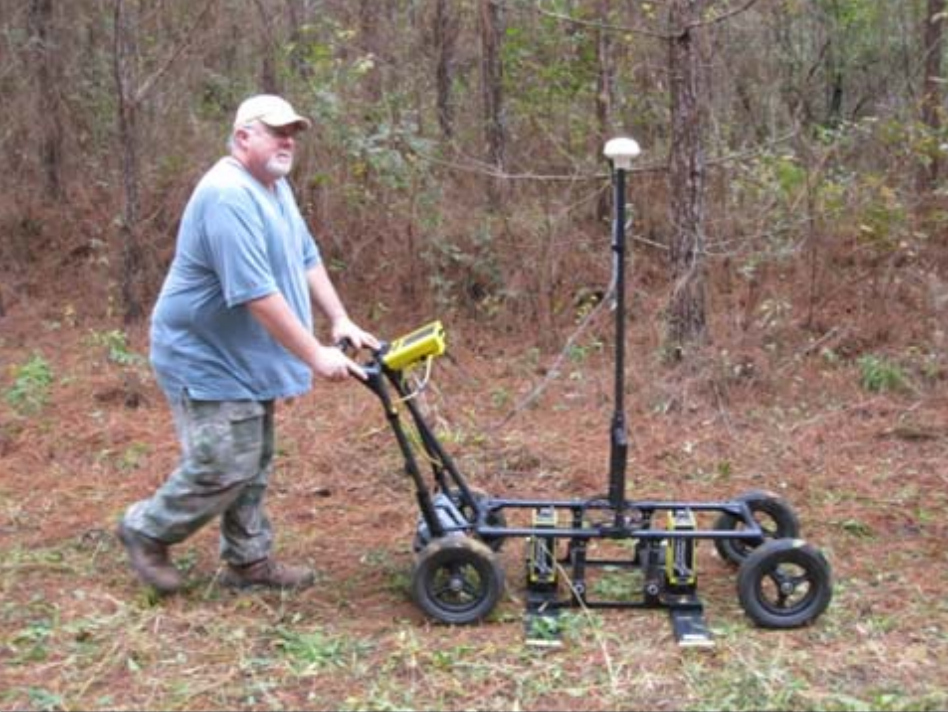
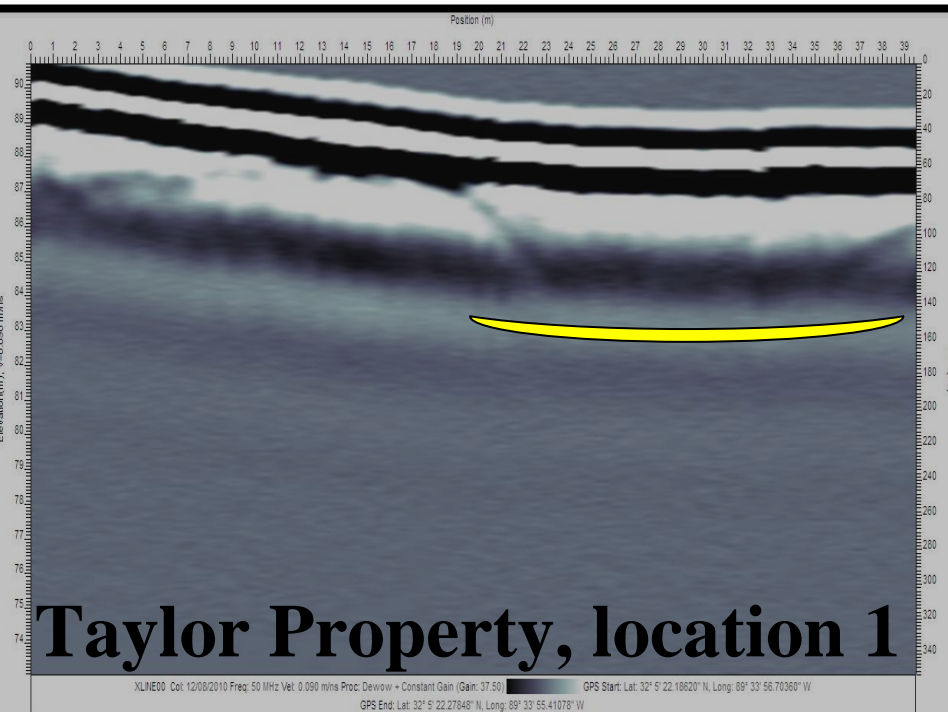
Ground penetrating radar located anomalies, but when drilled, they were not karstic.

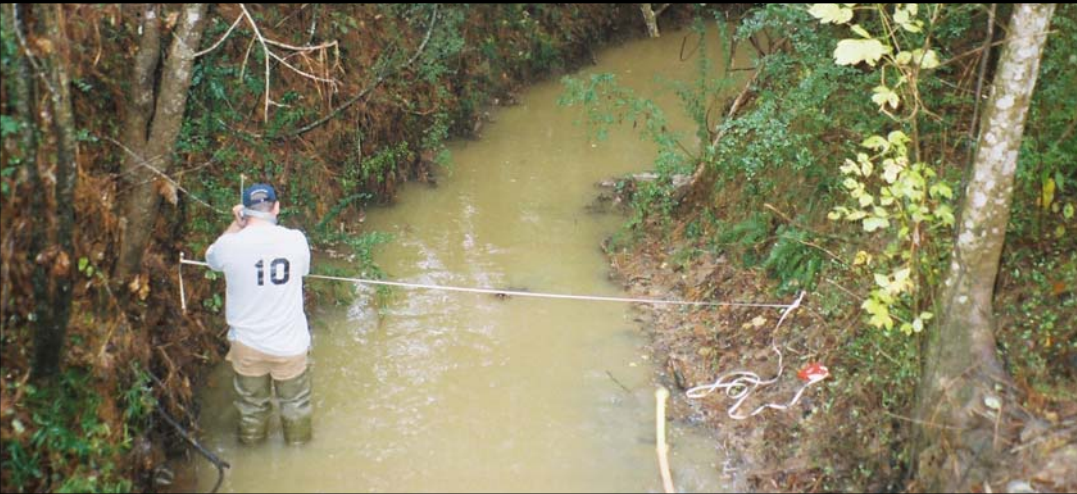
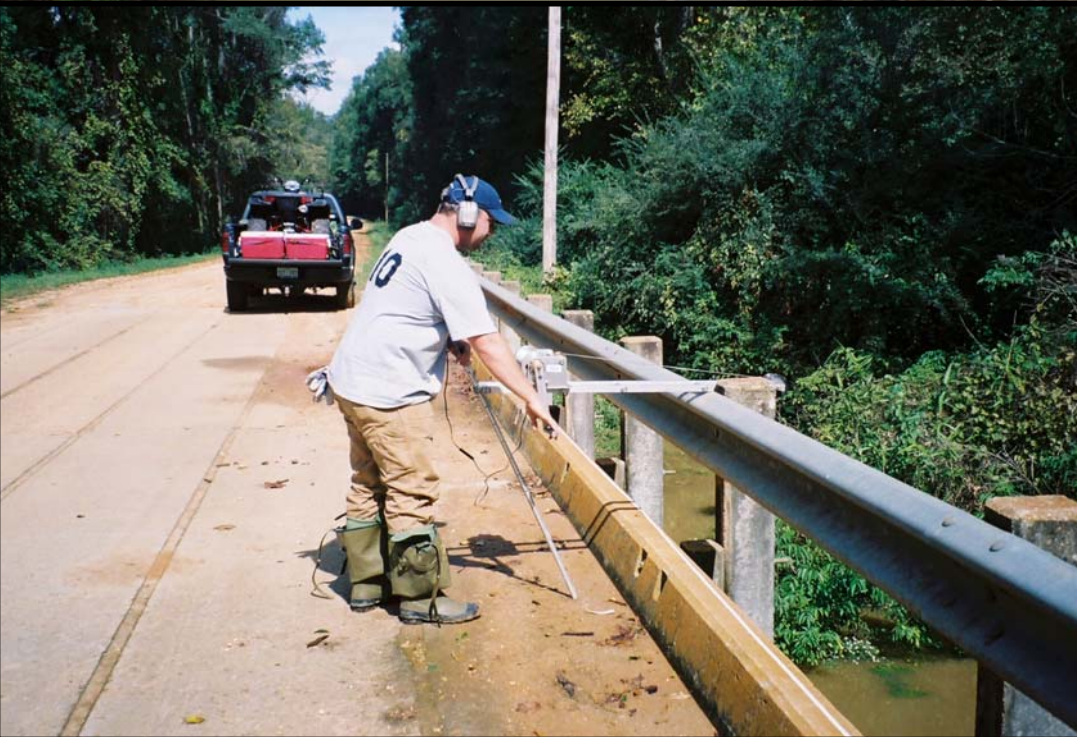
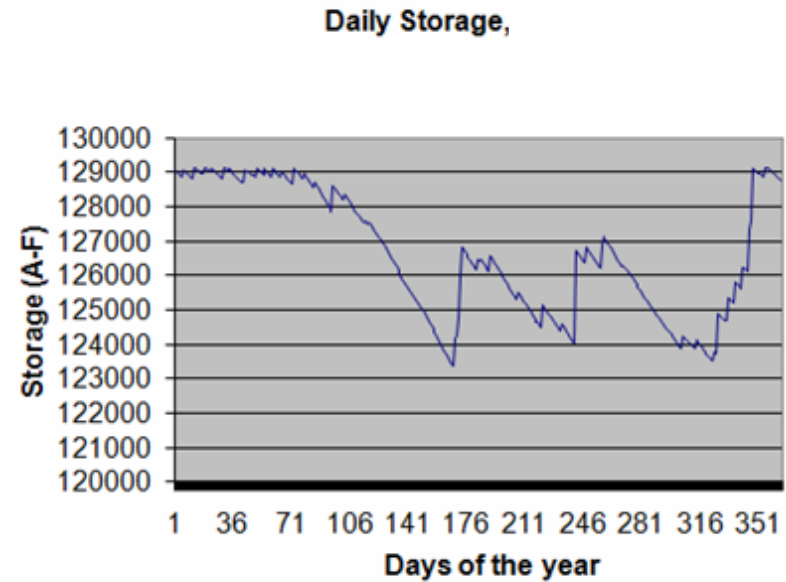
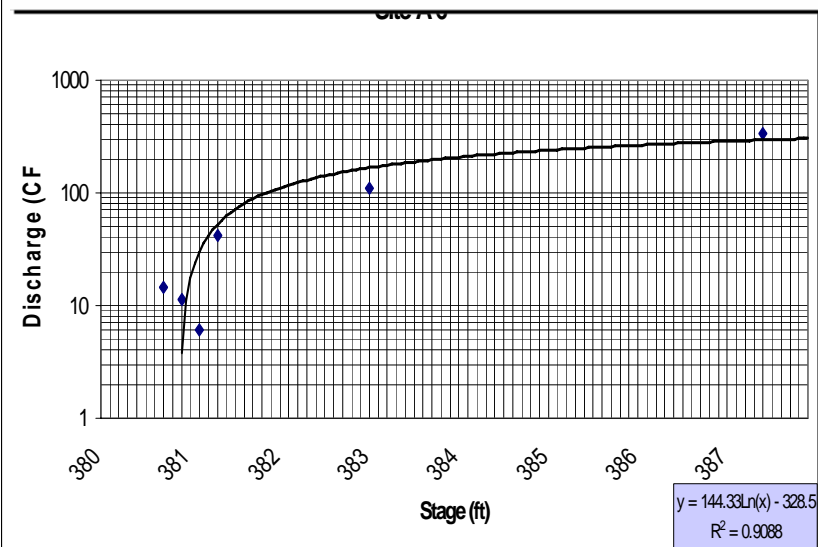
Stream flow and water budget analysis did not identify losing or gaining reaches.

**HARD
GLENDON
LIMESTONE**

**SOFT MINT
SPRING MARL**

Drilling revealed that when the hard Glendon Limestone was penetrated, the soft Mint Spring Marl below absorbed drilling fluid and also allowed very rapid penetration, mimicking a bit drop.

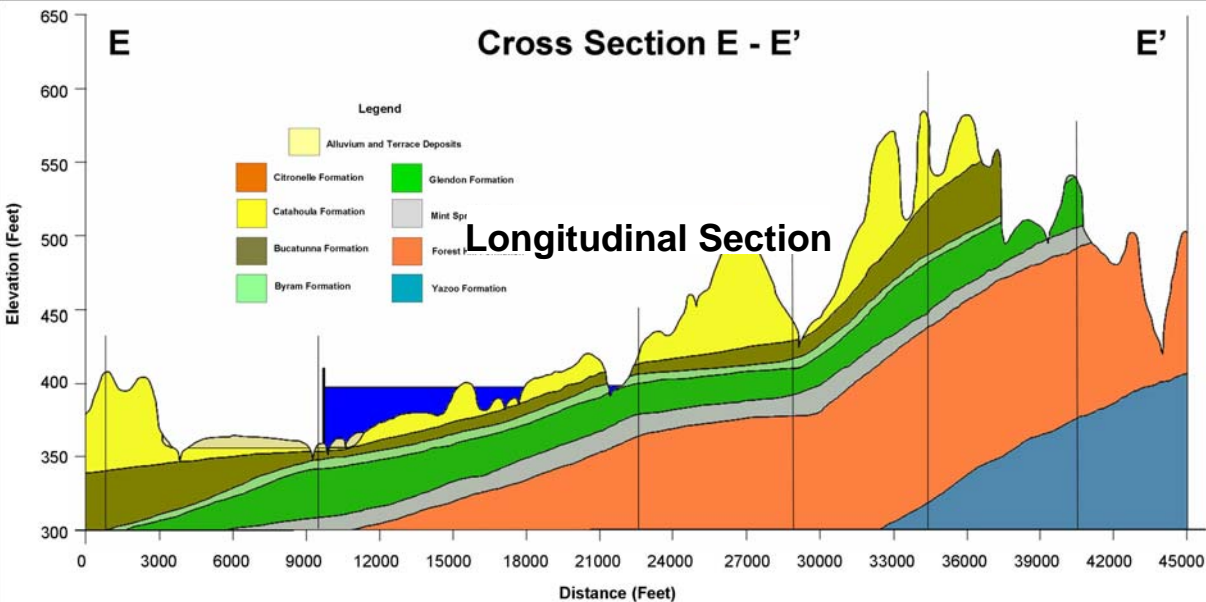
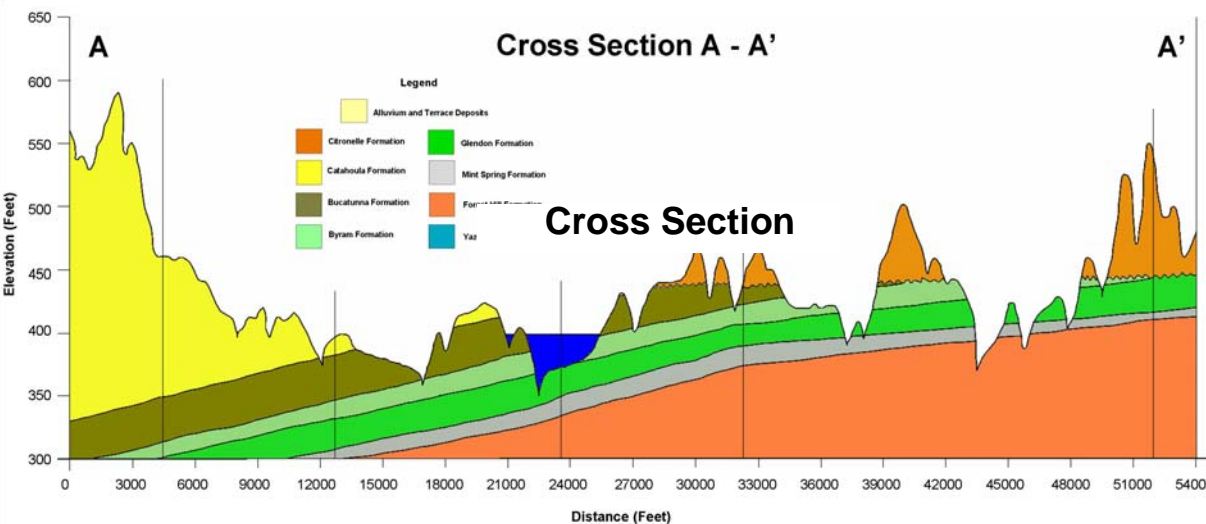
10X vertical exaggeration

Variation in Glendon Limestone thickness, once thought to be possible paleokarst, is now believed to be deformation caused by salt flow at depth.

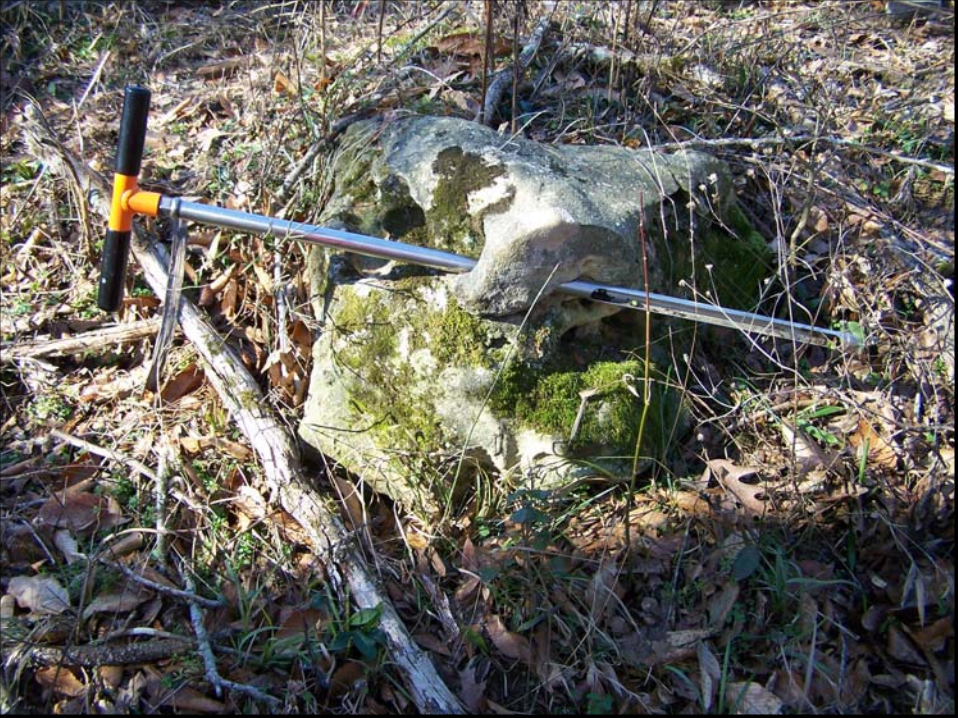
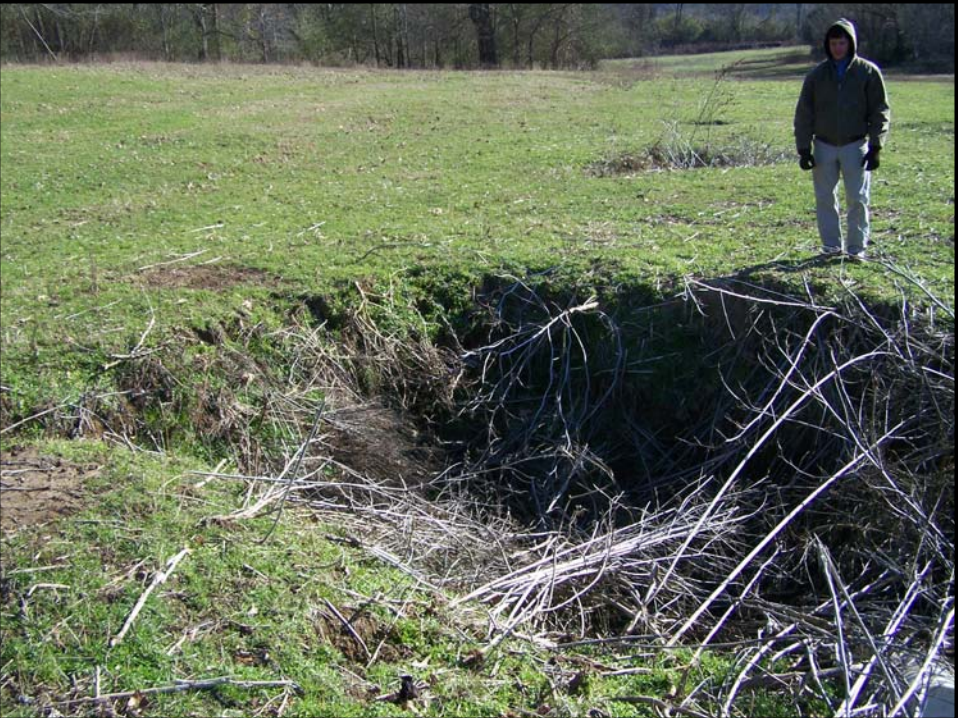
The evidence to date suggests that there is no active karst flow within the footprint of the proposed reservoir.

Some relict karst does exist, and there is a risk of re-activation of paleokarst pathways in the valley wall when the reservoir fills and creates high heads.

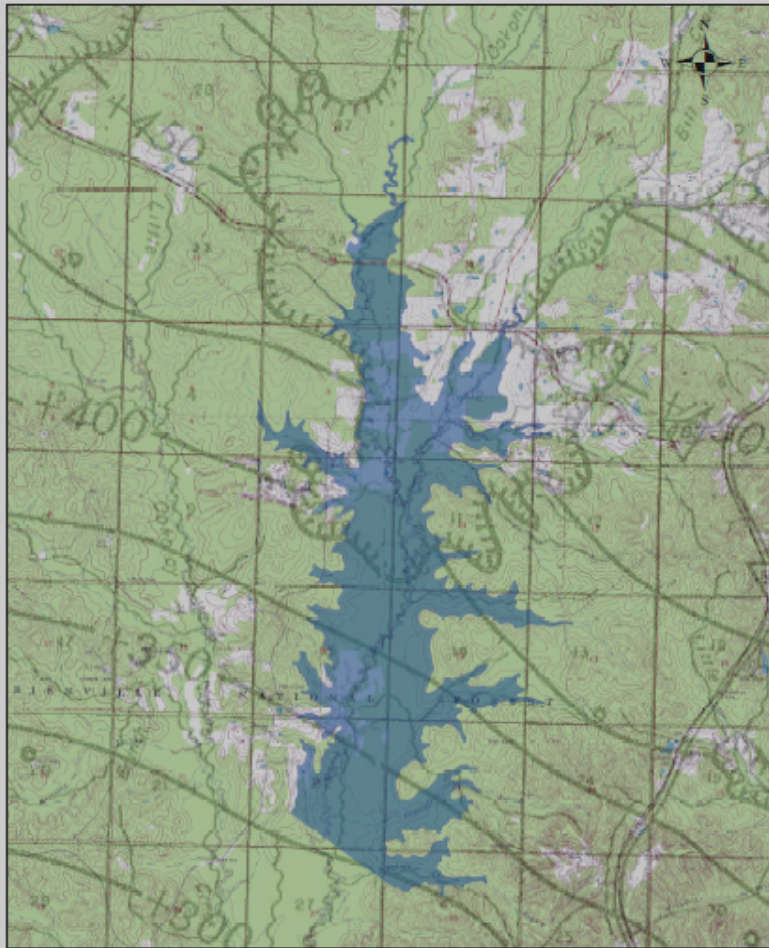
Glendon Structure Map

1) Karst is not well expressed.

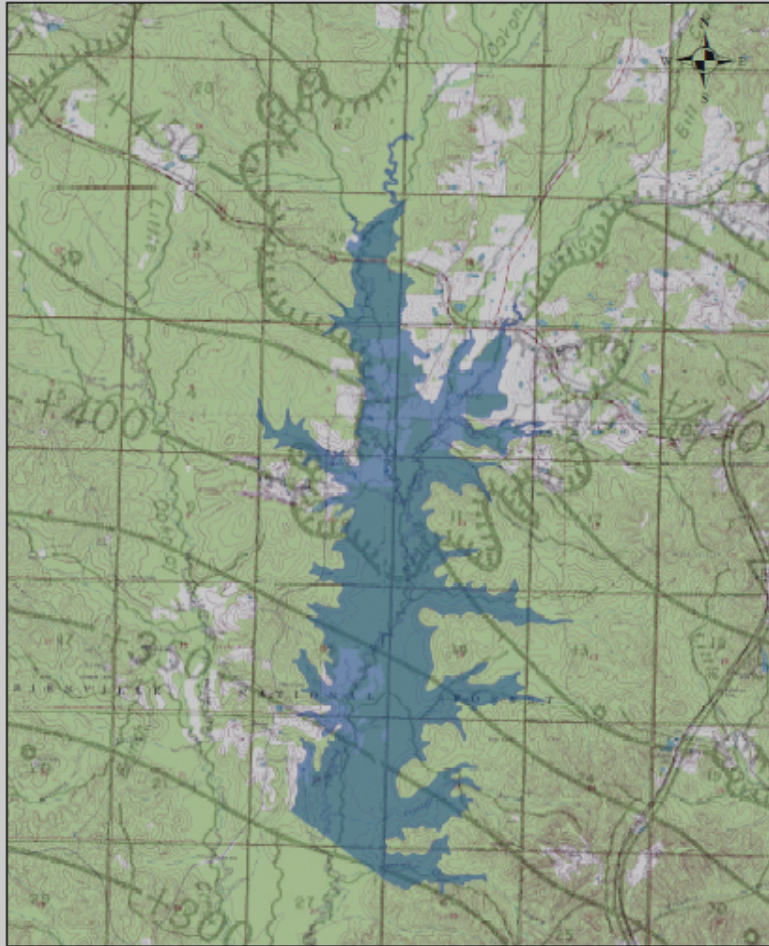
Glendon Structure Map

- 1) Karst is not well expressed.
- 2) Karst flow was not observed.
- 3) Bit drops and loss of circulation are artifacts.
- 4) Paleokarst was not observed.

Reactivation of abandoned conduits in the valley wall is still possible.
