Investigation of self-sustaining combustion of a coal waste heap in Scotland.

Torrance, Keith¹; Switzer, Christine¹; Keenan, Helen¹, Rein, Guillermo²; Hadden, Rory²; Belcher, Claire, M.² and Carvel, Ricky.²

¹Department of Civil Engineering, University of Strathclyde, Glasgow, UK.

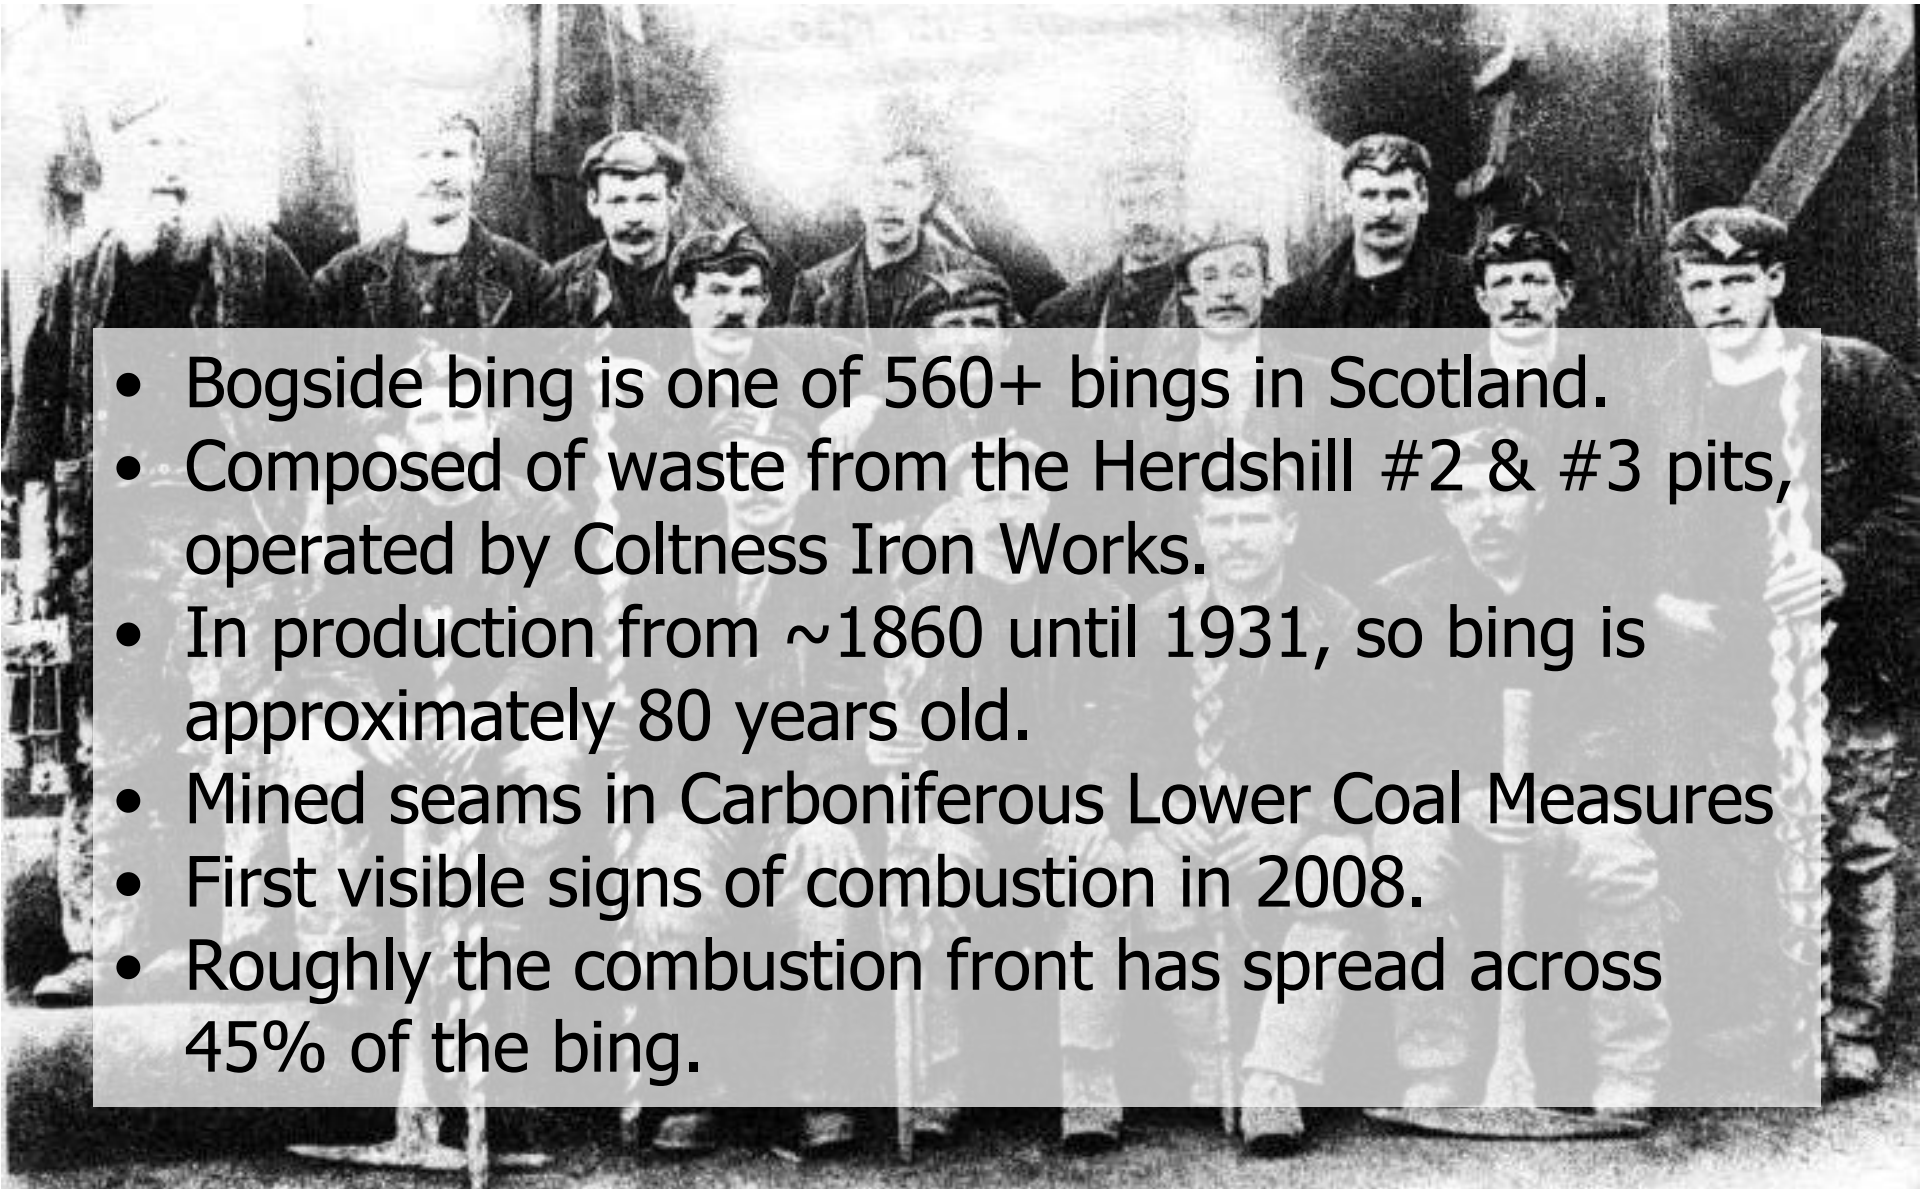
Bogside bing, N.Lanarkshire

- Bogside bing is one of 560+ bings in Scotland.
 - Composed of waste from the Herdshill #2 & #3 pits, operated by Coltness Iron Works.
 - In production from ~1860 until 1931, so bing is approximately 80 years old.
 - Mined seams in Carboniferous Lower Coal Measures
 - First visible signs of combustion in 2008.
 - Roughly the combustion front has spread across 45% of the bing.

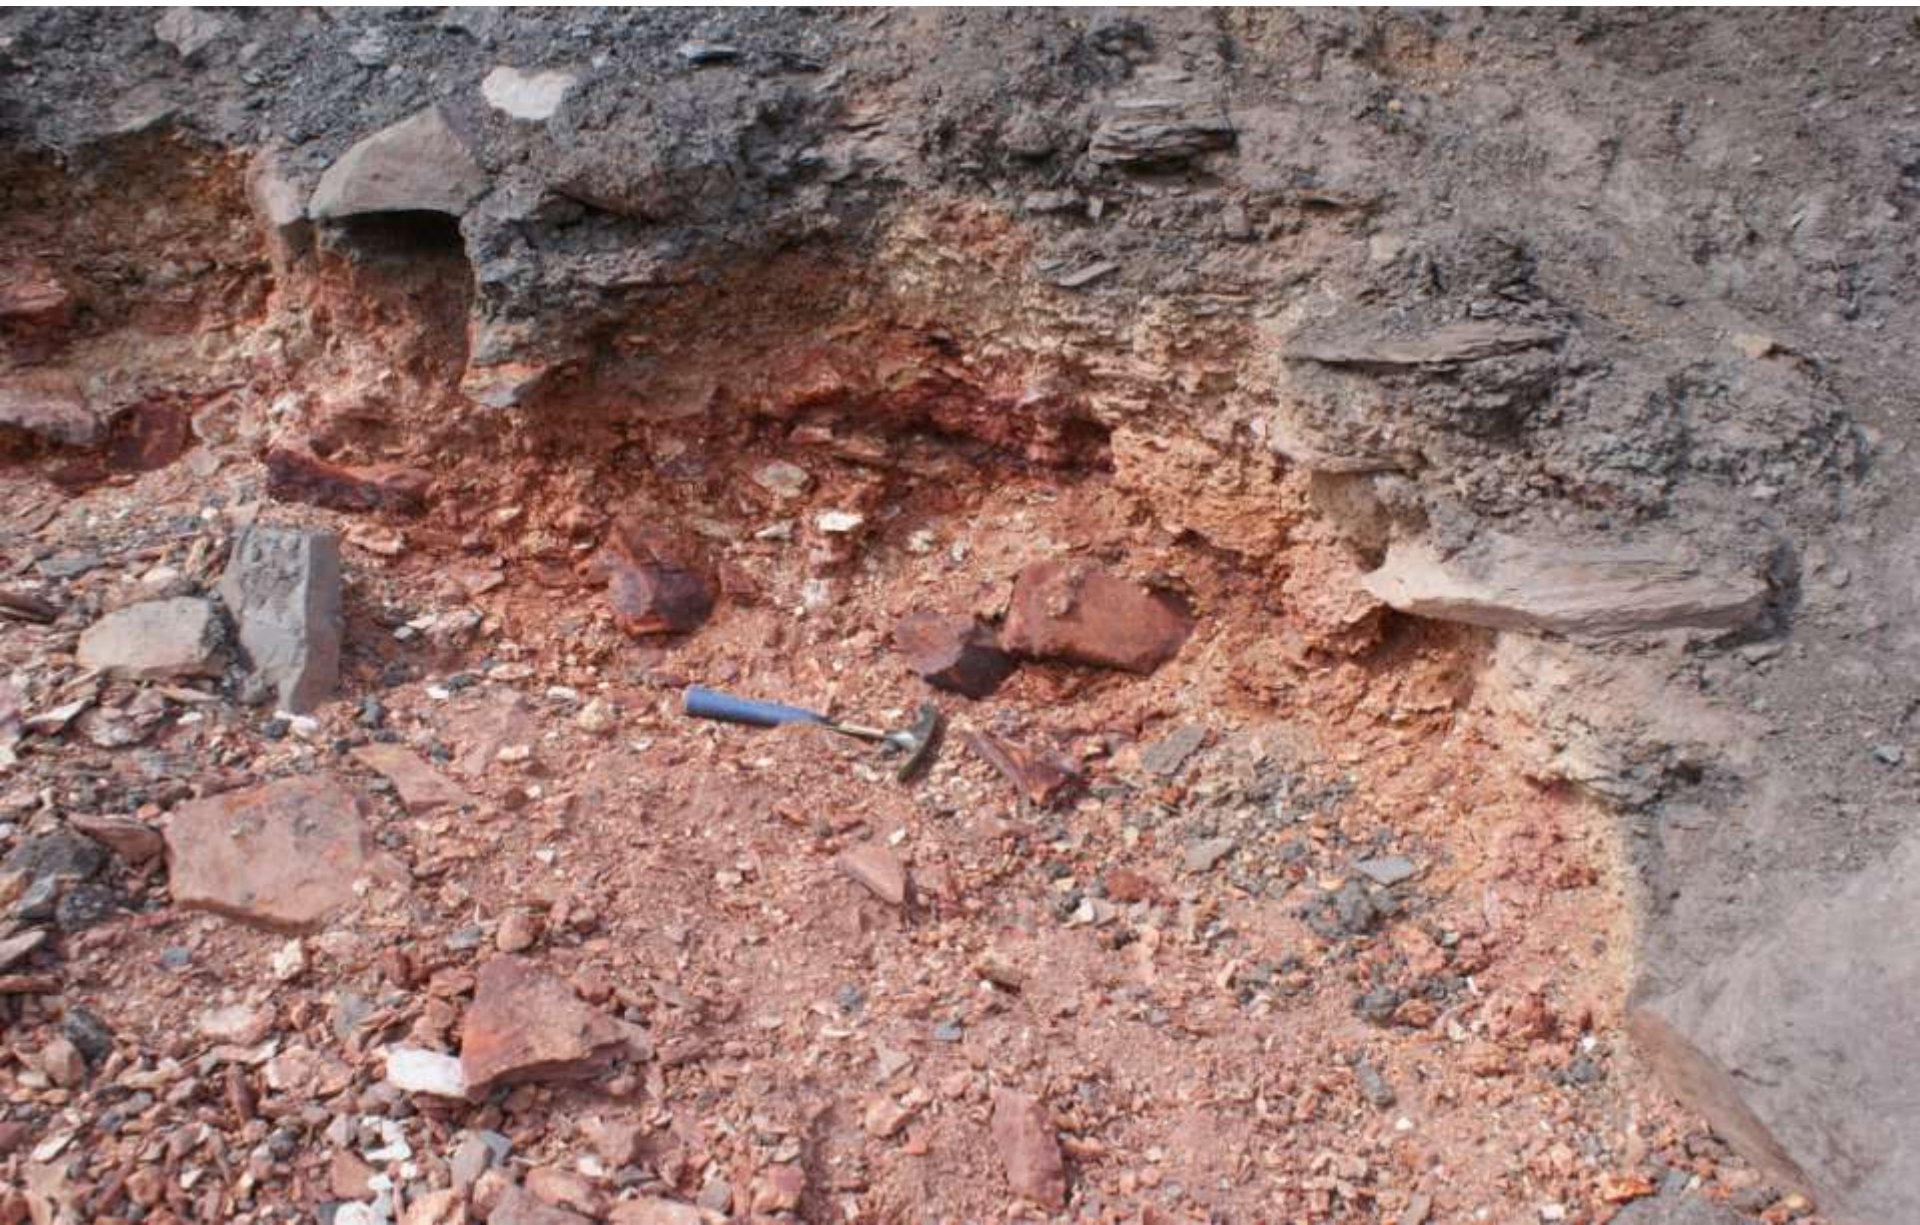
Post-combustion – ‘red blaes’

Combusted 'red
blaes' bing,
denuded of
vegetation -
unstable.

Moisture	Carbon	Color
BOG2	0.64%	4.57%	Red

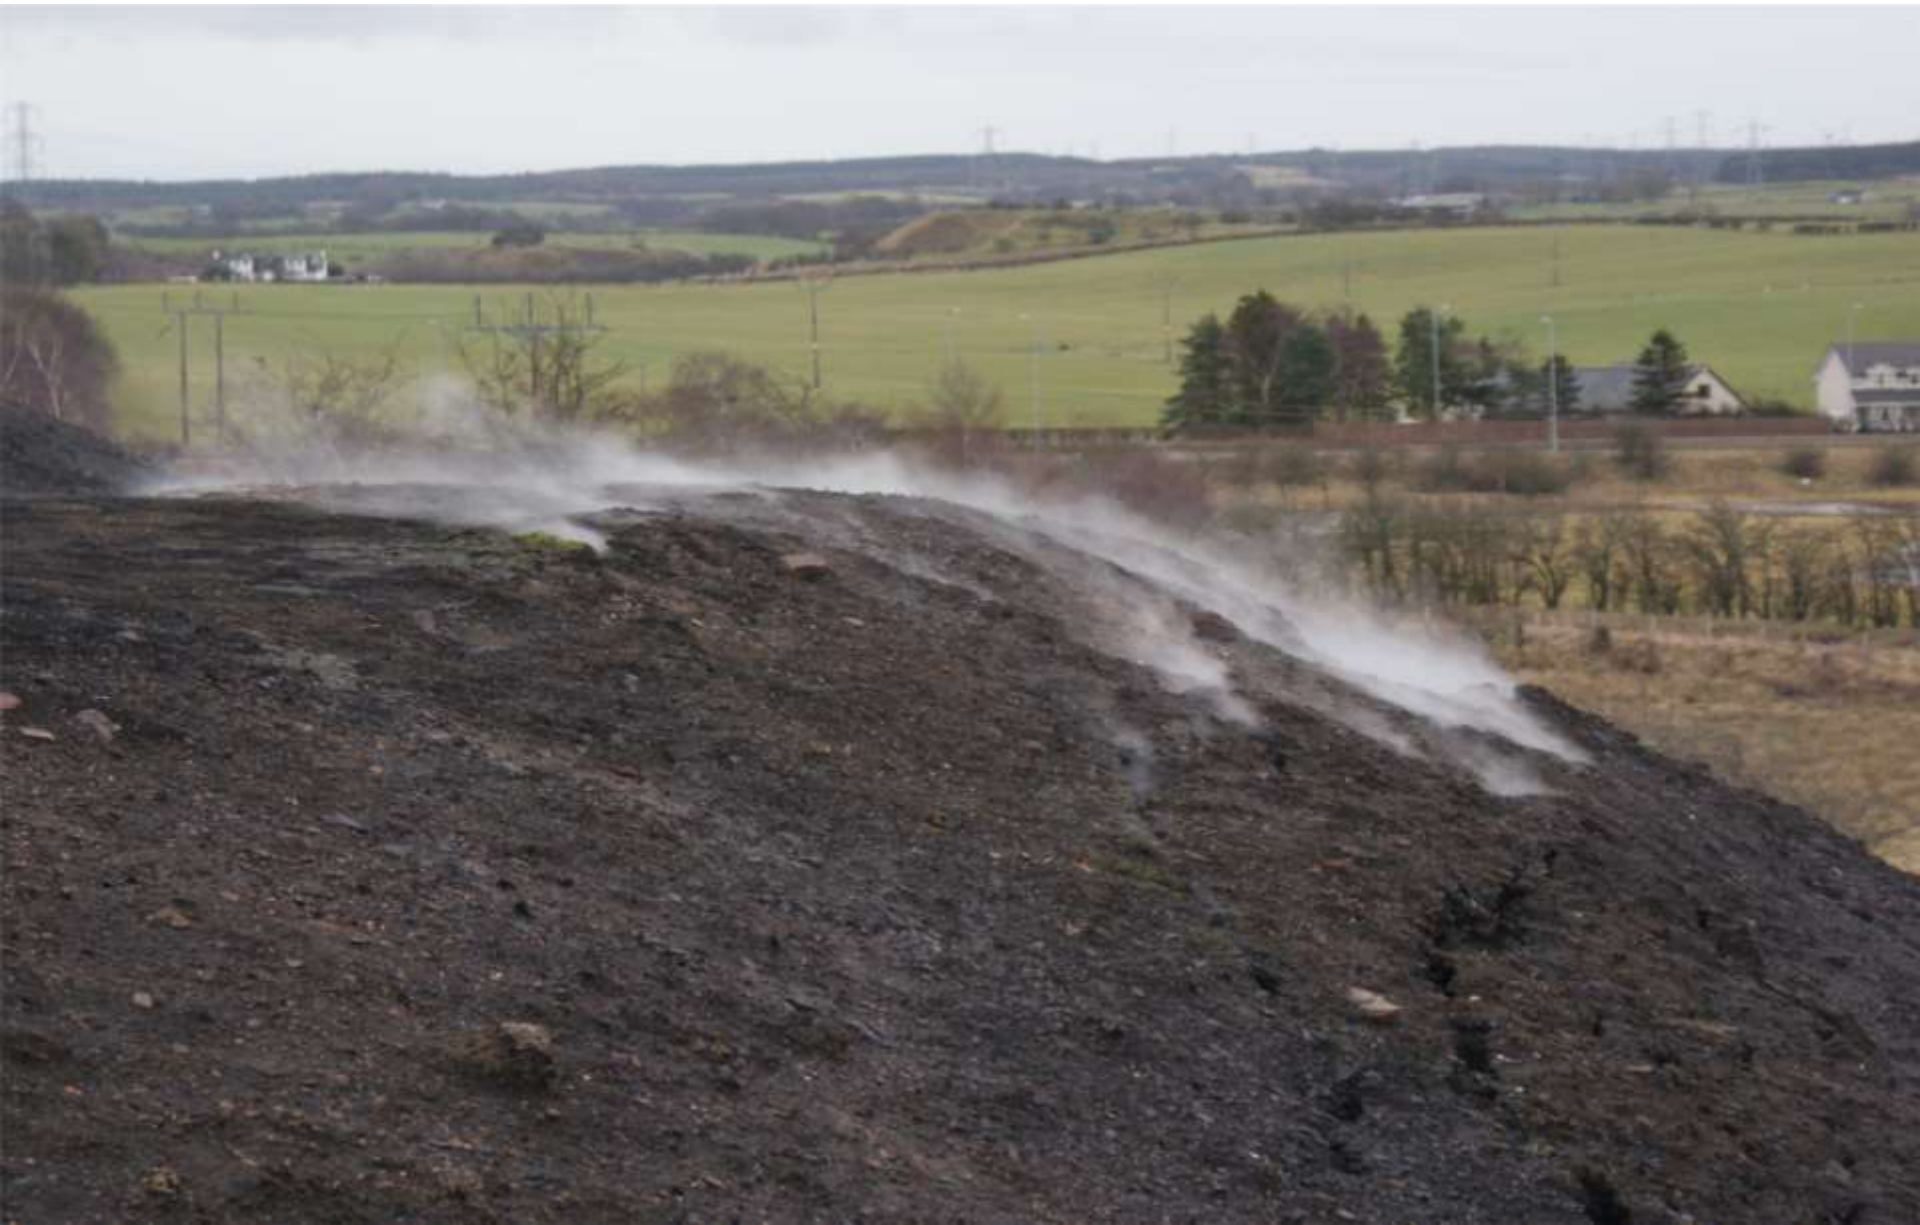
Vent gas analysis

Blank	DOD4(1)	DOD4(2)	DOD3 (1)	DOD3 (2)
H ₂ O (vol%)	0.99	1	0.94	0.95	0.98
CO ₂ (vol%)	0.09	0.81	1.91	0.6	0.51
CO (ppm)		13	33	14	10
SO ₂ (ppm)			trace	trace	
CH ₄ (ppm)		116	274		
C ₂ H ₆ + (ppm)		10	27	trace	trace
O ₂ (vol%)	21.41	20.41	19.06	21.03	21.04

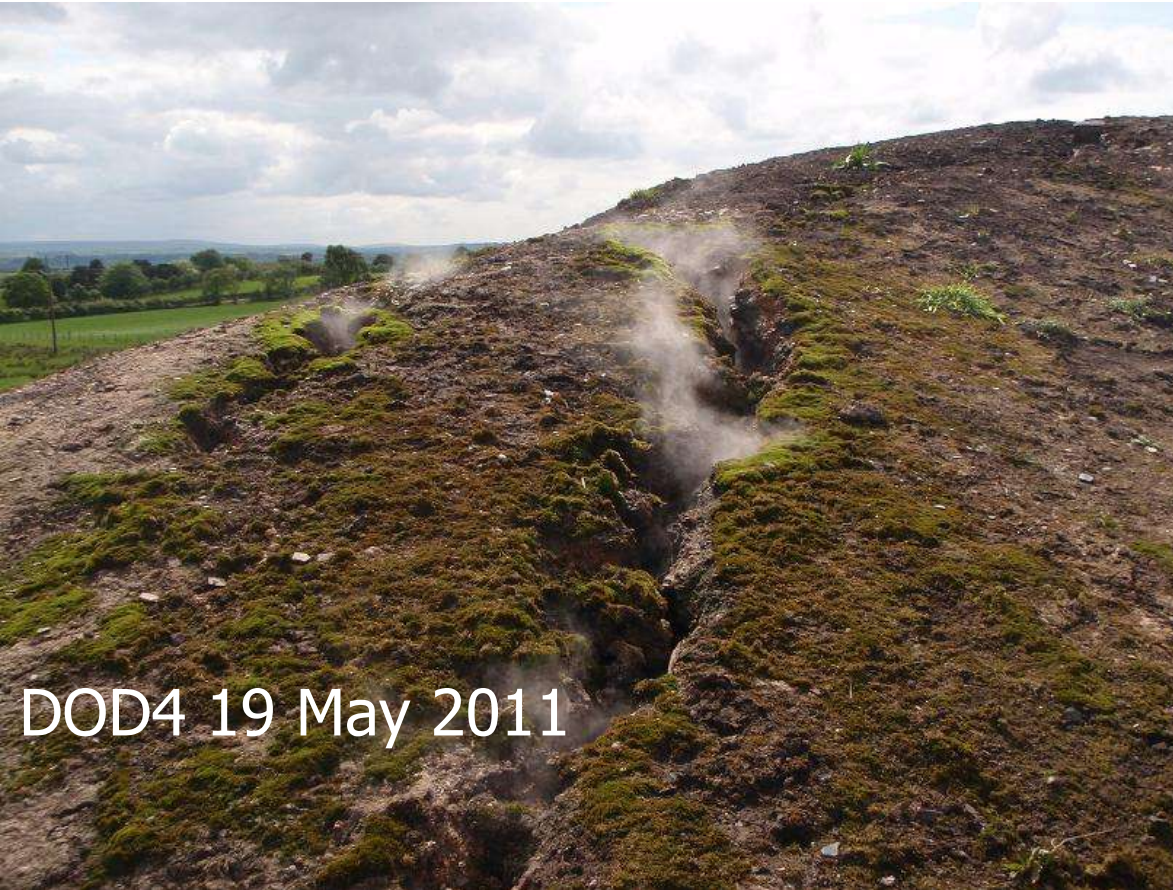
DOD4 19 May 2011

Sample point DOD4 is initially in the drying zone, but within a month temperature has increased and the moss surrounding the vent has died.
