A COMPARISON OF OVERBANK SEDIMENTATION THICKNESS AND TEXTURE IN NON-EMBANKED FLOODPLAINS DURING THE 2011 AND 1973 FLOODS ALONG THE LOWER MISSISSIPPI RIVER, USA

The Geological Society of America
 Annual Meeting and Exposition
 Charlotte, NC; November 4-7, 2012

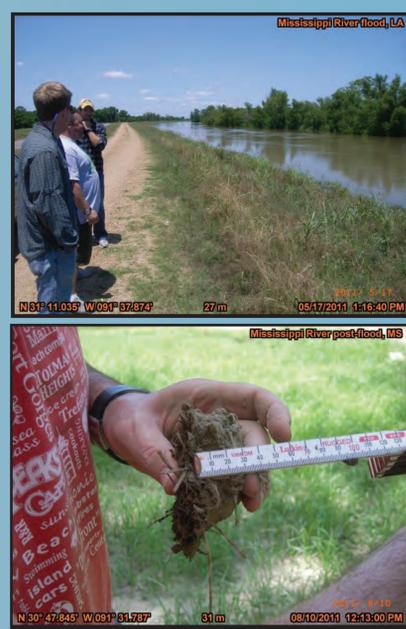
Figure 2. The 2011 flood exceeded previous stage records between Vicksburg, Mississippi, and St. Francisville, Louisiana. This photo was taken along a flood-control levee in Louisiana one day before the crest (22.06 m) at nearby Red River Landing.

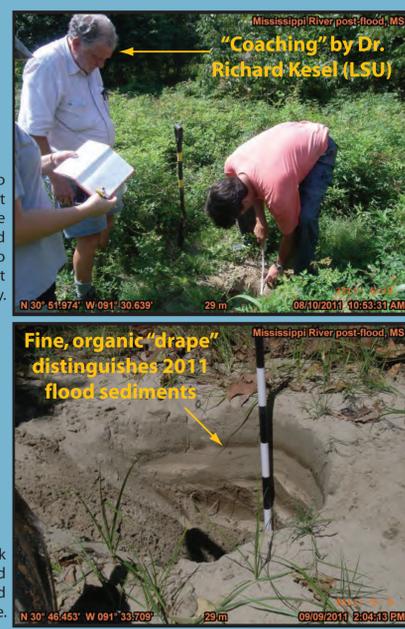
Figure 4. Accurate measurements of overbank sediment thickness required field research to be done in August and September 2011, a little over a month following flood recession. Otherwise, additions of organic litter would darken the deposits and make distinction from underlying soils difficult. This sample is discerned from the former surface by a buried organic litter layer.

Figure 5. Relatively thick overbank deposits on natural levees required excavation and identification of a buried fine-grained, organic-rich drape.
