# Million cubic meter scale post-glacial rock block slide on Cadillac Mountain, Acadia National Park

Duane D Braun, Emeritus, Geography and  
Geosciences, Bloomsburg University,  
Bloomsburg, PA.

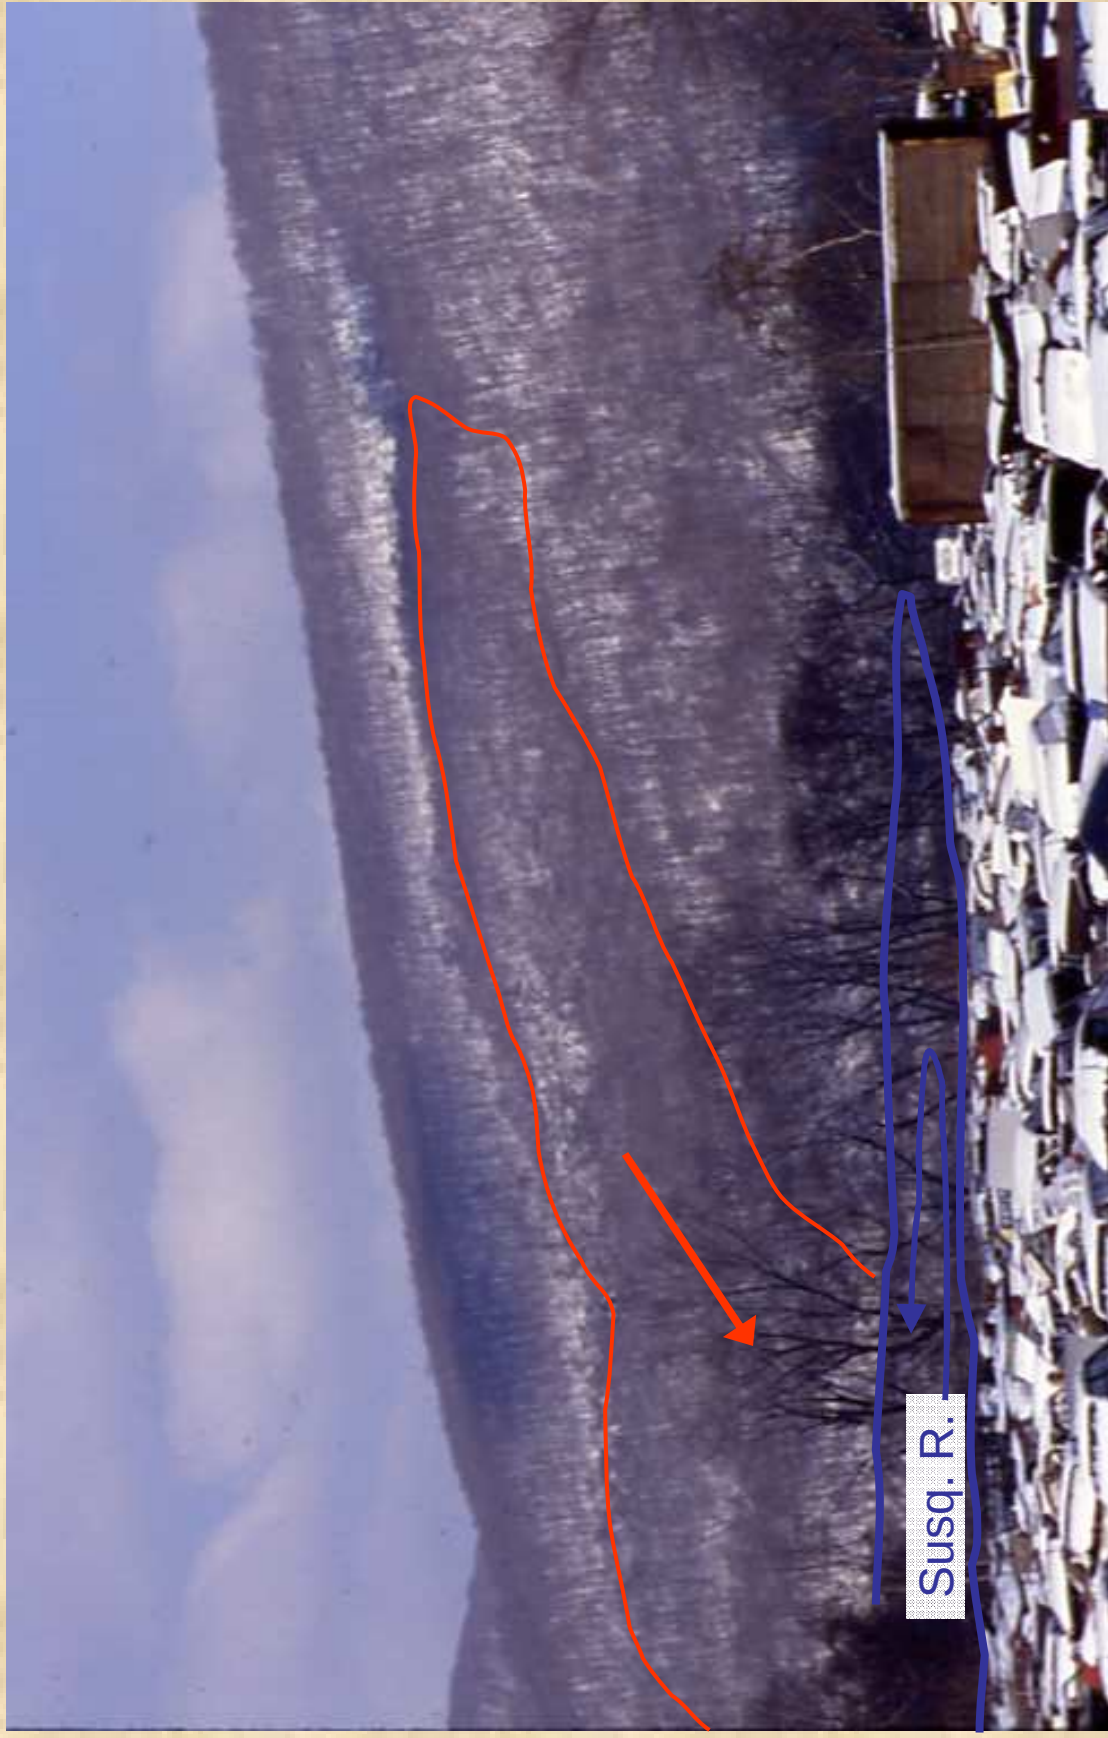
Geologic map showing the trace of the downslope dipping, undercut or daylighted red mudstone slip surface. Each slide detaches along joints perpendicular to bedding.

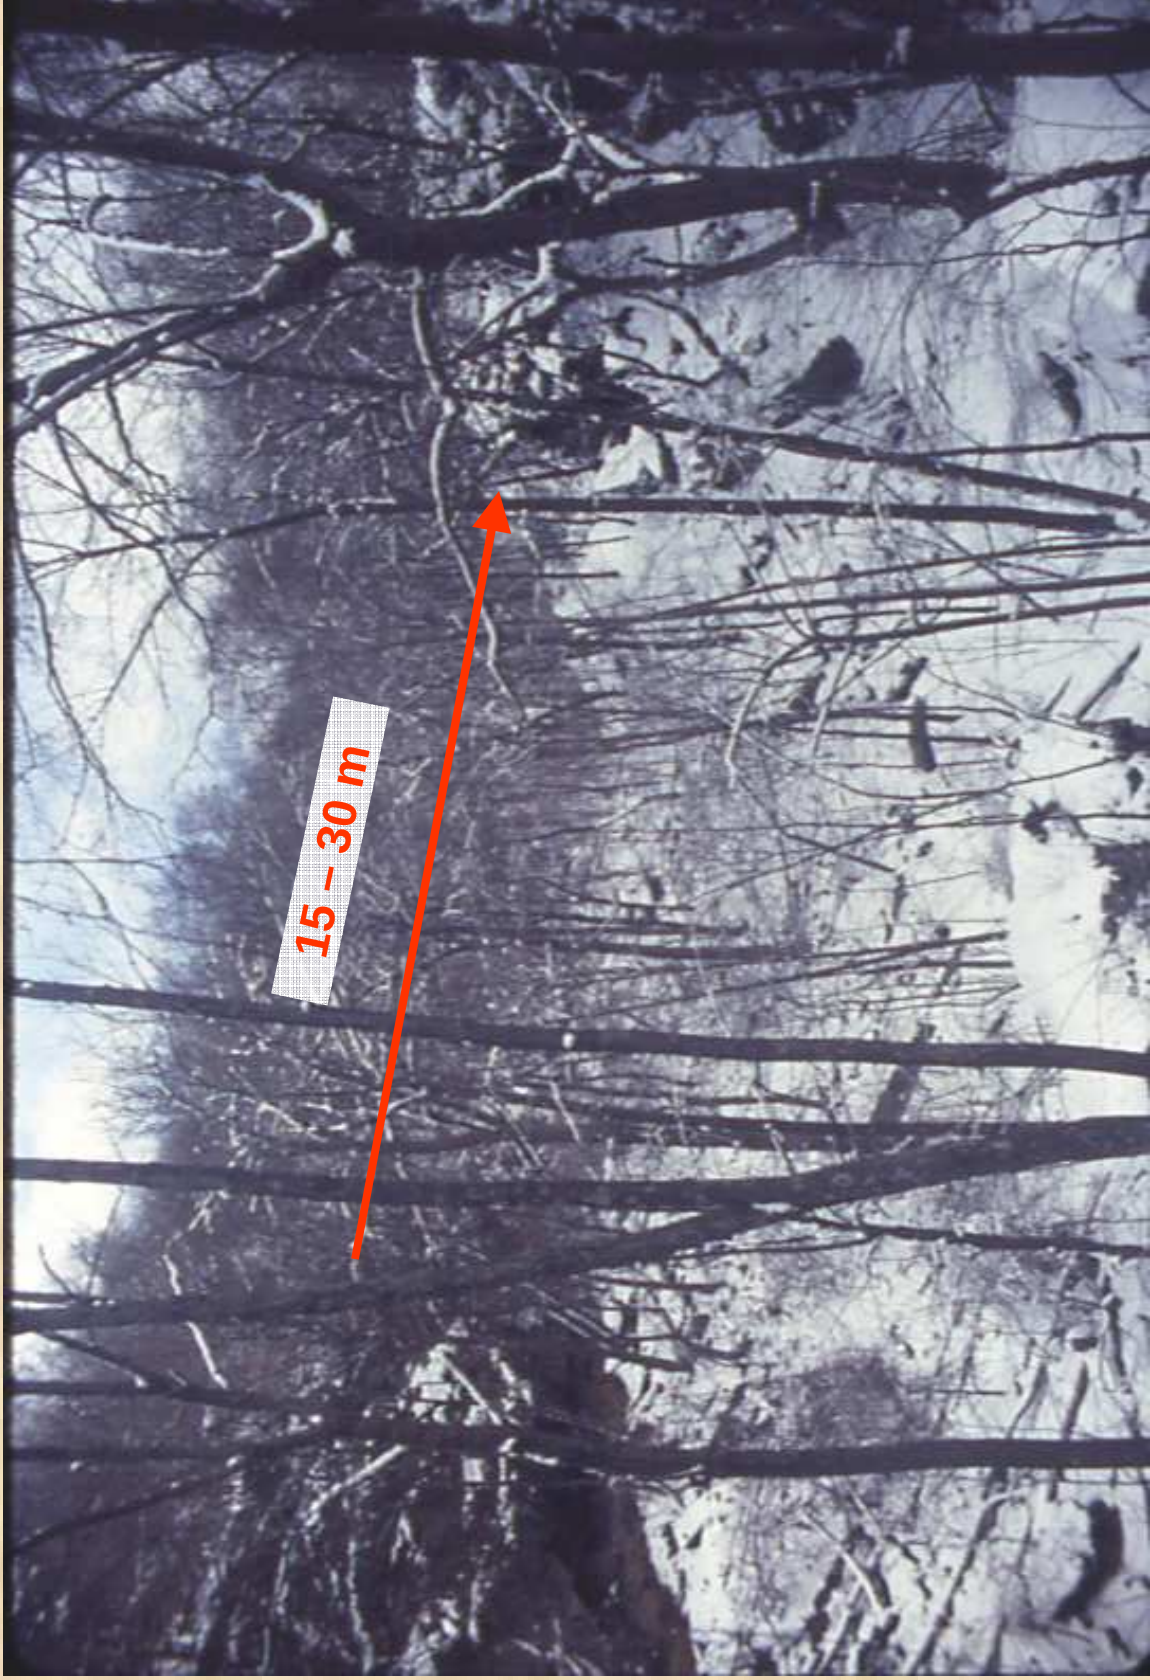
## Detachment headwall of the Cemetery slide

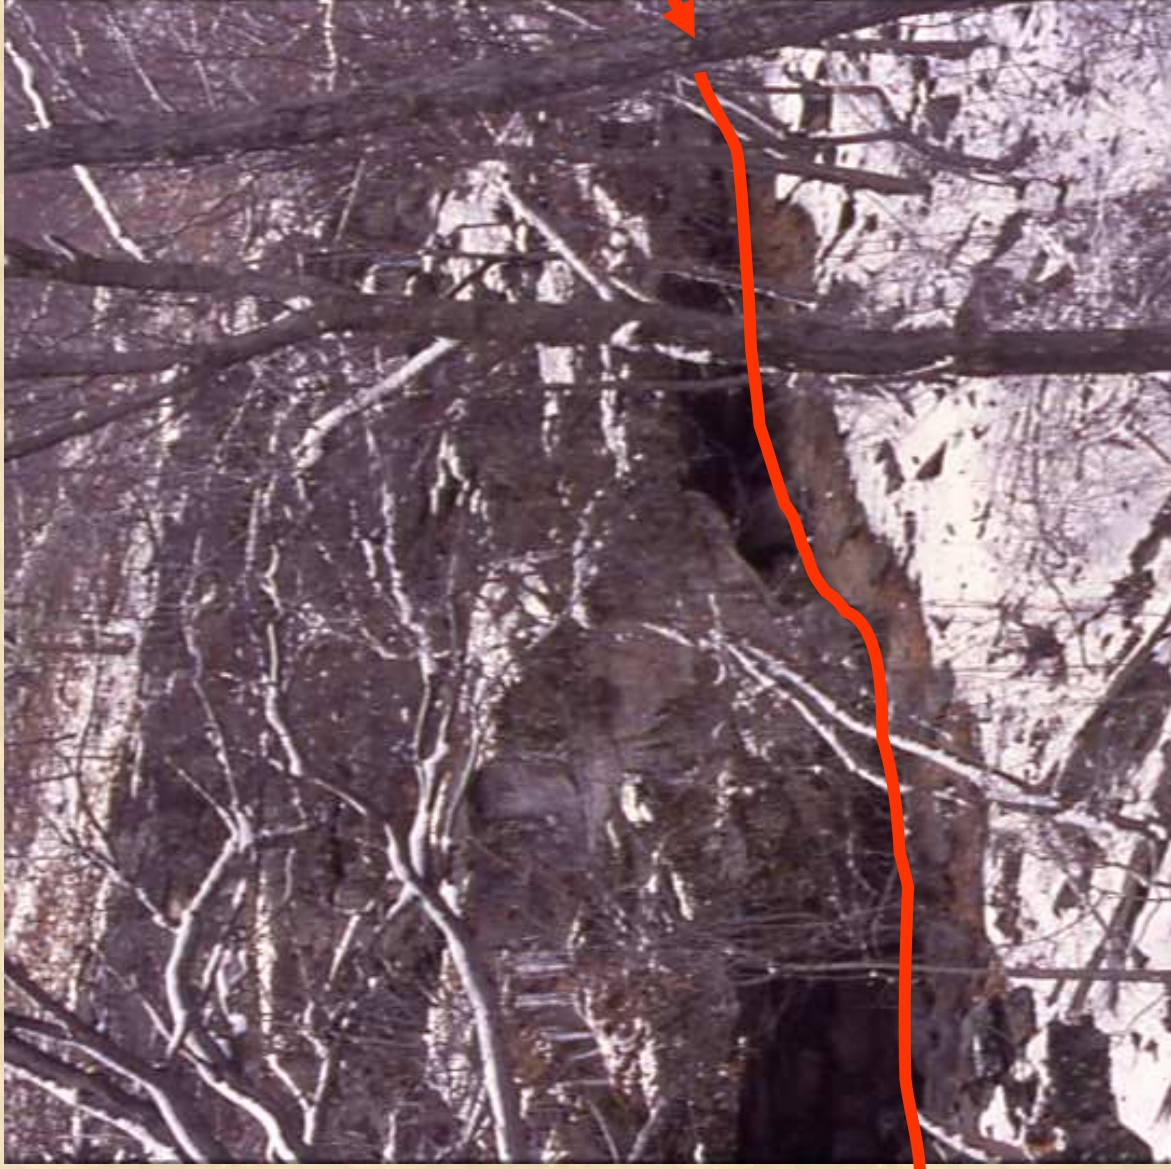
Slide plane at  
the contact with  
red mudstone  
and overlying  
gray sandstone

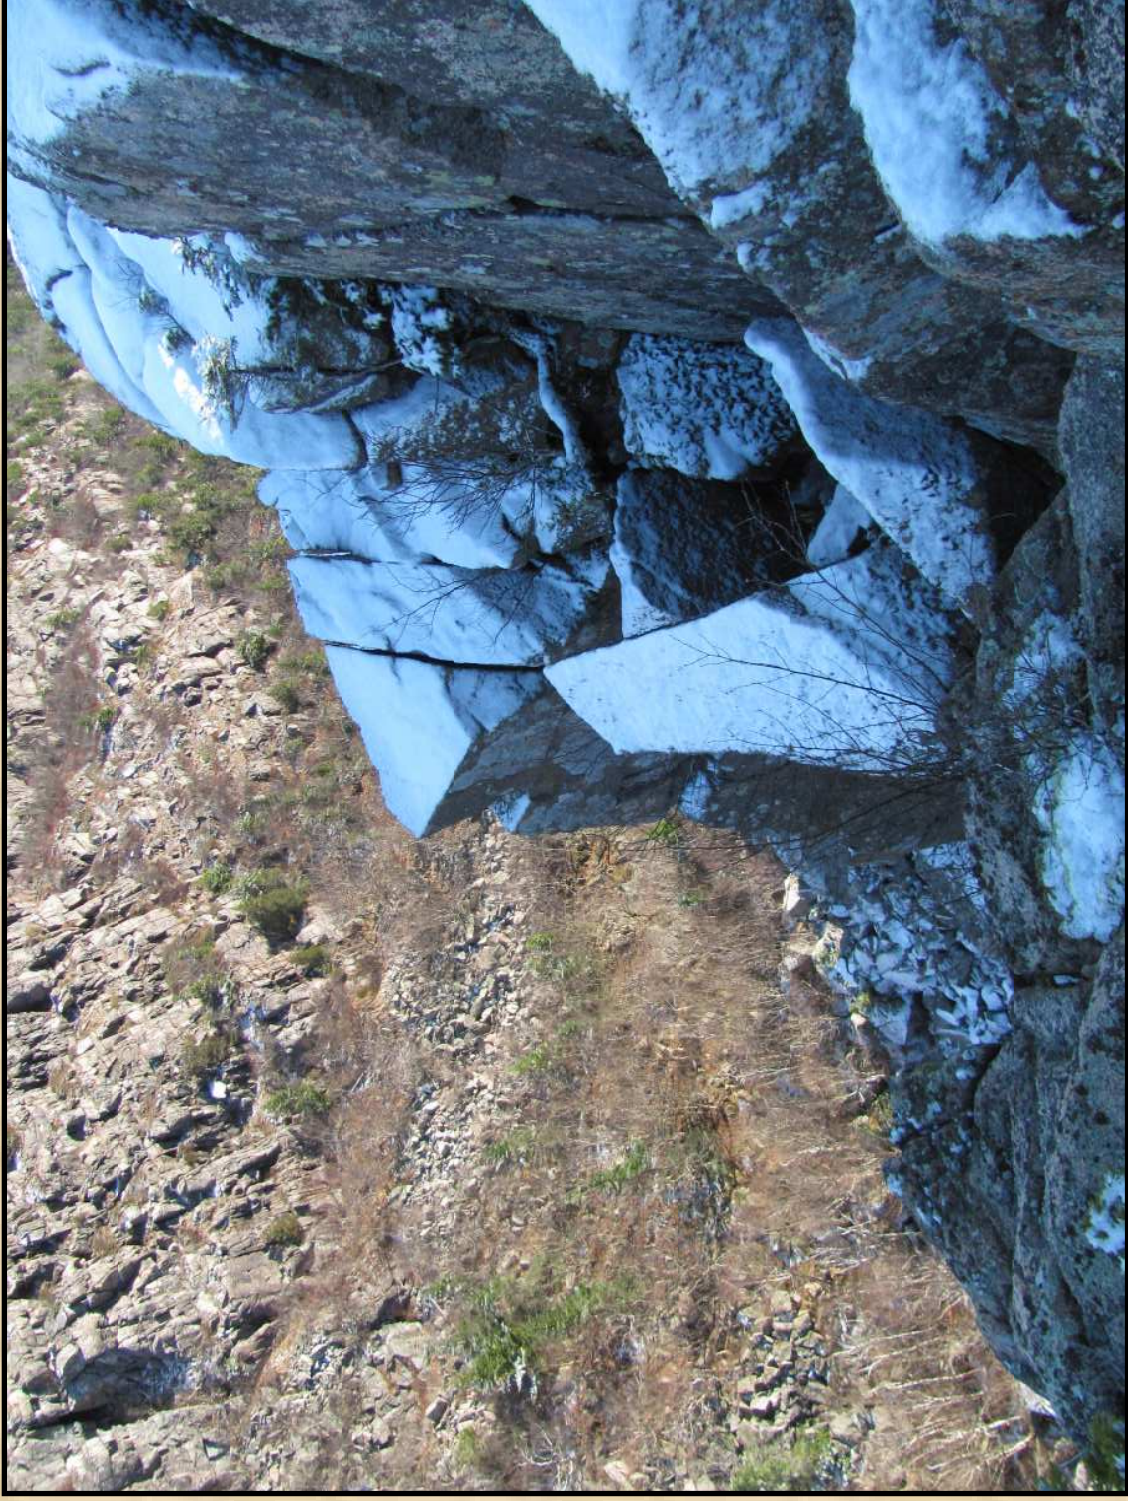
The Gorge from the cliff top of the slide toe  
Snow highlighted large joint block talus at slide toe  
Sunlit smaller block talus from into slope sheeting of Dorr Mtn.

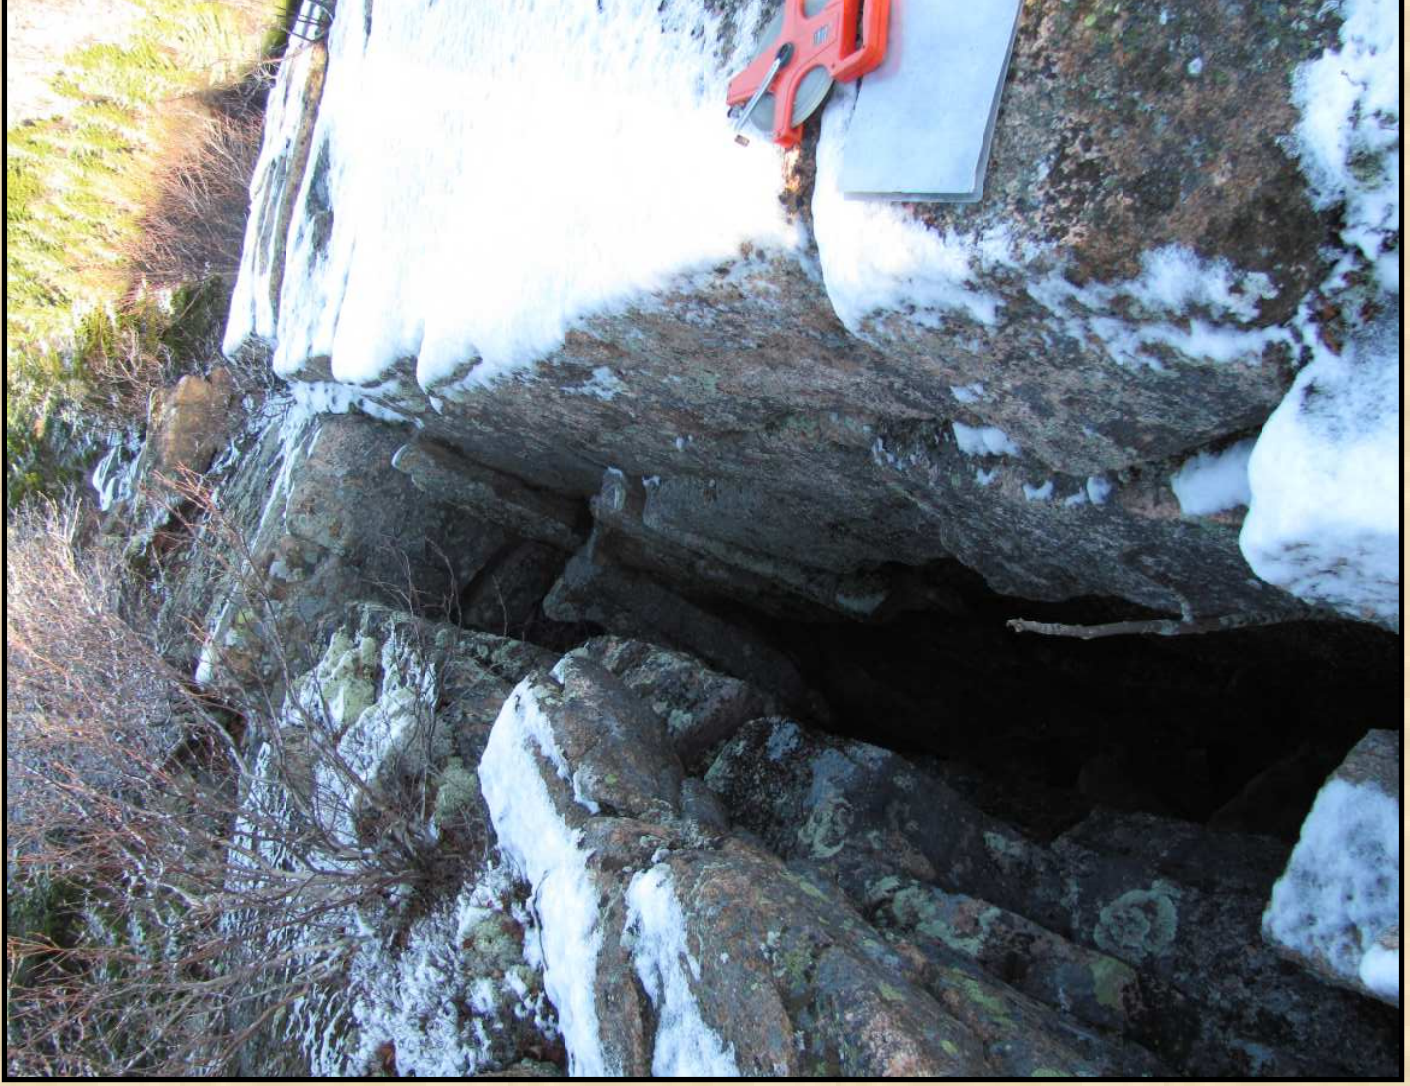
Joint block ready to  
topple off the cliff top  
as frost widening  
continues in the  
fractures initially  
opened by impact of  
the rock block slide  
on the floor of the  
gorge.

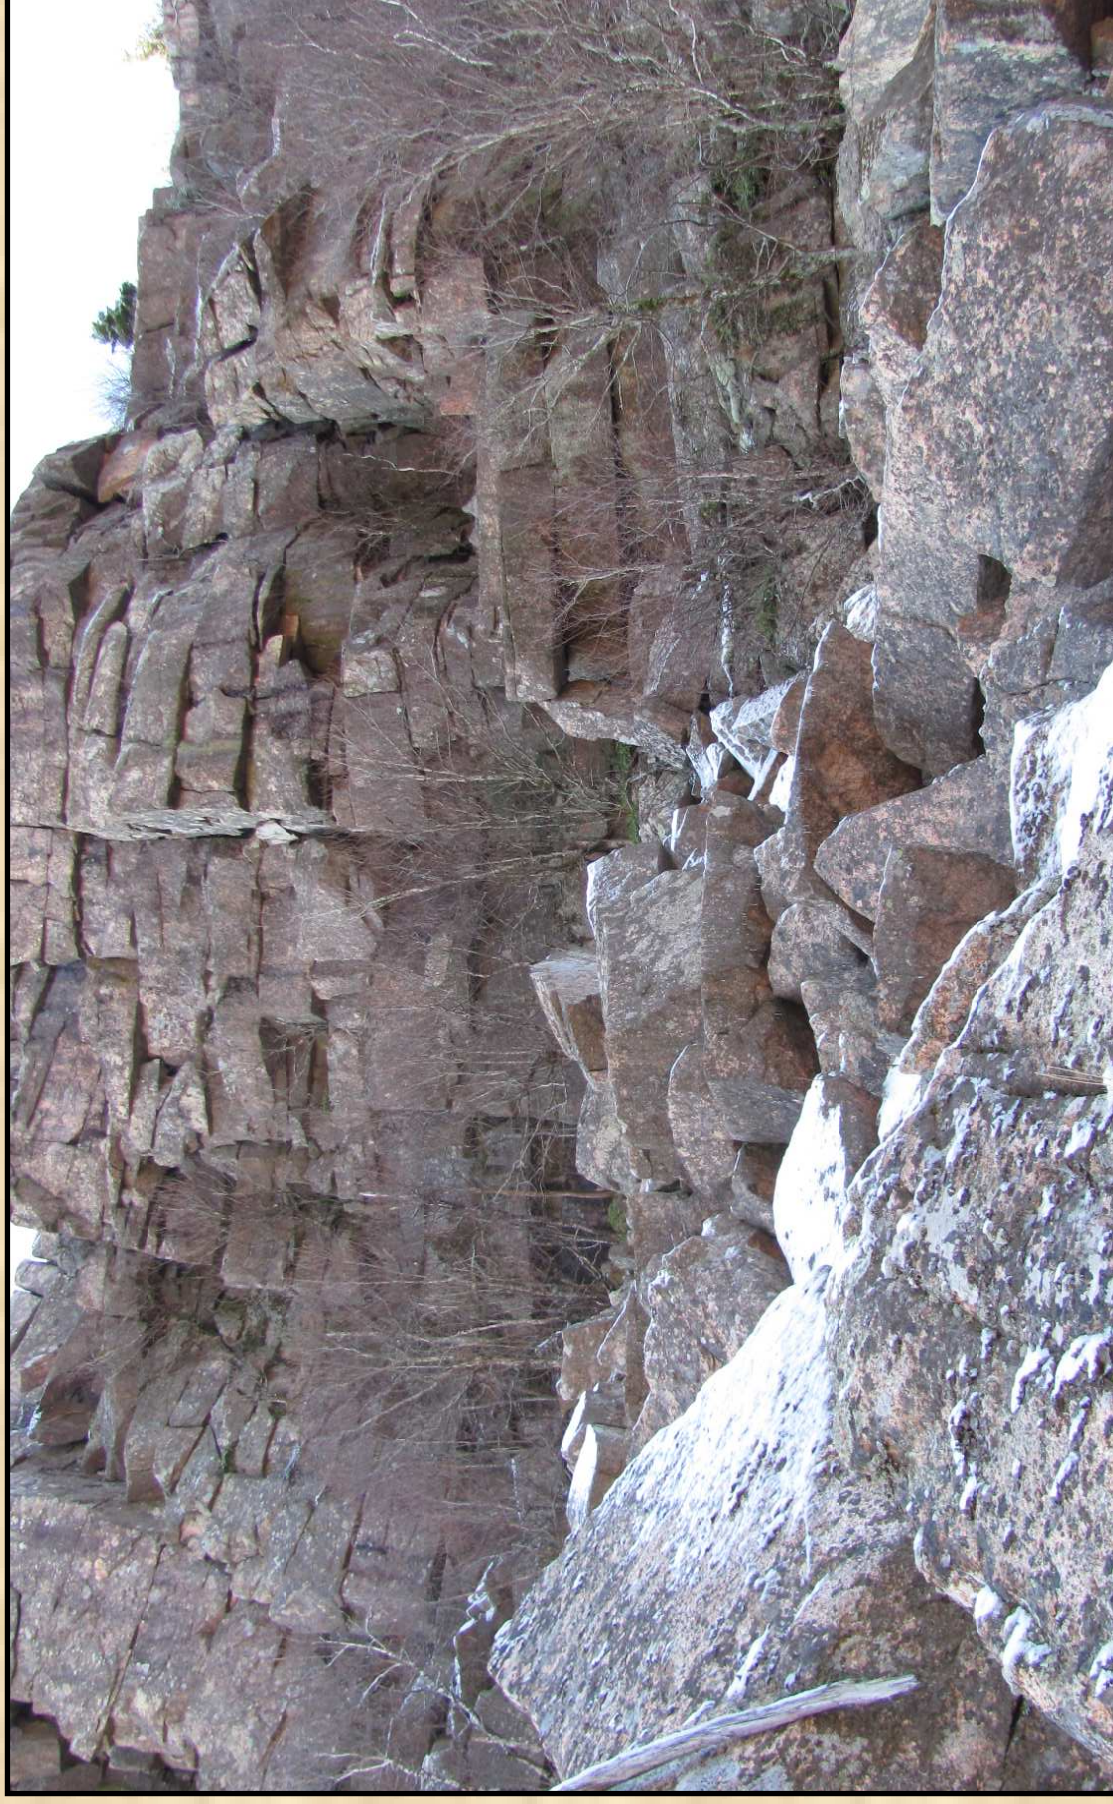
Slide toe with sheeting and vertical joints opened up  
Slip surface buried by talus from post slide frost splitting
