Observations demonstrating the runoff-initiation of the July 12, 2008 Piute wildfire debris flows, Sierra Nevada, California.

Jerome V. De Graff and Alan J. Gallegos, USDA Forest Service, Clovis, CA

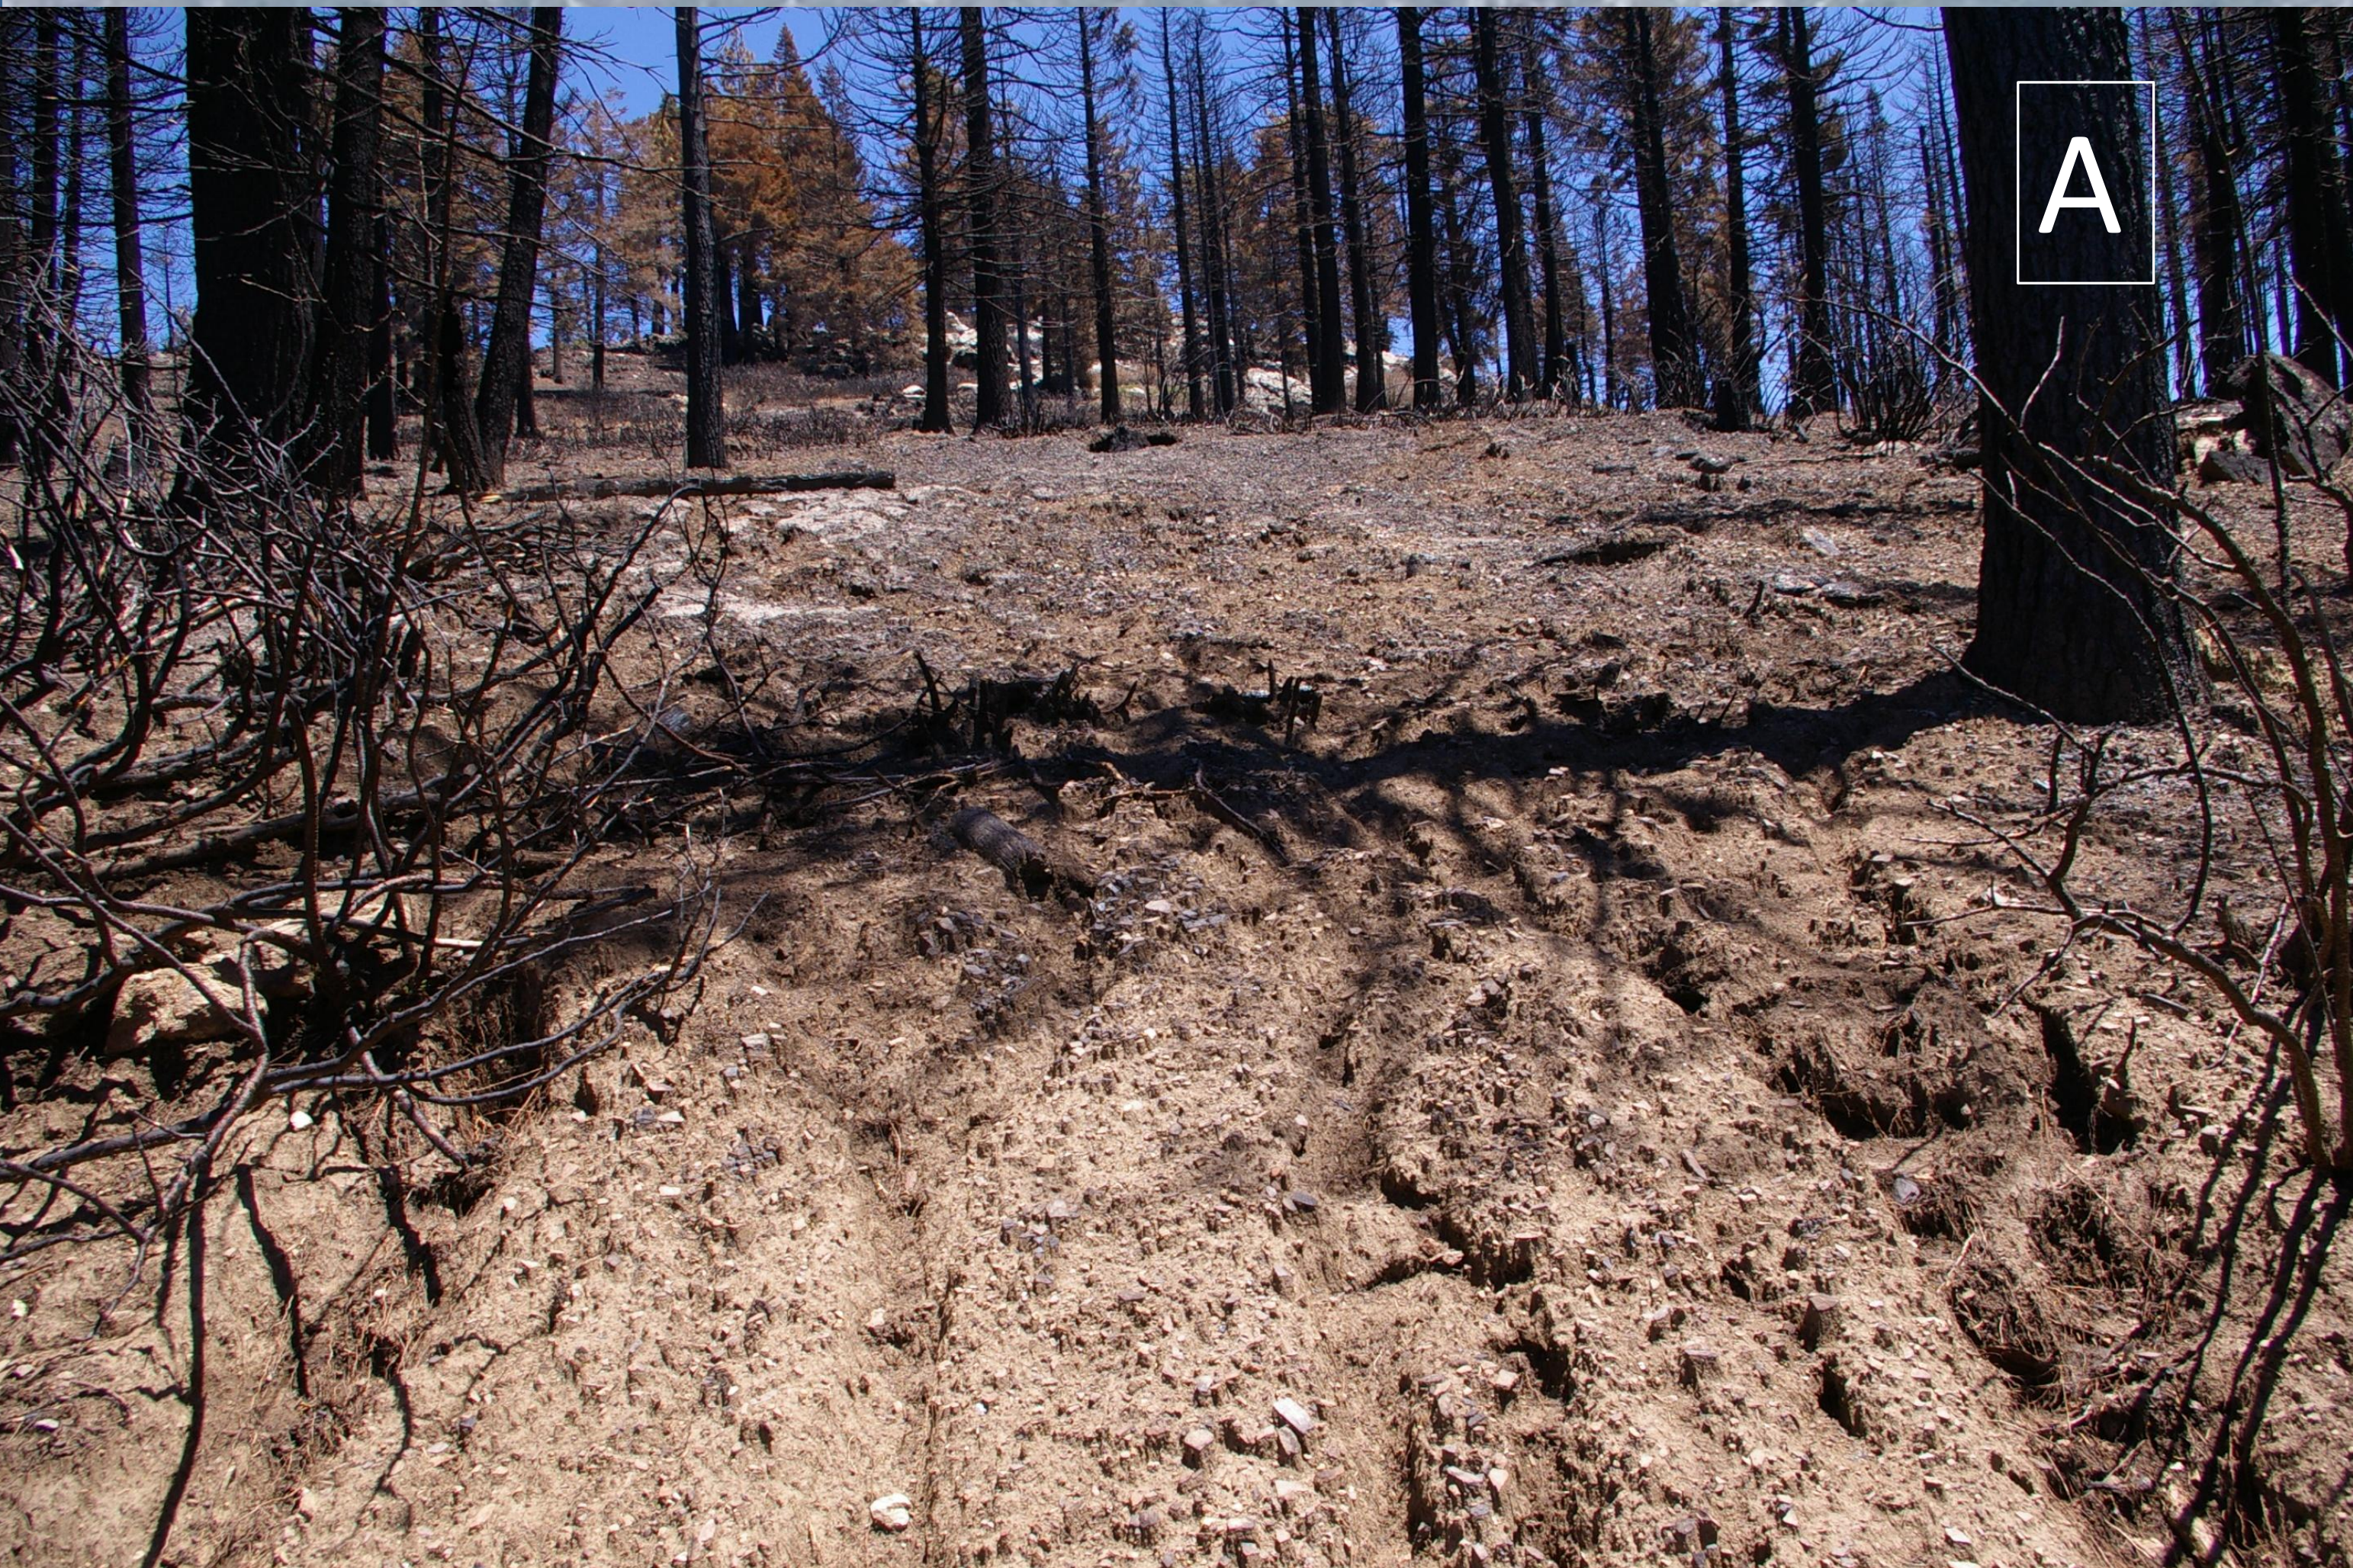
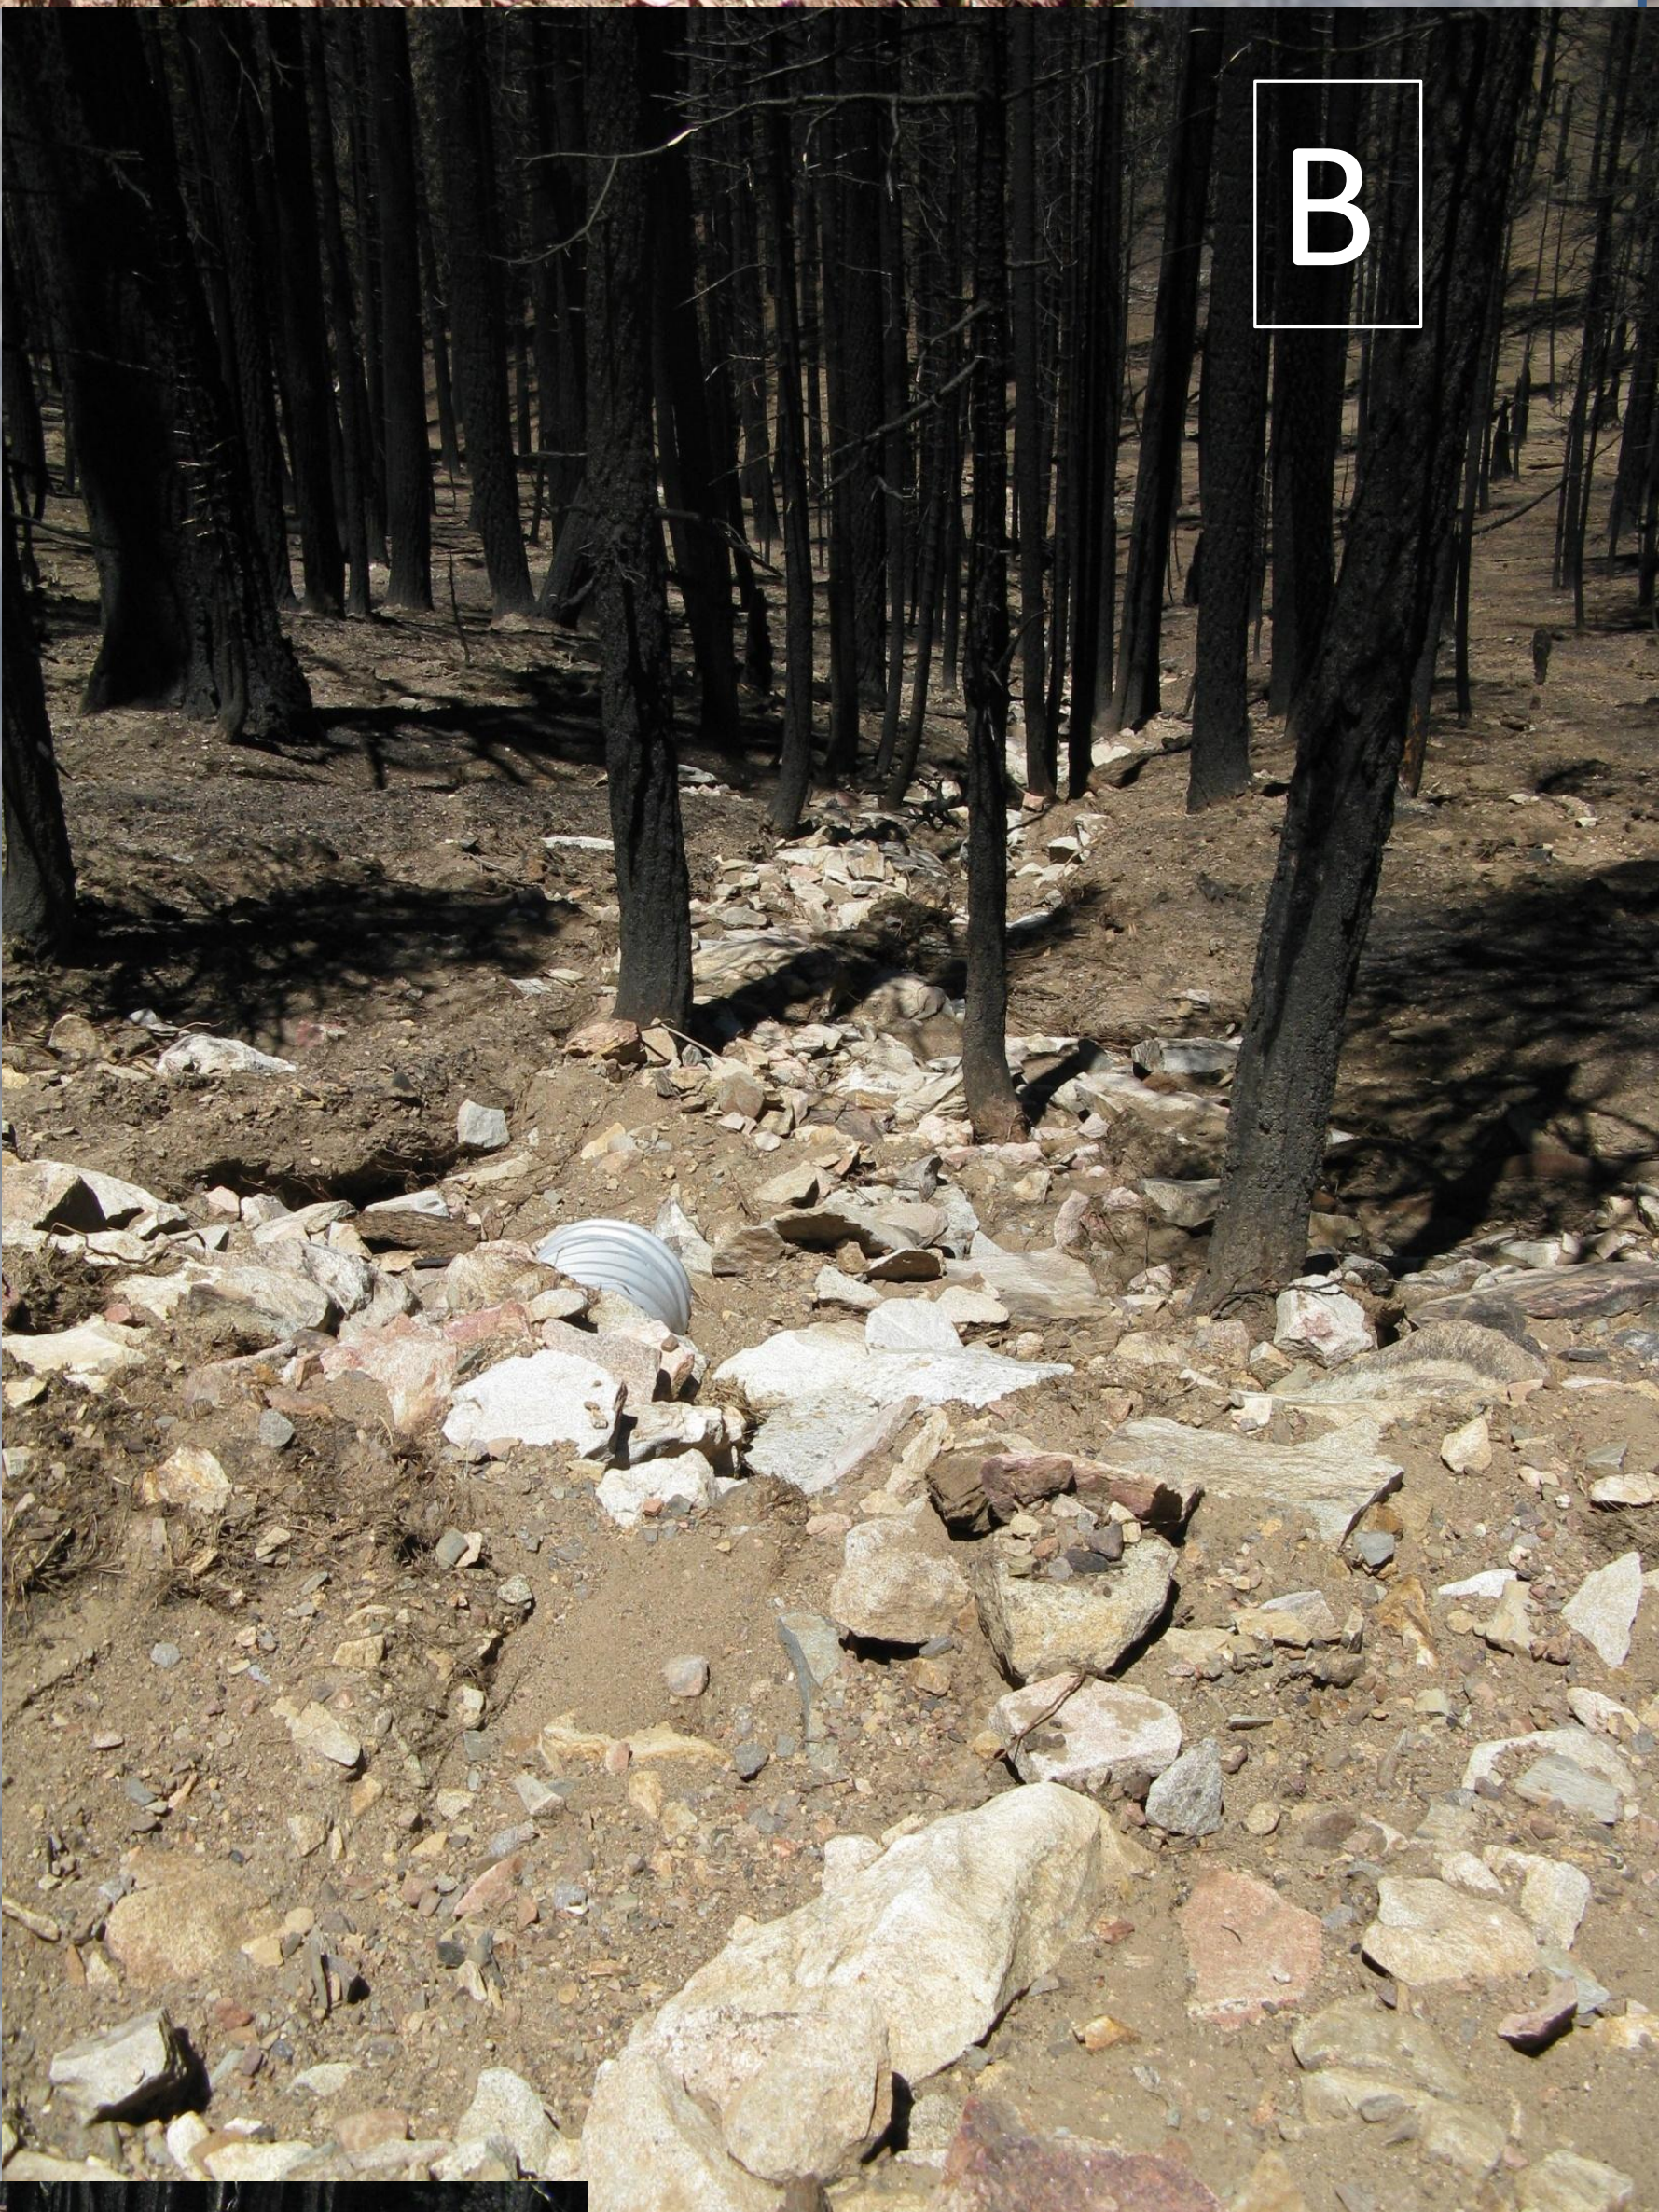
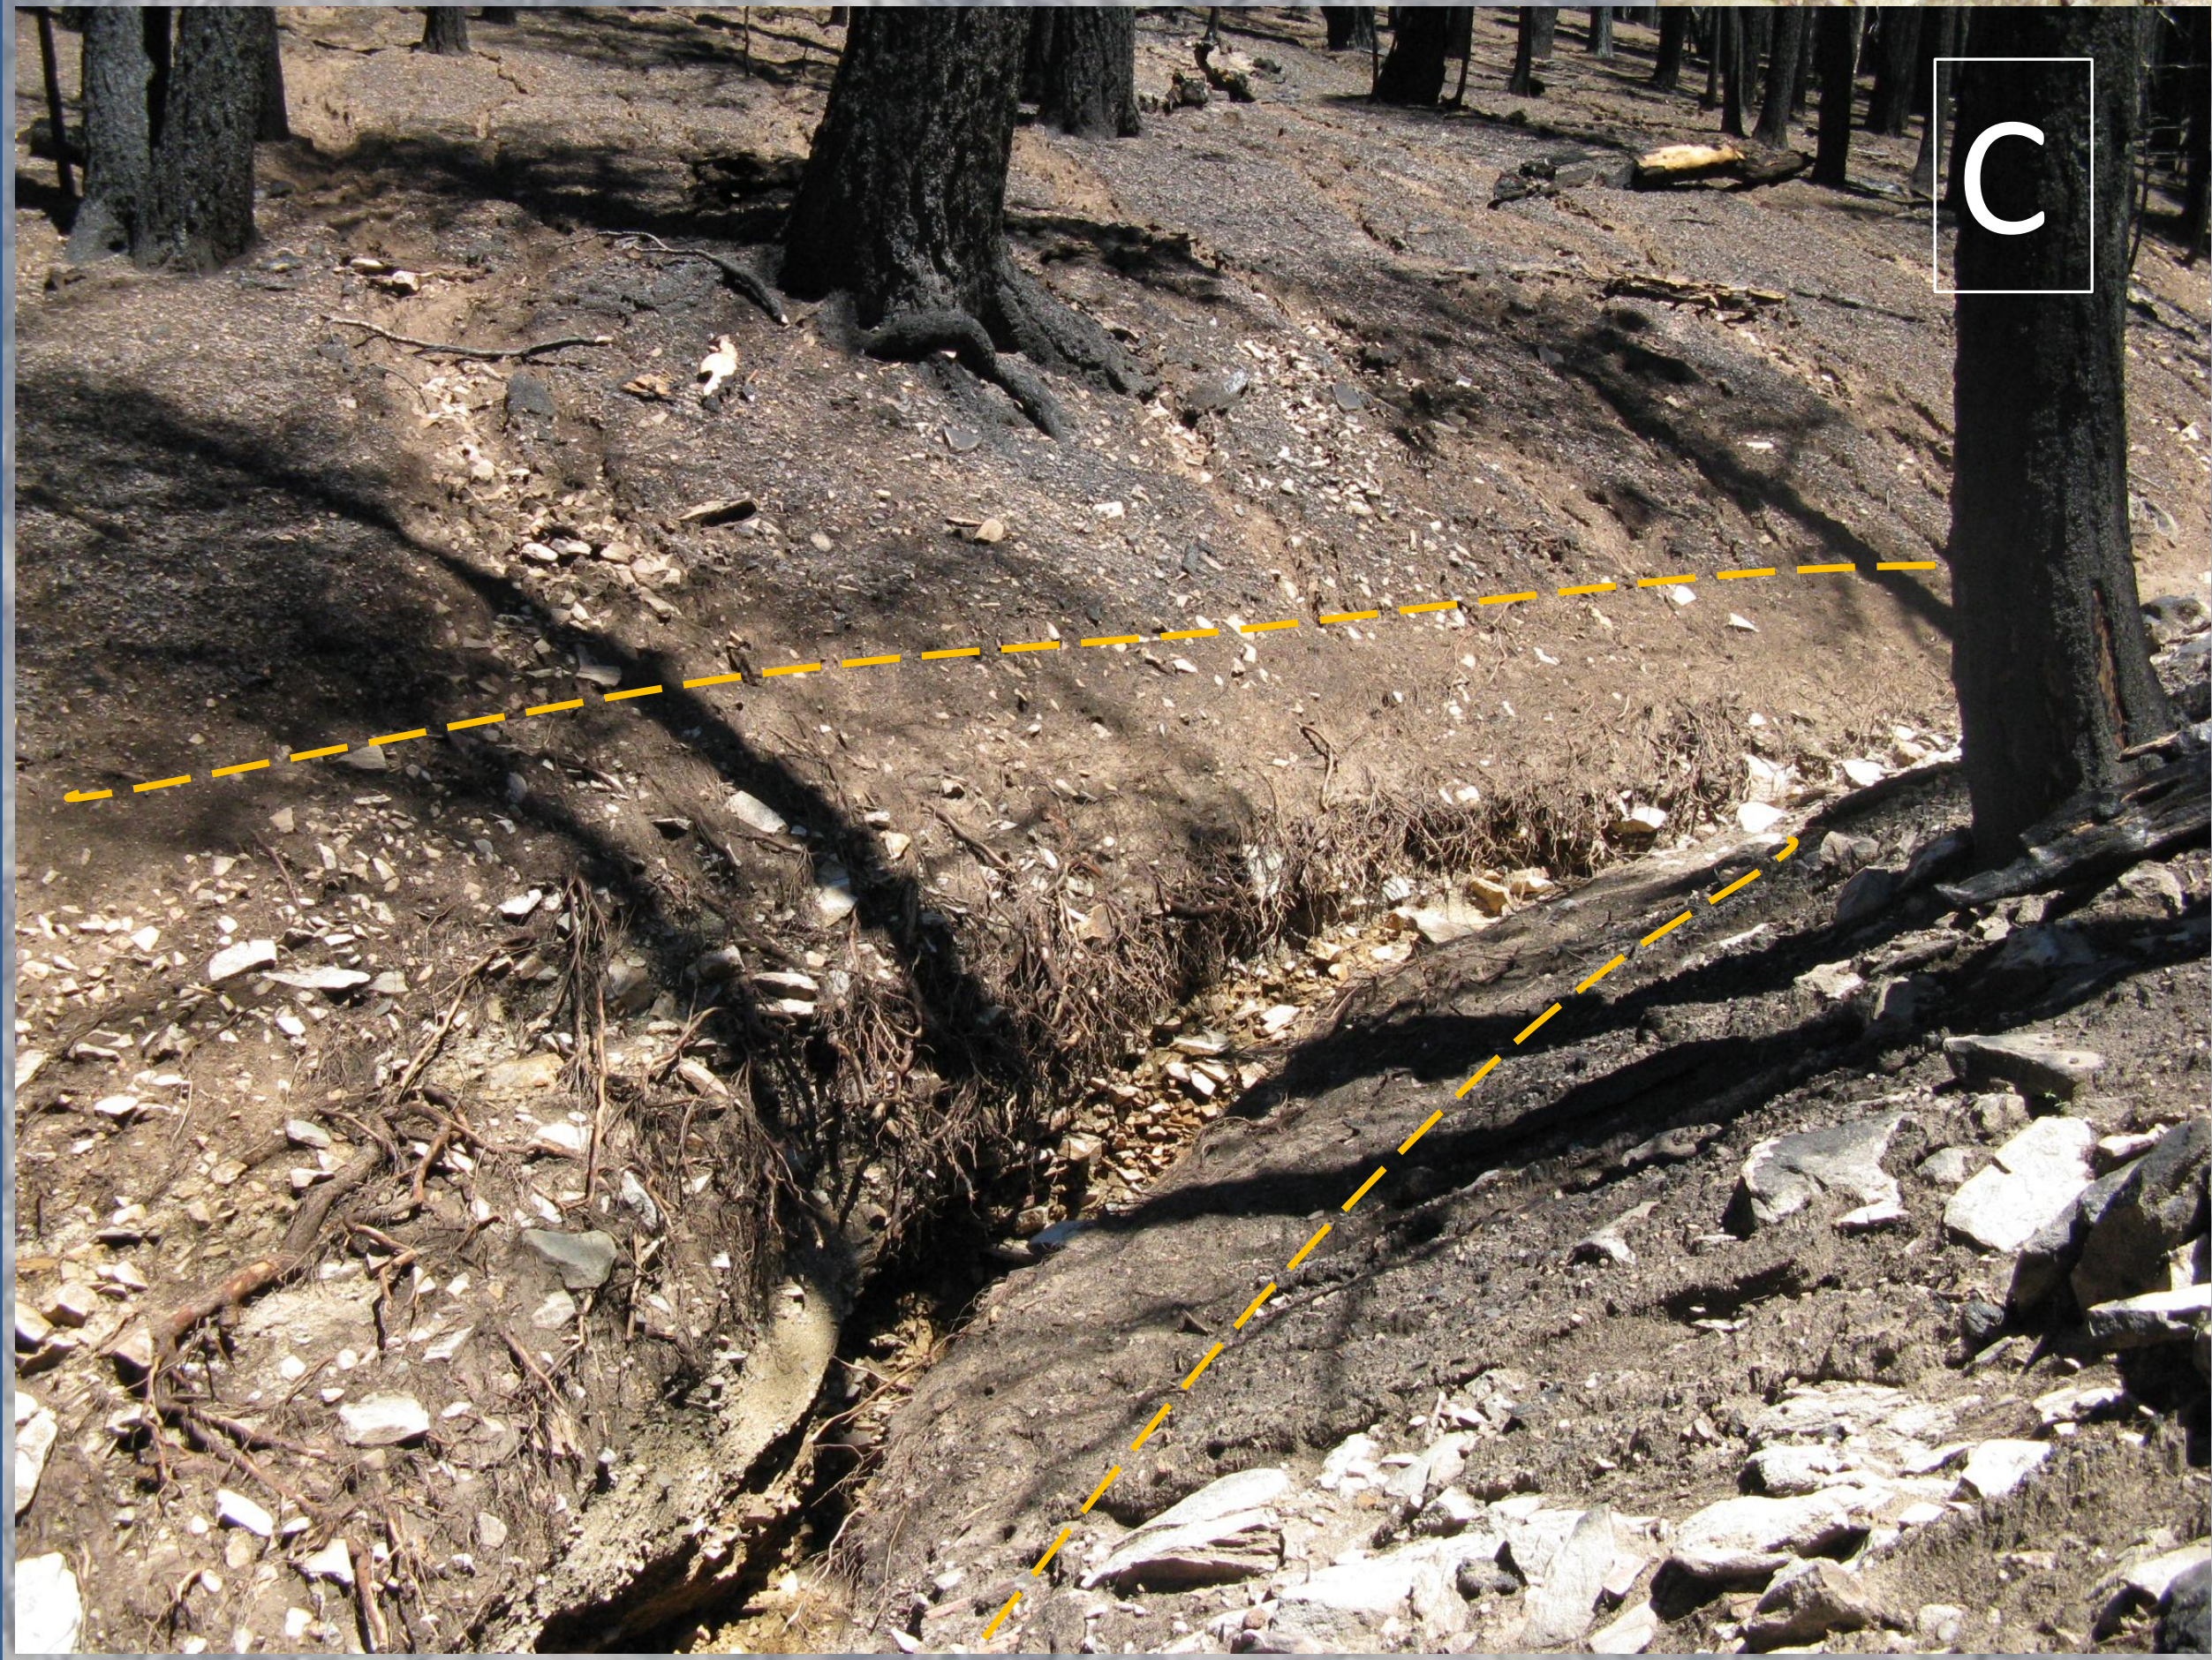
Thompson Canyon near Piute Peak

- A. Closely-spaced rills in the headwaters of Thompson Canyon were eroded in the soil bared by the wildfire. This is close to the location of the remote automated weather station at Piute Peak.
- B. Runoff from the rills collected along ephemeral channels.. This runoff contained significant sediment eroded from the channel leaving a lag deposit of large rocks behind.
- C. At some point down channel, theis hyperconcentrated sediment flow transformed into a debris flow. The viscous, fluid debris flow mass had sufficient shear strength to “track” like a race car in a curve. The channel was efficiently eroded by its passage.

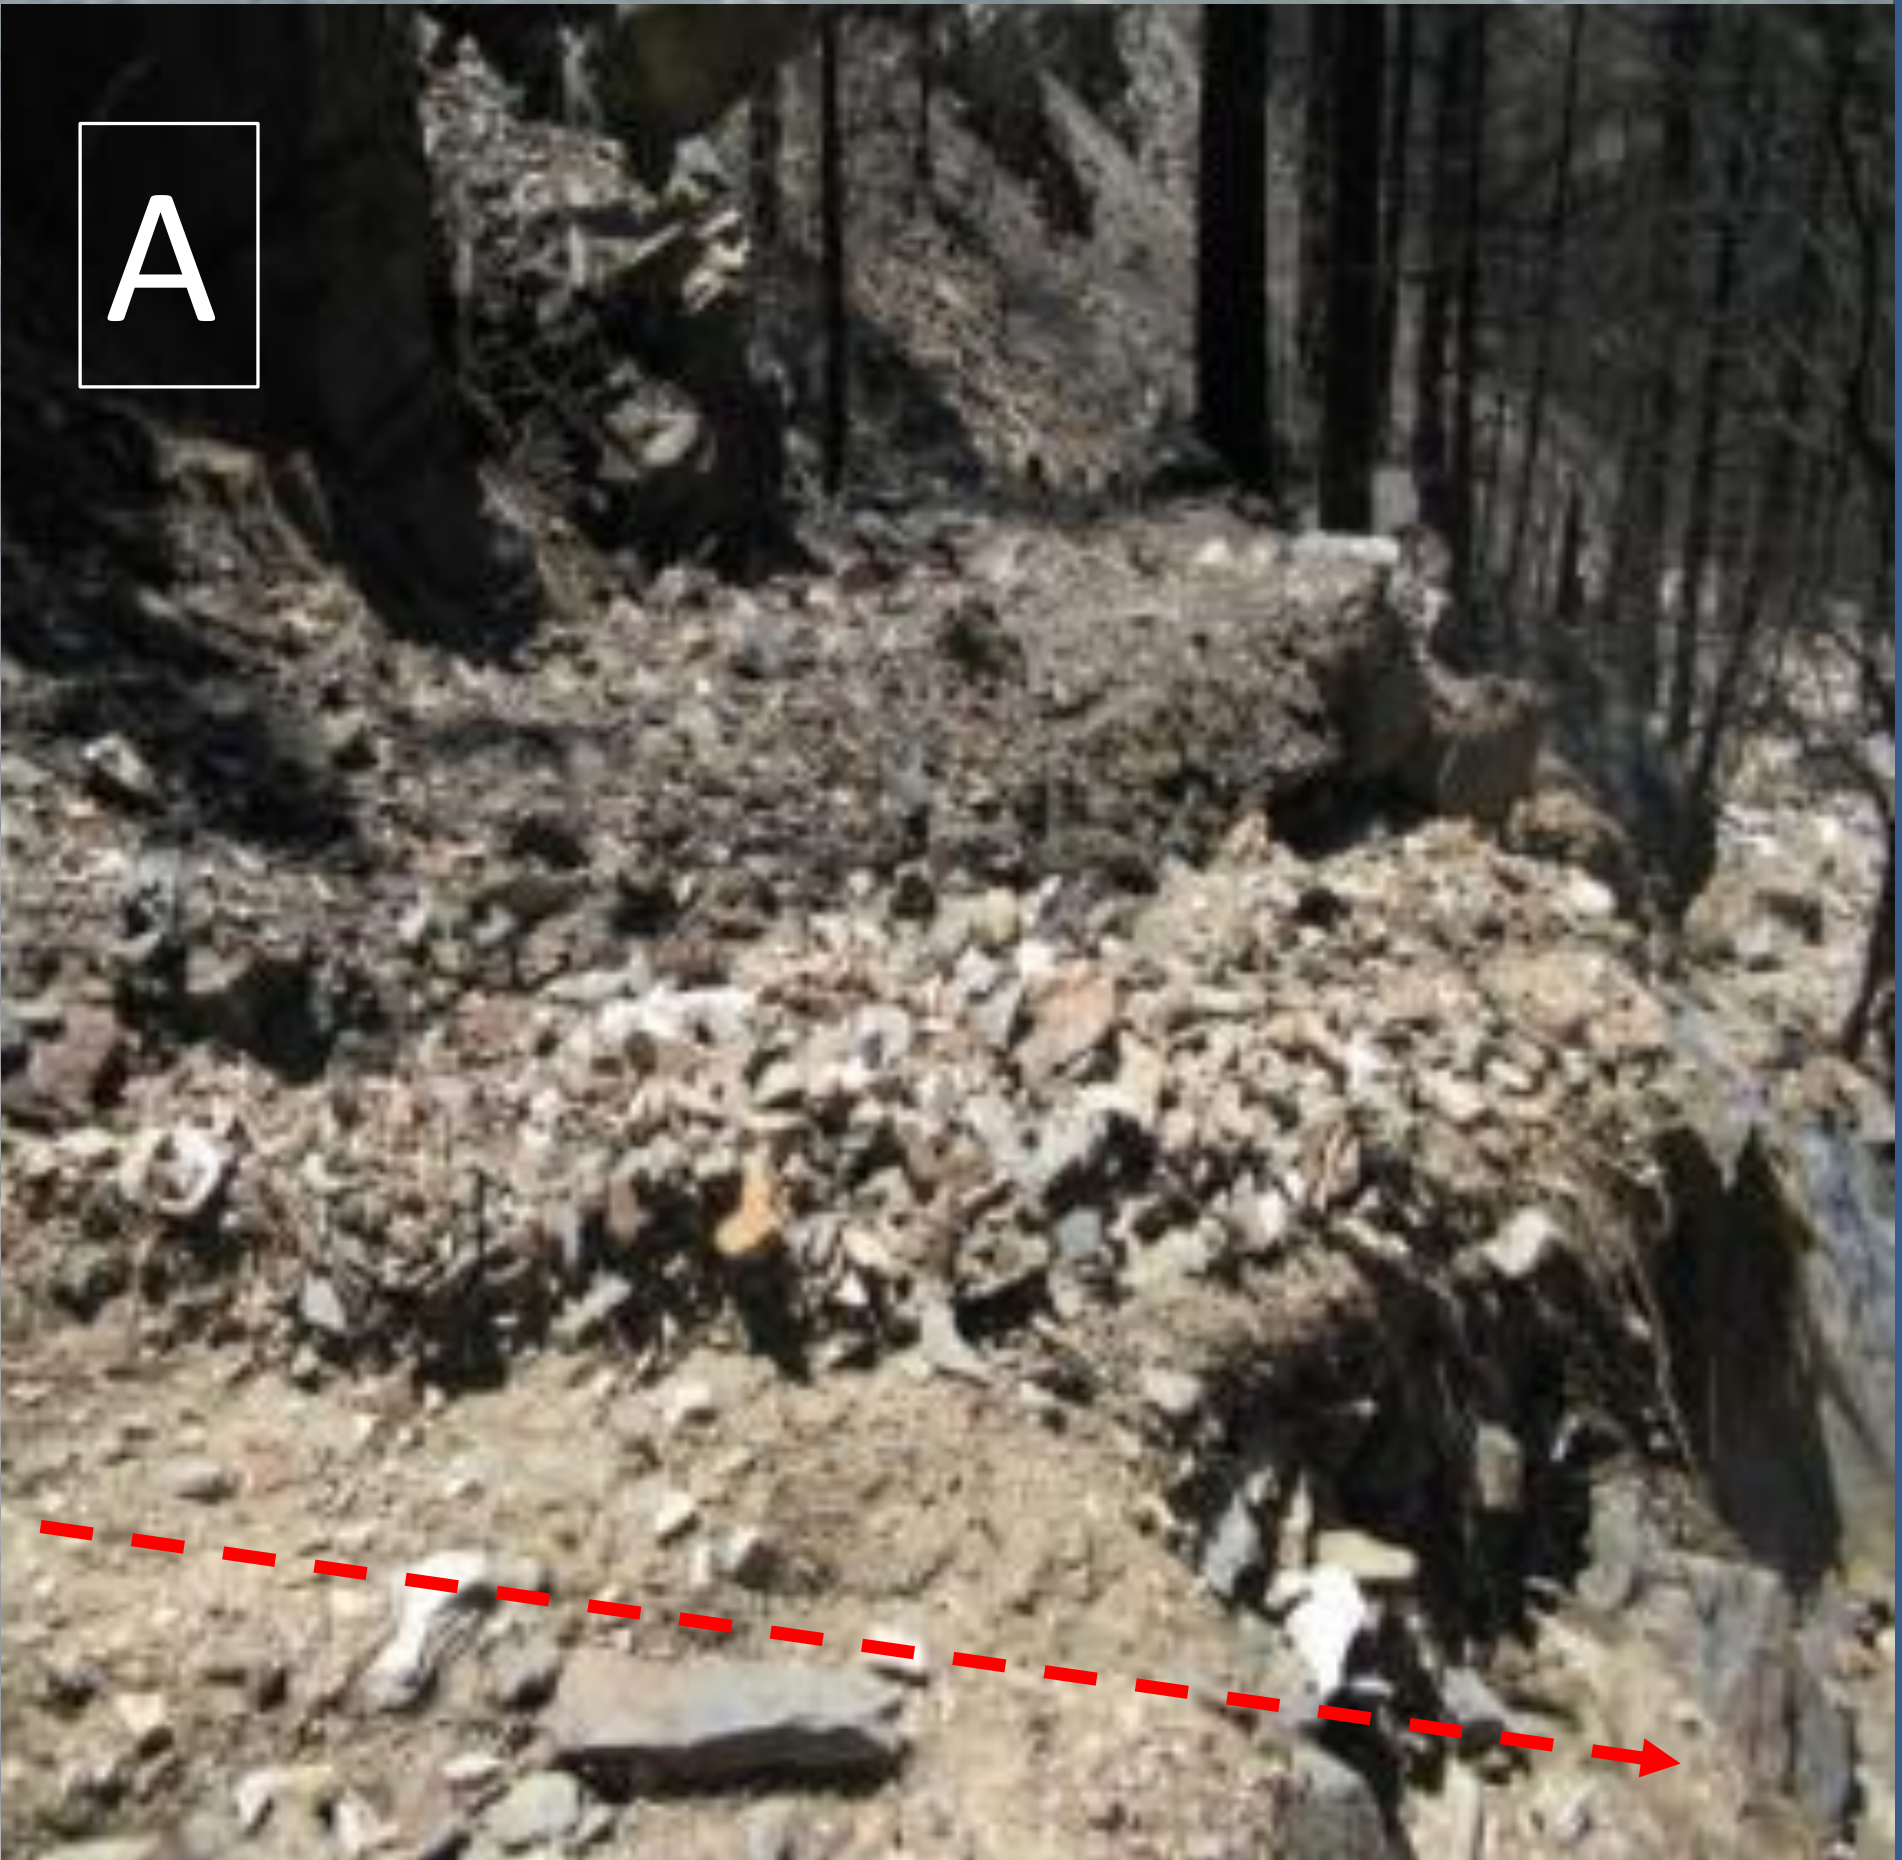
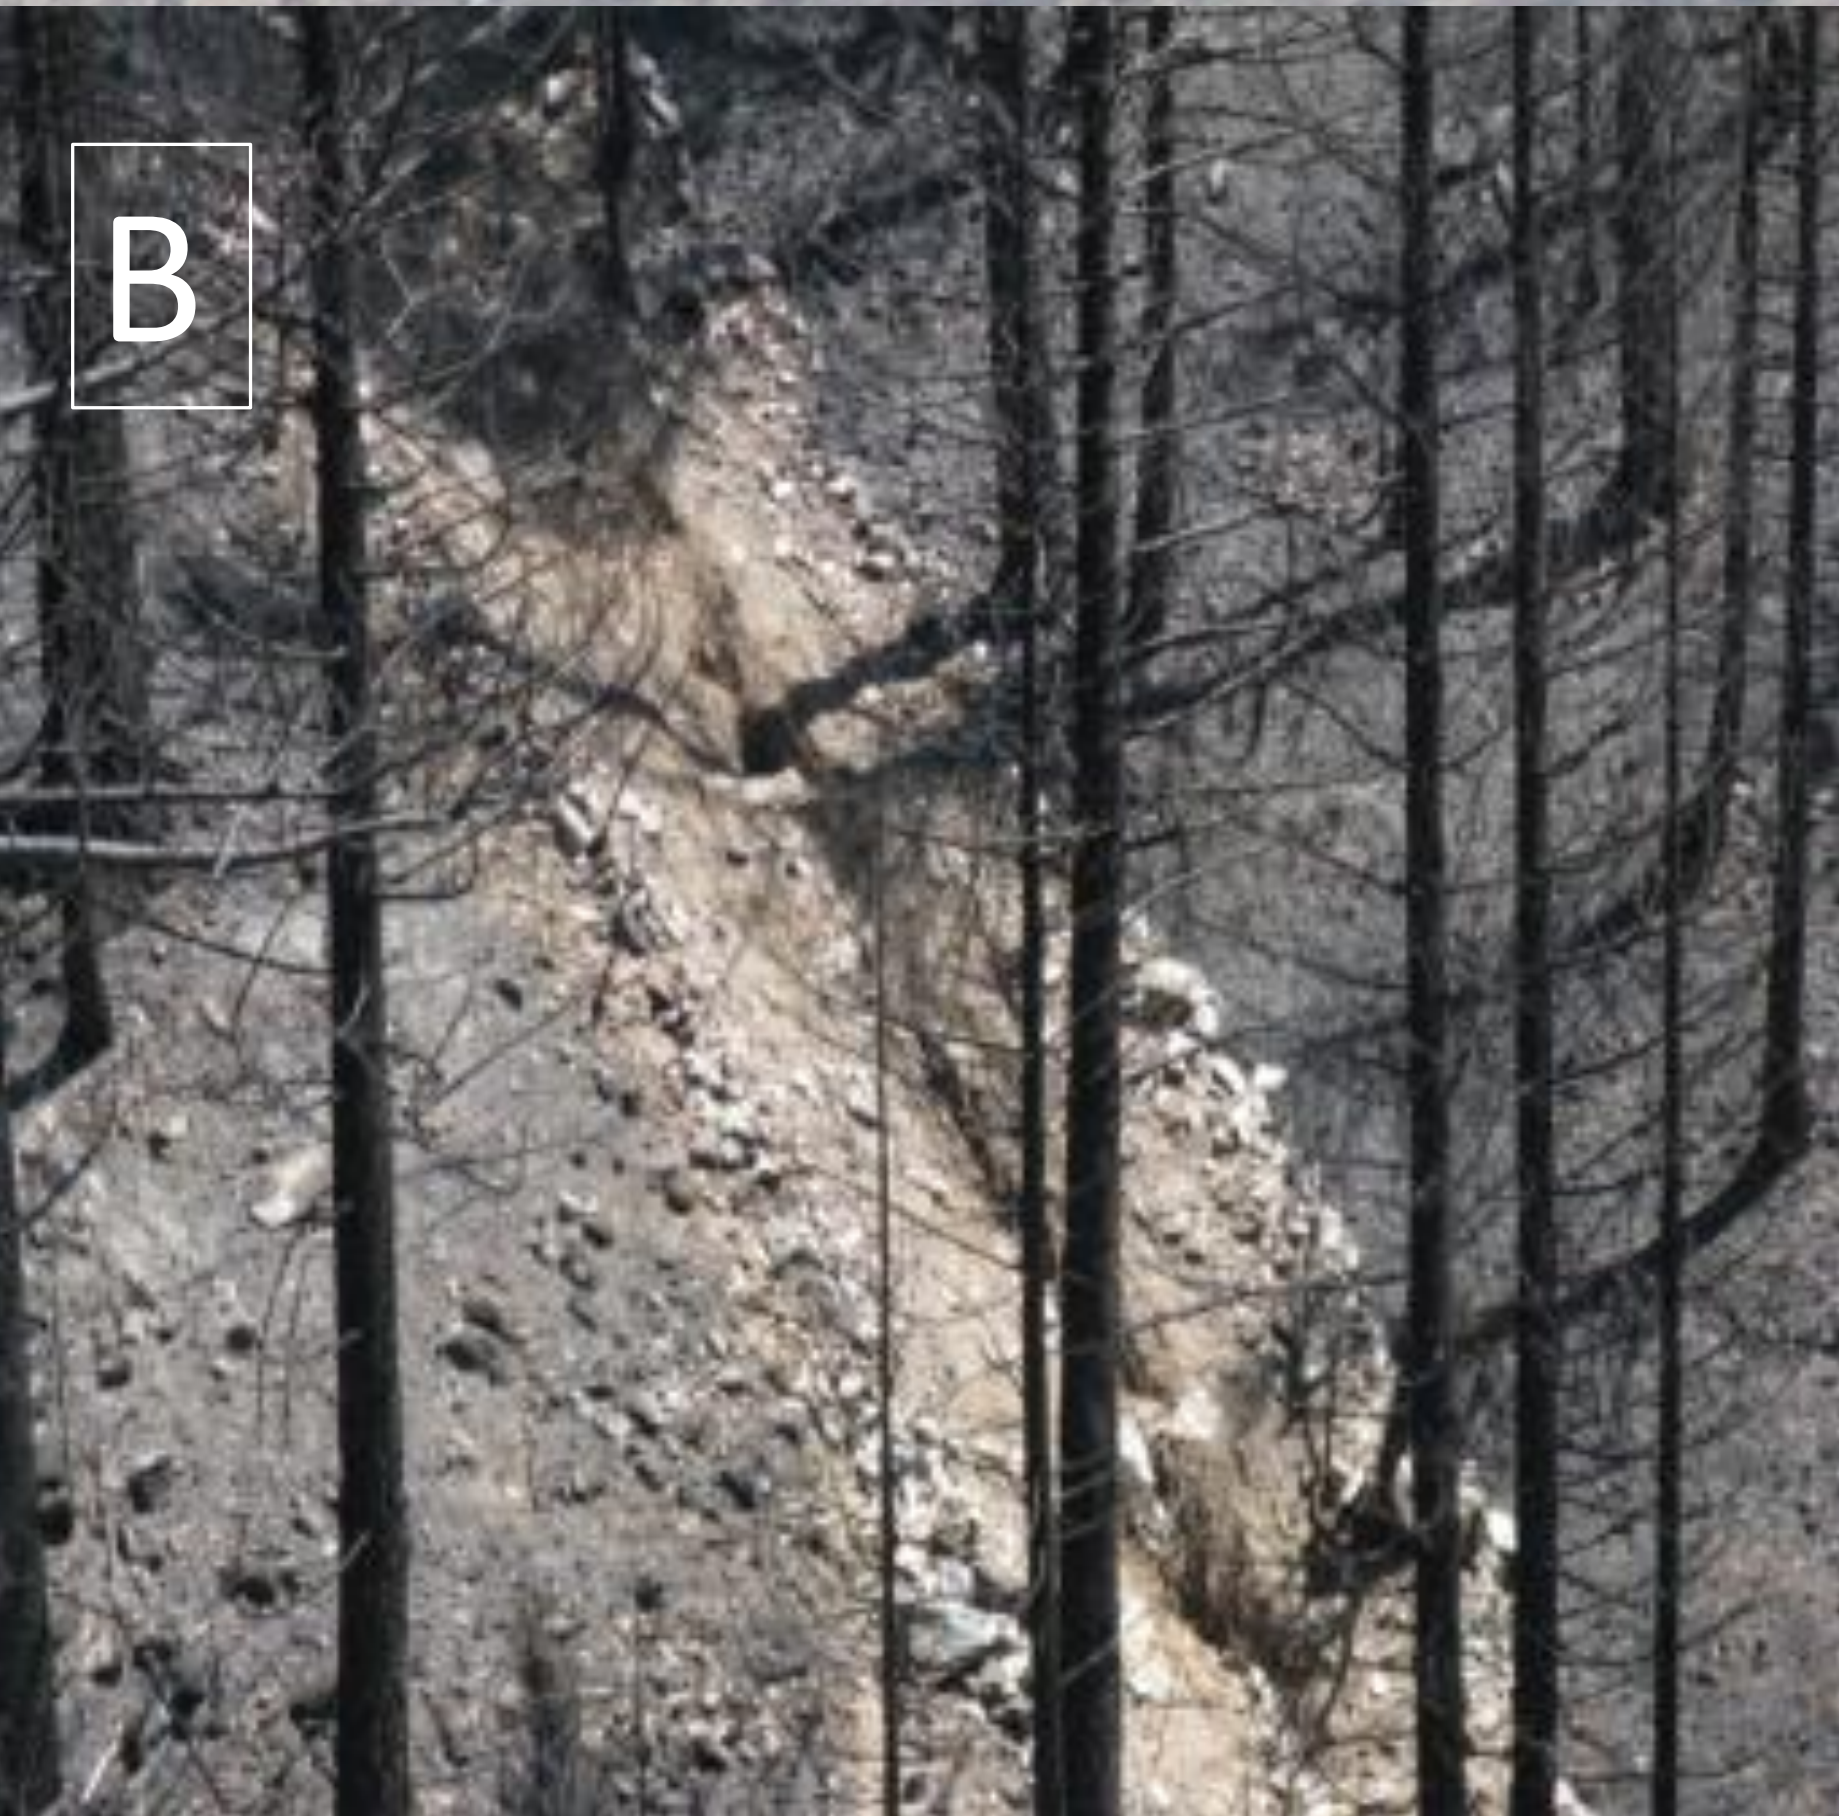
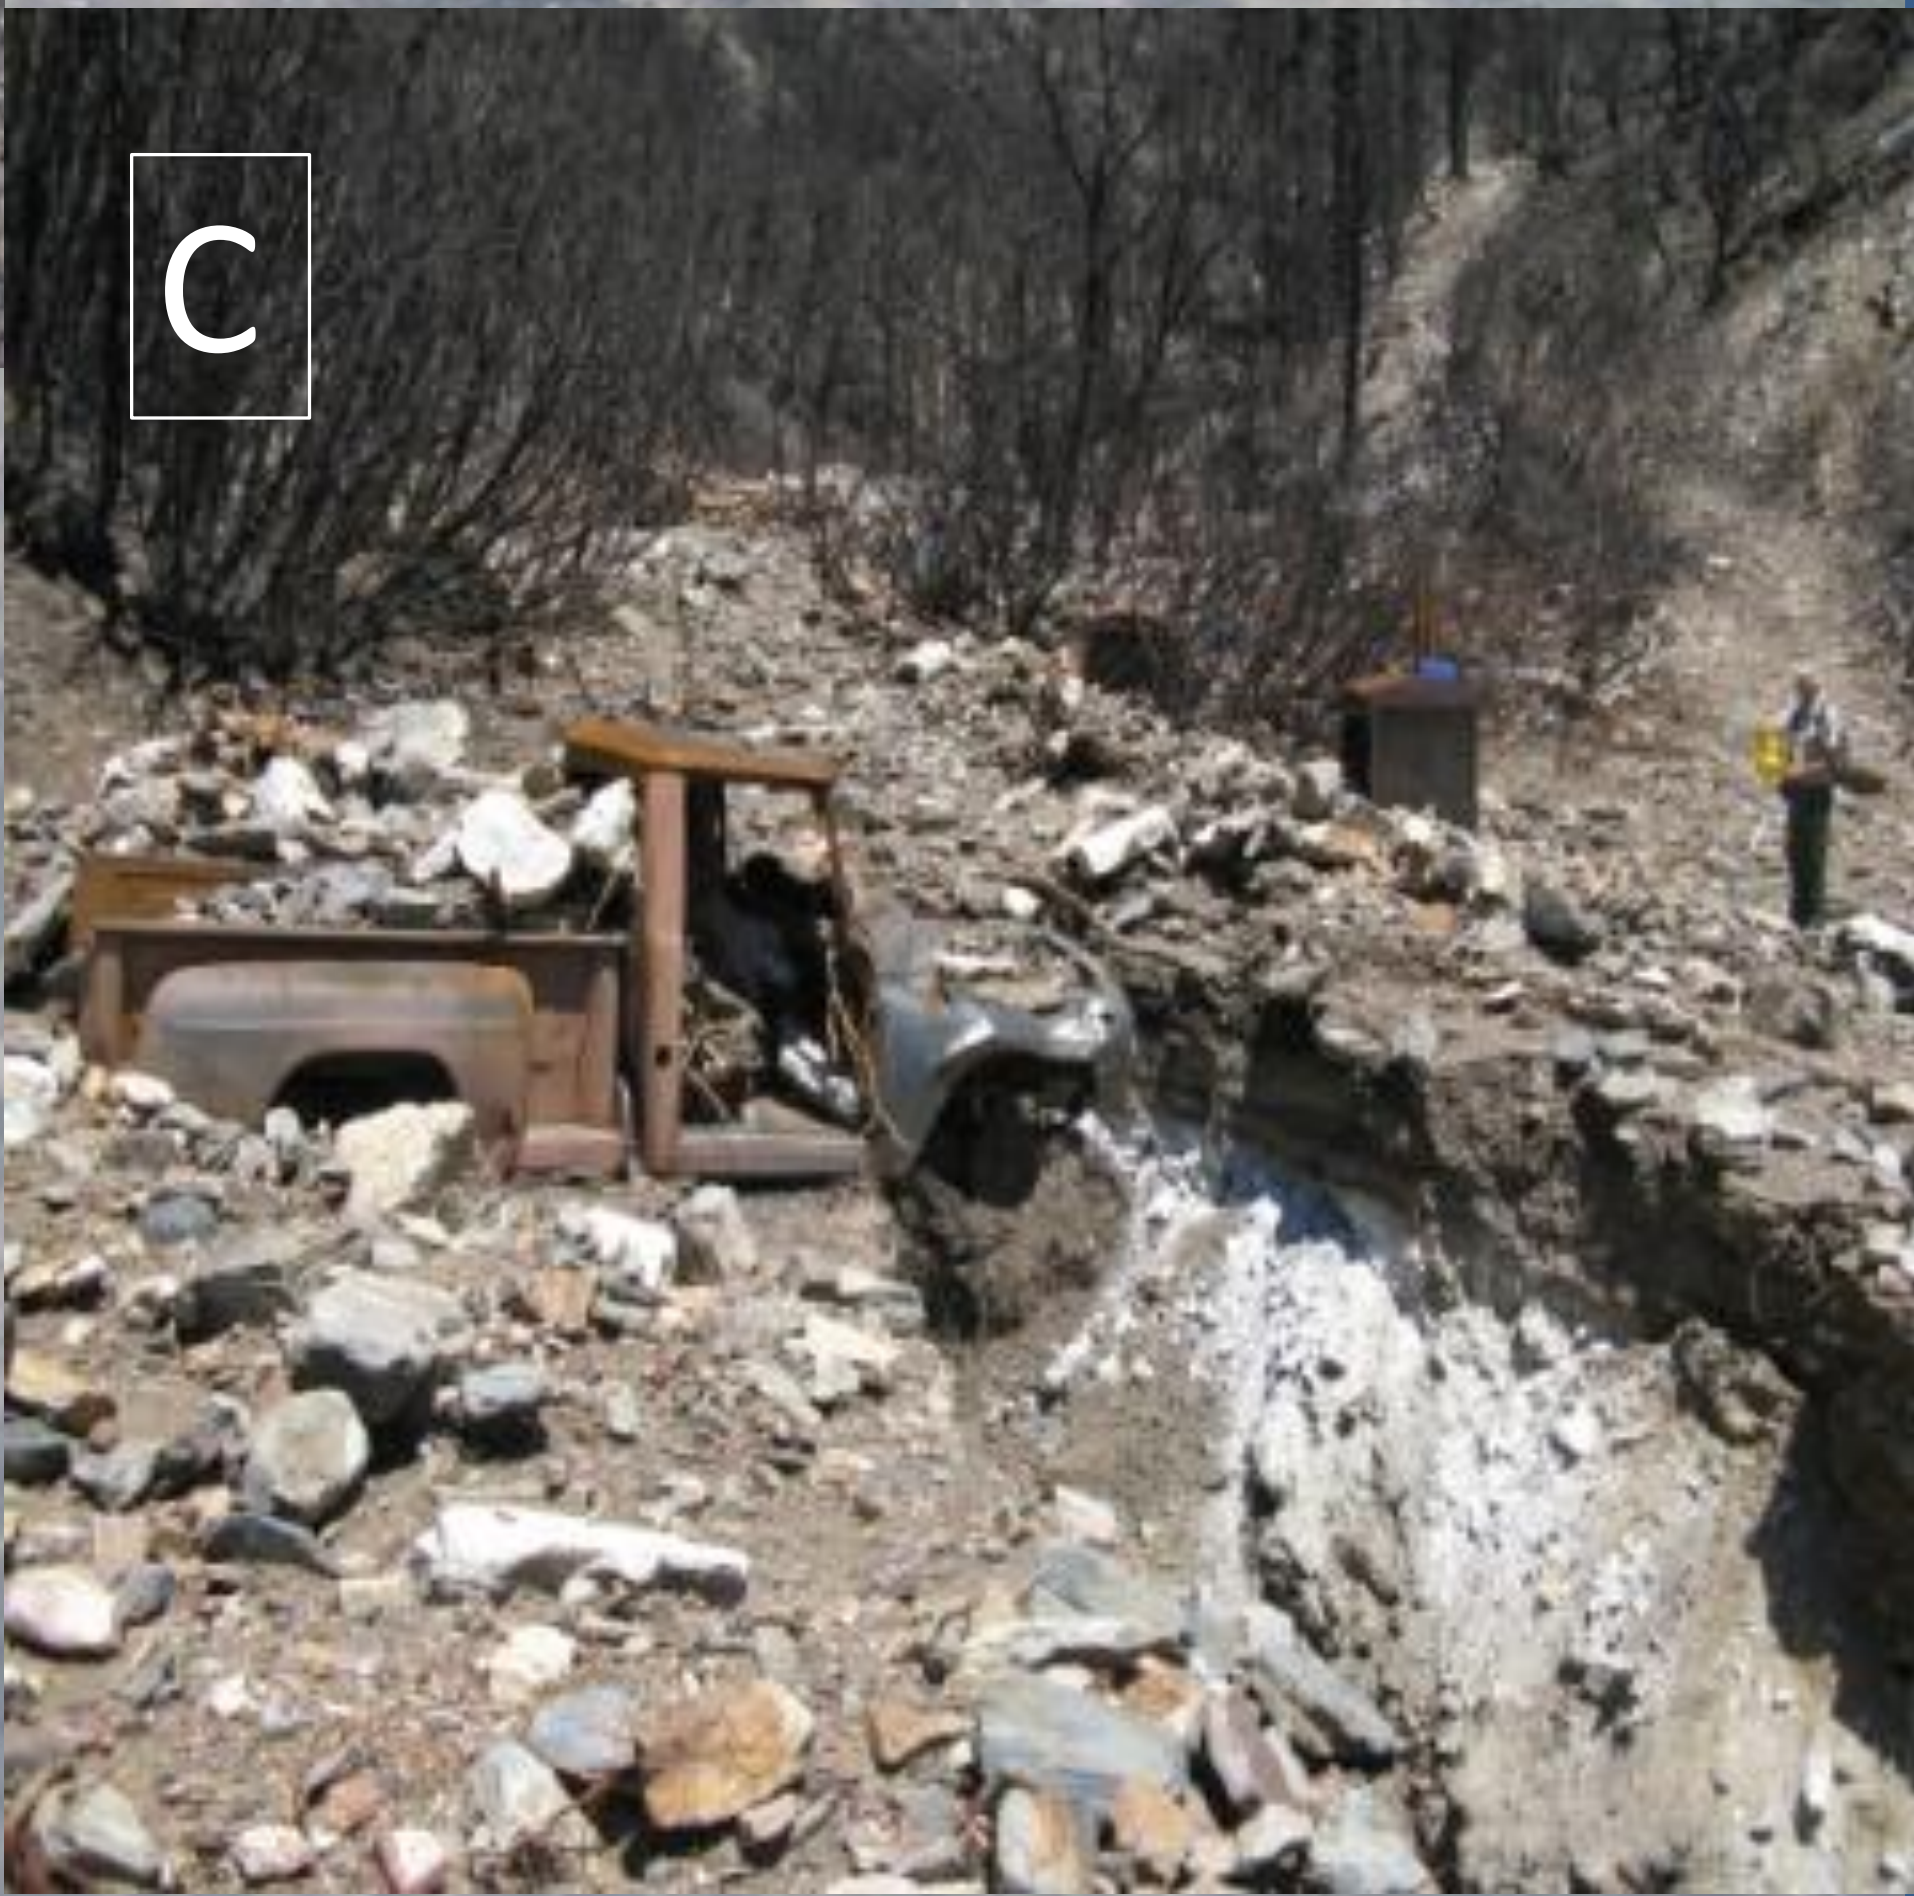
Tributary to South Fork of Erskine Creek

- A. Levees at the mouth of small unnamed branch of tributary channel. At least, two surges of debris issued into the main flow based on the presence of the smaller levee inset from larger outer levee. The red dashed line indicates the center of the contributing debris flow path into the main debris flow.
- B. Another of the multiple small debris flows which joined the debris flow in the main tributary. The flow path is clearly bordered by levees of coarse rock along its steep channel.
- C. A view up the channel along the path taken by the debris flow in the tributary to the South Fork of Erskine Creek. The debris flow passed through an abandoned mine destroying small structures and eroding a large waste rock pile (in the foreground). The mine access road is visible in the right background behind the person standing on the outer edge of the debris flow levee.
