Historical 3D modeling of erosion in Stony Clove Creek for sediment volume analysis using GIS

Chris Hewes
Environmental Science & Earth Systems
University of Massachusetts Amherst

Lawrence McGlinn
Geography
SUNY New Paltz

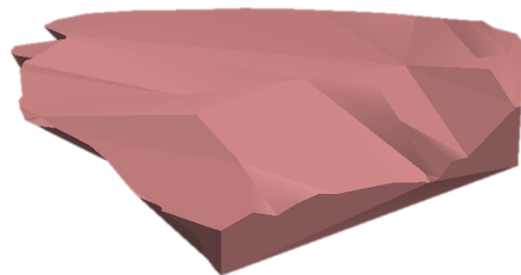
SEDIMENT VOLUME ANALYSIS

2,410,106 cubic feet of
sediment lost 1970-Present

- ◉ Stony Clove Creek at Chichester Site 2 began forming after stream straightening around 1970
- ◉ From 1970-2012, the feature has contributed a very significant 2.4 million cubic feet of clay into the creek
- ◉ The rate of sediment loss is increasing

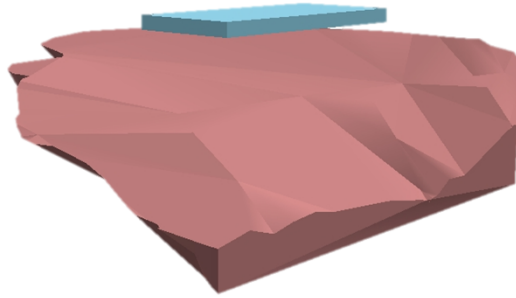
SEDIMENT VOLUME ANALYSIS

(~27 olympic-sized swimming pools)
