DIAGNOSTIC ASSESSMENT OF WARNER CREEK, CATSKILL MOUNTAINS, NY - THREE YEARS OF STUDENT CONDUCTED RESEARCH: CONCLUSIONS AND IMPLICATIONS

W. Danyelle Davis (NYCDEP)

Geological Society of America Northeastern Section

March 18 – 20, 2013

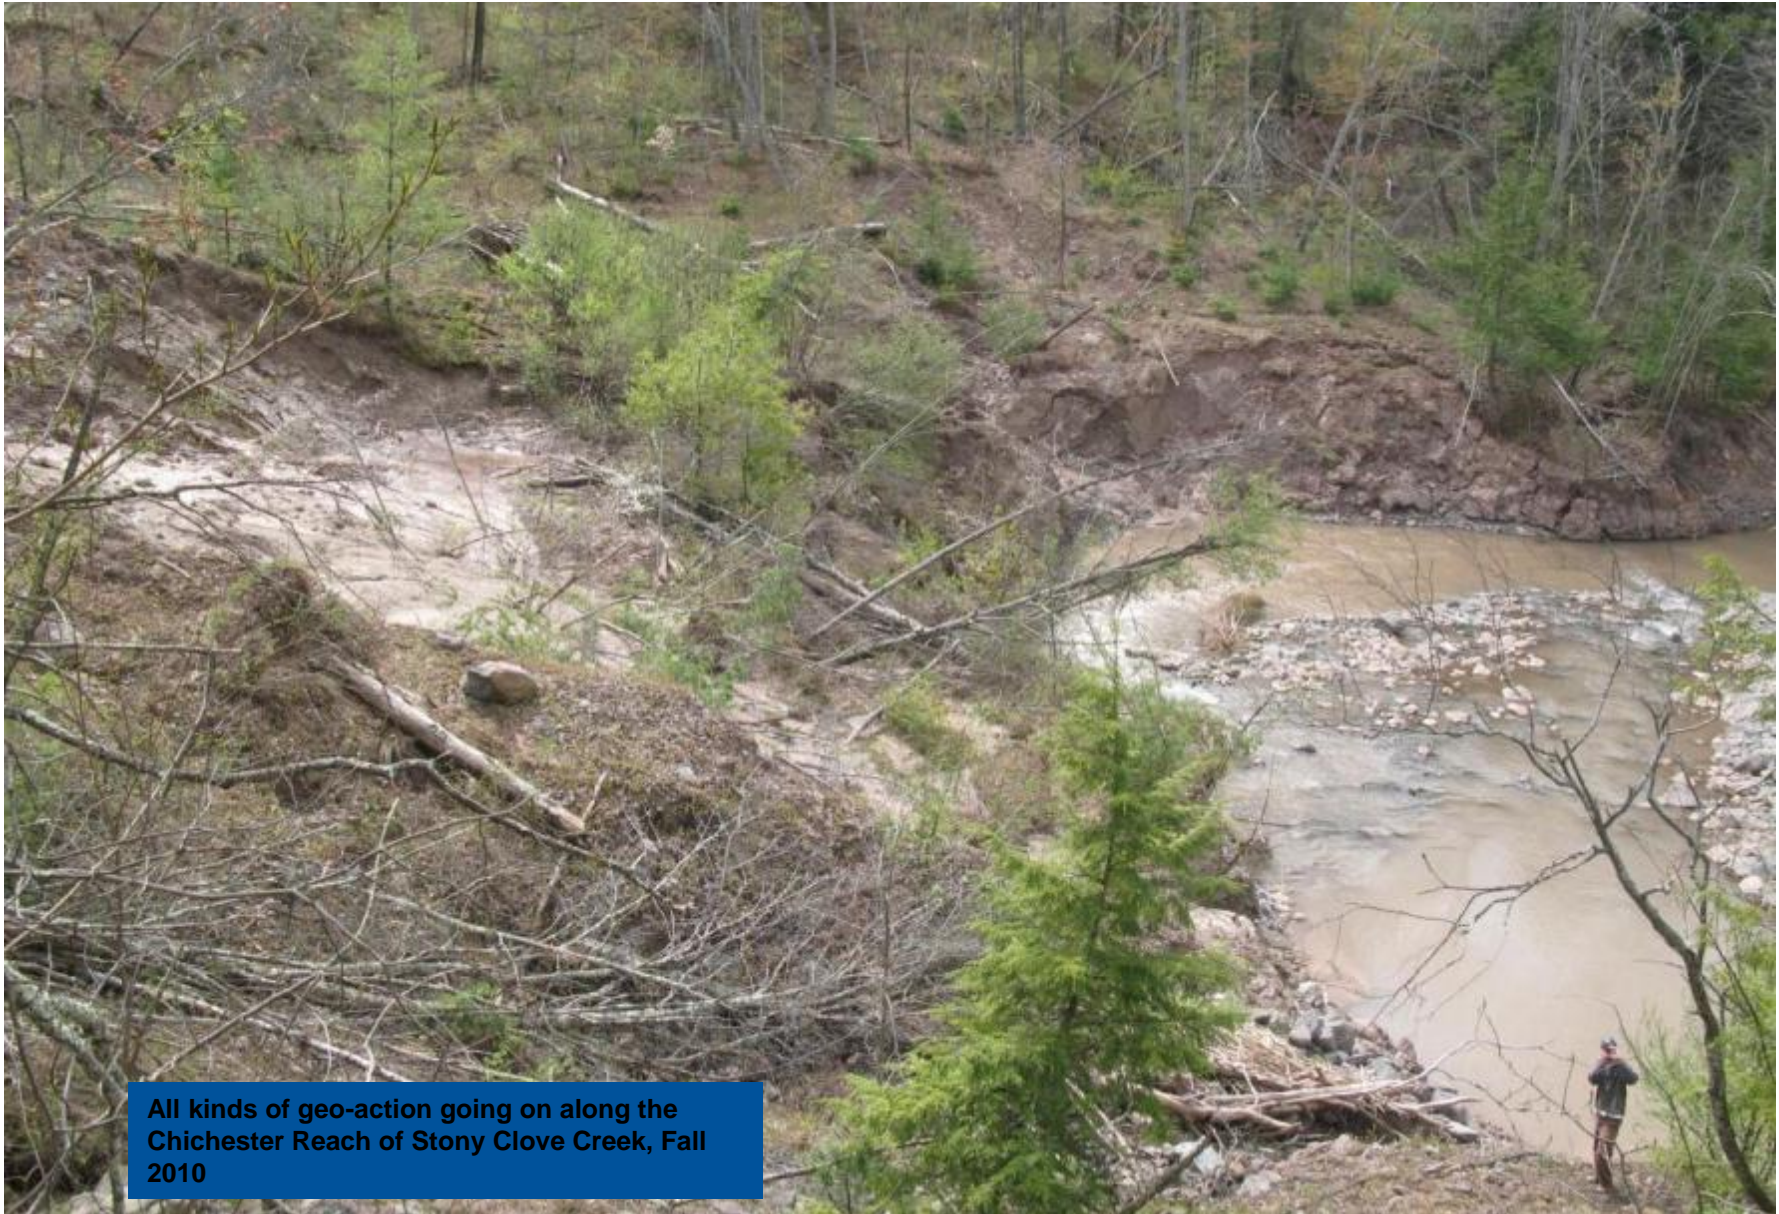
All kinds of geo-action going on along the
Chichester Reach of Stony Clove Creek, Fall
2010

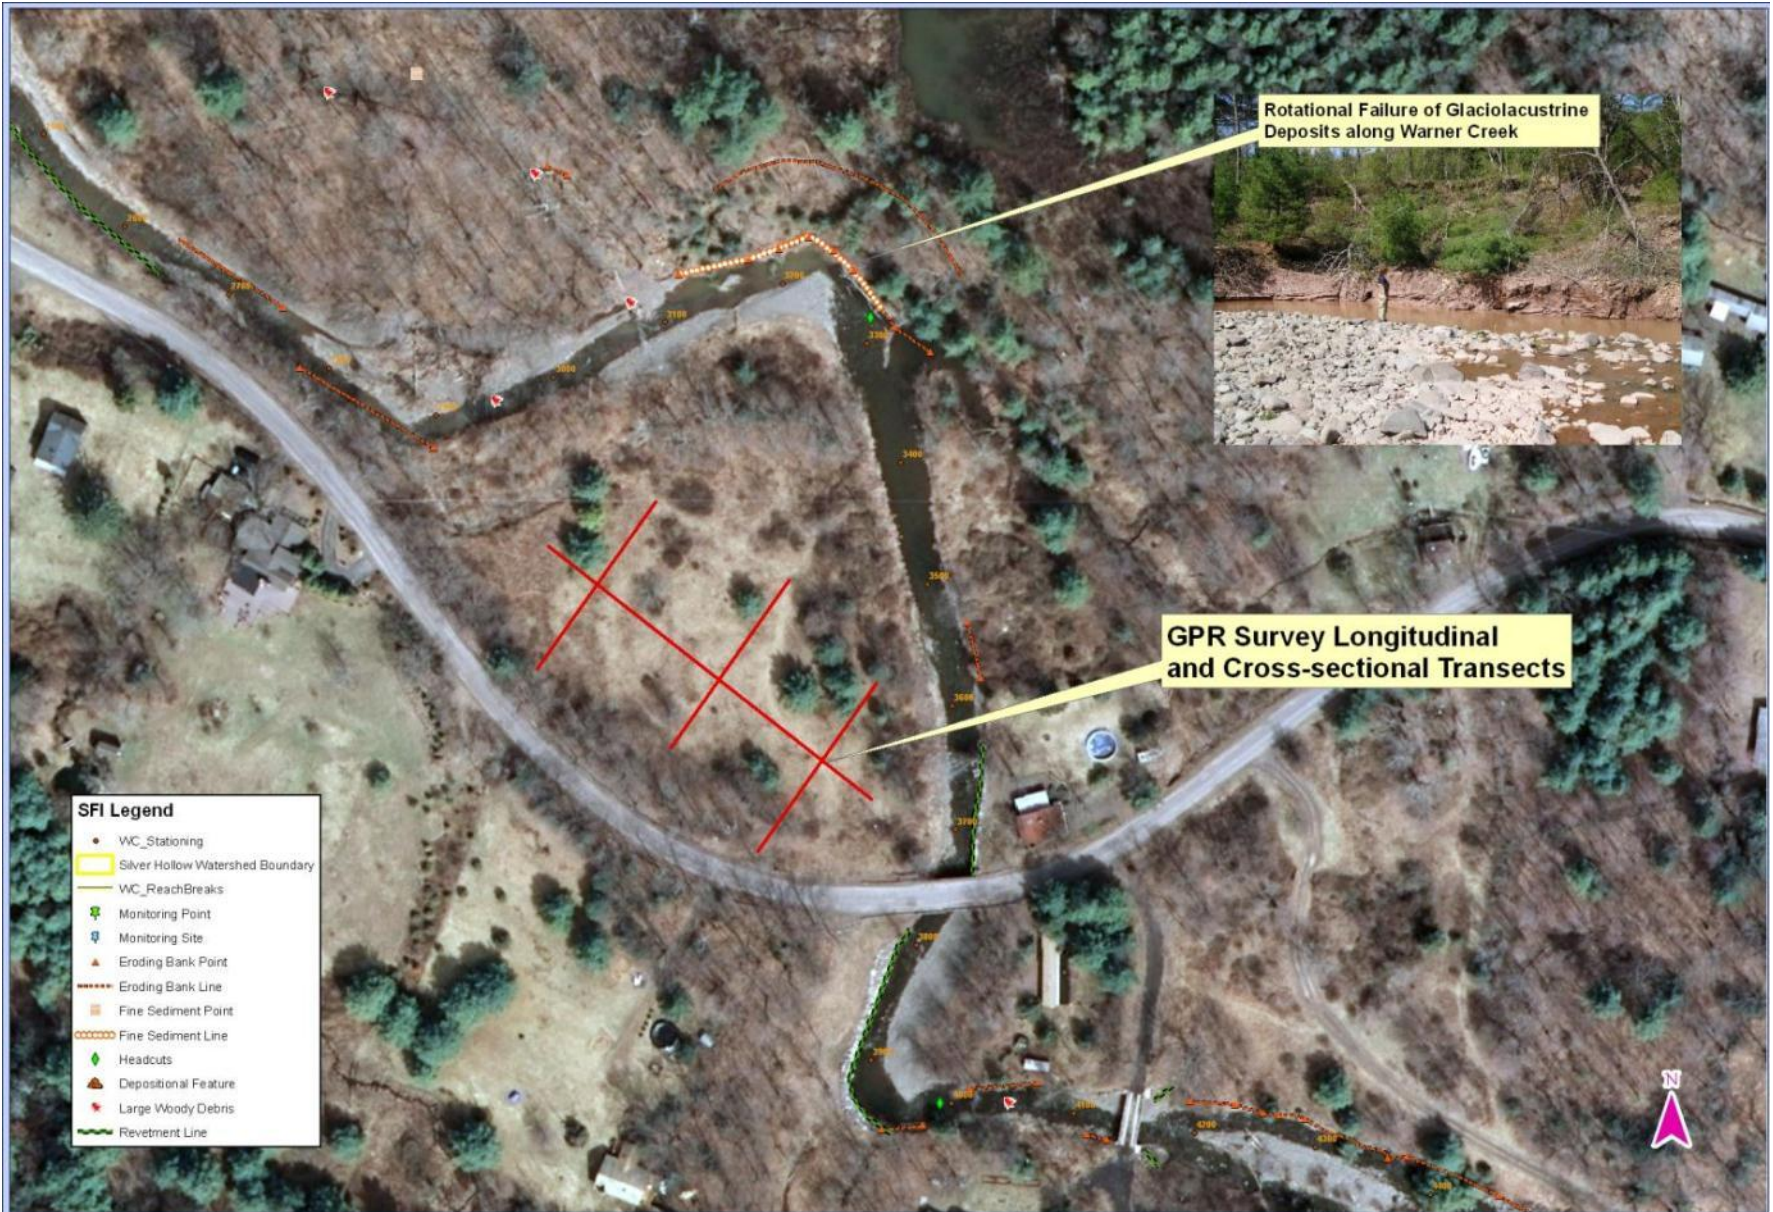
Ground-Penetrating Radar Survey Adjacent to Warner Creek Reach 12 (July, 2010)

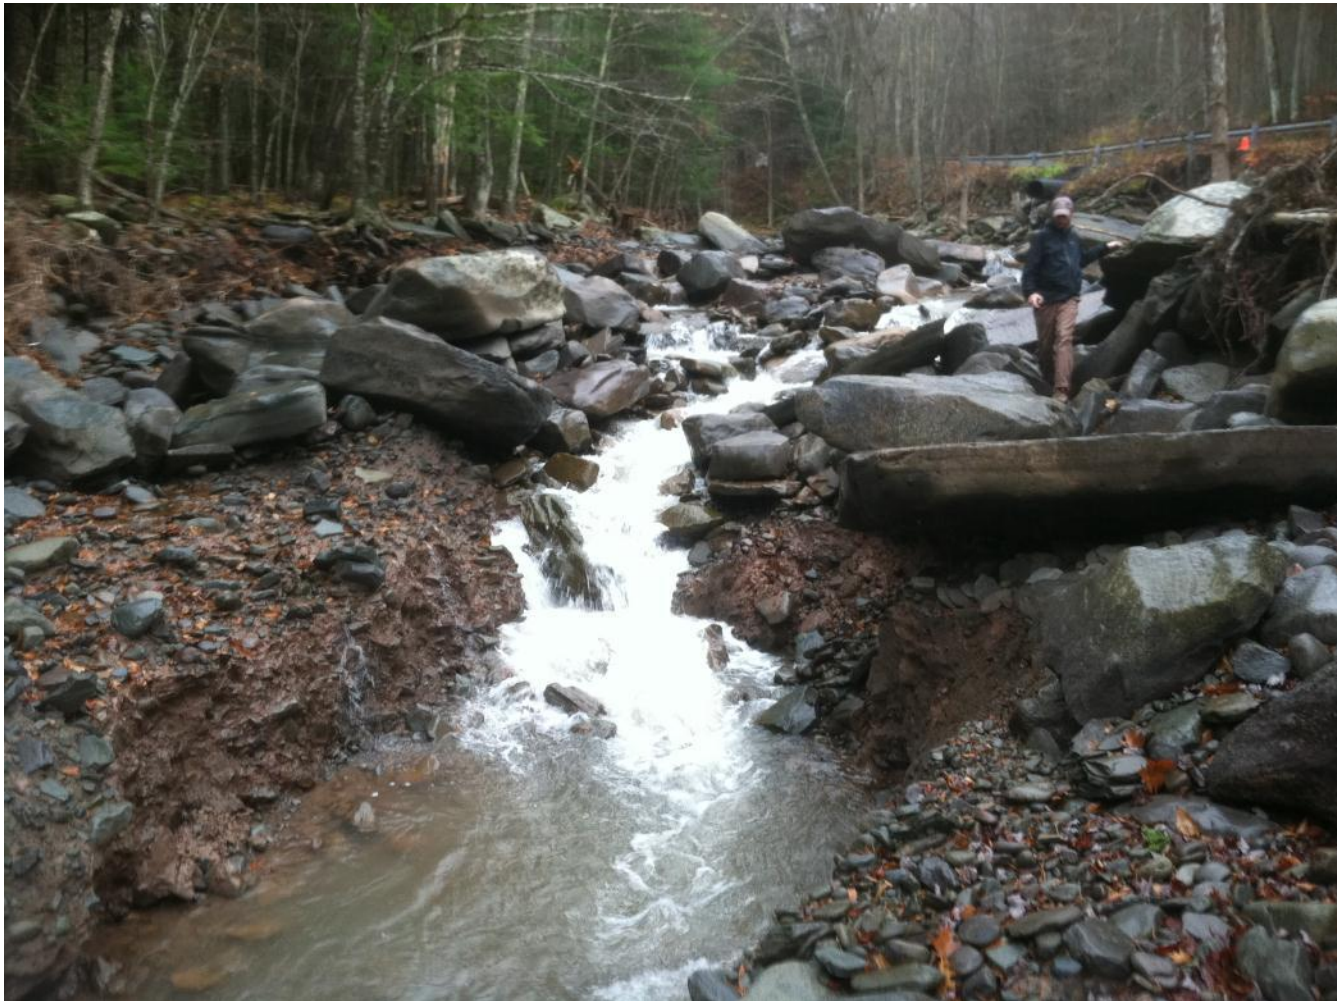
Warner Creek/Stony Clove Creek Confluence: Headcut Mitigation
