# Monitoring the Destruction and Natural Recovery of a Monsoon-Dominated Stream System After a Wildfire Damages its Watershed, Stout Canyon, Utah

CHRISTENSEN, Peter, and HARGRAVE, Jennifer, Physical Science Department, Southern Utah University, 351 West University, 351 West University, 251 West Univer

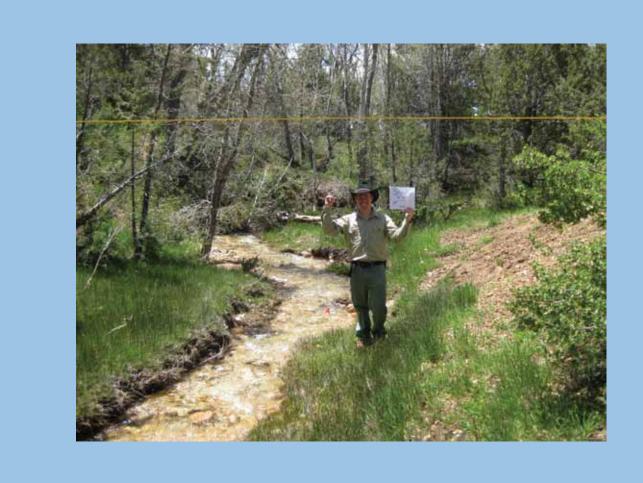
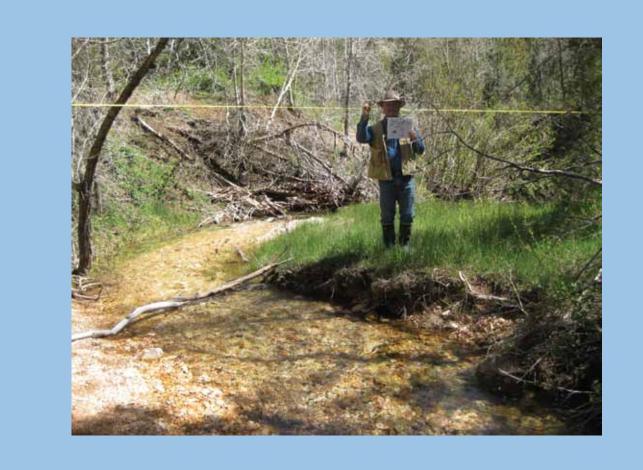
<b>D50</b>	Area at Bankfull	Width to Depth Ratio	Wette Perime
Coarse Gravel	2.70 ft <sup>2</sup>	7.40	5.18

- Before the fire, Stout Canyon's bank geometry was stable.
- After the fire the bank geometry changed drastically.
- The largest change occurred two years after the fire.
- The average size of sediment (D50) in the substrate decreased after the fire.
- As of 2014, the D50 shows signs of increasing and returning to pre-fire conditions.
- The area at bankfull, width to depth ratio, and wetted perimeter all increased after the fire.
- The floodplain appears wider and less vegetated after the fire.
