#### UNIVERSITY CONTRIBUTIONS TO RISK REDUCTION IN A POST-DISASTER CONTEXT: A CASE STUDY OF REORIENTING RESEARCH EFFORTS AT SAN VICENTE VOLCANO, EL SALVADOR

#### Luke Bowman<sup>1</sup>, John Gierke<sup>1</sup>, and Fredy Cruz Centeno<sup>2</sup>

#### San Vicente Volcano, El Salvador

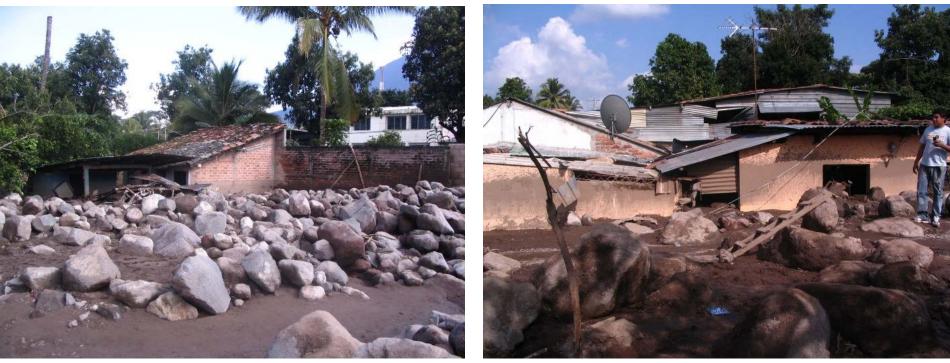
## Hurricane Ida (Nov. 7-9, 2009)

- 480 mm of rainfall over 3 days, <u>360 mm in 5-hr</u>
- Debris flows inundated 5 towns
- Over 200 fatalities; 60 people were never found

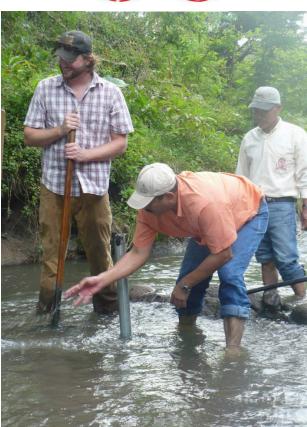
## **Slope Stability Modeling**

Modeling showed vulnerability of slope to rainfall

Depth to water table was most important variable Hazard assessment of rainfall-induced landslides: a case study of San Vicente volcano in central El Salvador

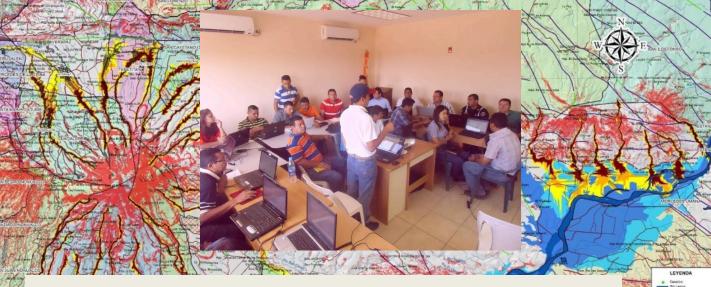
#### MAPA MULTIAMENAZAS REGIONES VOLCÁN SAN VICENTE Y LEMPA ACAHUAPA, EL SALVADOR, C.A.

#### GIS and LaharZ modelling workshops Dissemination of hazard maps Surface Crack Monitoring

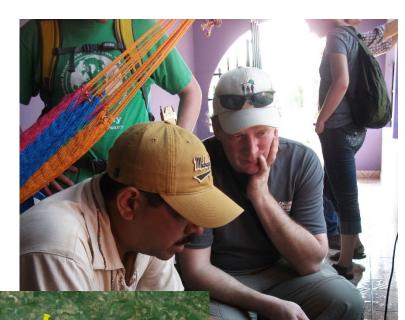
#### **Remote Sensing and Modeling**

- 6 Weather stations monitoring precipitation
- Water-level monitoring in handdug wells and the upper and lower portions of the Rio Acahuapa
- Intensive workshop at Michigan Tech, supported by PEER
