Stratigraphy, Structure and Rock Mass Properties of the Hartland Formation, Second Avenue Subway, NYC, NY

*Charles Merguerian
Hofstra Geology
J. Mickey Merguerian
Univ. Texas @ El Paso
24 Mar 2014*

Second Avenue Subway

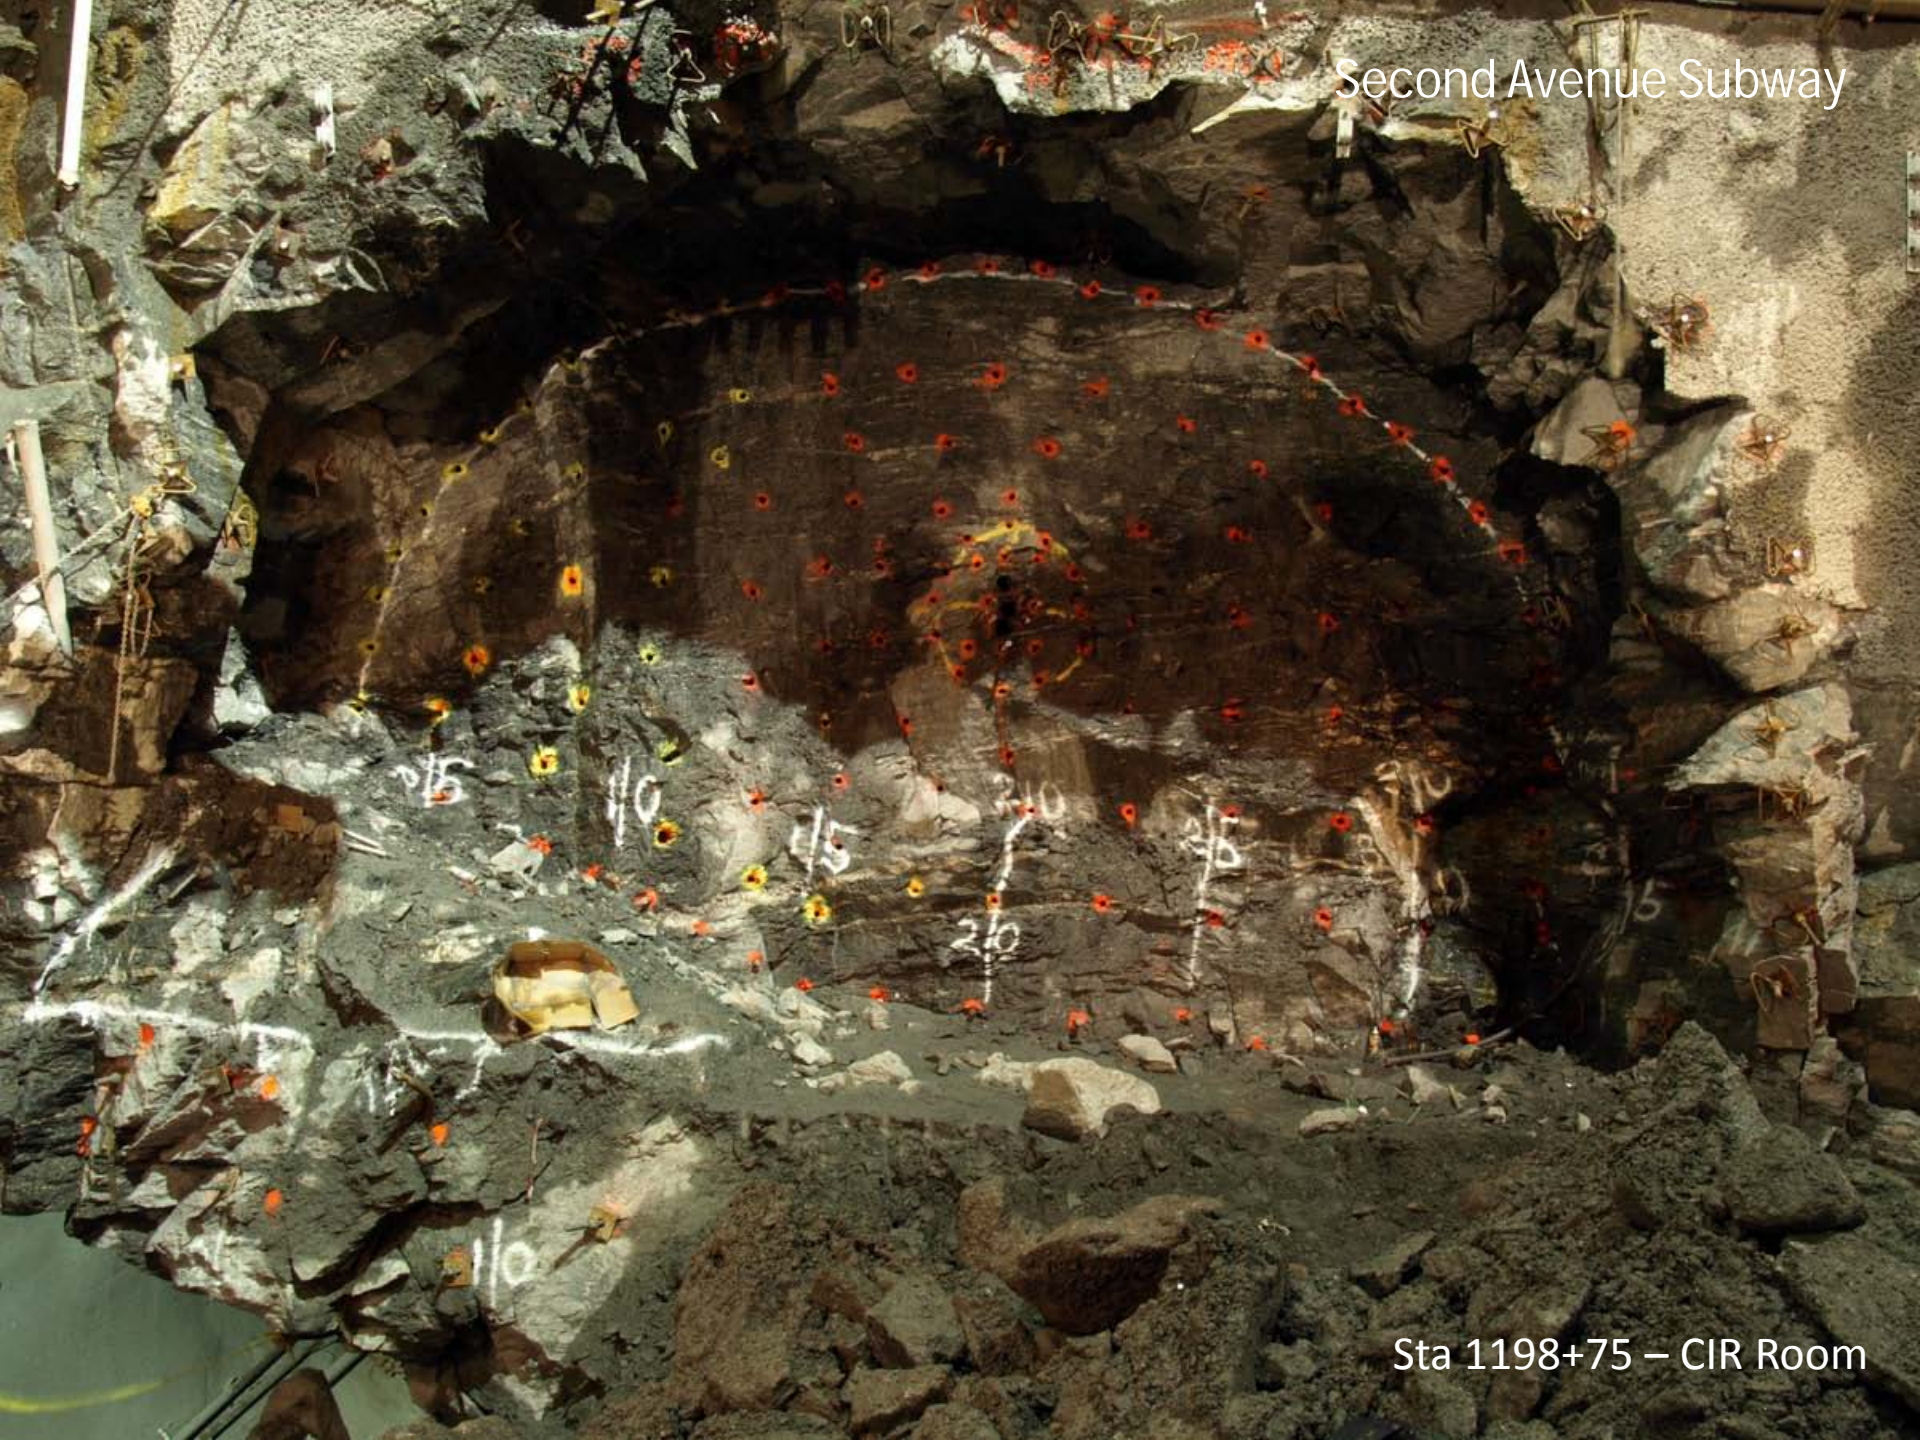
Sta 1198+75 – CIR Room

CIR Room Floor
Elev. = +81.5'

**J2 joint
[Feature 13]**

**J3 joints that
cut TBM tunnel**

**N50W, 71SW Normal Fault
[Feature 9]**

**N65W, 55NE J3 Joint Set
That Intersects Northbound
TBM Tunnel Crown (Feature 3)**

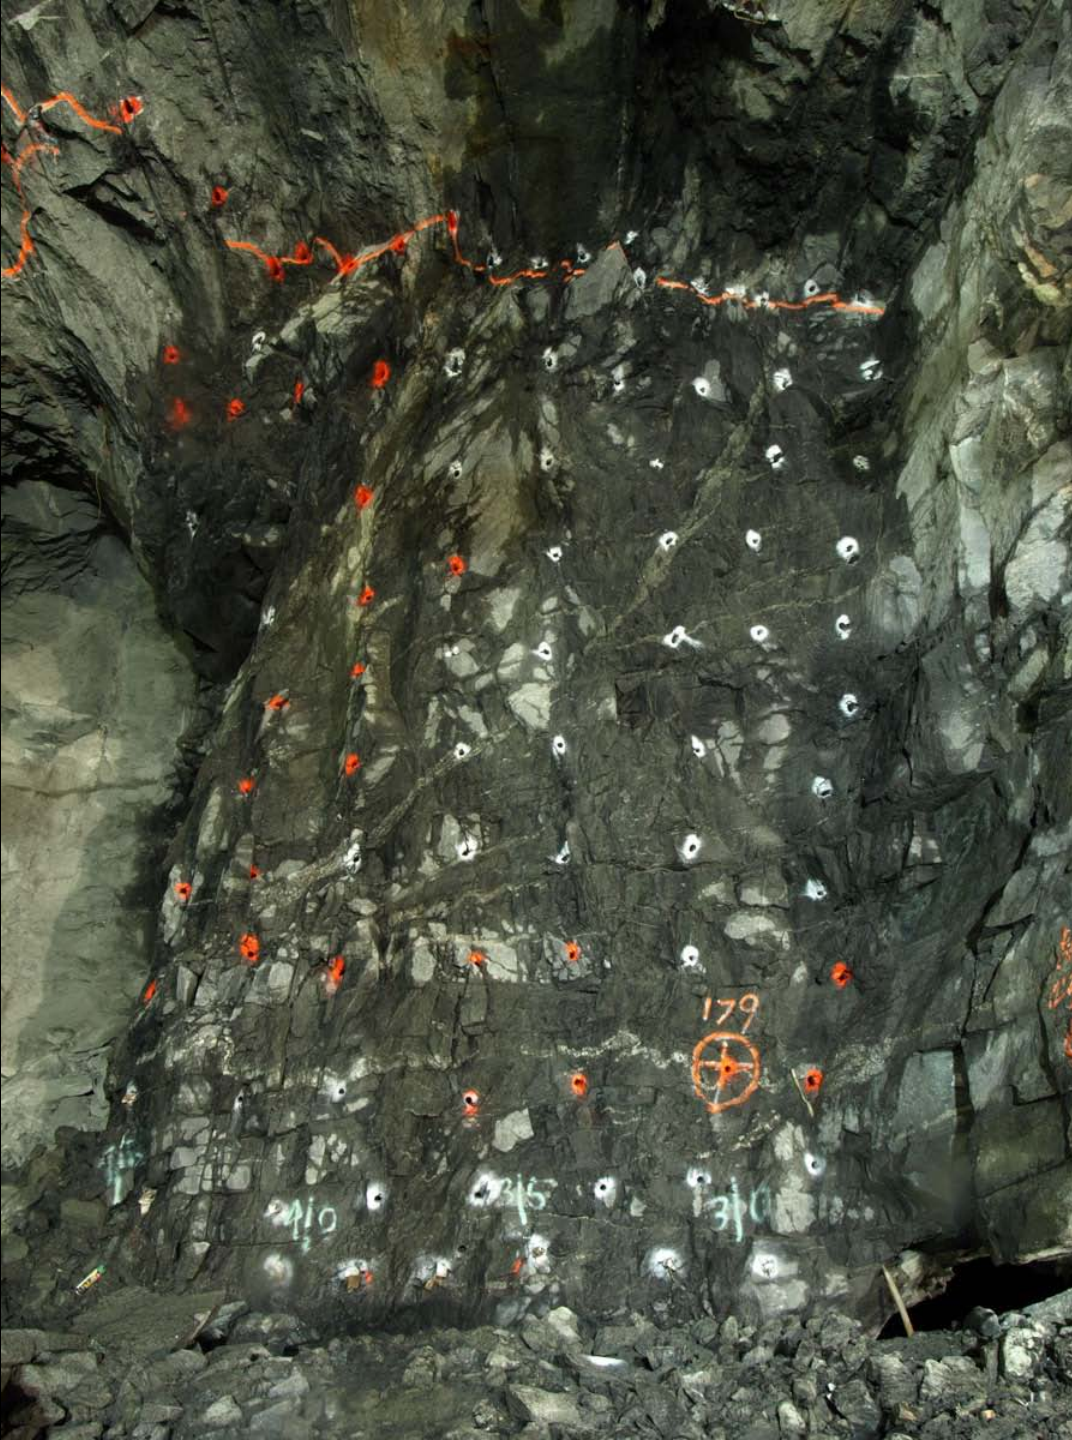
Sta 1204+90
North Cavern Center Slash

Second Avenue Subway - North Cavern Center Slash
Working Face at Sta. 1204+90; Elev. +75' to +108'

Mapped 19 December 2012

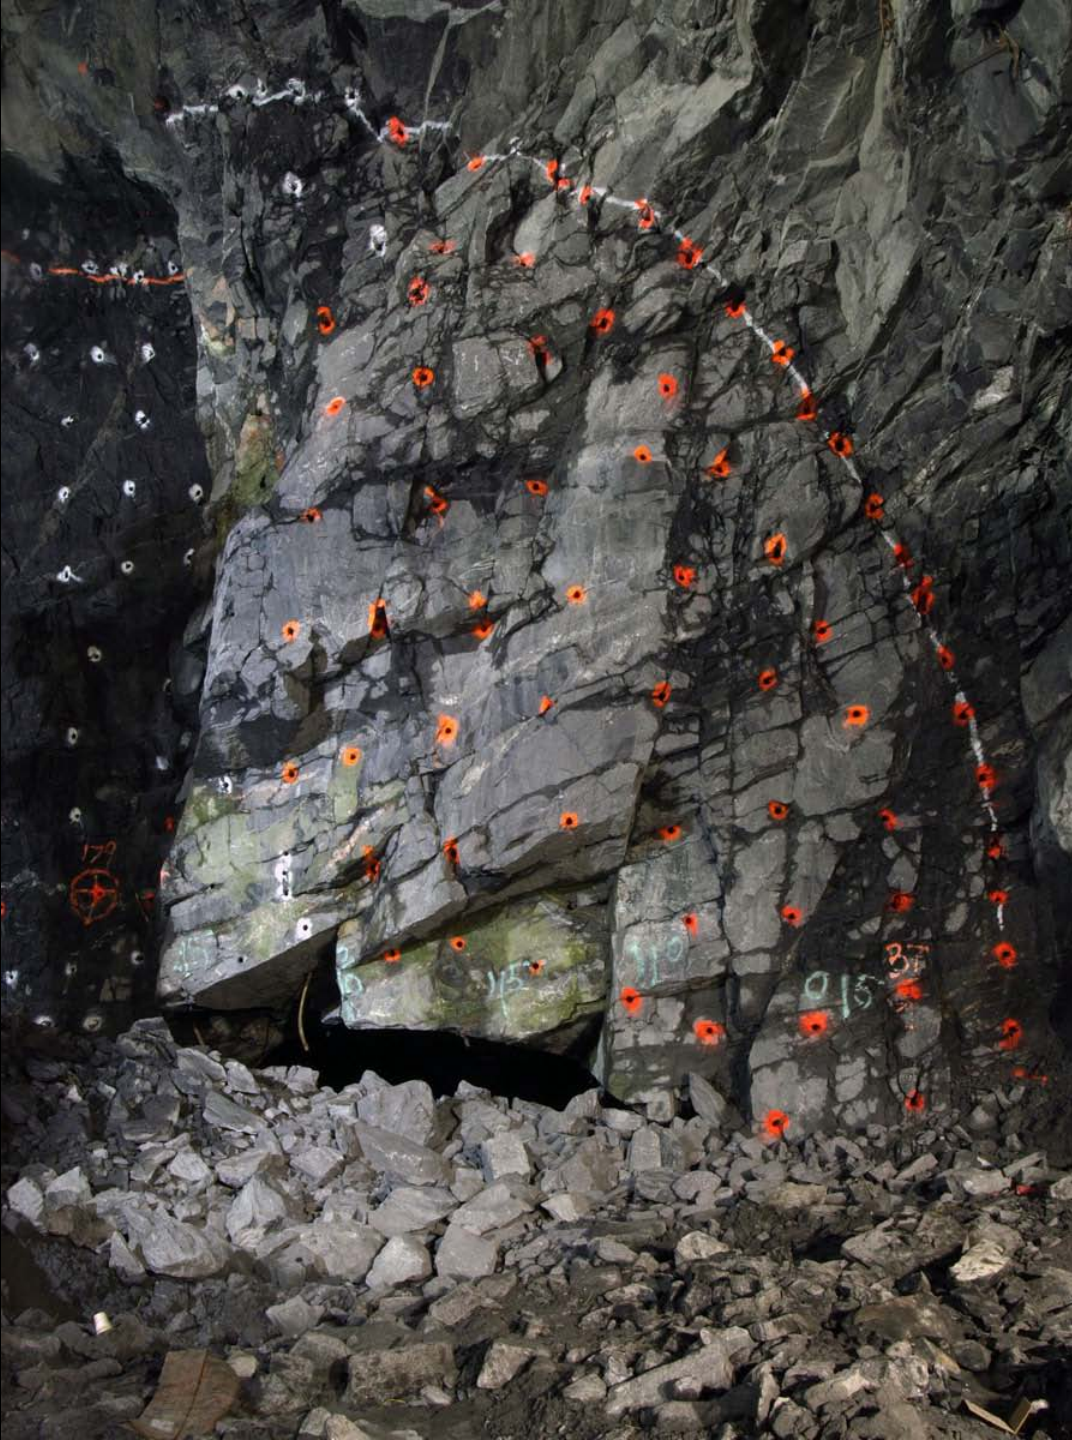
Sta 1205+10 – North Cavern

**Second Avenue Subway - North Cavern West Slash
Working Face at Sta. 1205+10; Elev. +75' to +105'**

Stationing in Feet West of Second Avenue Centerline →

Mapped 19 December 2012

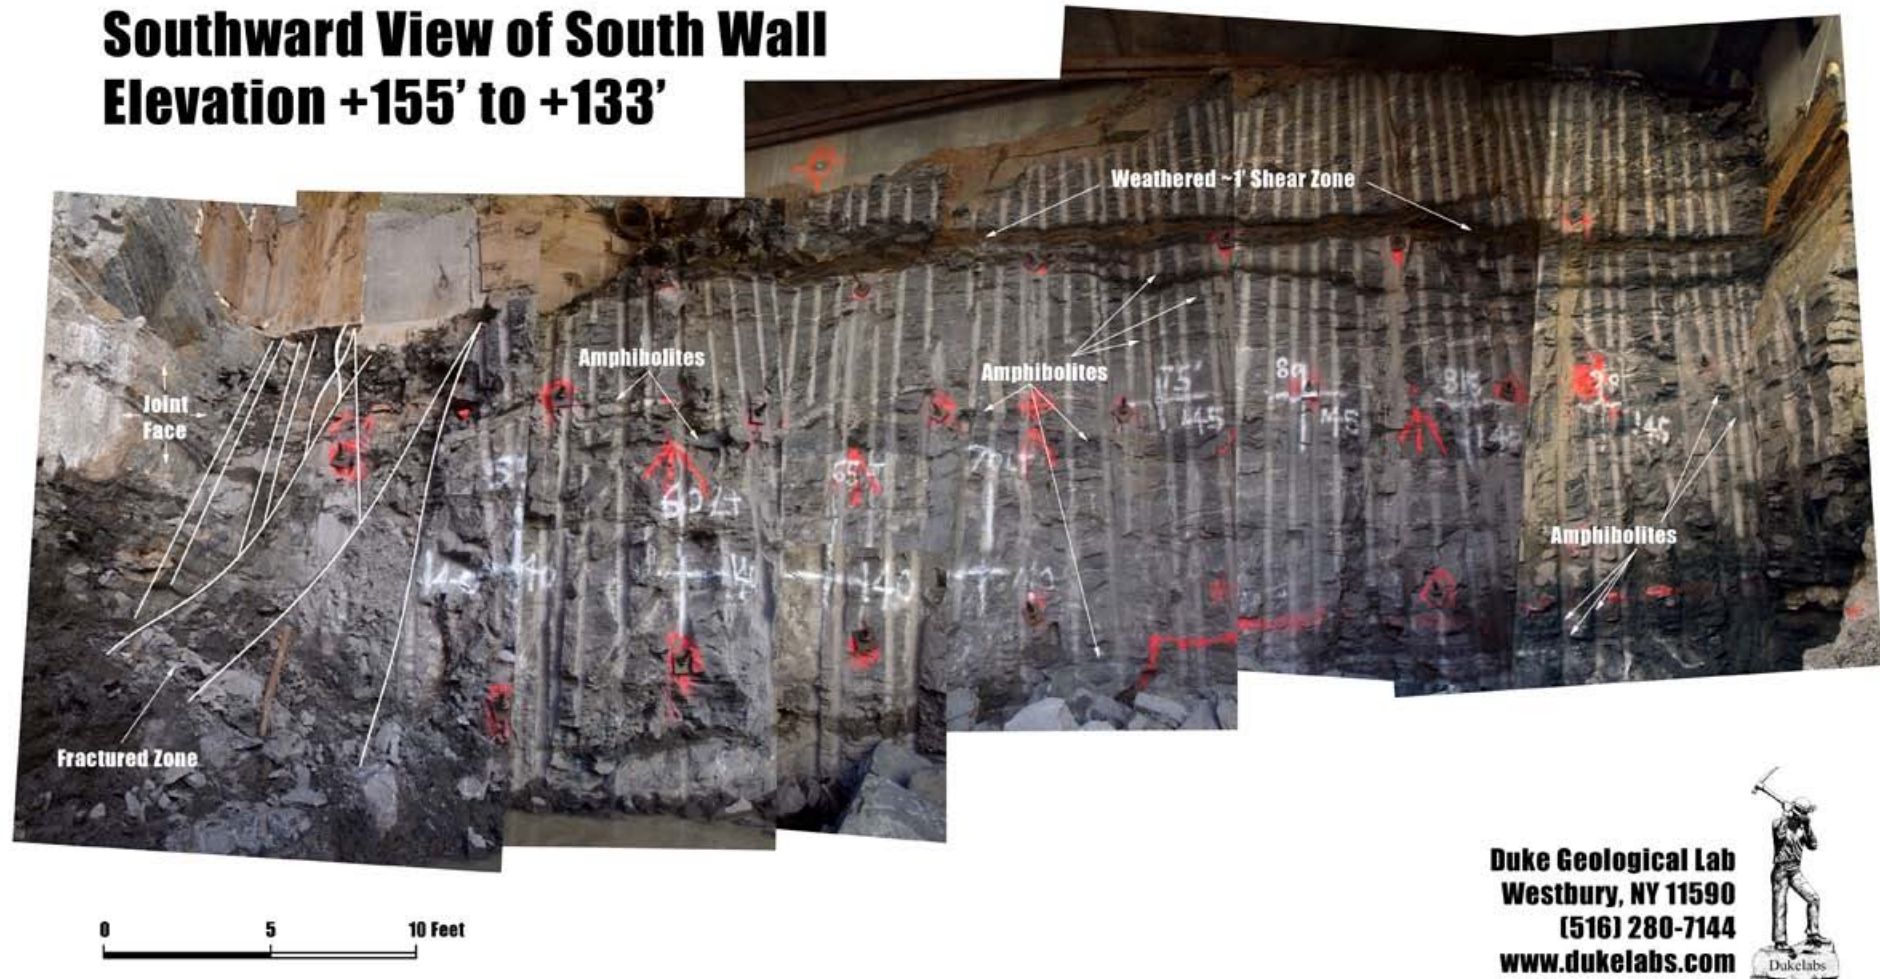
Plate 2

**Second Avenue Subway
86th Street Ancillary #2
Southward View of South Wall
Elevation +155' to +133'**
