Geochemical Analysis of Surface Materials Surrounding the Bautsch-Gray Mine Superfund Site near Galena, Illinois

**A senior thesis written by
Ryan Plath**

**Augustana College
Rock Island, Illinois 61201
2011**

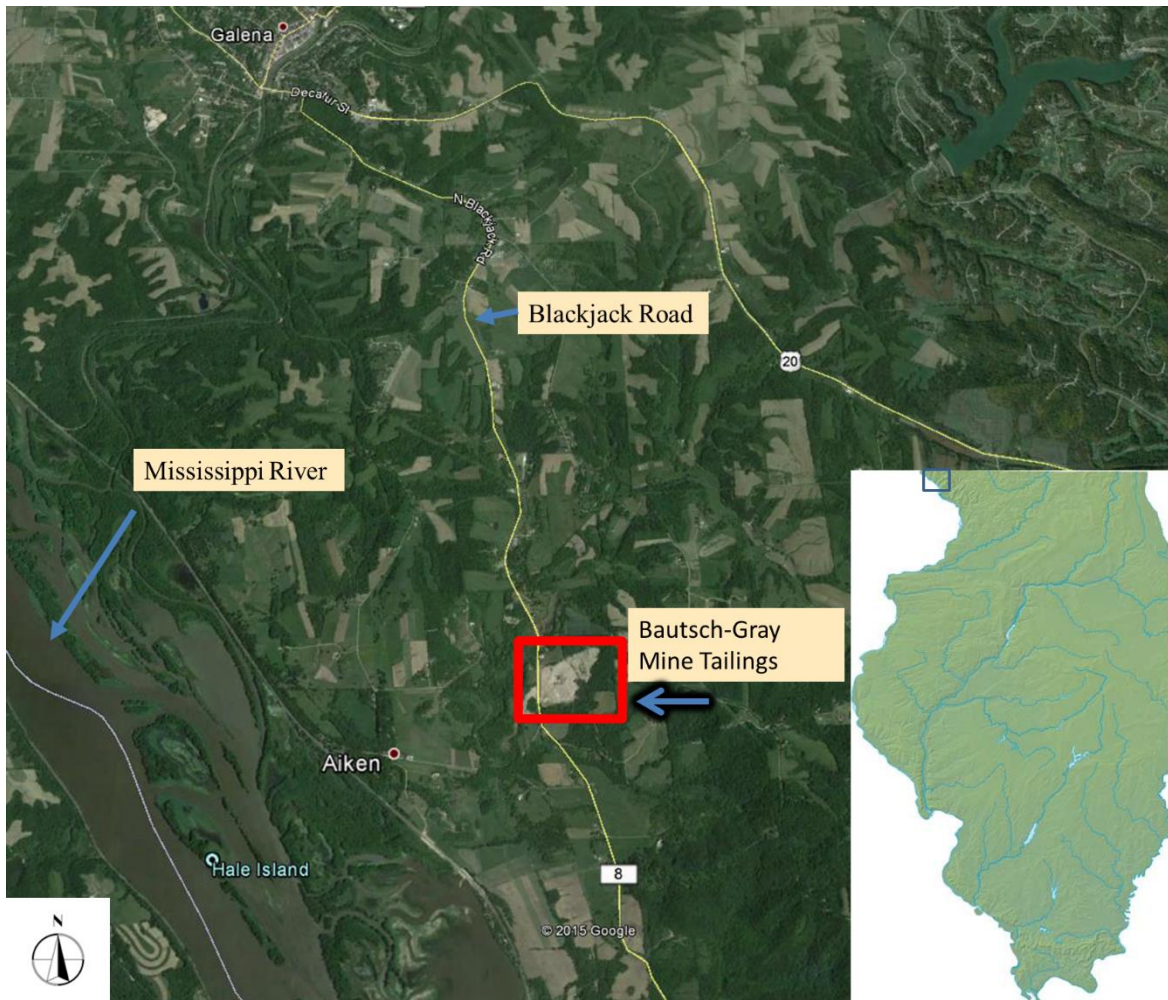
Figure 1: Map showing general location of Bautsch-Gray Mine

The Bautsh-Gray mine is located at 1000 South Blackjack Road in Jo Daviess County Illinois ($42^{\circ} 21' 26.72''$ N, $90^{\circ} 23' 54.85''$ W). This site is about 4 miles south of Galena, Illinois and within the driftless zone of northwestern Illinois (A region not subject to glaciation in recent geologic history) (Figure 1). The area is hilly and located in a rural agricultural and residential area. To the east of Blackjack Road is the 55 acre, approximately 50 foot high mine tailings pile. The pile is on a hillside which is sparsely vegetated and contains several retention ponds installed by the EPA. West of the retention ponds, a berm borders Blackjack Road. To the west of Blackjack Road is a residential property owned by the Hartness family. South of the Hartness property a marshland area borders Blackjack Road and extends westward towards Smallpox Creek. Smallpox Creek drains thirty square miles of land and feeds into the Mississippi River, which is approximately two miles west of the site. The general trend of the site is slopping east to west (Figure 2). The gradient on the mine tailings pile is greater than the gradient west of Blackjack Road.

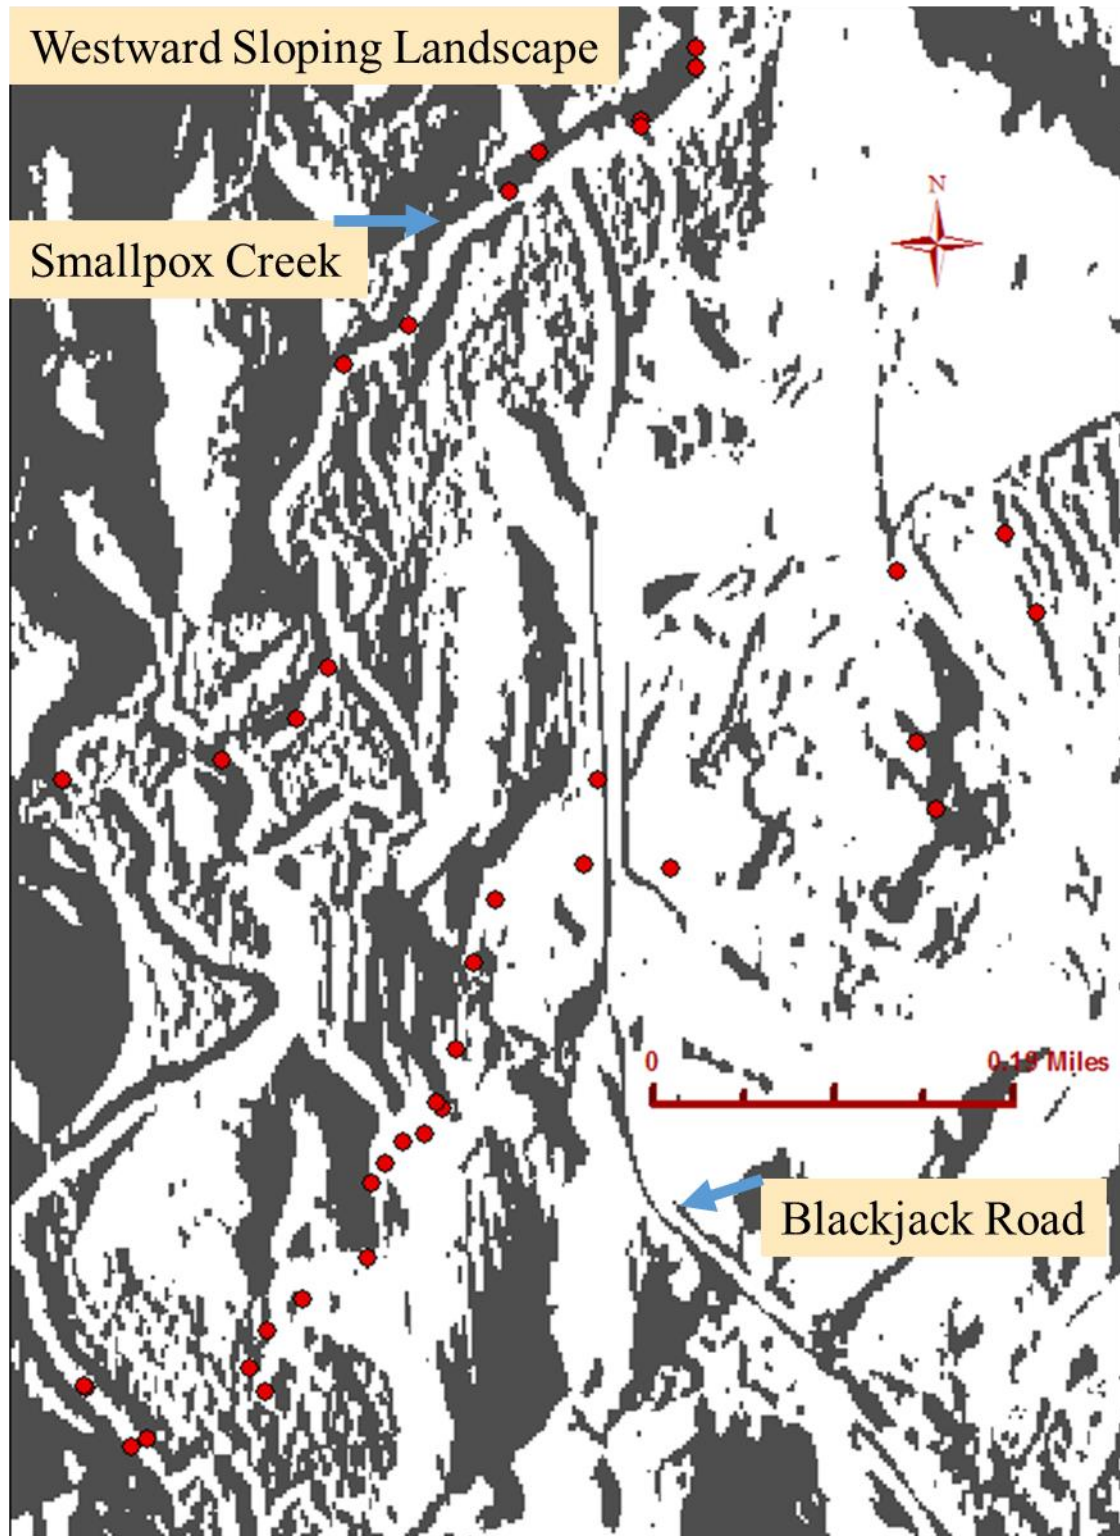
Figure 2: This map shows all generally eastward sloping areas (0-180 degrees) in gray and all generally westward sloping areas (180-360 degrees) in white. This map shows that almost all sediment and overland flow from the mine tailings pile would be funneled through the outwash basin and towards Smallpox Creek.

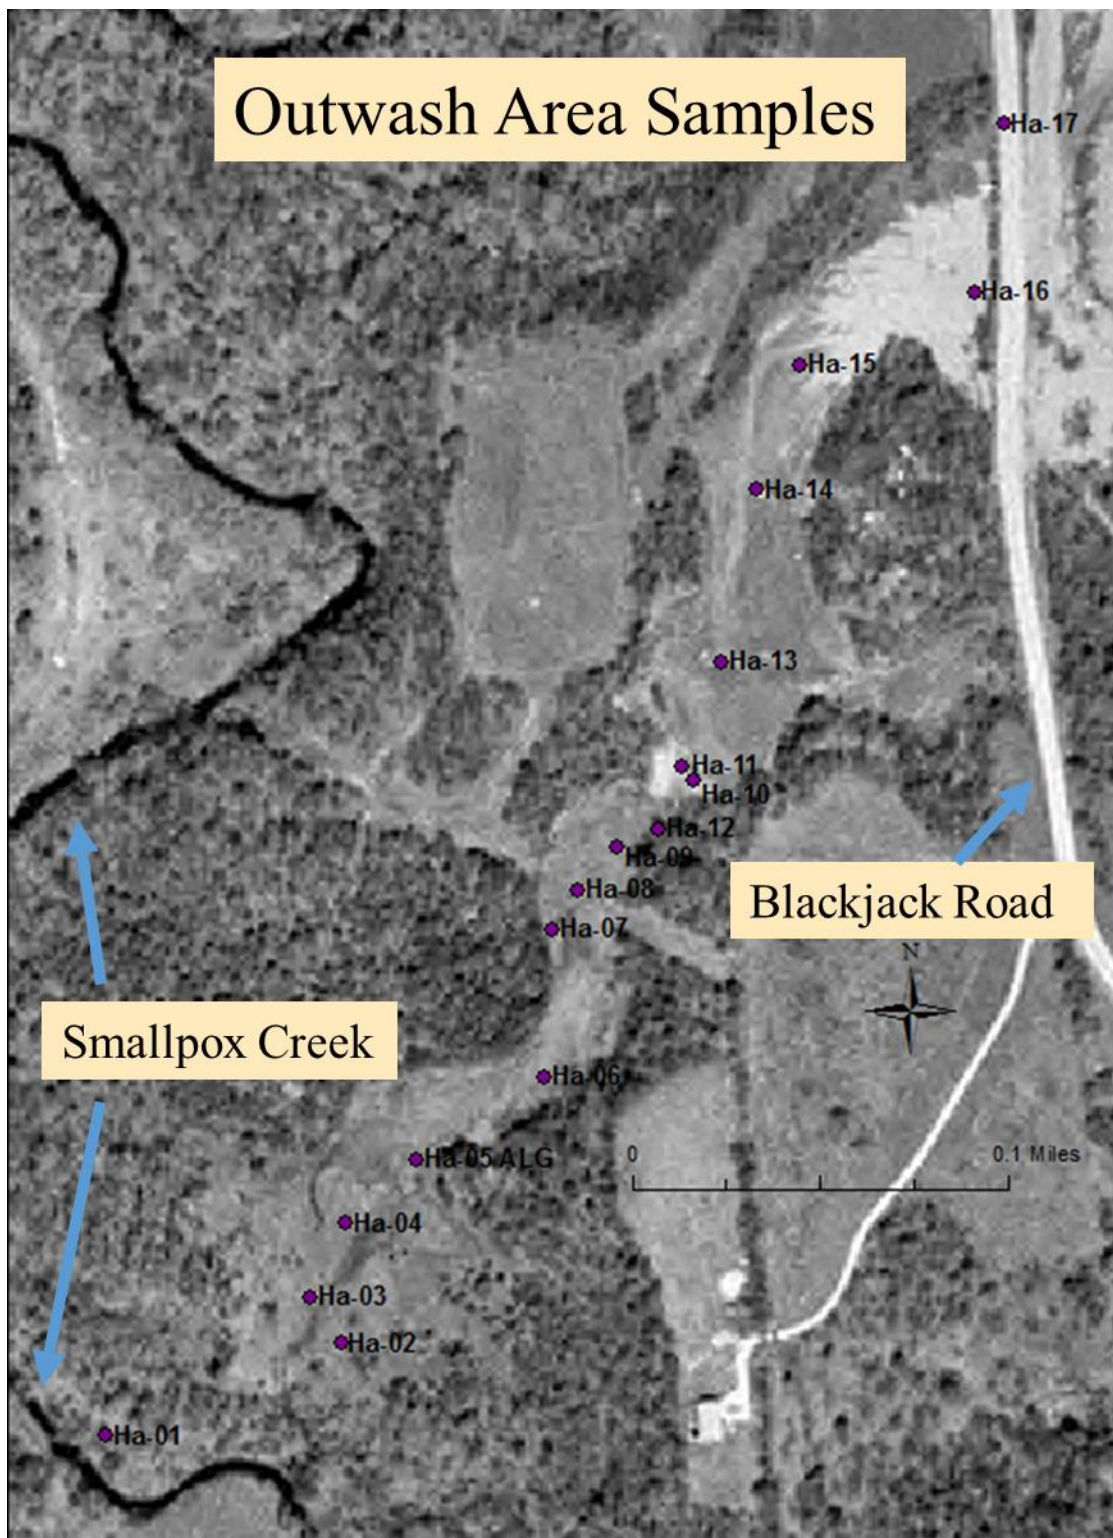
Figure 6: A map showing the locations of samples taken from Marshland / Outwash Basin

There were 17 samples collected from the outwash basin. Eight of the samples were above the TCR for lead and 14 were above the COL for soils near a Superfund site. Three of the samples were above the TCR for zinc and 13 were above the cleanup objective level for soils near a Superfund site. These samples were not collected randomly. There was a bias towards a cluster of samples (samples 7-14) near the middle stretch of the outwash (Figure 6). This was because there was an approximately twenty foot steep slope of mine tailings at this location. This seemed like a very probable area for contamination, so it was important to get multiple samples from this area. Furthermore, there was a visible wetland just downslope from the mine tailings with cattails, sedges and other wetland plants. These two features made this area a highly desirable sampling area.

Though this area certainly had high values of contamination, most of the other areas within the outwash basin also had high values. Therefore this central area does not skew or misrepresent the type of contamination that is occurring throughout the outwash basin. For example, sample Ha-02 has very high levels of lead and zinc despite the fact that it is approximately 900 feet downgradient from the central area. This sample had 25821 ppm of zinc and 4539 ppm of lead, which is the highest concentration of lead for all of the samples taken throughout the whole entire study. The fact that there are such high concentrations of heavy metals near the end of the outwash basin suggests that Smallpox Creek has the potential to be prone to runoff contamination from the mine site.

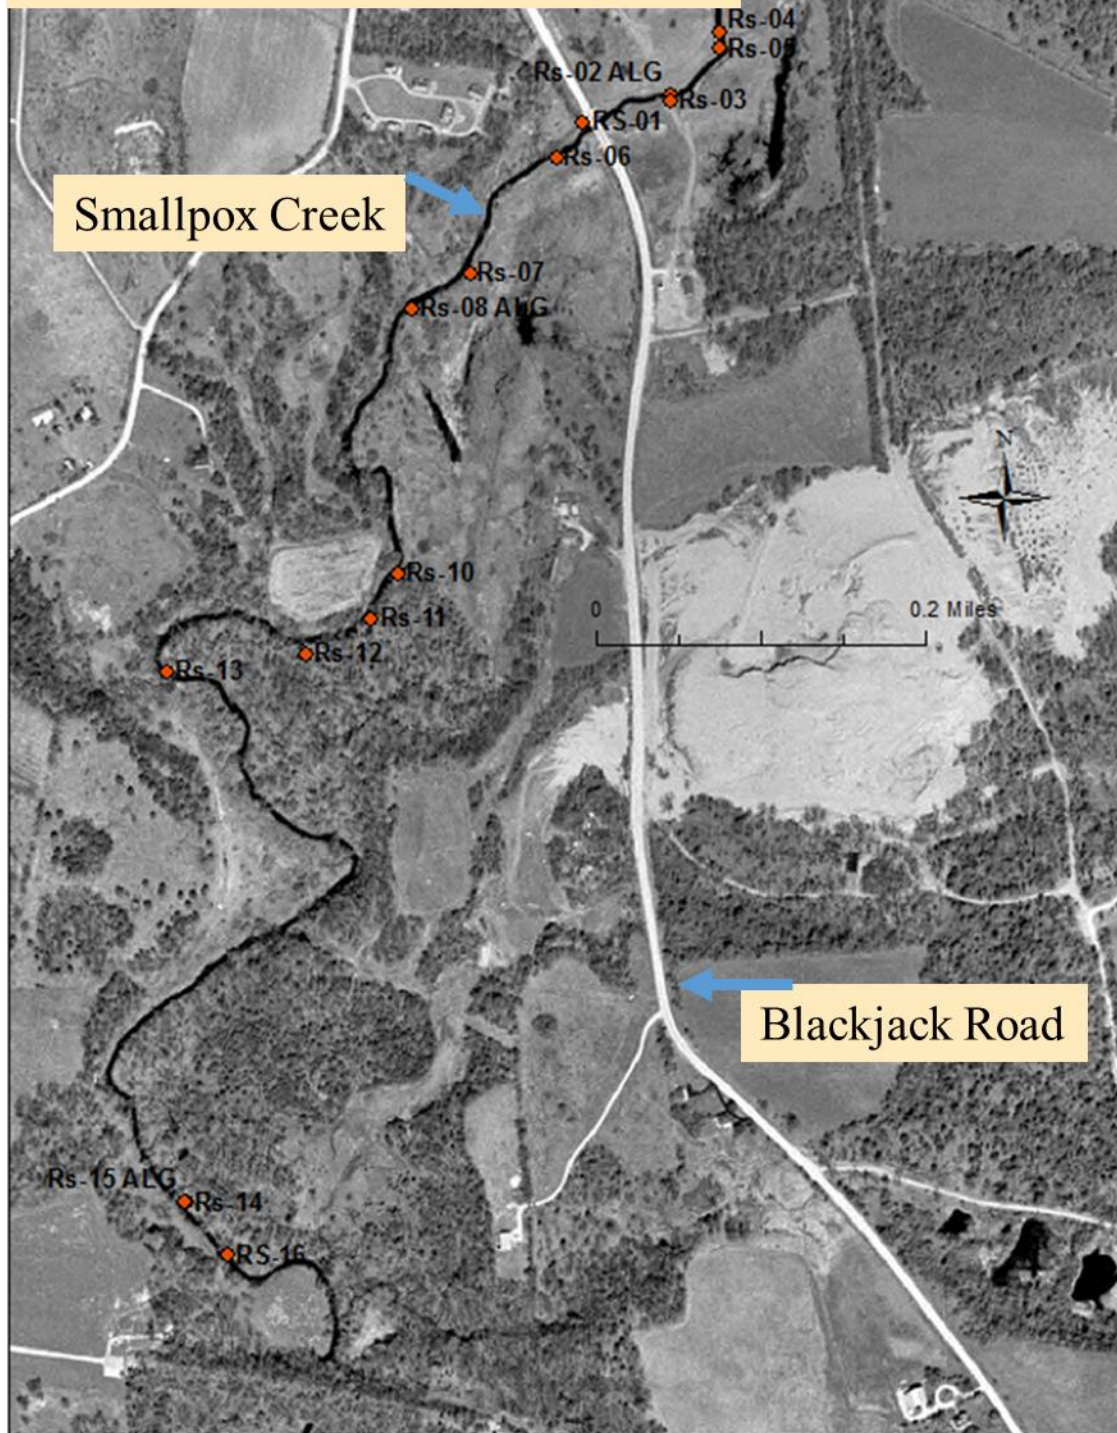
Figure 8: A map showing the locations of samples taken from the River Sediment bedload of Smallpox Creek

There were 15 samples collected from the outwash basin (Figure 8). There were originally 16 river sediment samples, but one had to be discarded because a GPS location was not collected for that location. One sample was above the TCR level for lead and 3 samples were above the COL. Three samples had levels above the TCR level for zinc and 6 samples had levels above COL for soils near a Superfund site. Overall the levels of lead and zinc within these soils were low (Figures 9 and 10). This is not surprising because all these samples are upstream of the confluence of the outwash basin with Smallpox Creek. Though there are certainly other potential sources of heavy metal pollution to Smallpox Creek, the outwash basin is the most likely and obvious source. Sample RS-16 is from the sediment bedload of Smallpox Creek and lies directly at the confluence of Smallpox Creek and the outwash basin. This sample has the highest level of lead for all of the river sediment samples as well as an elevated zinc level. Though this sample alone cannot verify that contamination from the outwash basin is entering Smallpox Creek, it certainly supports this hypothesis. More samples downstream of the confluence of the outwash area with Smallpox would need to be taken to make a more definitive claim on whether the outwash area was contaminating Smallpox Creek.

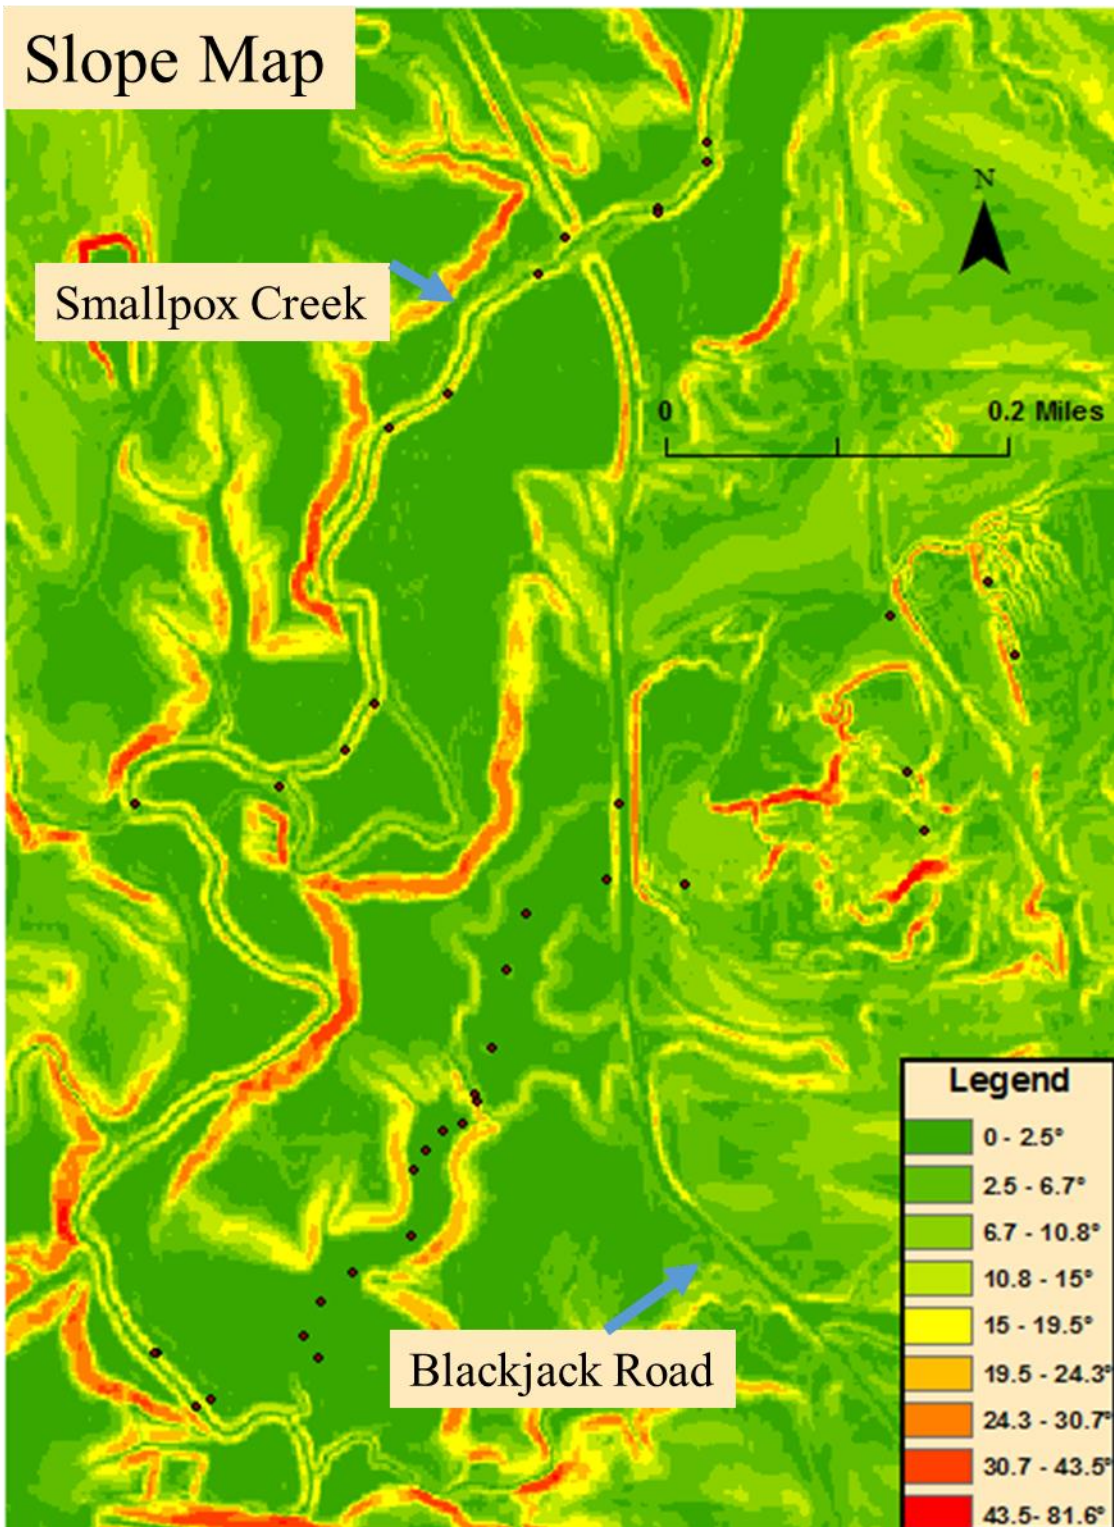
Figure 11: A slope map that shows the slope steepness of the site and surrounding landscape. Areas shaded green have the lowest slope while red areas have the steepest slope

A third, and most likely, hypothesis is that Smallpox Creek is cutting into and eroding bedrock from either the Platteville limestone or Galena dolomite. These are the same source rocks layers that were mined at Bautsch-Gray, the source of the mine tailings. These layers certainly have an abundance of sphalerite which could account for such high levels of zinc. Furthermore from looking at my field notes samples Rs-1, Rs-4 and Rs-11 all are described as gravel-sized sediment. These could very likely be sediment from the limestone and dolomite layers which are a source for sphalerite. Many of the river sediment samples that were described as clays had much lower heavy metal contamination. The slope map (Figure

11) is a GIS map that shows relatively flat areas in green while progressively steeper gradients shade from yellow into reds. This map shows a number of steep gradients located on or just upslope of the stream bank that could be sources of bedrock due to erosion or stream bank cutting. Once this rock is mass wasted into Smallpox Creek, fluvial and geomorphic dynamics likely cause gravel-sized sediments to congregate in certain particular areas while clays are segregated into other, likely slower flow, areas. This was observed in Smallpox Creek. For example, sample Rs-1, with 31,565 ppm of zinc was collected from a thick gravel-bar that rose above the surface of Smallpox Creek. Figures 12 and 13 are other types of GIS surficial maps which can provide insight into erosion and stream bank cutting.

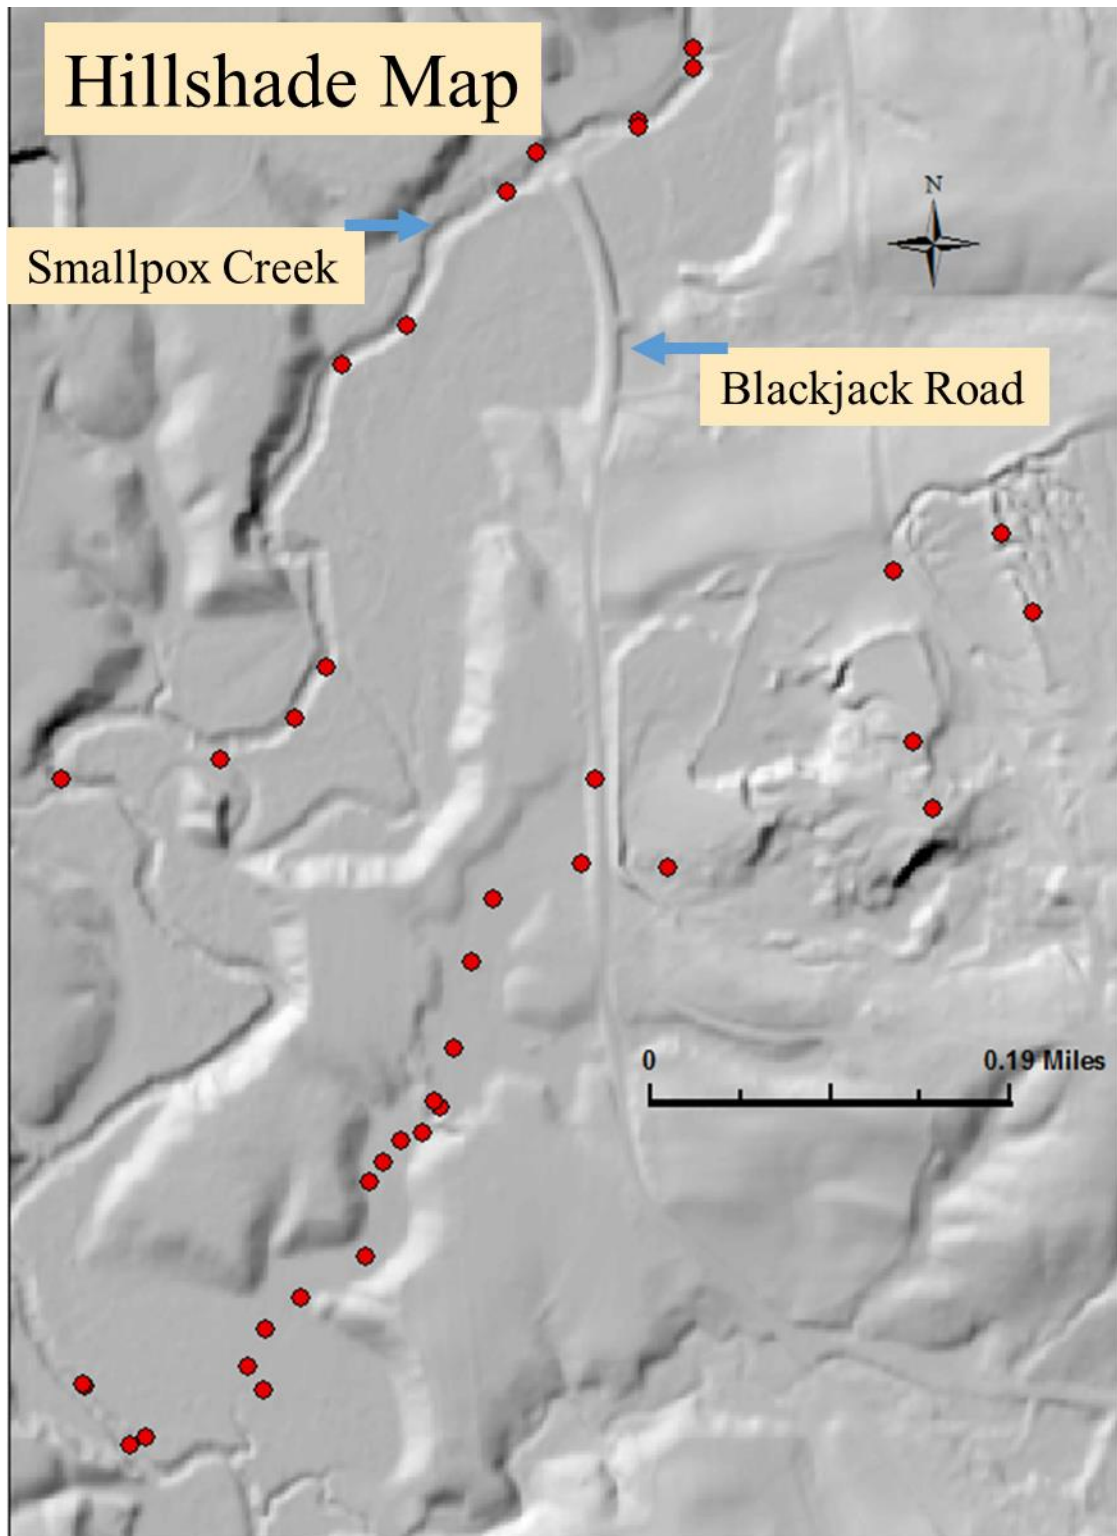
Figure 12: shows the study area's land surface as though an illumination source were shining on it. Similar to what would be seen from an aerial view if no vegetation were present.

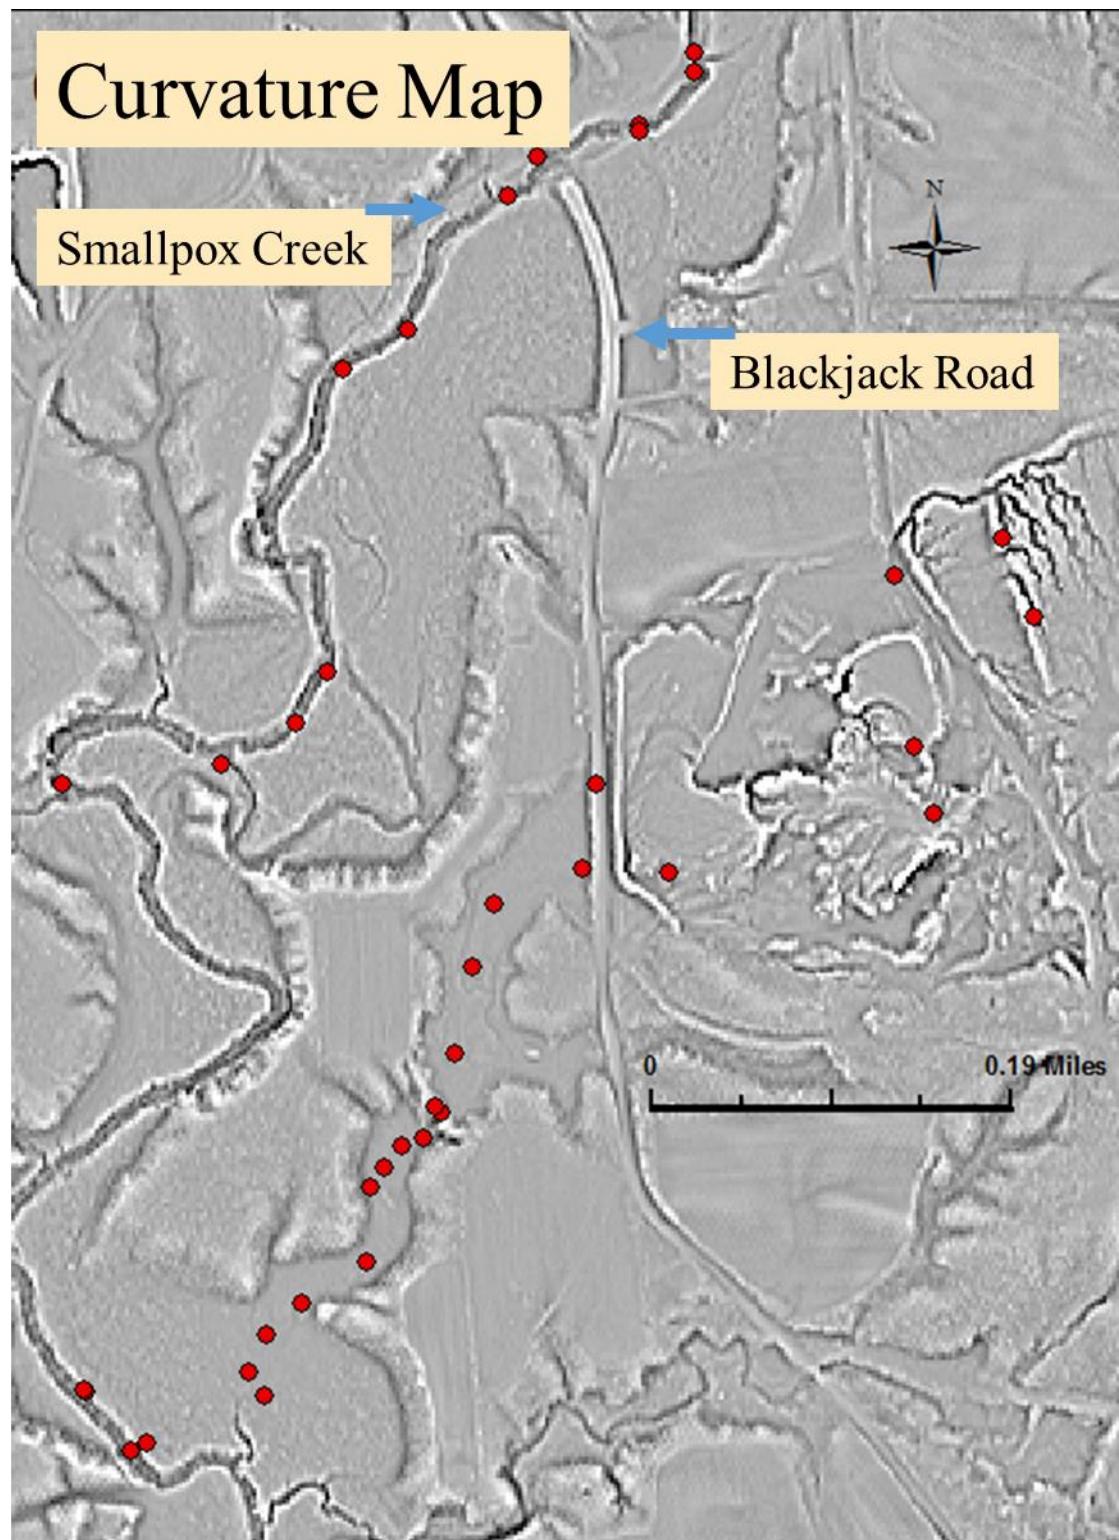
Figure 13: A curvature map which shows the slope over distance of the study area. This map can be thought of as the derivative of the slope map. This map shows fine details (such as rills) that often are not displayed on surface or hillshade maps.
