Complex Earth Slide-Flows in Glaciolacustrine Deposits Over the Past 100 Years in Jeffersonville, VT.

Leslie Kanat, George Springston and Adam Sevi

50th Annual Meeting of the NE GSA

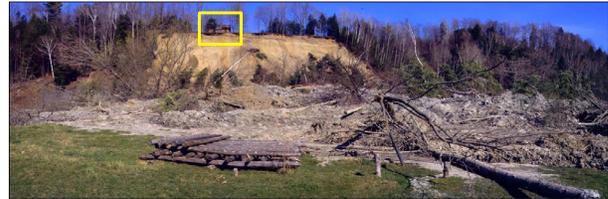
≈27,000 m³ displaced on 18 April 1999

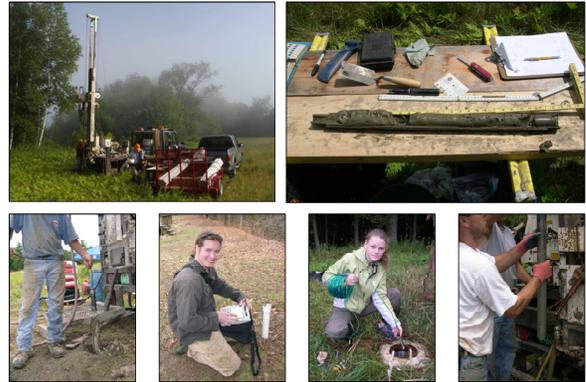
Stratigraphy was determined through field mapping, borehole analysis, and seismic profiling.

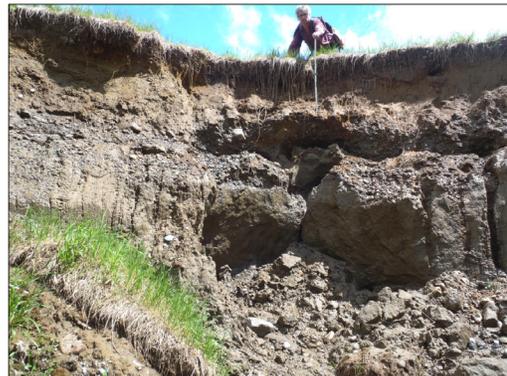
The terrace, Unit A, is capped by Holocene fluvial sands and gravel.

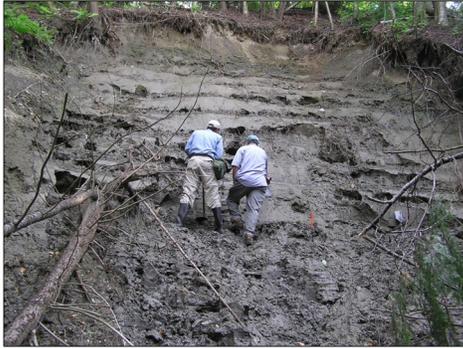
Late Pleistocene glaciolacustrine deposits of Unit B represented by 1.5-2.5 ft thick layers of fine sand separated by thin silty-clay layers (thick varves).

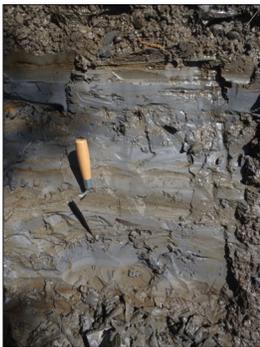
Late Pleistocene glaciolacustrine deposits of Unit C represented by stiff varves of fine sands and clayey-silt (brown), and silty-clay (grey) varves.

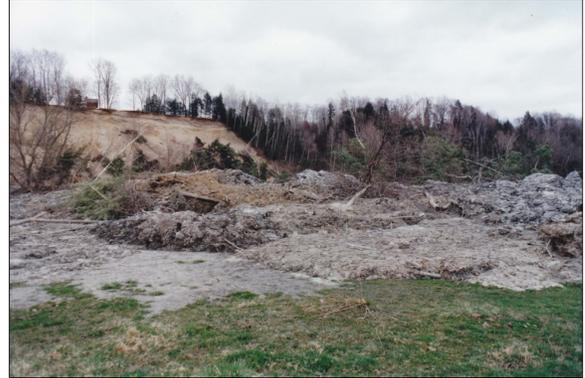
Complex earth slide-flows have a runout length ≈ 233 m, extending ≈ 110 m across the river; travel angle of 11.2°.

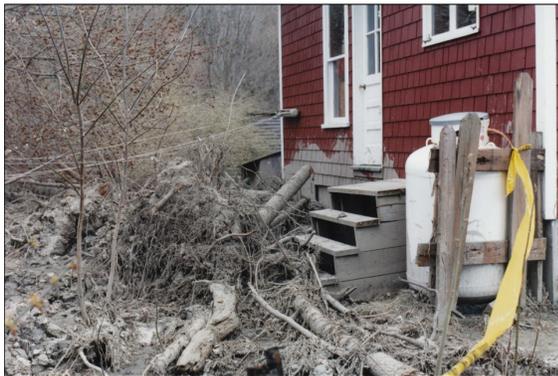
Debris impacted house at the southwest extent of the runout, near the elementary school.

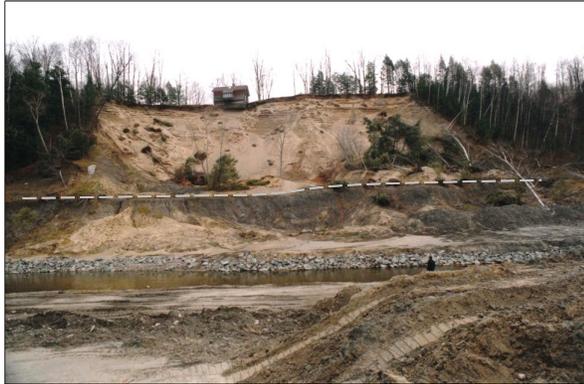
Rotational movement took advantage of a décollement zone defined by the top of the grey bench.
