* SHALLOW KARST DETECTION IN SOUTH CENTRAL TEXAS USING GROUND PENETRATING RADAR

Evelynn J. Mitchell*, Harold S. Campbell, and Gamaliel O. Rodriguez Department of Physics and Environmental Sciences, St. Mary's University, San Antonio, TX emitchell1@stmarytx.edu

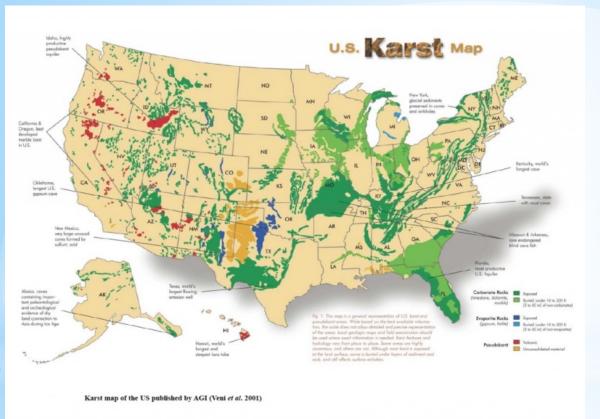
Figure taken from Wheeler et al. (2001)

*San Antonio and the Hill Country to the north of the city are well known karst areas.

- * Austin Chalk Outcrops to the west of town
- * Glenrose Limestone Outcrops in much of the Hill Country north of San Antonio

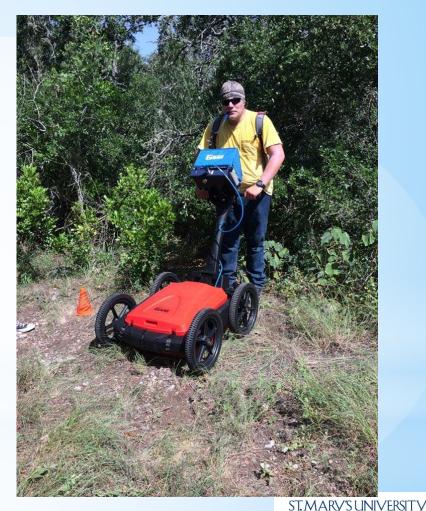
*GSSI 270 MHz Unit

*SIR 3000 Interface

- *Dielectric Constant ranged from 11.71 to 23.4 due to different soil conditions
 - *Moisture

*Clay

*Range of 75 to 175 ns depending on desired depth.

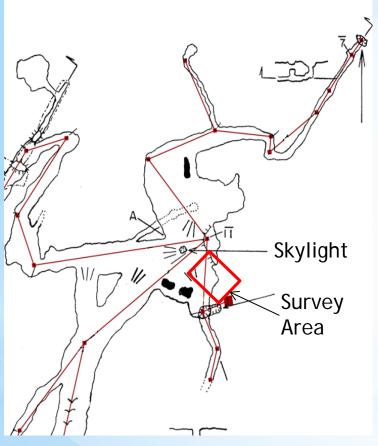
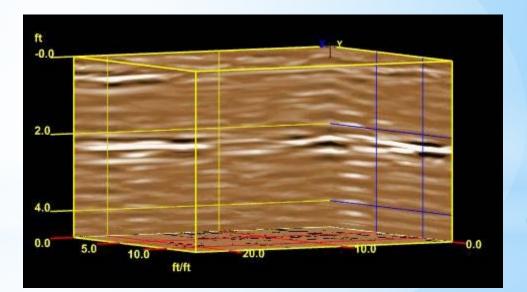
Wurzbach Bat Cave

- *Range 75 ns
- *Dielectric Constant 23.4
- *Saw the ceiling of the cave at approximately 1m depth

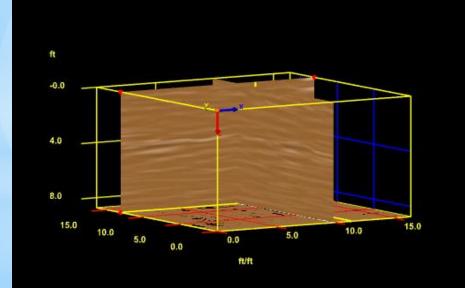
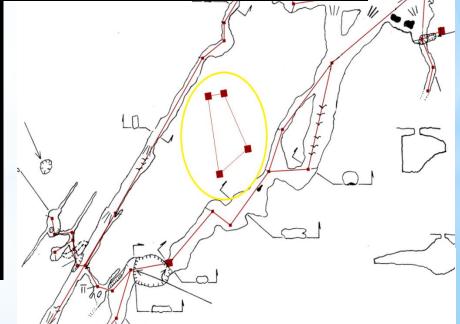
* A second site at Wurzbach Bat Cave was chosen to analyze, but the survey results were confusing.

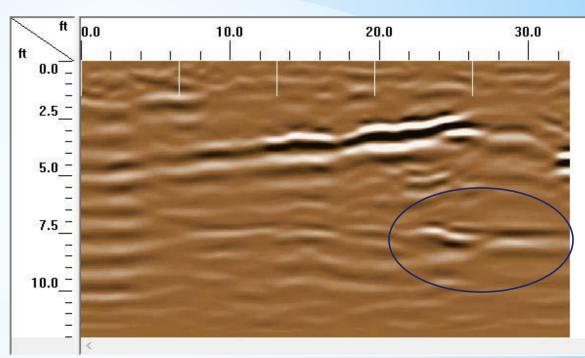
- *First test in the Glen Rose Limestone
- * Joe's Diet Hole, a small shaft to a room about 7.5 feet below the ground
- *Survey was run past the hole and picked up a feature at 7.5 feet

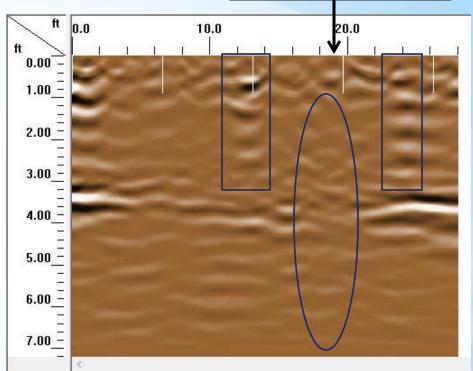
Entrance Fissure to Wong's Wrong Hole

- * The area near a fissure sinkhole was surveyed
 - * Showed a set of signals equidistant from the line of the fracture
 - * Soil fill seems to break through a stratigraphic layer at about 4 feet deep
- * When survey was attempted during wet conditions:
 - * No surface features were detected
 - * The layer at 4 feet was undetectable

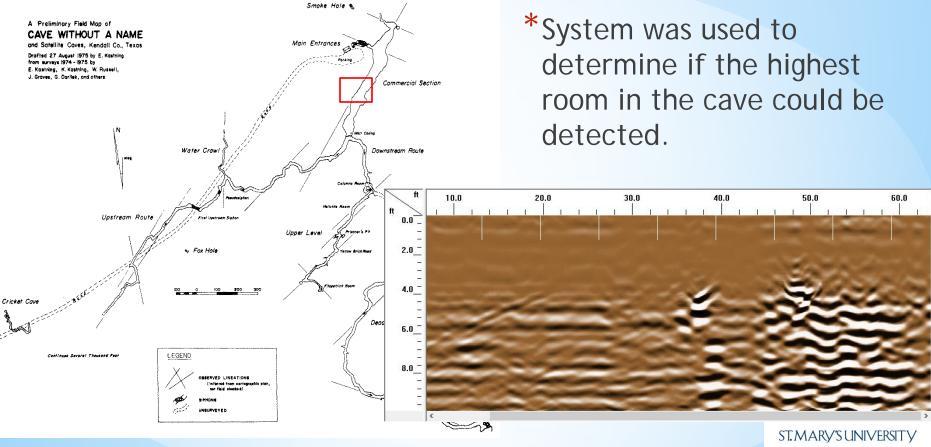
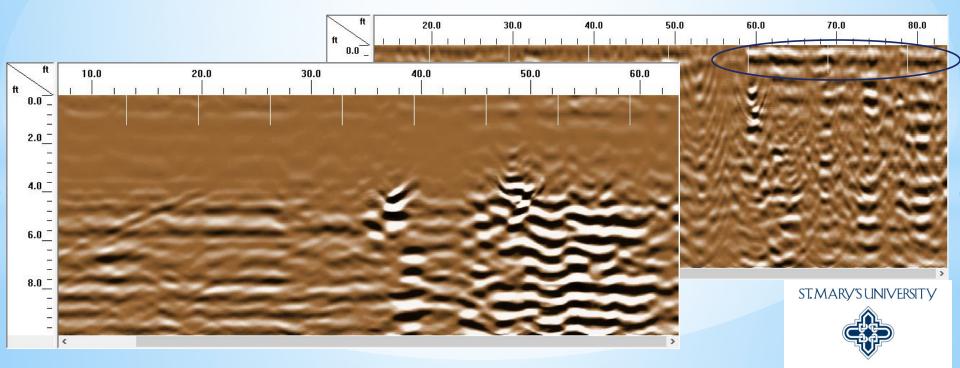
*In Dry conditions, large voids were easy to detect, but the saturation of surface soils made it a challenge in saturated conditions.

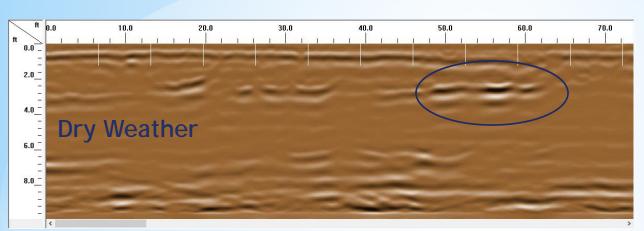
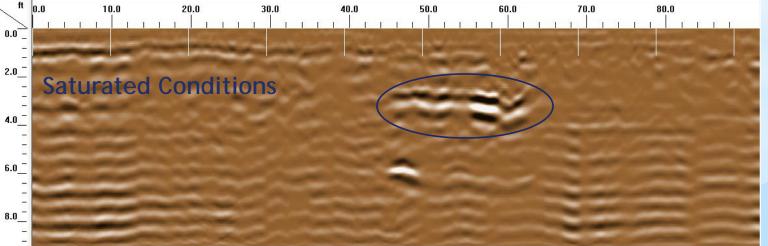
*Range - 75 ns
*Dielectric Constant -11.17 dry, 13.54 wet
*Obvious layering in the top image, but not as obvious in wet
**Obvious in wet

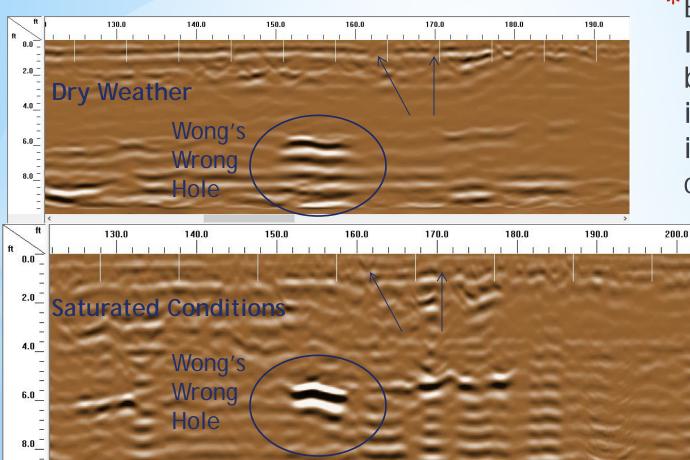
*Breakages in layering seem to be linked to increased signal in saturated conditions

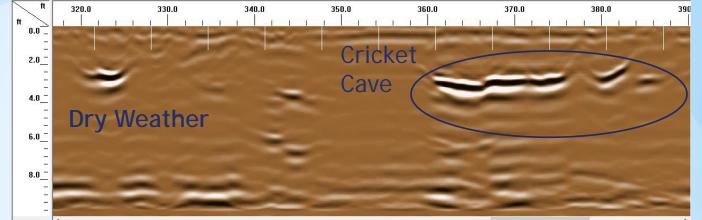
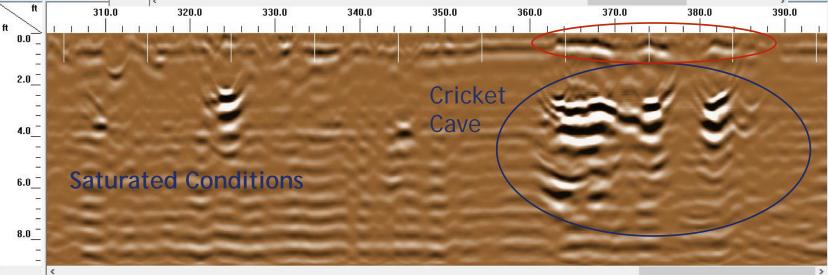
*Continuous layer appears to show pathways when saturated
