# The Use of Lichenometry for Assessment of the Destruction and Reconstruction of Buddhist Sacred Walls in Langtang Valley, Nepal Himalaya, following the 2015 Gorkha Earthquake

Steven H. Emerman (Email: StevenE@uvu.edu), Department of Earth Science, Utah Valley University, Orem, Utah 84058, USA

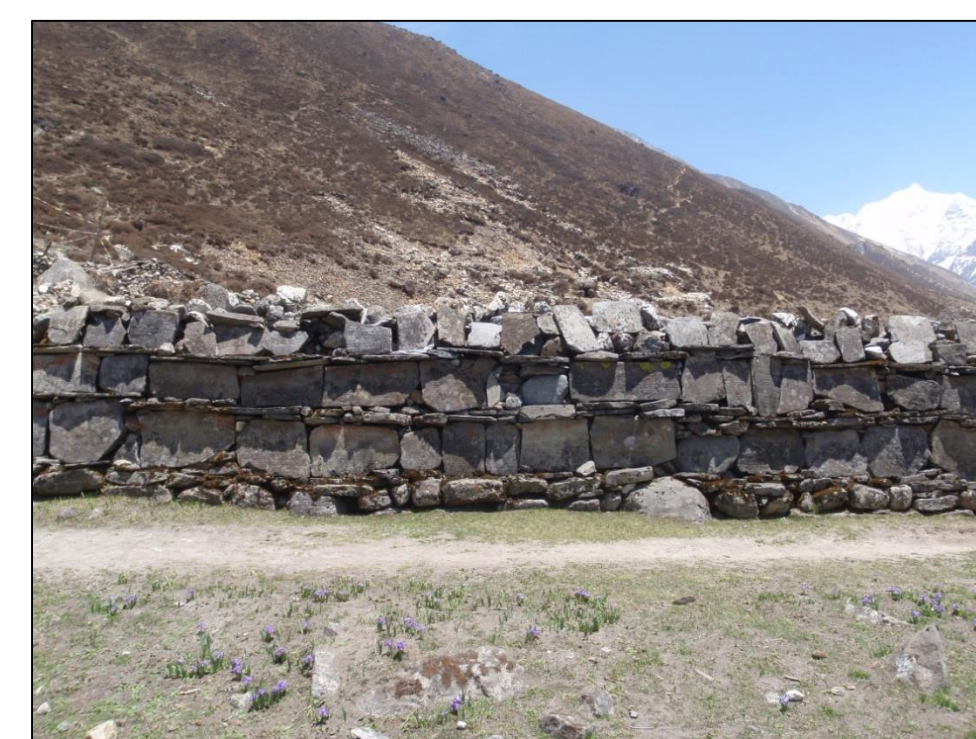
**Fig. 1** Buddhist sacred walls, called mani walls, are common in Langtang Valley (Nepal Himalaya) and especially between the site of the former Langtang Village and Kyanjin Gumpa. This mani wall is adjacent to the monastery in Kyanjin Gumpa (Mani Wall No. 80). The mani wall suffered no apparent damage from the 2015 Gorkha earthquake, although the monastery was heavily damaged.

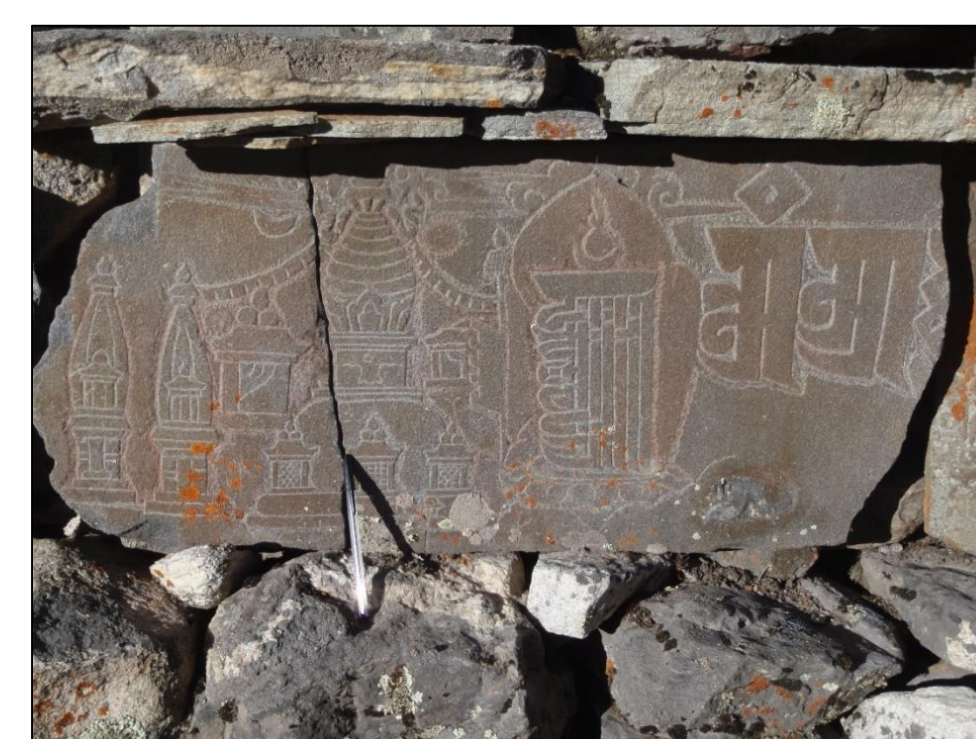
**Fig. 3** Many of the mani wall blocks include carved imagery (Mani Wall No. 80, Fig. 1). Note that the apparent jagged edges of the block are simply shadows.

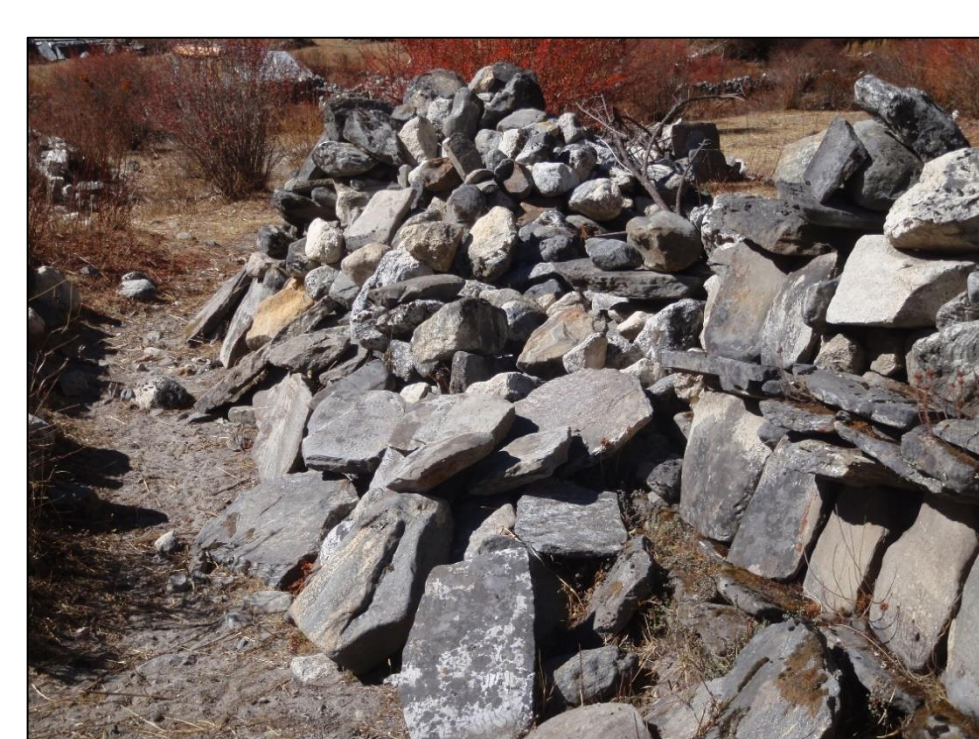
**Fig. 6** Mani Wall No. 64 was classified as "severely damaged" because it was not obvious how to reassemble the fallen blocks. The largest lichen found in 2015 (49.05 mm) was much larger than the largest lichen found in 2014 (22.82 mm) and was not the same lichen. Most likely, the earthquake damage exposed a larger lichen on an interior block.

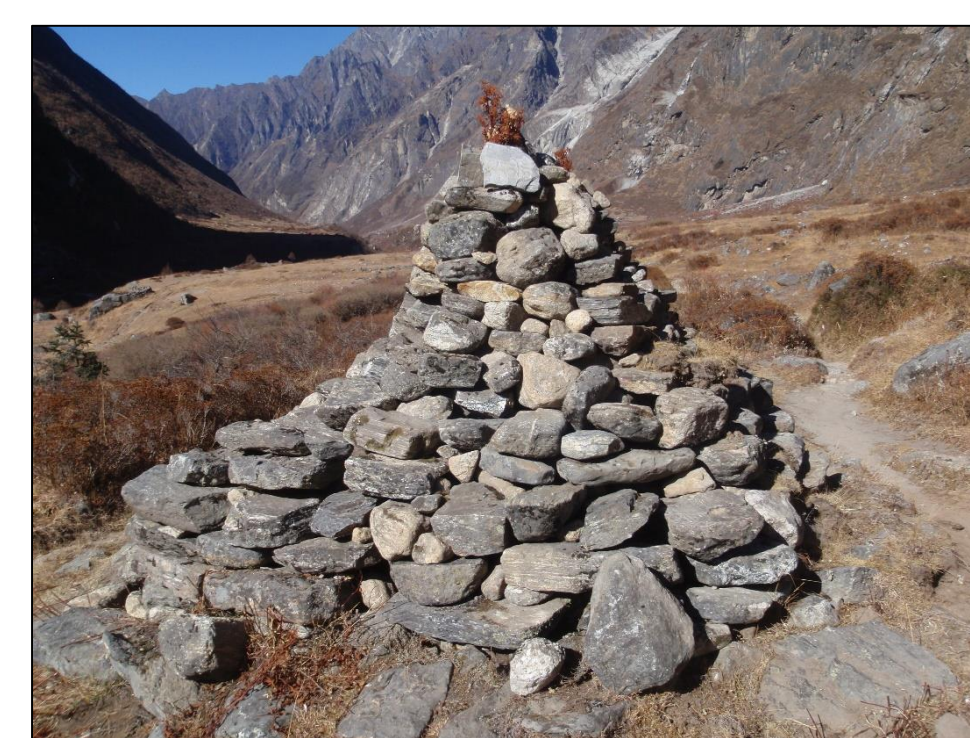
**Fig. 7a** Mani Wall No. 77 was mapped in 2009 and 2014, but could not be located in 2015. In its place stood a conical structure (called a chorten) that had been apparently constructed out of the scattered blocks.

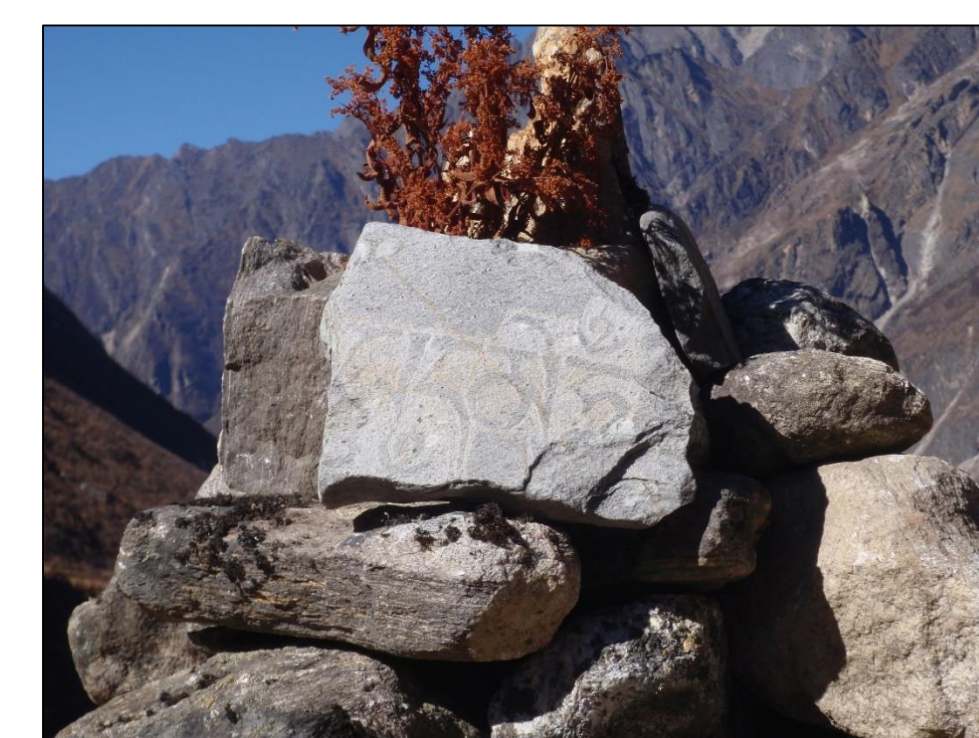
**Fig. 7b** This is a close-up of Fig. 7a. The broken block with carved Tibetan letters on the top of the chorten was probably a remnant of Mani Wall No. 77.

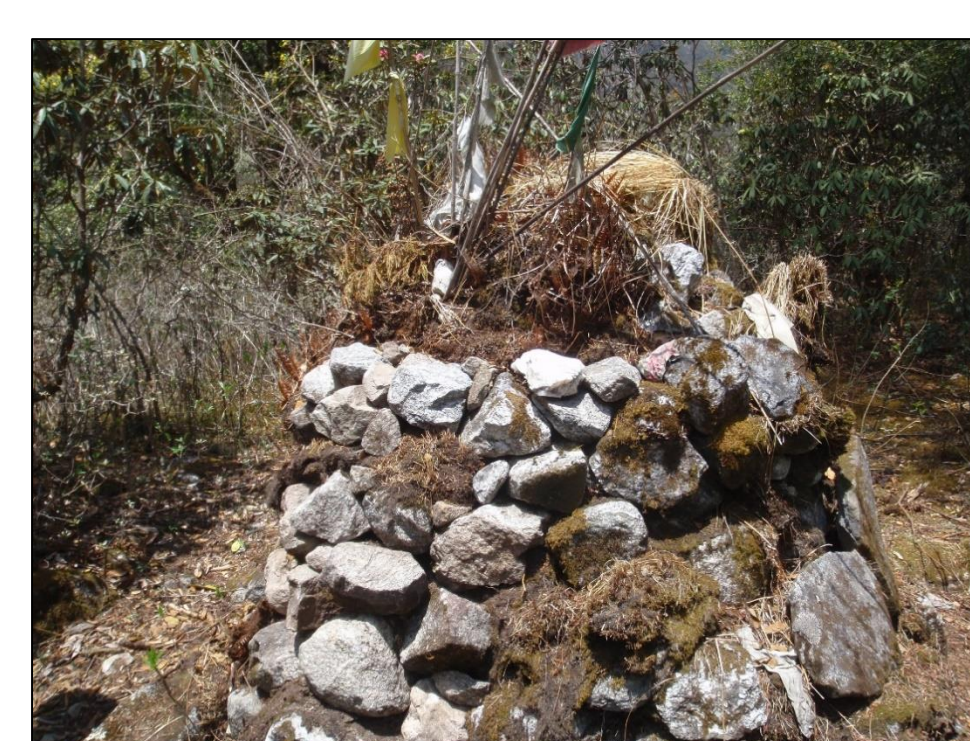
**Fig. 8a** The appearance of Mani Wall No. 4 near Ghoratabela, as seen in 2014, was consistent with the oral tradition that this was the original mani wall (constructed 400-600 years ago) and had never been cleaned.

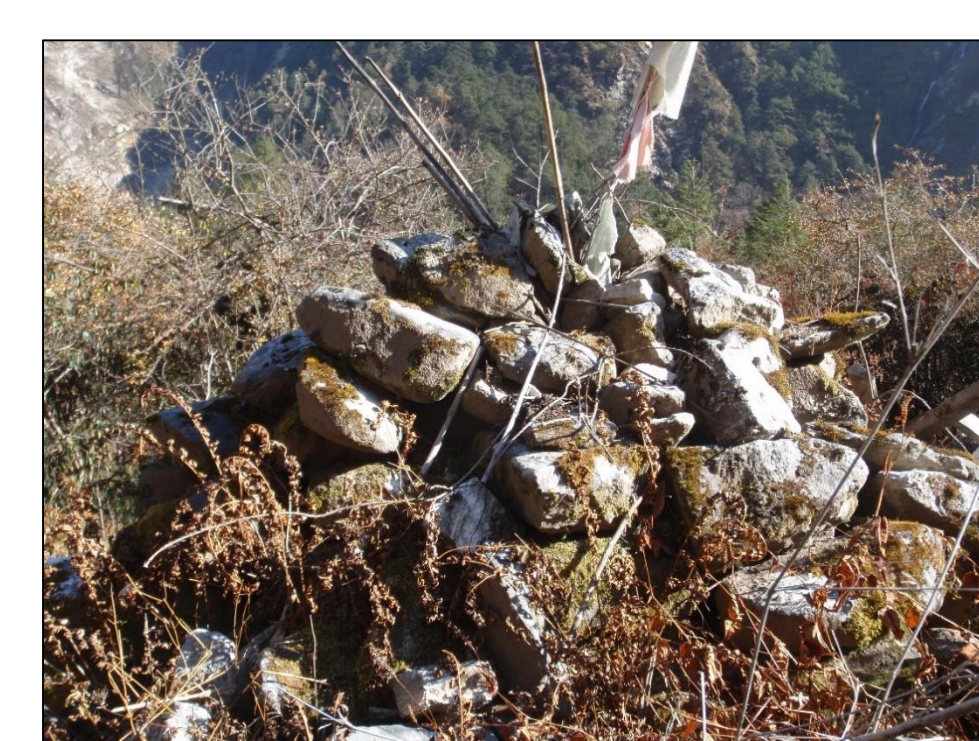
**Fig. 8b** Mani Wall No. 4 (Fig. 8a) could not be located in 2015. However, Mani Wall No. 5 with a similar appearance was found in 2015 and was also referred to as the original mani wall by local informants.

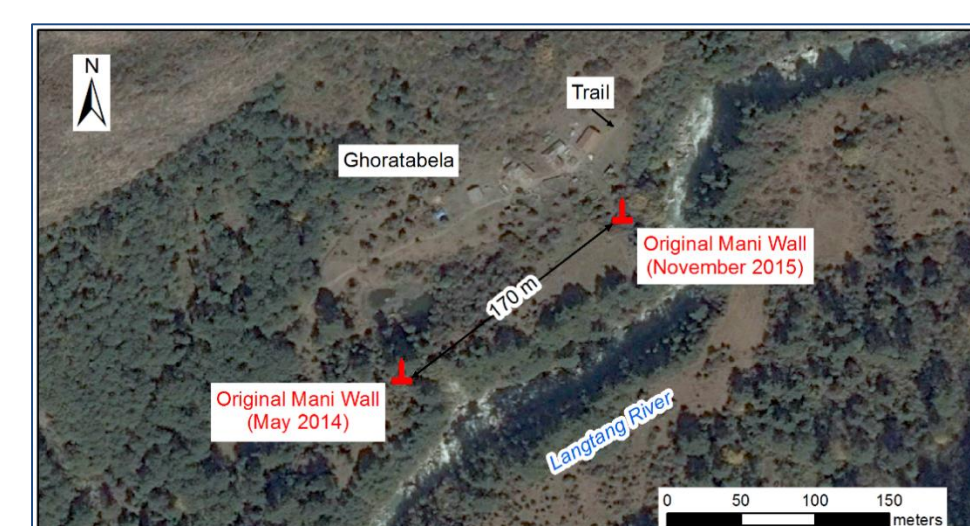
**Fig. 9** The original mani wall was apparently rebuilt 170 m to the northeast and closer to the trail that passes through Ghoratabela. The background aerial photo is a Google Earth image dated November 8, 2014 (before the 2015 Gorkha earthquake). In November 2015 all buildings in Ghoratabela were still heavily damaged and there were no residents.

- 1) The structure that had been called the original mani wall by pre-earthquake informants could no longer be located. After the earthquake, a structure with a similar, but not identical, appearance was found 170 m from the previous original mani wall and was referred to as the original mani wall by post-earthquake informants.

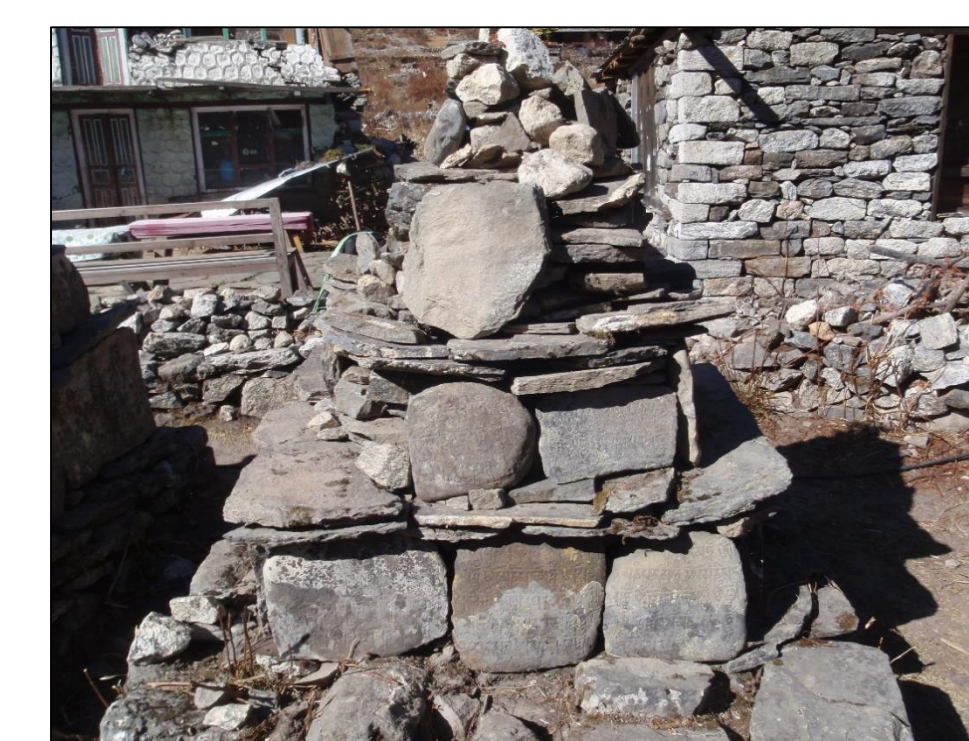
**Fig. 10** Although Mani Wall No. 53 had no apparent damage, the largest lichen in 2015 was 43.42 mm, although no lichens were present in 2009 or 2014. The most likely explanation is that the mani wall had already been reconstructed in such a way that a formerly interior block was placed on the exterior of the mani wall. The mani wall was in the village of Mundu (Fig. 5), which was inhabited at the time of the 2015 fieldwork (note house in background).

The most challenging observation is the existence of five mani walls on which the largest *R. geographicum* in 2015 was not even present during any previous fieldwork. Two of the mani walls were severely damaged, but the other three appeared to have suffered no damage at all (Figs. 6, 10-12). Where did these previously unseen lichens and the mani wall blocks that hosted them come from? The only plausible explanation for the post-earthquake appearance of previously unseen lichens is that mani wall blocks that were formerly interior blocks were present on the exterior. All of the previously unseen lichens were heavily bleached with a strong color contrast from white to pale yellow (Fig. 13), as opposed to the bright yellowish-green of healthy *R. geographicum* (Fig. 14). These lichen colors were consistent with a previous history as an interior block, where only diffuse light with a strong spatial heterogeneity of light intensity would be present. The three apparently reconstructed mani walls were all within 195 m of one another in the village of Mundu (note the houses in the background of Figs. 10 and 12). At the time of the fieldwork, aside from yak-herders living in temporary dwellings above Ghoratabela, Mundu was the only inhabited village in Langtang Valley between Rimche and Kyanjin Gumpa (Fig. 5), as all other villages were heavily damaged and still abandoned. It seems reasonable that an inhabited village would be one of the first places where mani walls would be reconstructed.

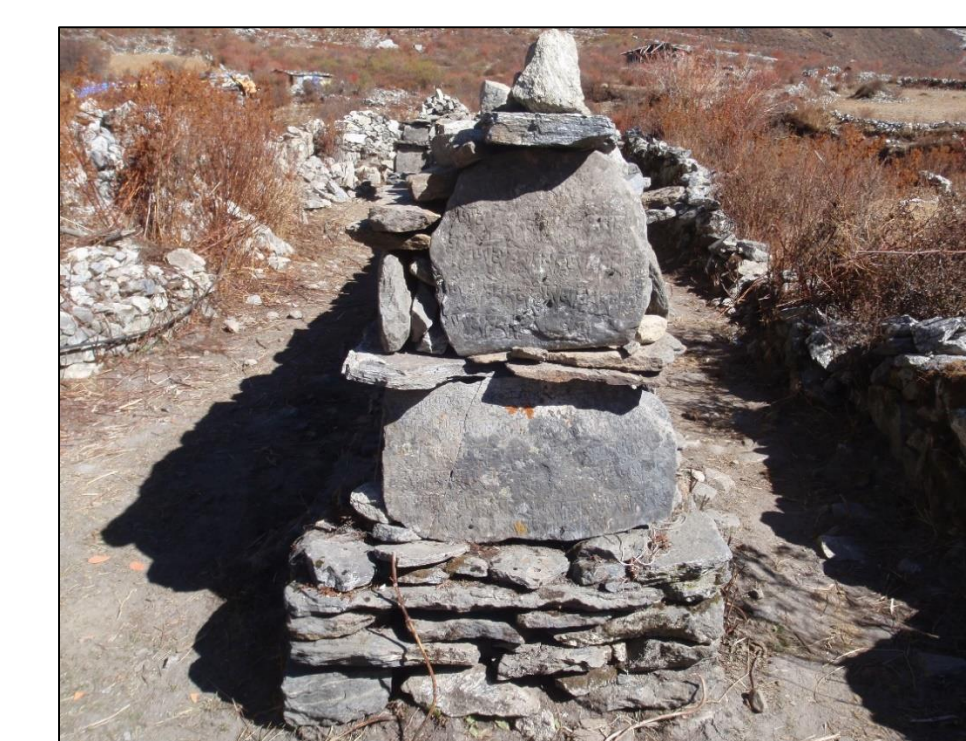
**Fig. 11** Although Mani Wall No. 54 had no apparent damage, the largest lichen in 2015 was 37.80 mm, although no lichens were present in 2009 or 2014. The most likely explanation is that the mani wall had already been reconstructed in such a way that a formerly interior block was placed on the exterior of the mani wall. The mani wall was in the village of Mundu (Fig. 5), which was inhabited at the time of the 2015 fieldwork. Mani Wall No. 54 is only 9 m east of Mani Wall No. 53 (Fig. 10).

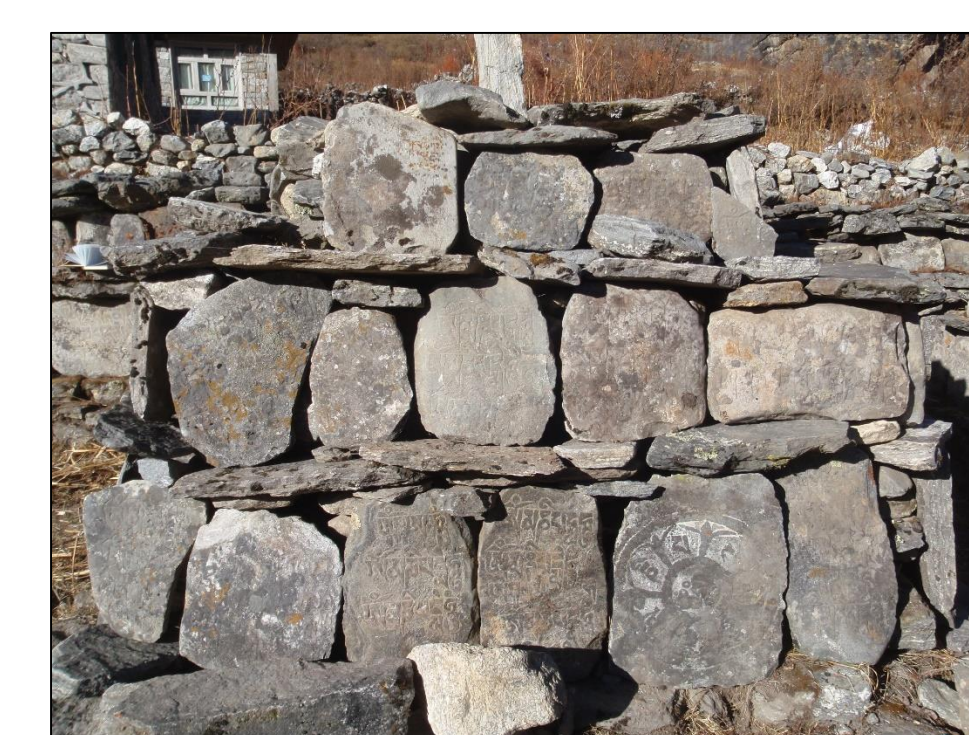
**Fig. 12** Although Mani Wall No. 44 had no apparent damage, the largest lichen in 2015 was 38.28 mm, although no lichens were present in 2009 or 2014. The most likely explanation is that the mani wall had already been reconstructed in such a way that a formerly interior block was placed on the exterior of the mani wall. The mani wall was in the village of Mundu (Fig. 5), which was inhabited at the time of the 2015 fieldwork (note house in background). The three reconstructed mani walls (Nos. 44, 53, 54) are within 195 m of one another.

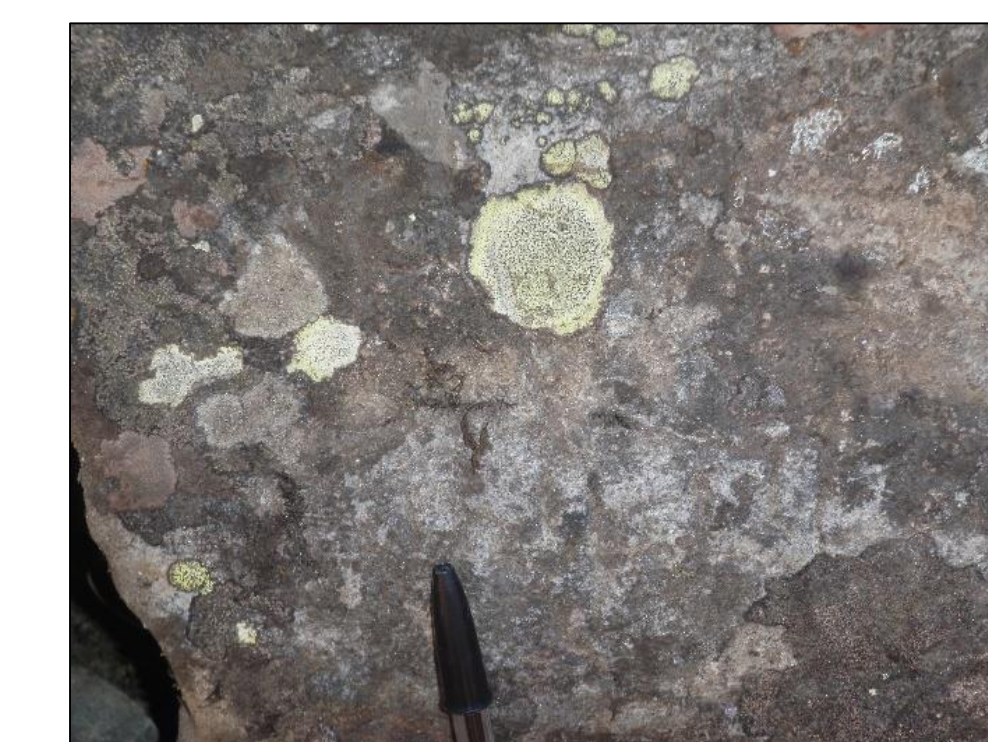
**Fig. 13** The lichens found on Mani Wall No. 54 (Fig. 11) were heavily bleached with a strong color contrast from white to pale yellow, as opposed to the bright yellowish-green of healthy *Rhizocarpon geographicum* (Fig. 14). The lichen colors were consistent with a previous history as an interior block, where only diffuse light with a strong spatial heterogeneity of light intensity would be present.

- 2) Three apparently undamaged mani walls in a single inhabited village were hosting previously unseen *R. geographicum* individuals. The exterior blocks that hosted these lichens must have previously been interior blocks, which was consistent with the bleached appearance of the lichens.

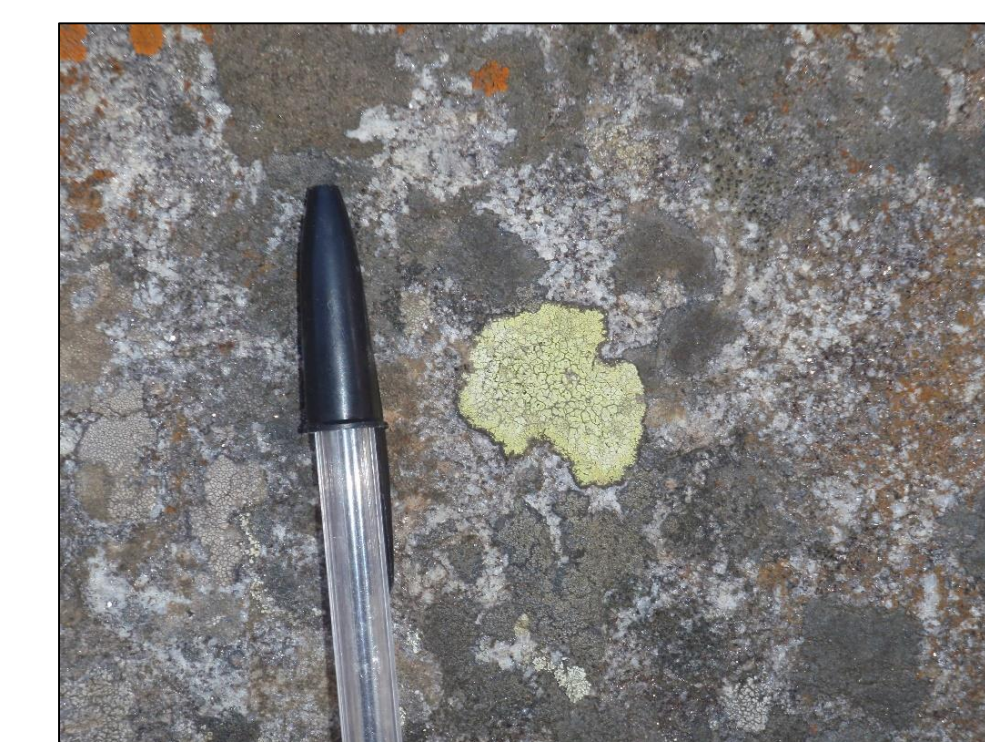
**Fig. 14** Healthy *Rhizocarpon geographicum* with bright yellowish-green color were found growing on Mani Wall No. 49, indicating that the host block was an exterior block with exposure to full sunlight both before and after the 2015 earthquake.
