Five Years After the Flood: Analysis of a river twice “restored” in the Deerfield Watershed

Stephen C. Lukas, John D. Gartner, Christine E. Hatch, Isaac J. Larsen
Geosciences, University of Massachusetts, Amherst, MA
slukas@umass.edu jgartner@umass.edu

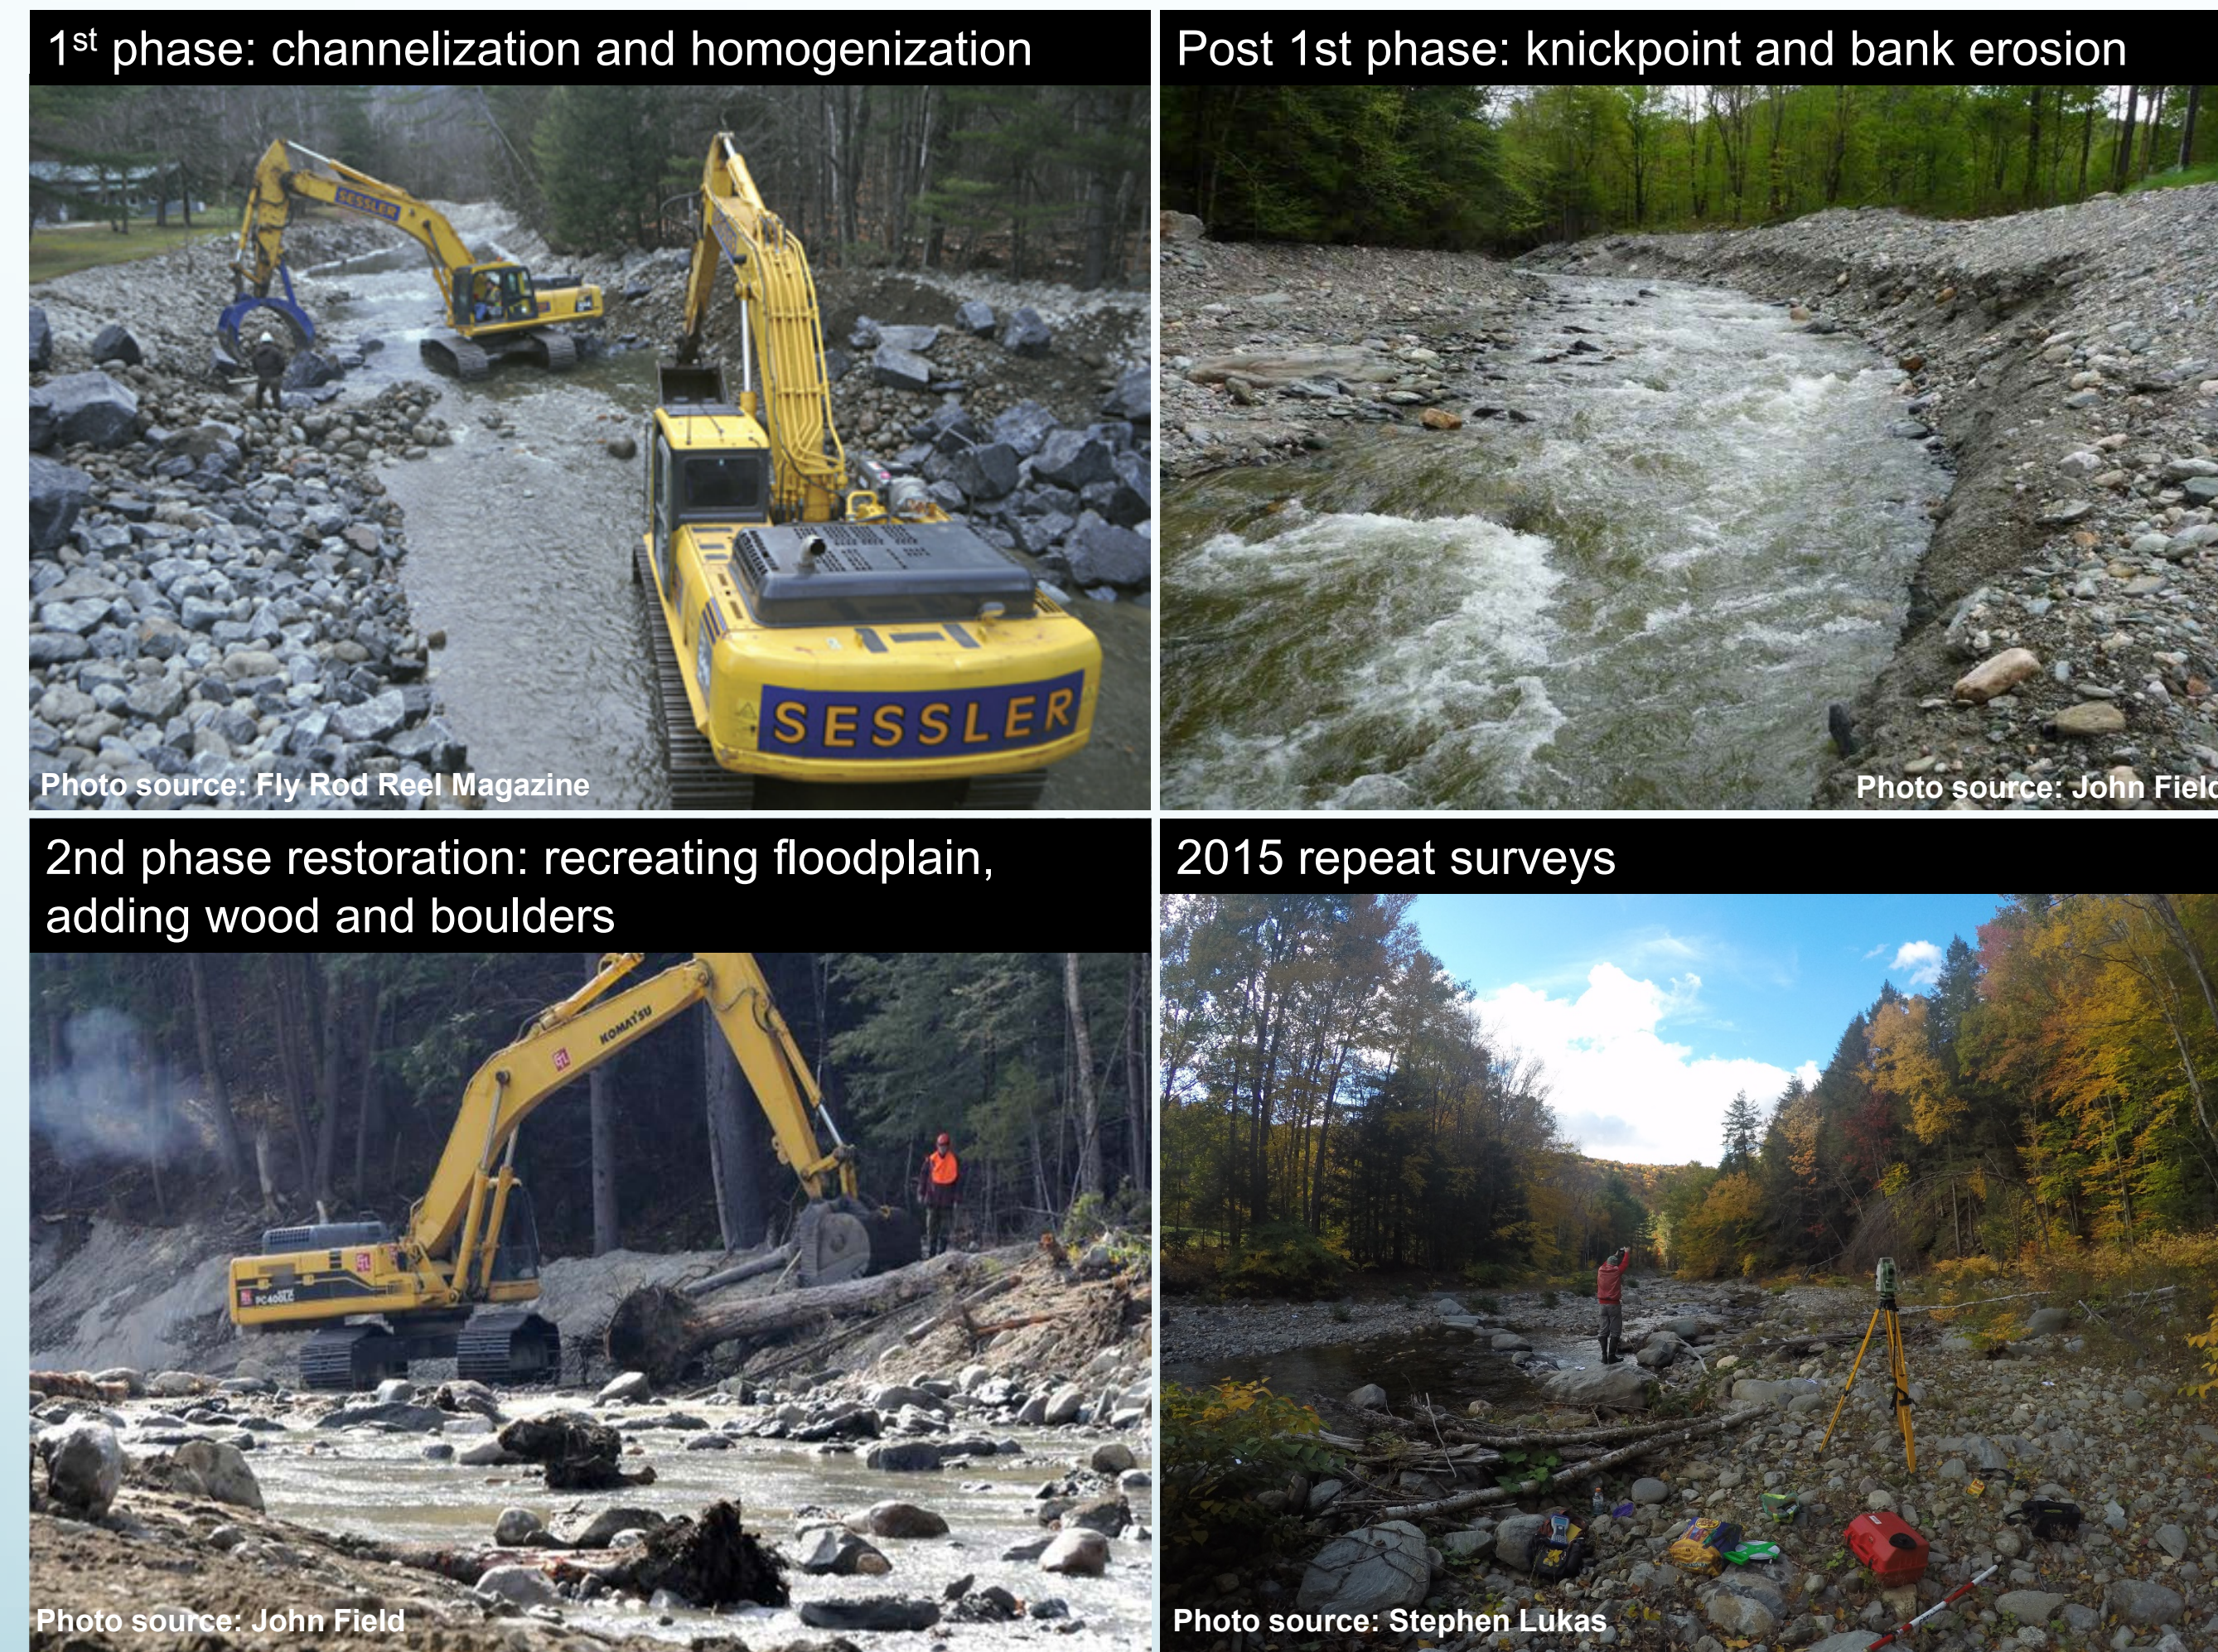
2011: Irene Flood: The Chickley River in the Berkshire Mountains of MA experienced extreme flooding during Tropical Storm Irene, causing landslides, bank failures, channel migration, stripping of riparian vegetation, and woody debris.

2011: 1st phase of human response: A desire to restore the channel and mitigate future flood effects led to channelization and homogenization of the river, focused on 8 km of river. This included (1) removal of logjams, (2) moving the channel back to the pre-flood locations, (3) armoring stream banks, and (4) removing riparian vegetation, bed forms, large rocks, and woody debris. Mass DEP halted the work, citing violation of Clean Water Act and Wetland Protection Act.

2012: 2nd phase of human response: A “natural channel design” approach was taken to undo the negative effects of the 1st phase, including riparian planting, large woody debris emplacement, large rock placement, and grading the channel.

2011 channelization: ● migrating knickpoints and bank failures indicate that channel was **not stable** (see Figure in introduction).

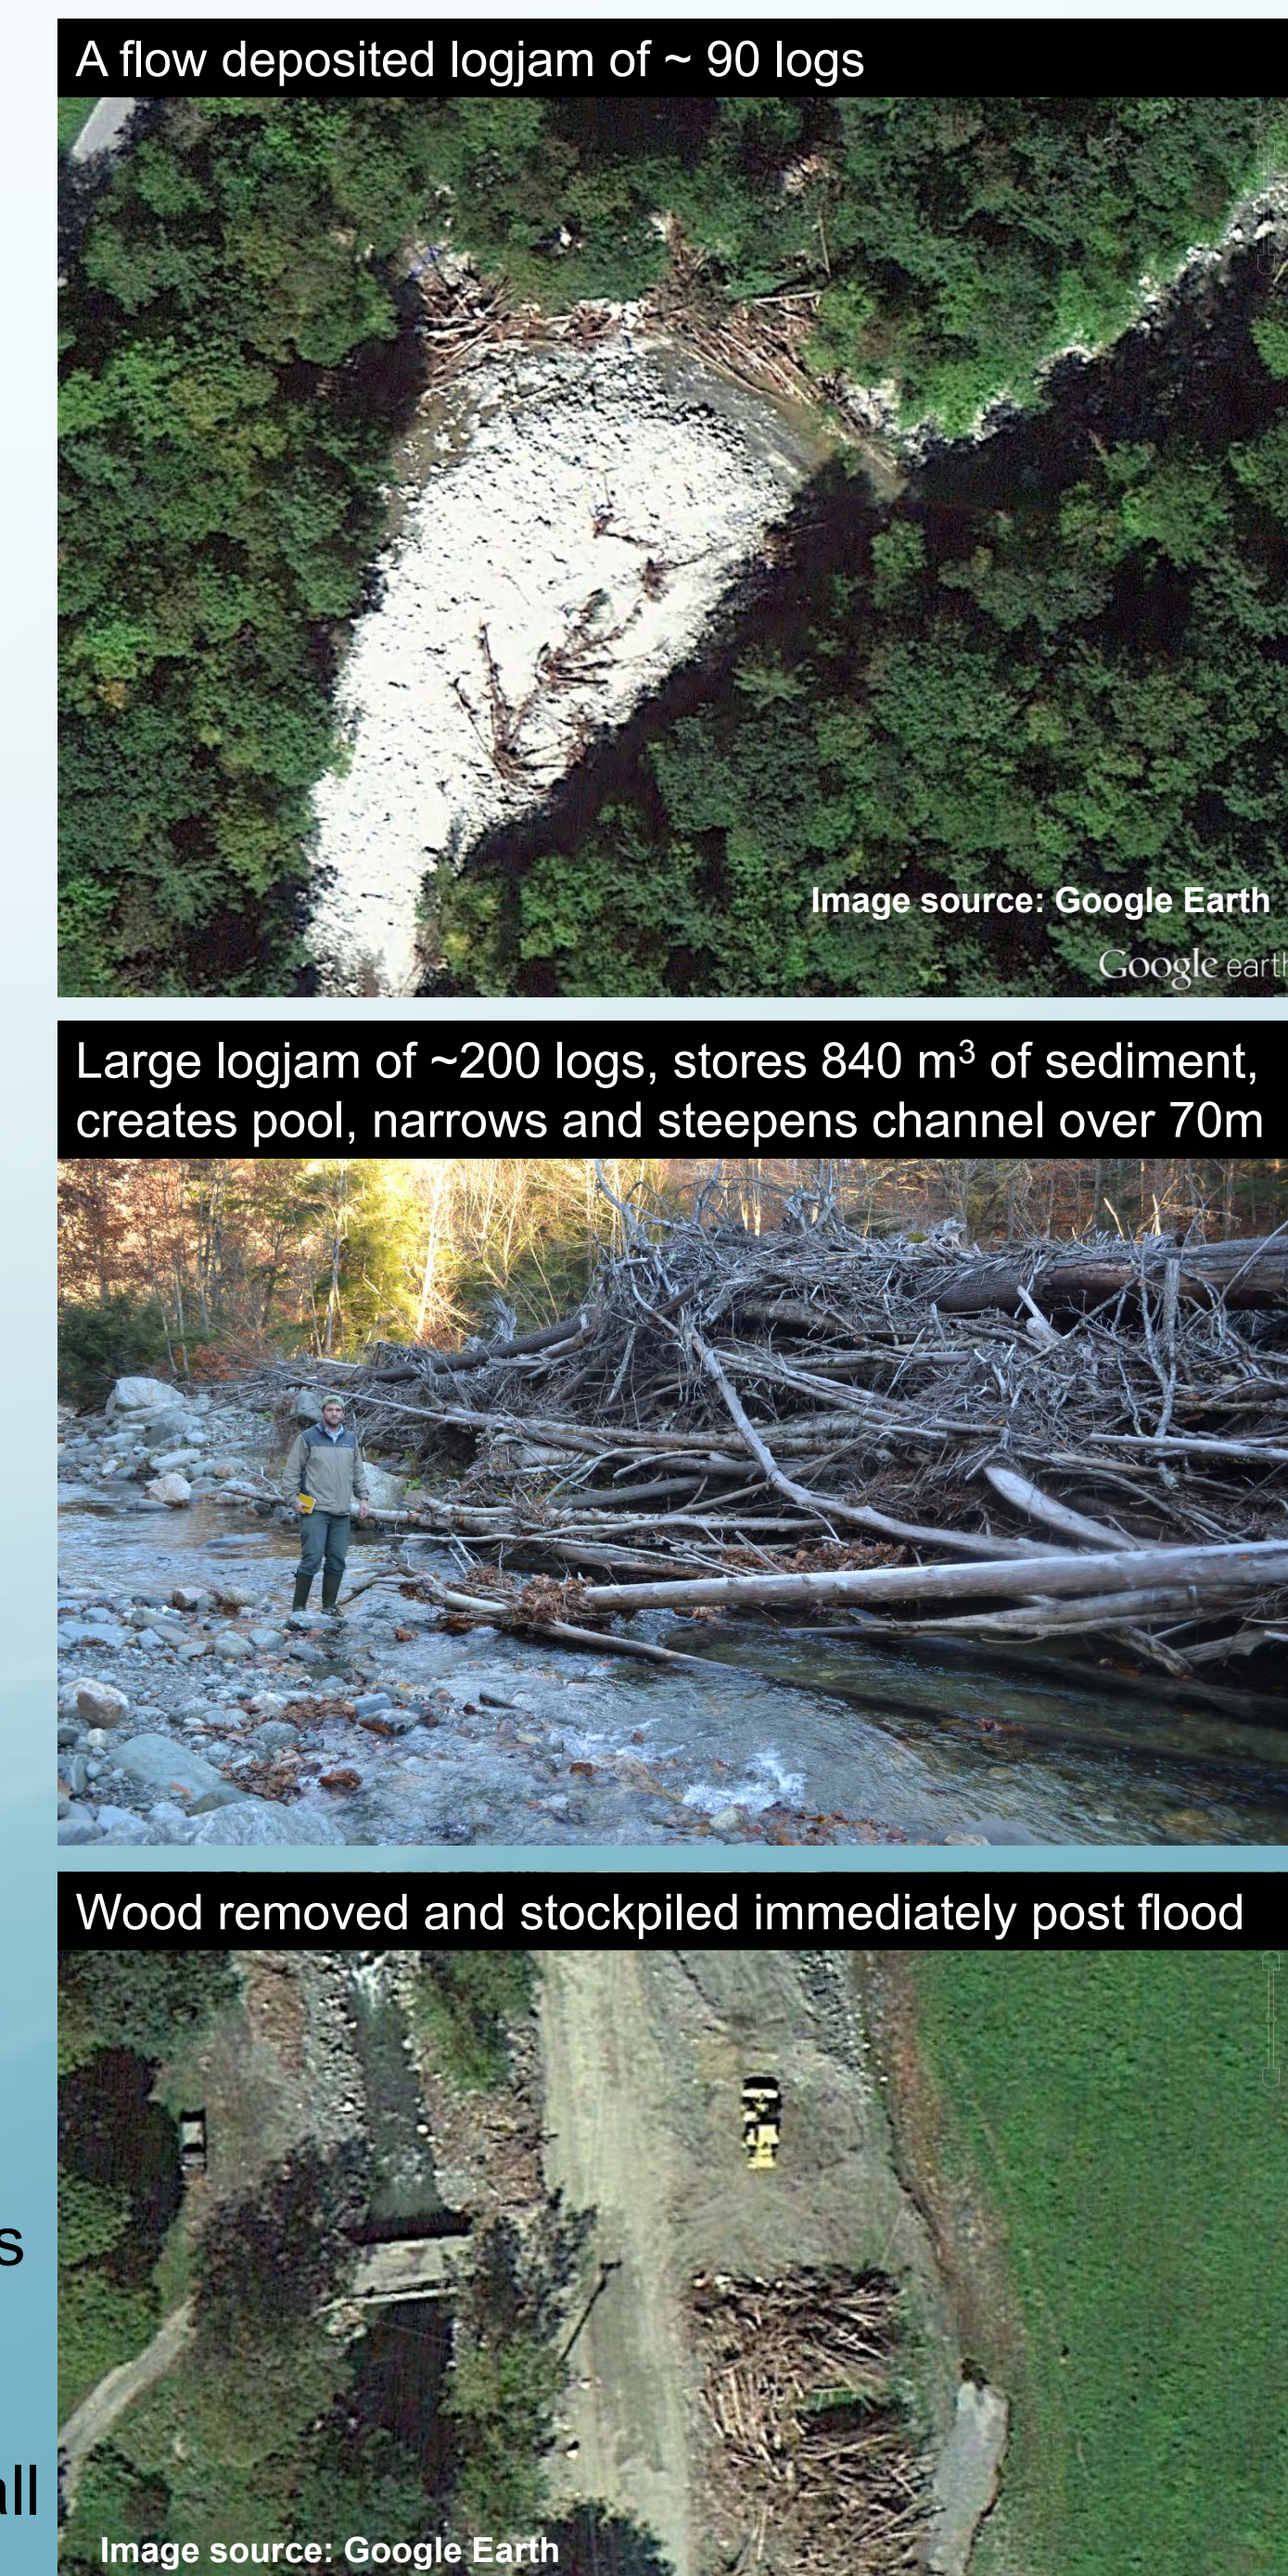
- Unexpected observation of many very large logjams (>25 logs)
- 1.2 logjams per km (14 total along Chickley)
- Frequency is consistent with expanded survey across Deerfield watershed
- 17 % at toe of landslides (@ 2 of 11 total landslides along 12 km reach)
- 83 % deposited by flowing water (all at river bends)
- Geomorphic effect locally: sediment storage, redirected flow, narrowed channel, increased local channel slope, created pools
- Sediment storage minor compared to sediment export during Irene

2011 channelization (1st phase response): removed or depleted 75 % of logjams and 100% of woody debris in channel over 8 km of focused work

2012 restoration (2nd phase): installed 1 large logjam (> 25 logs) and many small engineered logjams of 1-5 logs (up to 25 small logjams per km)
