Contemporary Forest Management and Mass Wasting: Making Significant Progress.

Factors contributing to declining shallow landslide erosion rates on managed timberlands in Northern California:

Abstract

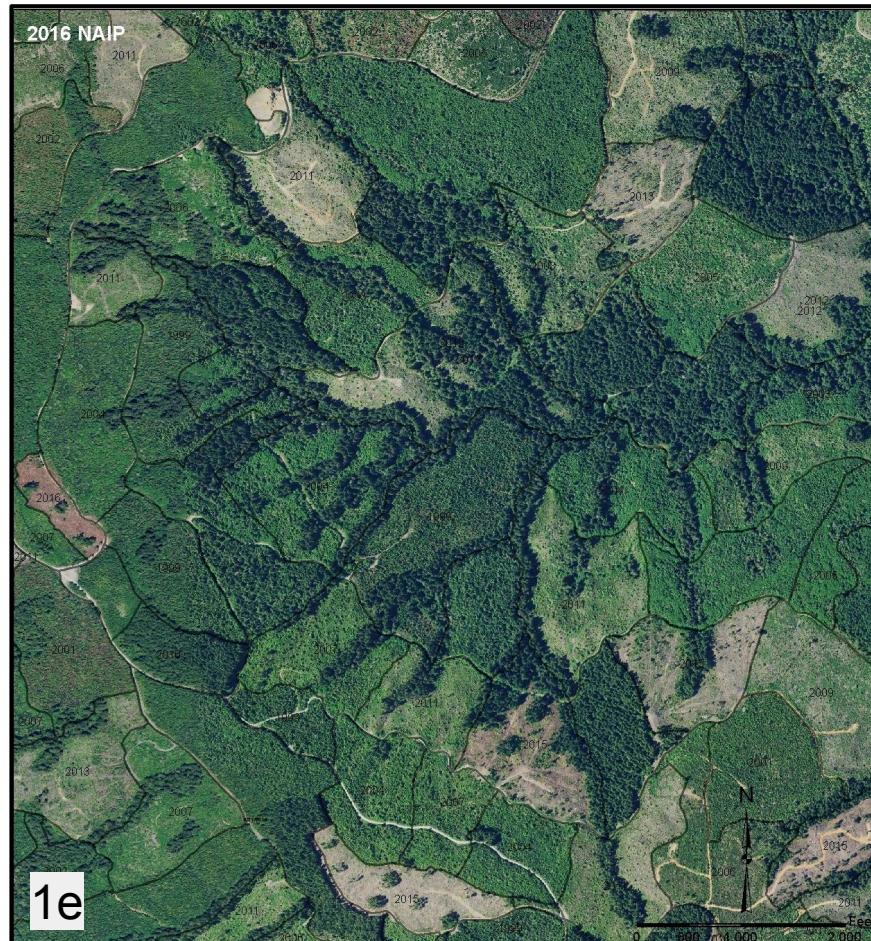
Photo 1e: Today clearcut blocks are still limited to 16 hectares, however contiguous opening size is less than 6 hectares on average. Over 25% of a harvest block is composed of WLPZ, geologic protection or other retention areas.

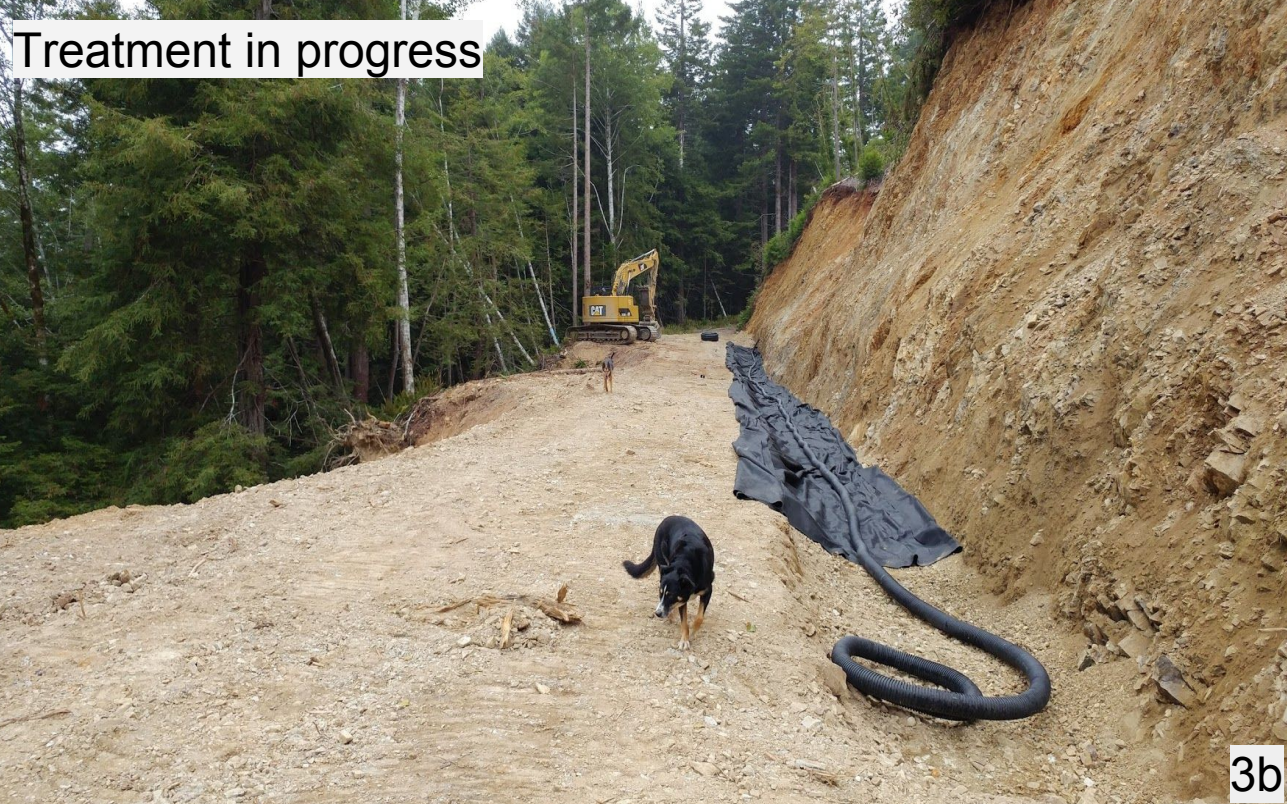
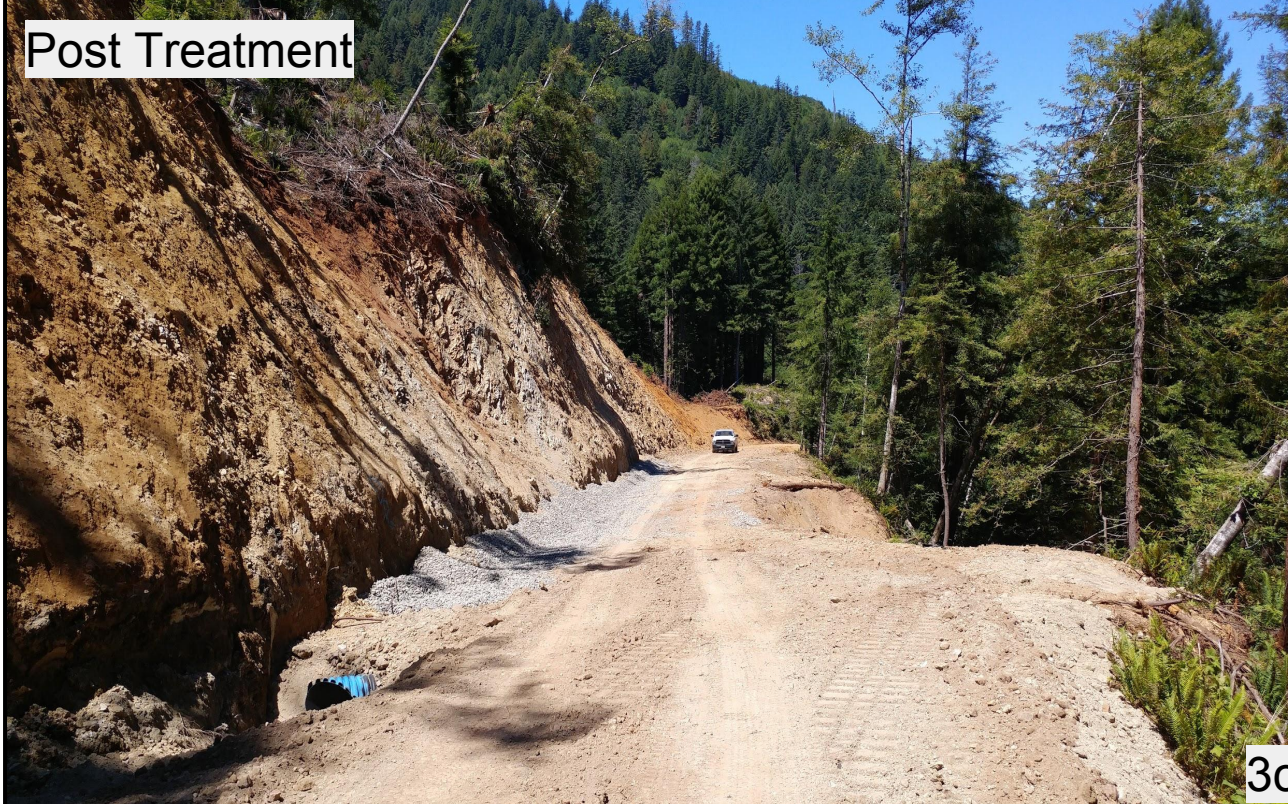
Photos 3a, 3b, & 3c: Improved road building and repair practices that include disconnecting road drainage systems from streams and input from licensed geologists as needed. Photos show debris slide repair on haul road.

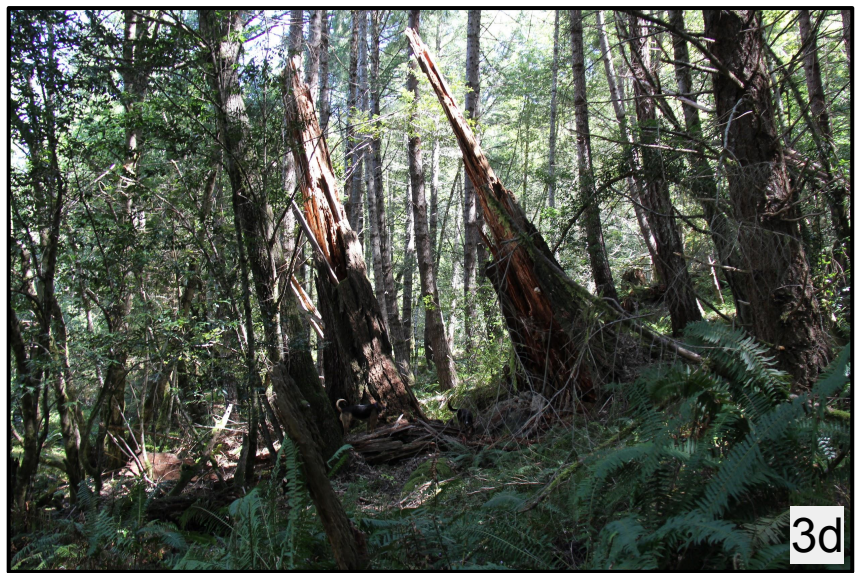
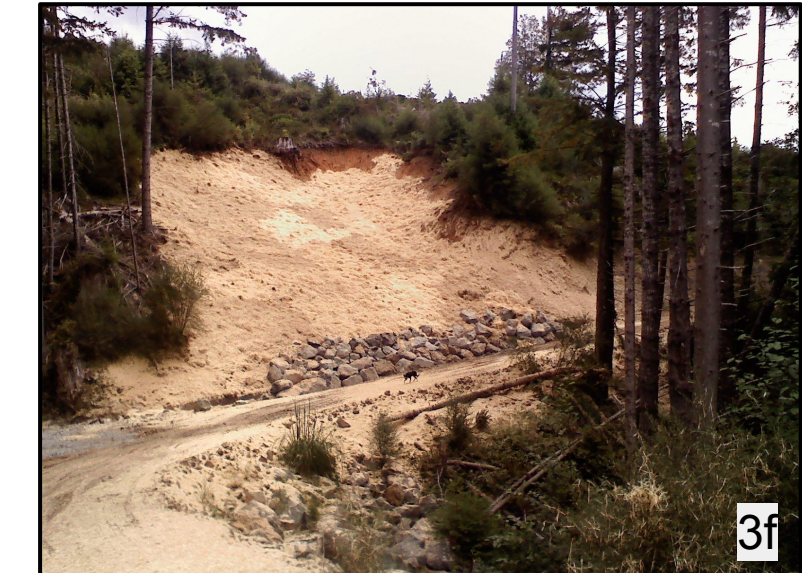
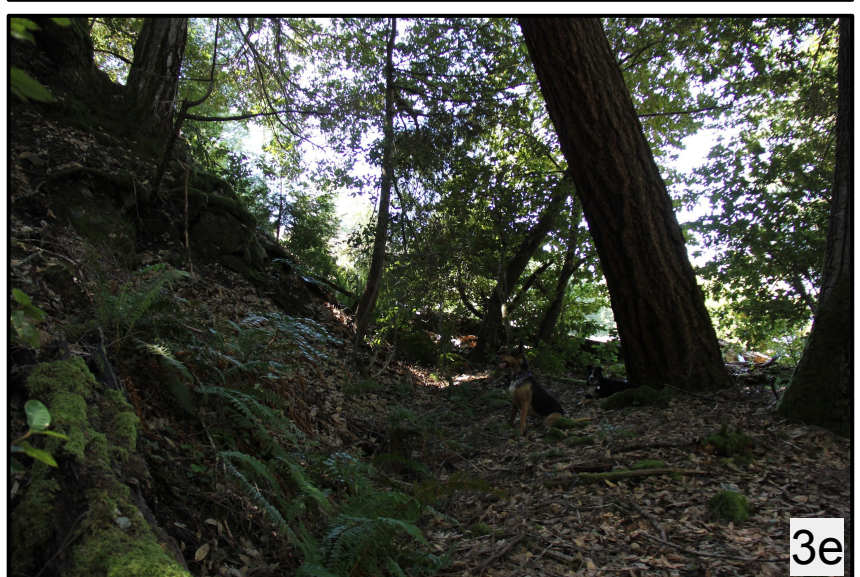
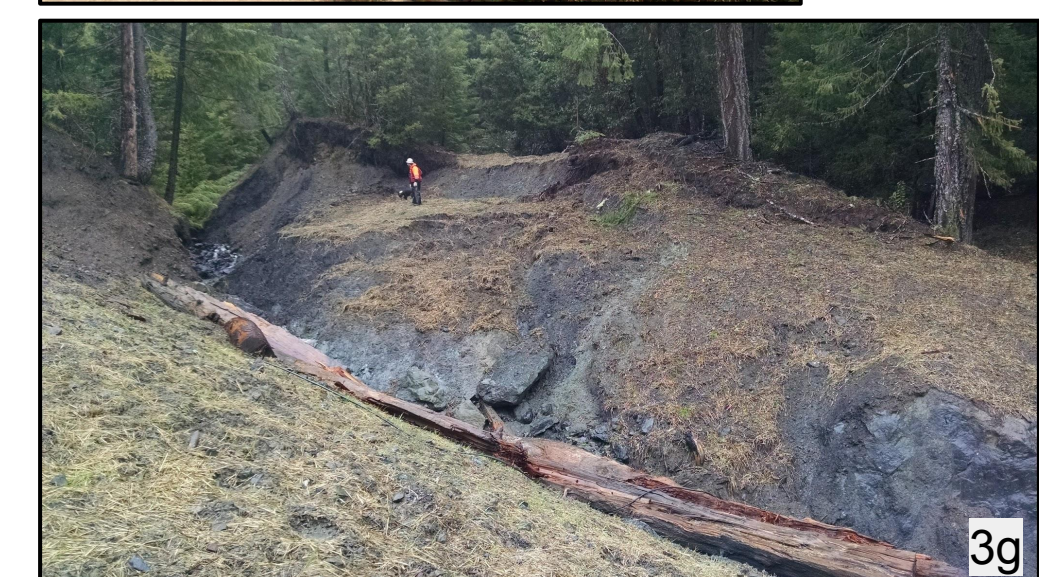
Photos 3d & 3e: Landslides identified during field reconnaissance of harvest block layout, note split stump and back-tilted tree. **Photo 3f** landslide adjacent to haul road and watercourse is mitigated with rock buttress, seed and mulch. **Photo 3g:** Geologist assess landslide identified during plan layout and plan mitigation.

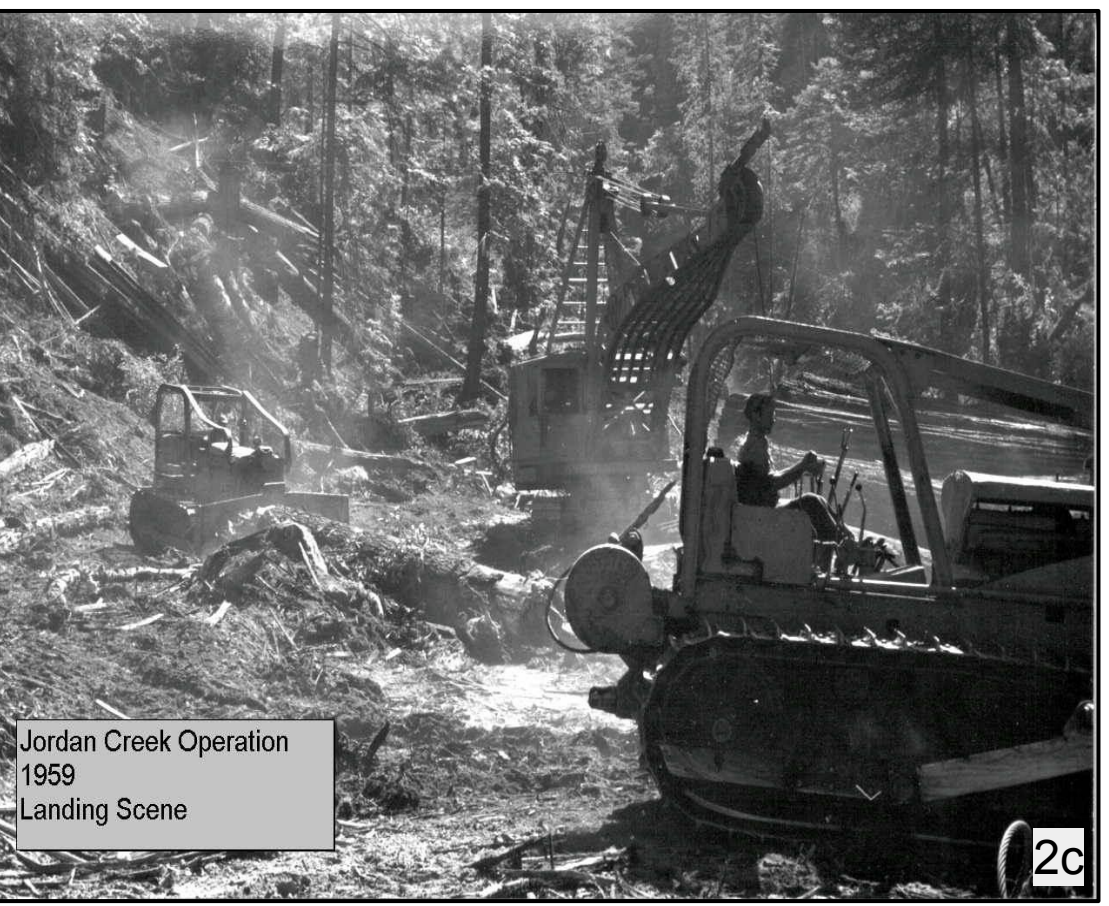
Photos 2c & 2d: Historical ground-based logging included skidders and bulldozers that cut skid trails throughout a harvest block resulting in significant ground disturbance and exposed bare mineral soil. This method of logging began in the 1950's and was prevalent into the early 2000's.

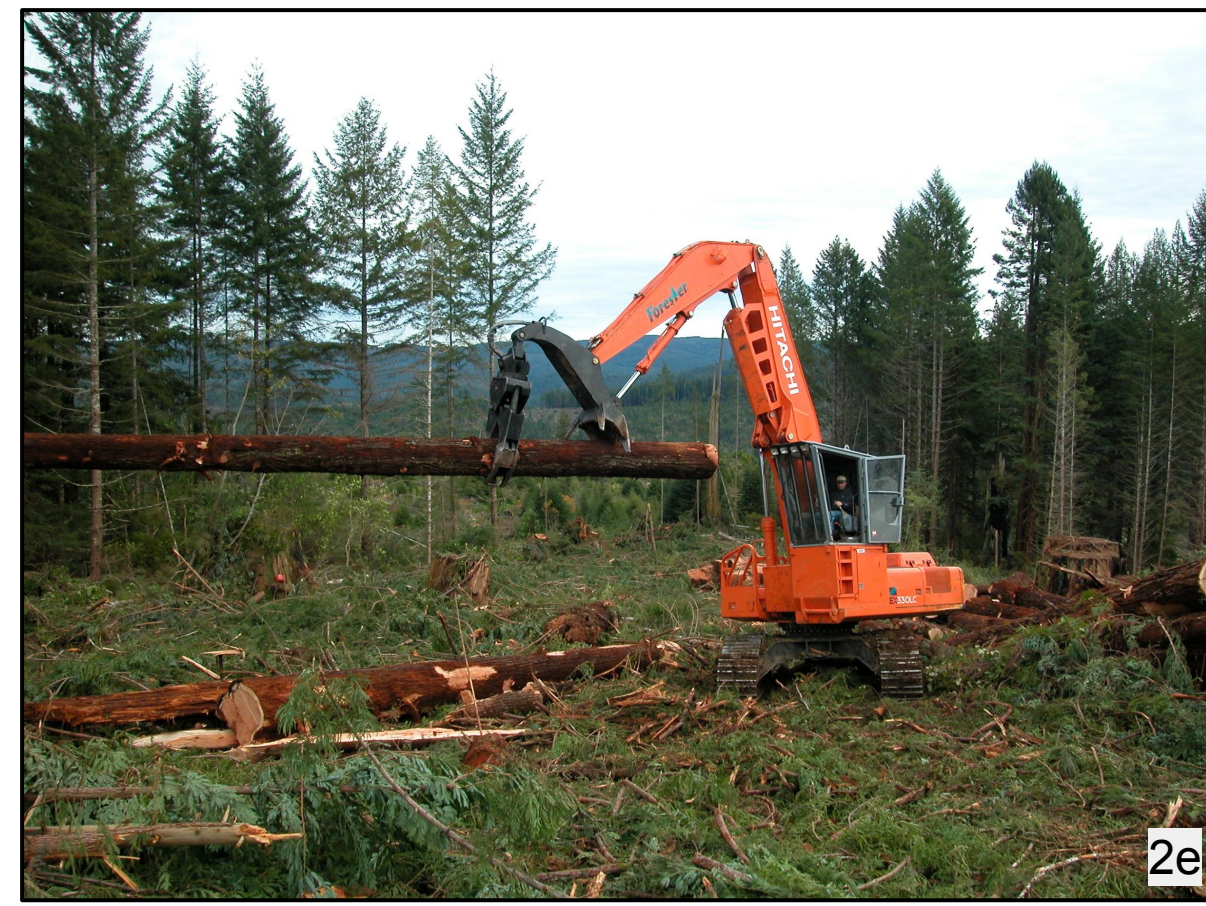
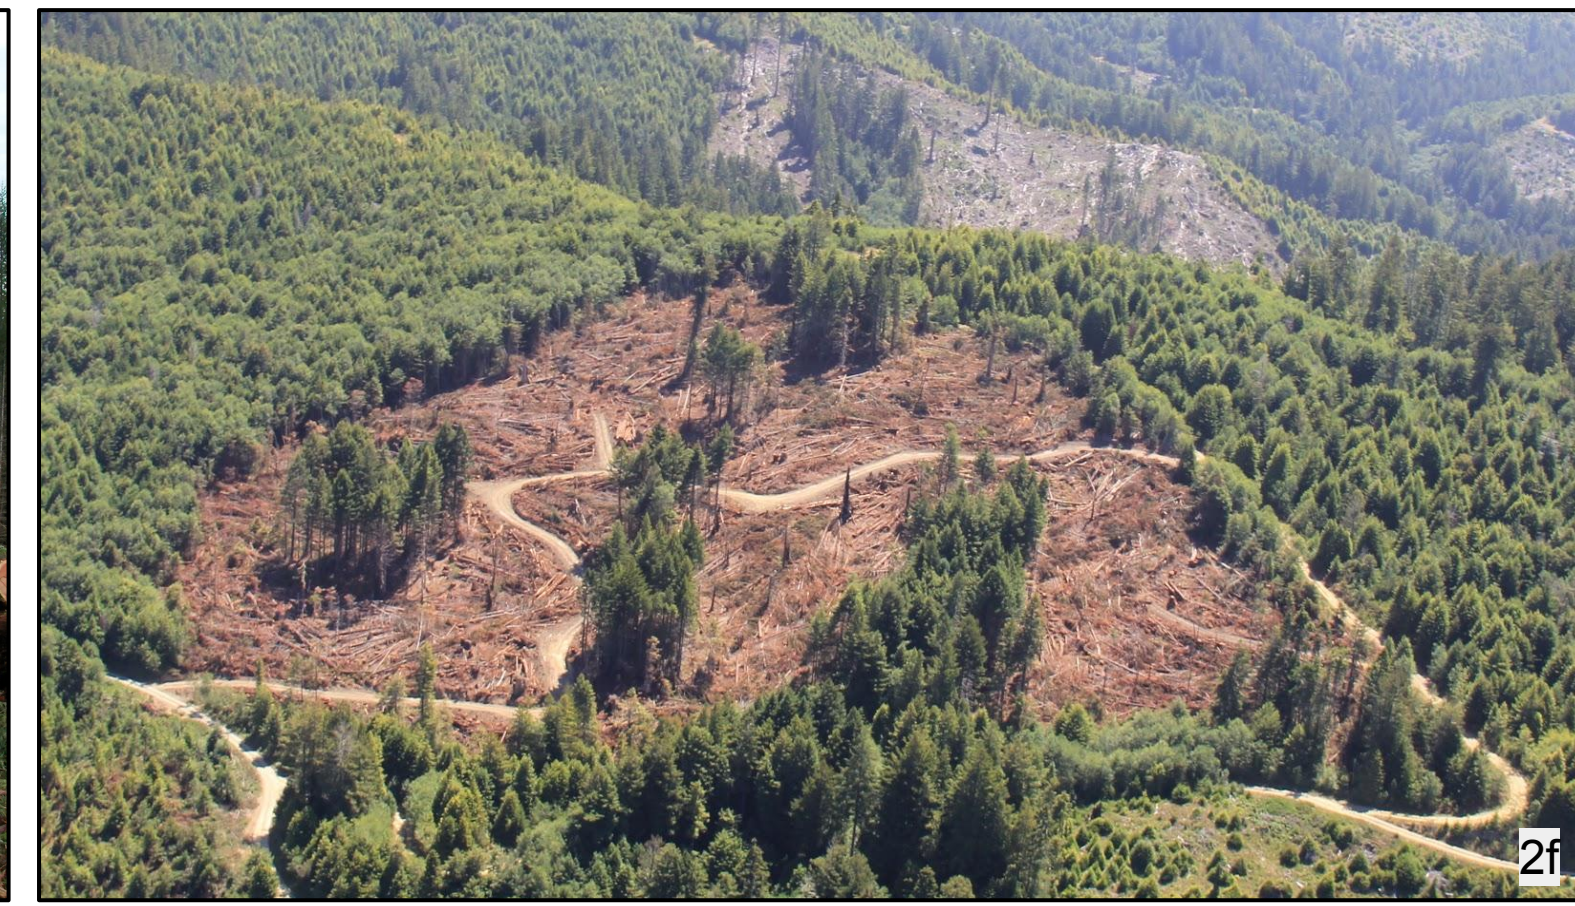
Photos 2e & 2f: Modern ground-based logging transitioned from tractor to "shovel" logging in 2000. Shovel logging utilizes track-mounted machines that operate on top of the slash without the need for cutting skid trails, significantly reducing the amount of bare soil exposed compared with historical ground-based operations.

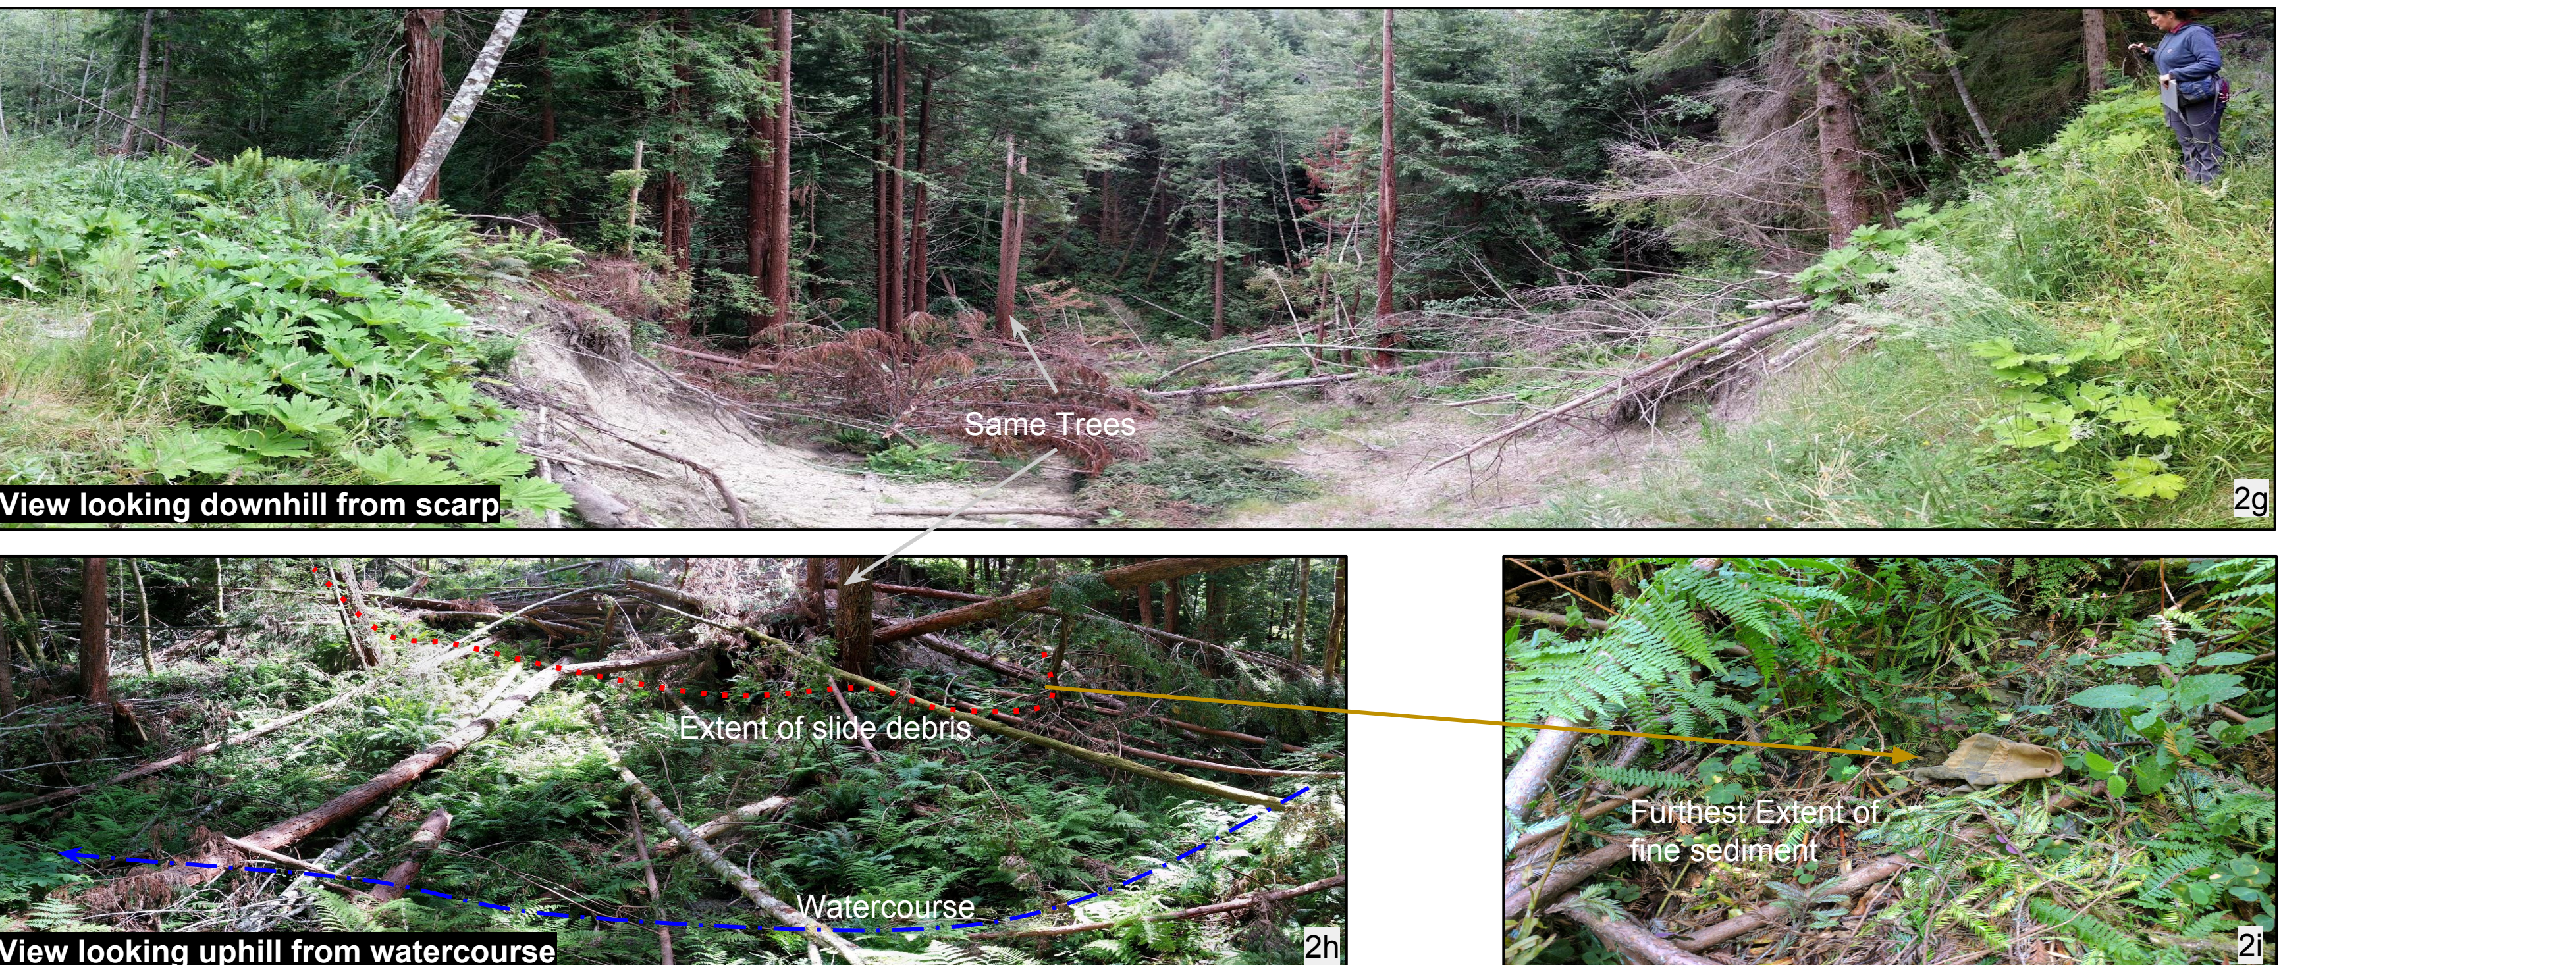
Photos 2g, 2h, & 2i: Tree retention related to Riparian Management Zones (RMZ) provides root strength and evapotranspiration for slope stability and if a landslide occurs they provide wood for recruitment to streams for aquatic habitat and minimize the delivery of fine sediment.
