Image Analysis of Gas Well Cement Exposed to Coal Mine Water

Mary K Tkach^{1,3*}, James Gardiner^{2,3}, Barbara Kutchko³

¹Oak Ridge Institute of Science and Education; ²AECOM, Pittsburgh PA; ³U.S. Department of Energy, National Energy Technology Laboratory, Pittsburgh PA, (*Mary.Tkach@netl.doe.gov)

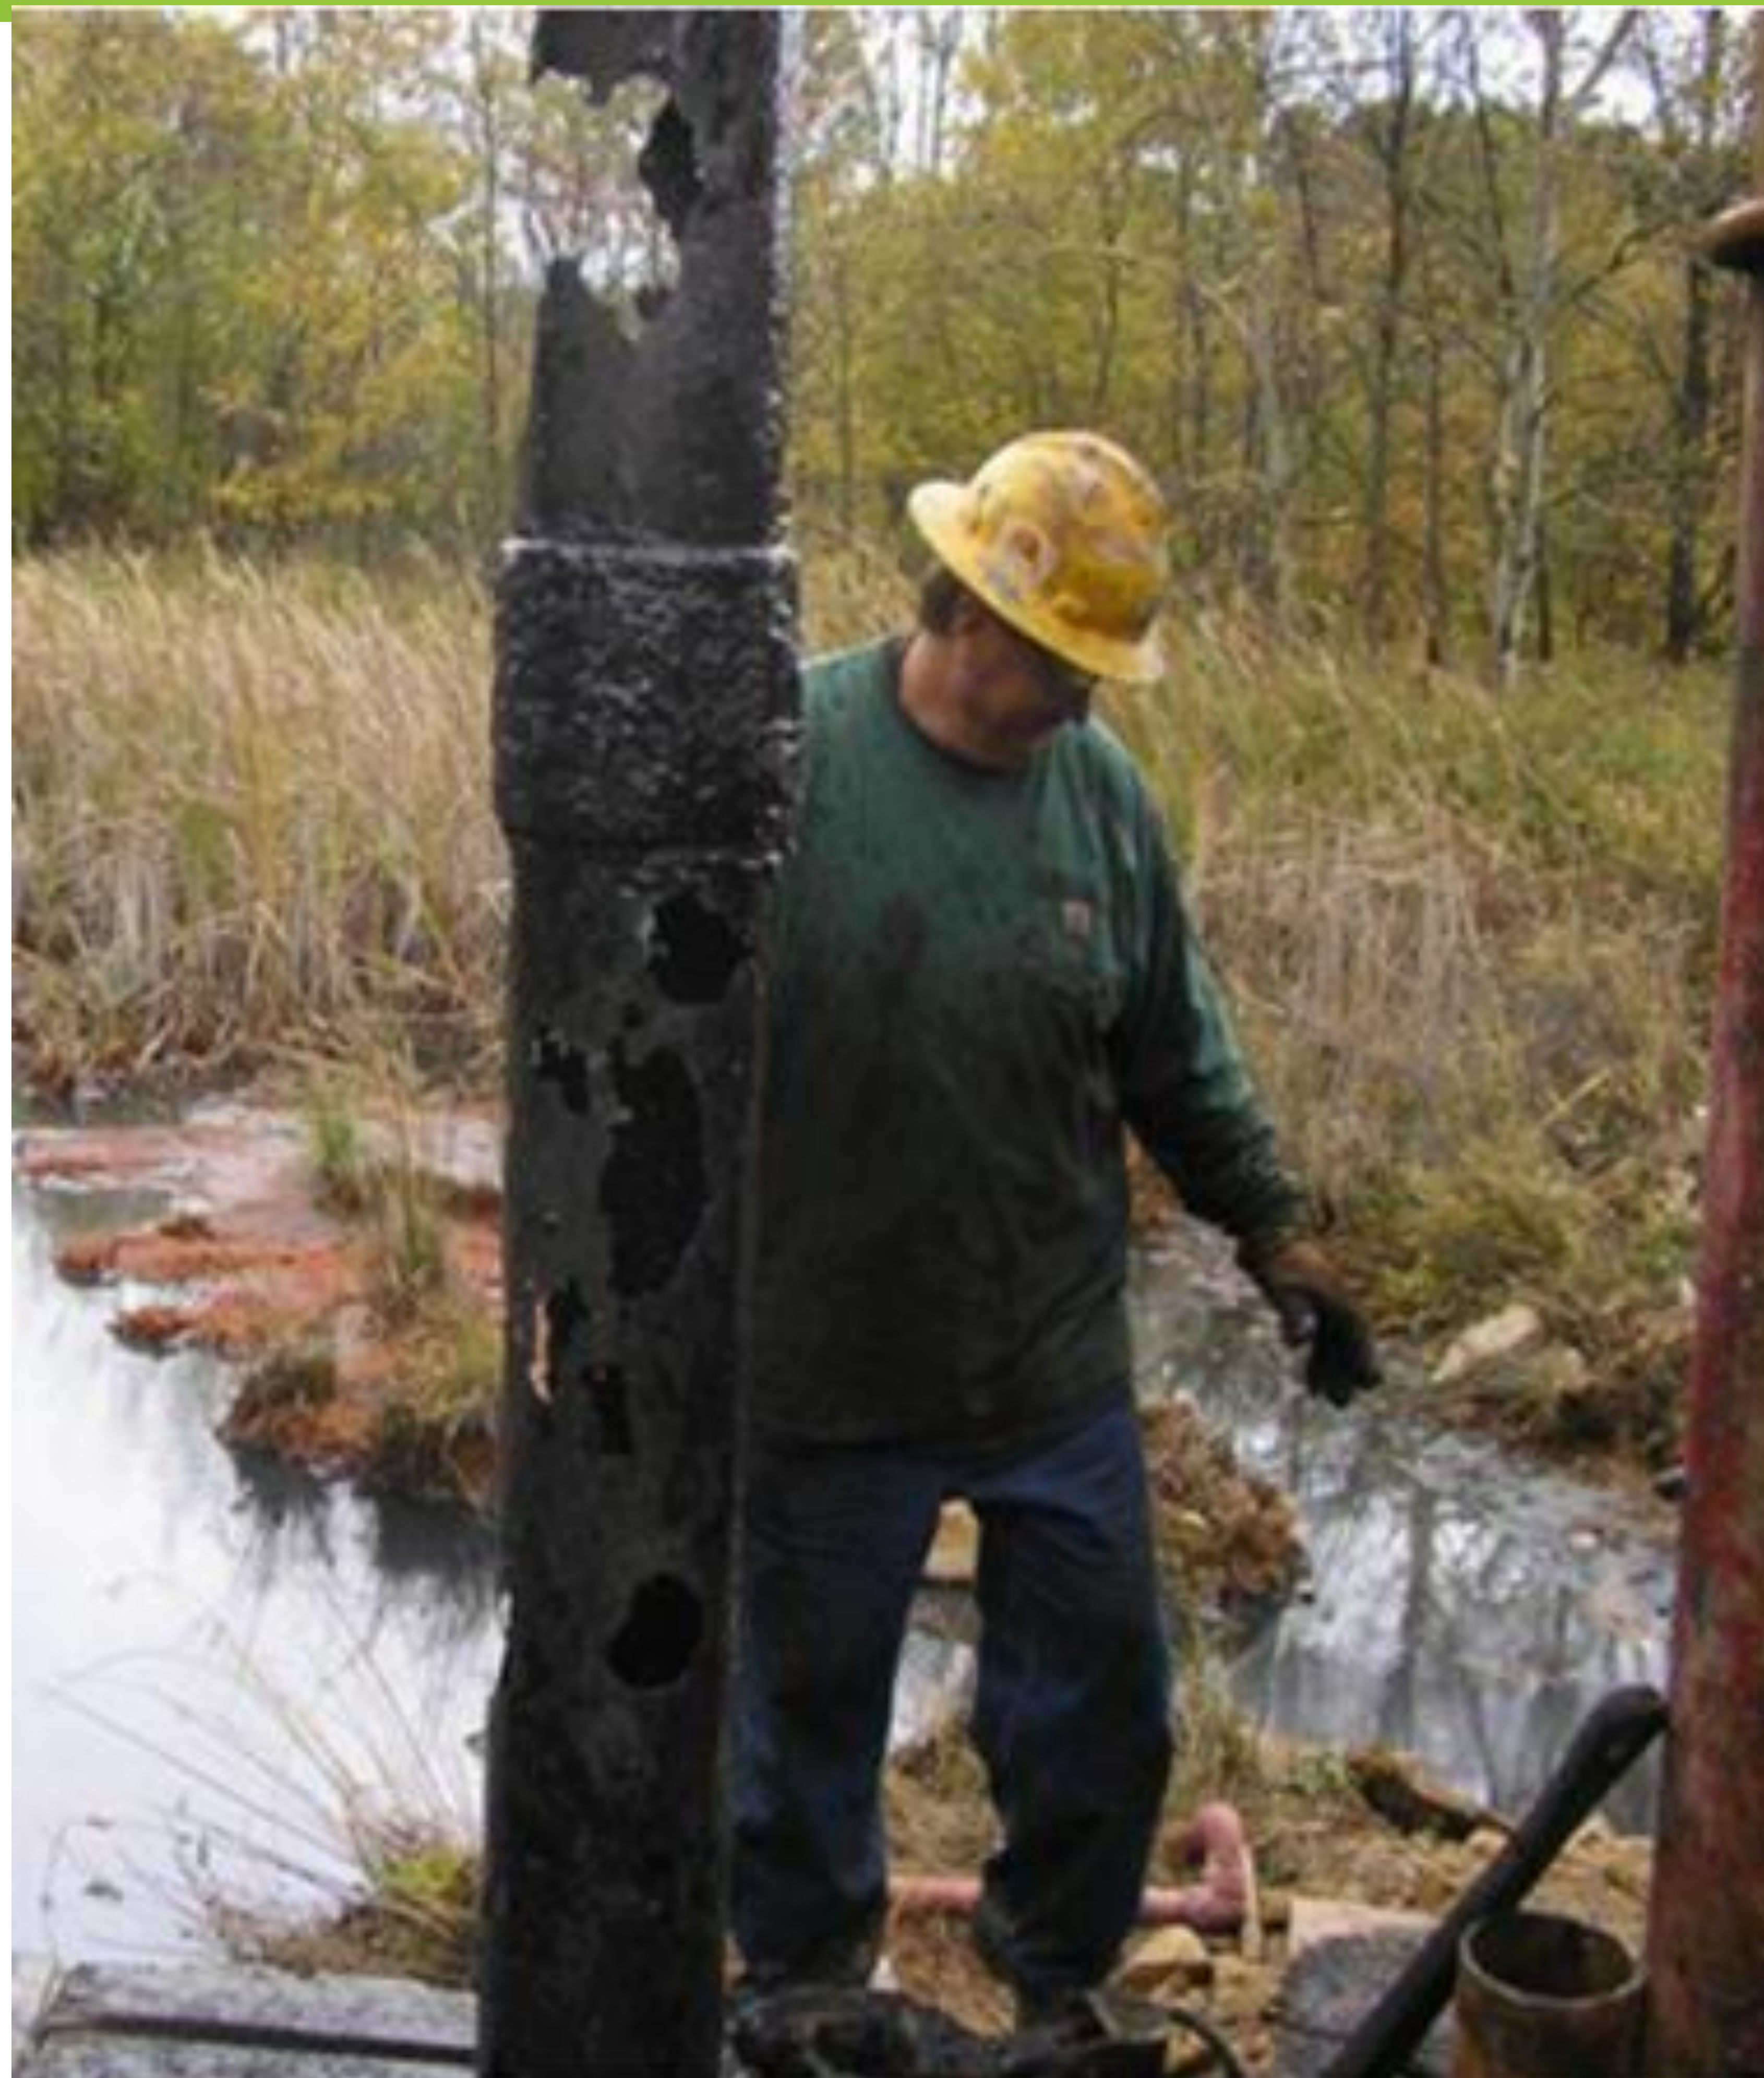
Figure 2. Corroded well casing from a well drilled close to a coal mine. Picture appears courtesy of the Pennsylvania Department of Environmental Protection.

Natural gas wells in Northern Appalachia are often drilled in areas where extensive coal mining has occurred (Fig. 1). Many of these coal mines are abandoned and a large portion of these abandoned mines (~40%) are flooded with water (Donovan et al., 2004). This coal mine water ranges in pH from acidic to circumneutral and could have an effect on gas well cement, which has a basic pH (Gaitero et al., 2008). Coal mine water has the potential to alter the microstructure of gas well cement and compromise the well's zonal isolation (Fig. 2).

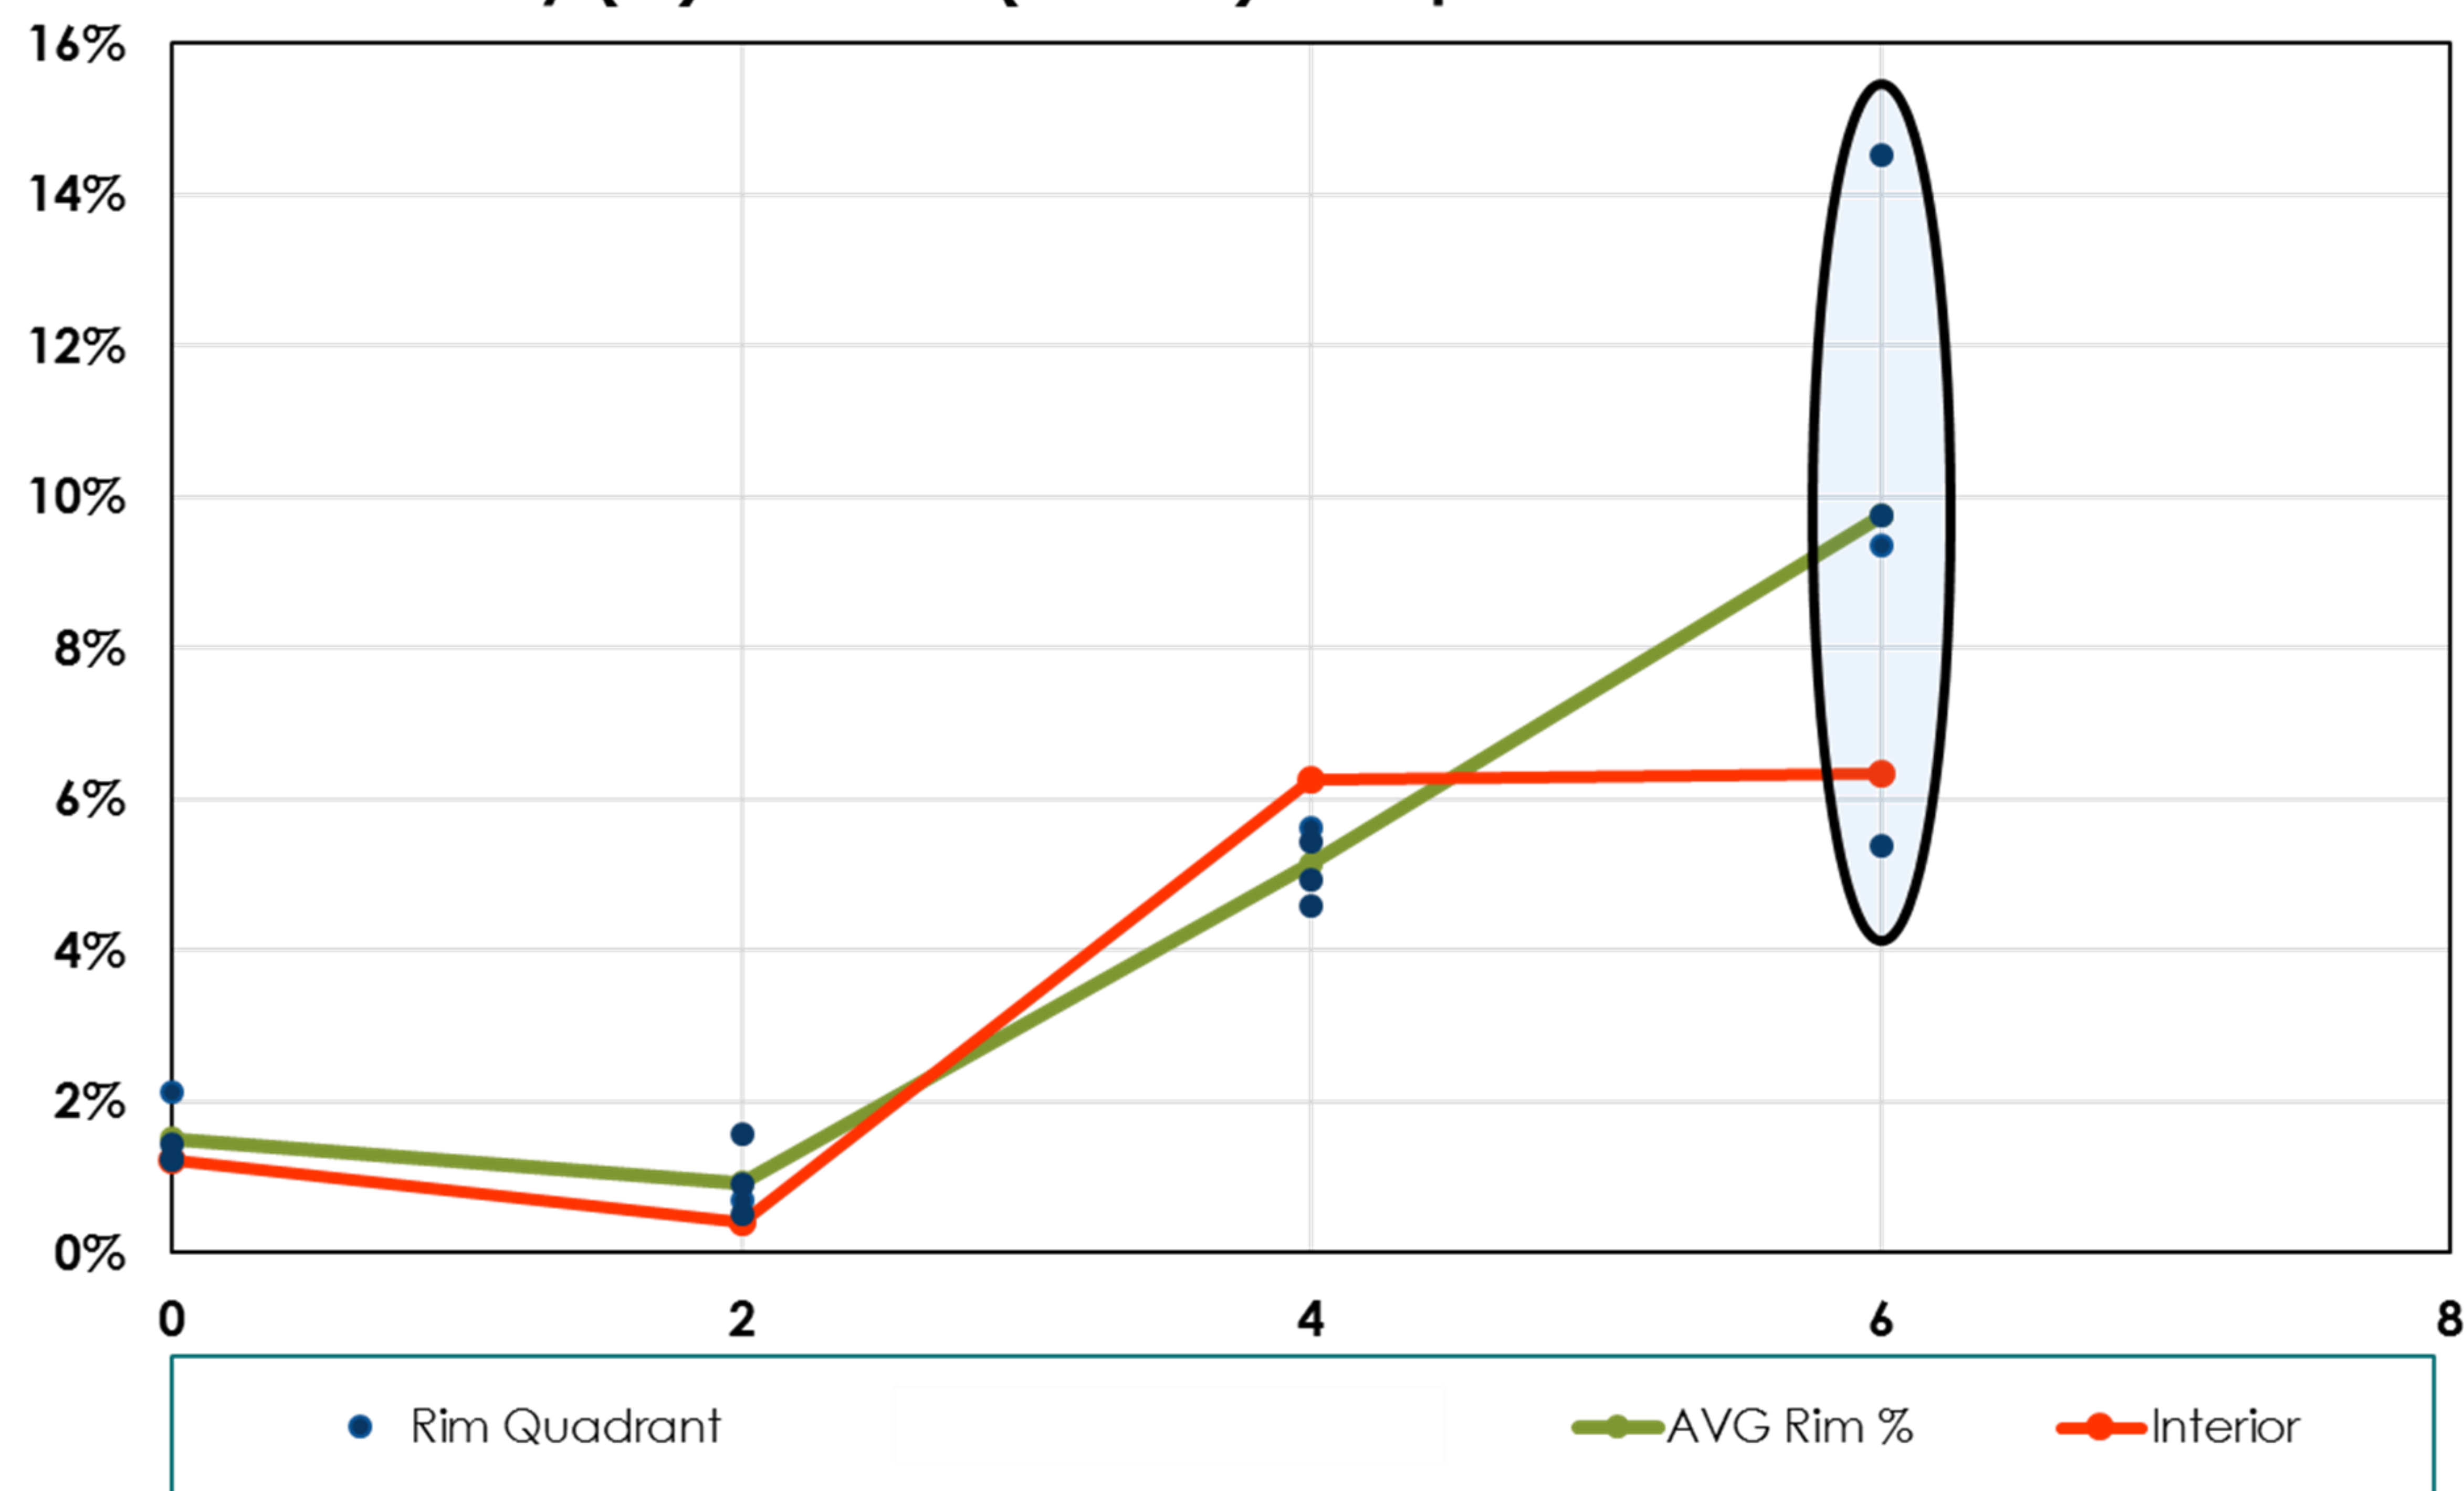
Porosity (%) vs. Time (Weeks) of Exposure to Coal Mine Water

With increased exposure to coal mine water, both interior and rim porosity measurements increased over time (Fig. 5). The measured interior porosity value after six weeks of exposure (6.33%) was higher than either the control (1.21%) or the two-week exposure (0.39%). This increase in porosity suggests that coal mine water infiltrated and altered the cement interior's pore space.

Average rim porosity measurements increased from the control (1.51%) and two-week exposure (0.92%) to the six-week exposure (9.75%), which had the highest porosity measurement in the study. The six-week average porosity measurement had the highest standard deviation (3.24) of all average rim measurements, but its relative standard deviation (33.24%) was within the range of other samples (7.94-44.28%). The relative standard deviation values of the rim measurements reflect the heterogeneity of the cement and how this heterogeneity is manifested in its reactions with the coal mine water. Larger pore spaces and dissolution veins become apparent in samples with increased exposure to coal mine water, suggesting that there are preferential reactions along the cement cores' rims.

While traditional porosimeters measure bulk porosity, the methodology used in this research also highlights localized porosity differences between horizontal slices of sample. These differences were not apparent from the SEM images and were only highlighted by the image processing software. For example, while the average rim porosity in the 6-week exposure is 9.75%, the values have a range between 5.38-14.52% (Fig. 5, Table 1).
