ELECTRICAL RESISTIVITY IMAGING OF A MULTIPLE ROCKSLIDE, PITTSBURGH, PA

Rucker, C.R.¹, Crawford, M.M.², Ashland, F.X.³, Fiore, A.R.⁴

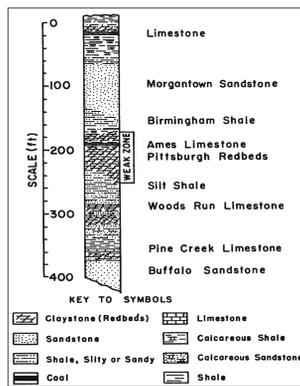
Figure 2. Generalized stratigraphic column showing major lithologies of the Pennsylvanian Conemaugh Group, from Flint and Hamel (1971).

- Lithologies in the study area are part of the Conemaugh Group of Pennsylvanian strata.
- Rockslide features include:
 - Vertical exposure of Morgantown Sandstone at head scarp.

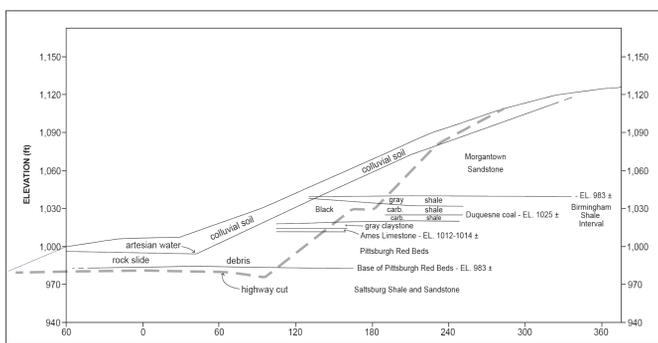
Figure 3. Cross section modified by Gray et al. (2011) showing pre-excavation slide topography, excavated bench associated with I-79 highway construction, and lithologies as determined by borings in 1963. Location of cross section is approximately one mile north along I-79 of our study area.

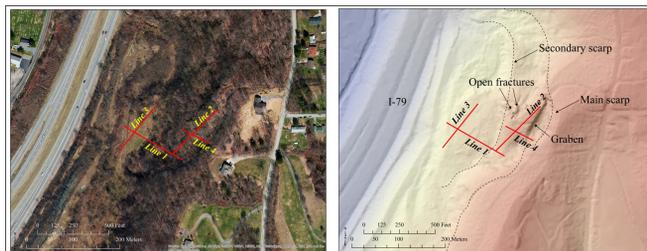
Figure 4. Aerial photo (left) and LiDAR derived hillshade (right) showing electrical survey profile lines and landslide surface features.

- Electrical resistivity data were collected July 11-12, 2016.
- 1150 feet of ER survey profiles.
- Survey profiles included two longitudinal lines (1 and 4) and two transverse lines (2 and 3) collected across the accessible parts of the slide footprint and where the potential to image rockslide features was maximized.
- Experimented using dipole-dipole, Wenner, and Schlumberger electrode configurations for all profiles, and used different electrode spacing.
- Used Advanced Geosciences, Inc. SuperSting 8-channel resistivity meter.
- Inversions were made using Advanced Geosciences, Inc. AGI EarthImager 2D ver. 2.3.0.

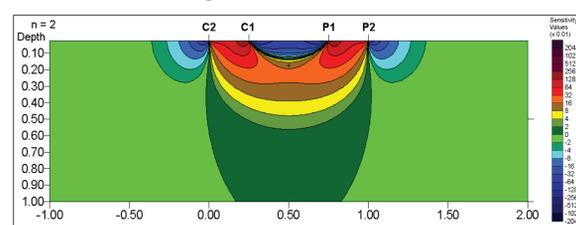
Figure 8. Dipole-dipole configuration diagram and sensitivity section, from Loke (2004). C1 and C2 are current electrodes; P1 and P2 are potential electrodes. In depth sounding, spacing of current electrode pair and of potential electrode pair is held constant, while spacing between the two pairs is increased. Sensitivity is greatest between each electrode pair, and contours are near vertical near electrodes. Dipole-dipole configuration is better suited for resolving lateral variation/vertical features.

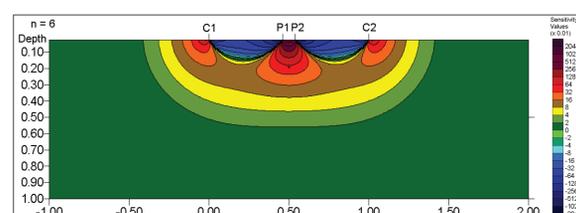
Figure 9. Schlumberger configuration diagram and sensitivity section, from Loke (2004). C1 and C2 are current electrodes; P1 and P2 are potential electrodes. In depth sounding, spacing and location of potential electrodes fixed while current electrodes are moved outwards. Sensitivity is greatest beneath the potential electrode pair. Schlumberger configuration has a slightly greater probing depth than Wenner configuration, and may be able to better capture lateral variation than Wenner configuration. Overall, this configuration is better suited to capture variation between horizontal layers.

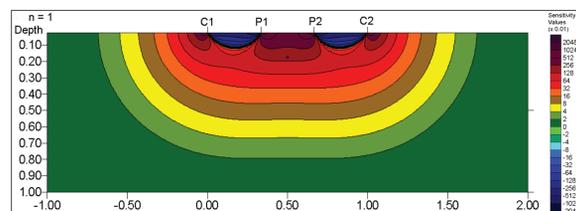
Figure 10. Wenner array diagram and sensitivity section, from Loke (2004). C1 and C2 are current electrodes; P1 and P2 are potential electrodes. In depth sounding, spacing between potential electrodes and current electrodes are uniform, and the array expands outwards about the array midpoint. Sensitivity is greatest beneath the center of the array. Wenner array is best for detecting vertical change and rather than lateral change.

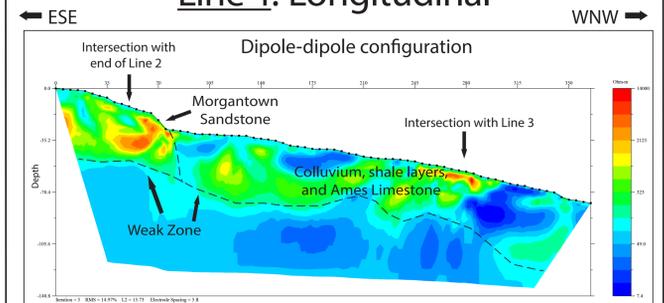
Line 1: Longitudinal

- 30 to 50 feet below surface is boundary between discontinuous medium to high resistivity zone and underlying lower resistivity zone.
- Depth to this boundary matches the onset of the "weak zone" described by Flint and Hamel (1971) (Fig. 2) and may represent failure surface of slide.
- High resistivity anomaly near secondary scarp corresponds with exposure of Morgantown Sandstone at scarp face.
- High resistivity anomaly near intersection with Line 3 corresponds with observed open fractures at surface. This area is interpreted as a geoelectric unit containing colluvium, thin shale layers, and Ames Limestone.
- Low resistivity zones at the surface near the middle of the line and at the toe of slope may indicate higher moisture content, the presence of clay-rich layers, or both.

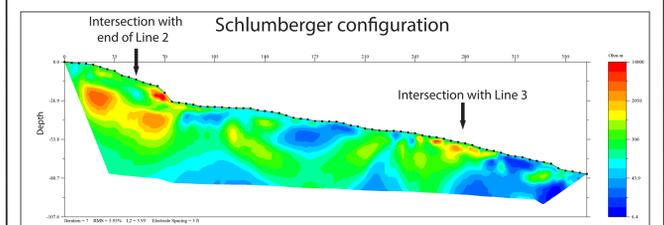
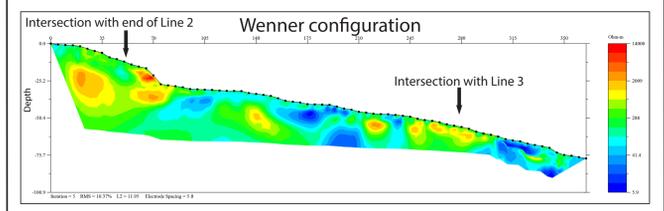
- Schlumberger (above) and Wenner (below) configurations capture high resistivity anomalies related to Morgantown Sandstone and observed open fractures.
- Low resistivity zones at the surface near the middle of the line as well as at the toe of slope may indicate higher moisture content, the presence of clay-rich layers, or both.
- Schlumberger and Wenner configurations are more limited in depth and do not fully capture the lower resistivity weak zone.

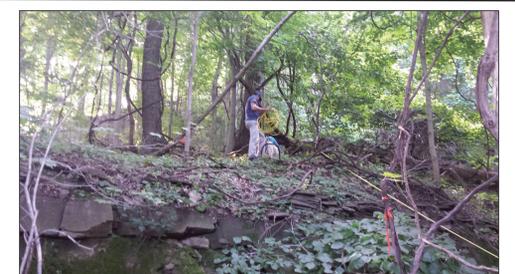
Figure 5. Secondary scarp along Line 1 showing jointed Morgantown Sandstone.

- Large secondary scarp approximately 270 ft downslope from head scarp.
 - Slide dimensions are approximately 1,100 ft wide by 650 ft long down axis.

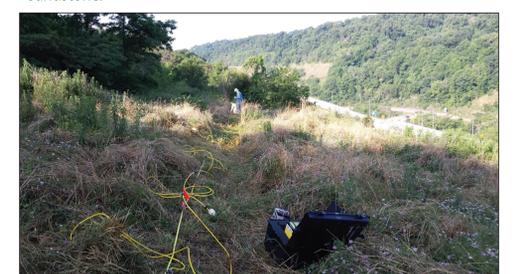
Figure 6. Looking south along Line 3. AGI SuperSting unit is in foreground. I-79 is visible along right side of the image.
