Goals

- Comfort Lake-Forest Lake Watershed is interested in remediation and management of impaired lakes and surface water.
- By using a paleo-ecological approach, watershed managers will be better informed for remediation and management.
- Shields, Moody, and Comfort Lake
- Using sediment cores and geochemical proxies to look at sediment loading and nutrients in the basins.

Duncanson, GSA 03/2017

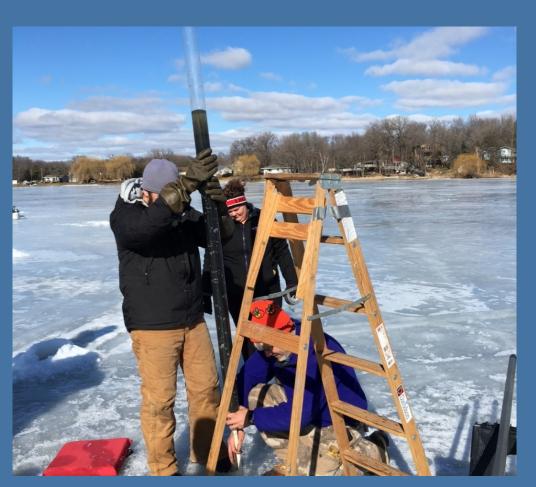
Methods

- Magnetic susceptibility
- Loss On Ignition (LOI)
- XRF analysis
- ²¹⁰Pb age dating
- P Fractions

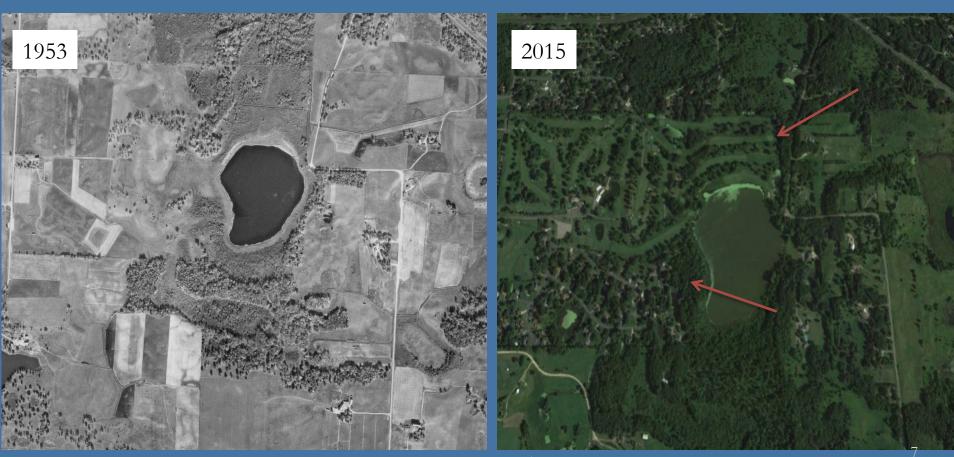
Shields Lake

Area: 30 acres. Depth: 7.8m

2015: 349 µg/L phosphorous*

Lake Grade: F+

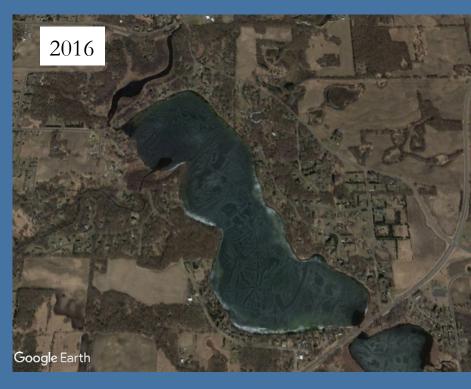
Preliminary results suggest notable event at ~120cm
