Integrating high-resolution vegetation data and 14 years of topographic surveys to quantify impacts to sandbar campsites, Grand Canyon National Park

Daniel R. Hadley^{1,2}, Paul E. Grams³, and Matthew A. Kaplinski¹

GSA Annual Meeting, 2018

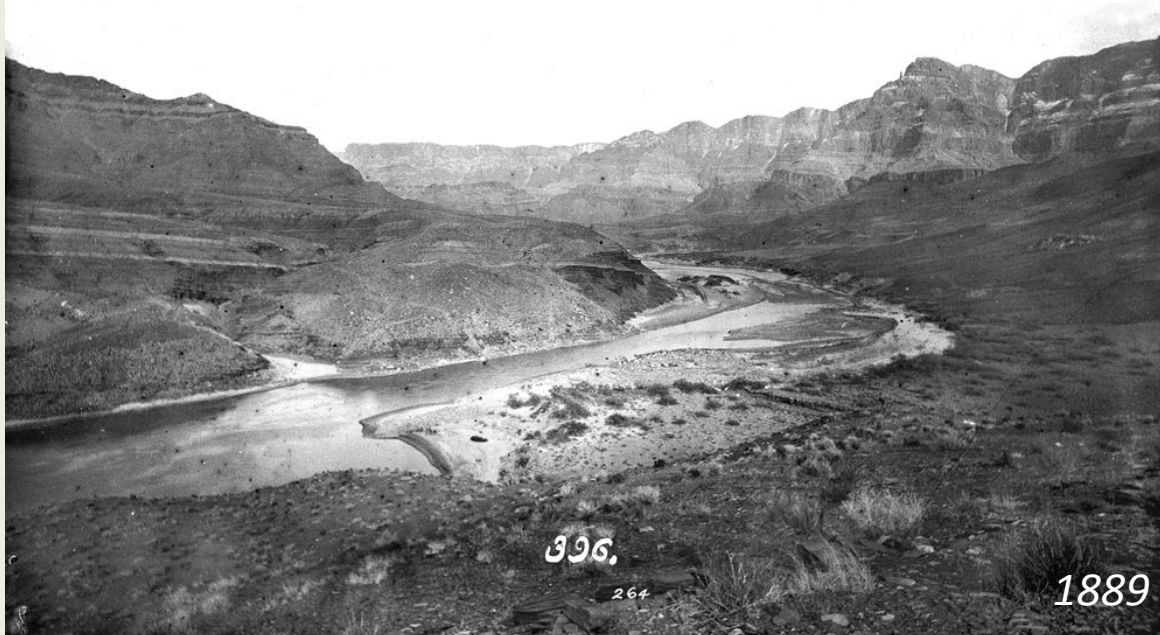
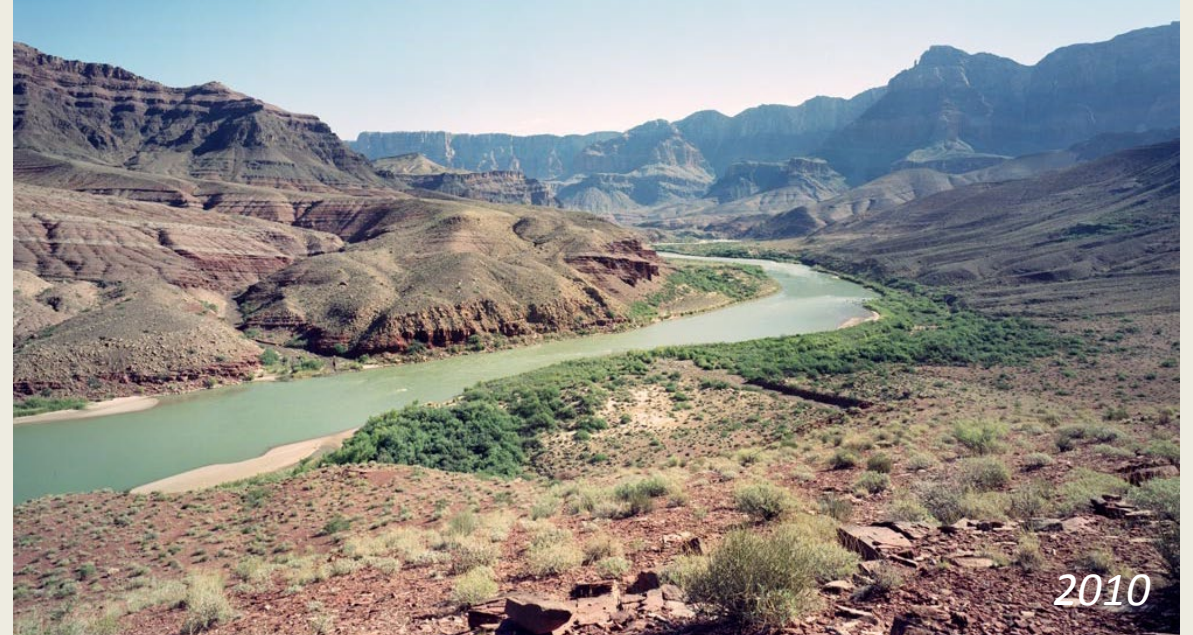
Cardenas Hilltop, RM 71.3

- Glen Canyon Dam constructed in 1963
- Erosion of sandbars due to lack of sediment replenishment
- Vegetation encroachment due to lack of flooding
- Reduction in size and number of sandbar campsites, a vital recreational resource
- Controlled floods primary management strategy to replenish sandbars

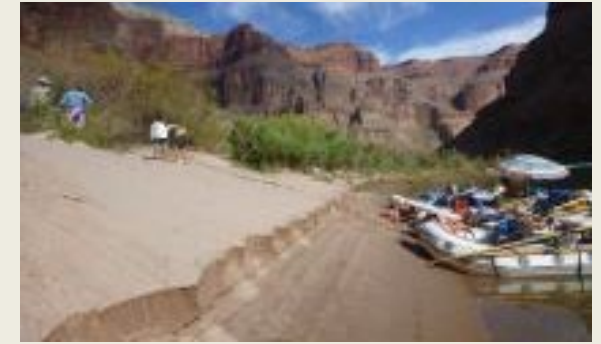
Erosion from daily fluctuations

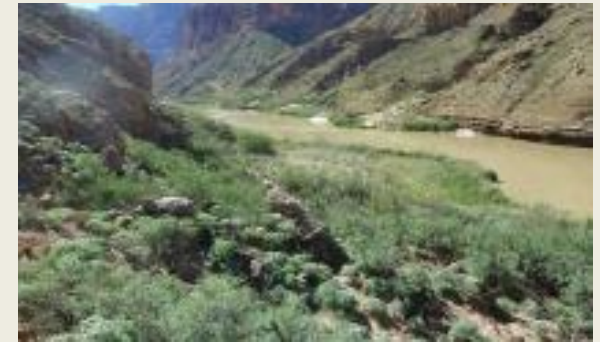
Vegetation Encroachment

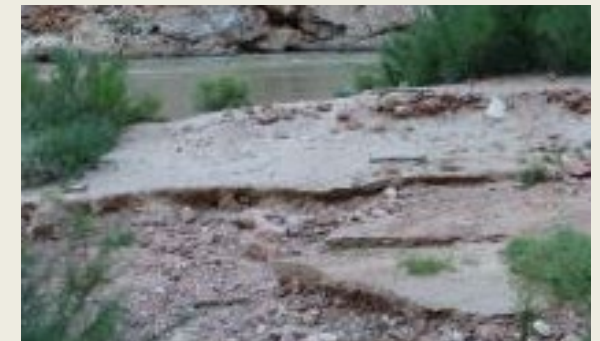
Gullying

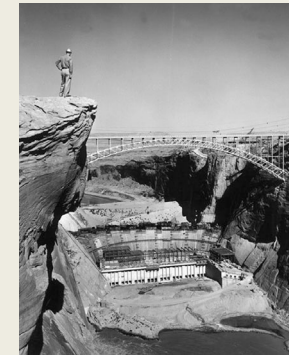
The debris-fan eddy complex

- Debris fans form channel constrictions
- Create pools, rapids, and recirculating eddies
- Slower velocities in eddies allow sand deposition
- Separation bars and reattachment bars areas are primary area used as campsites by river runners and hikers

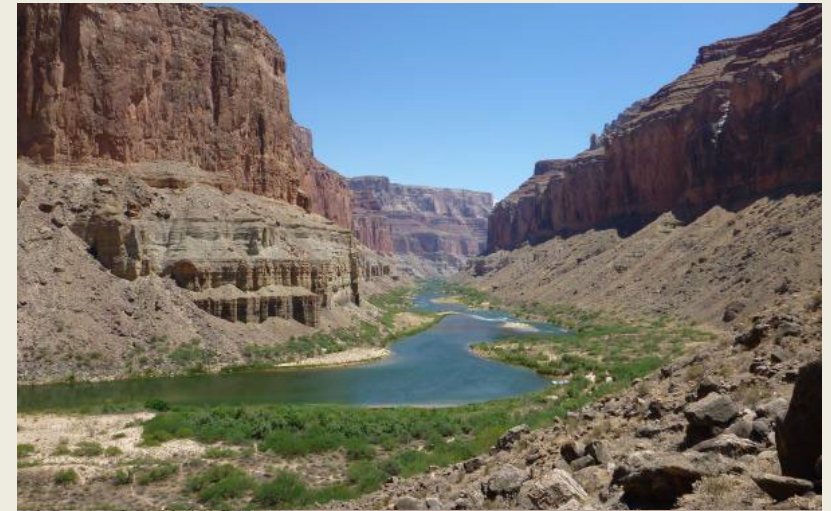
Non-Critical Reaches = wide sections of canyon, numerous debris-fans

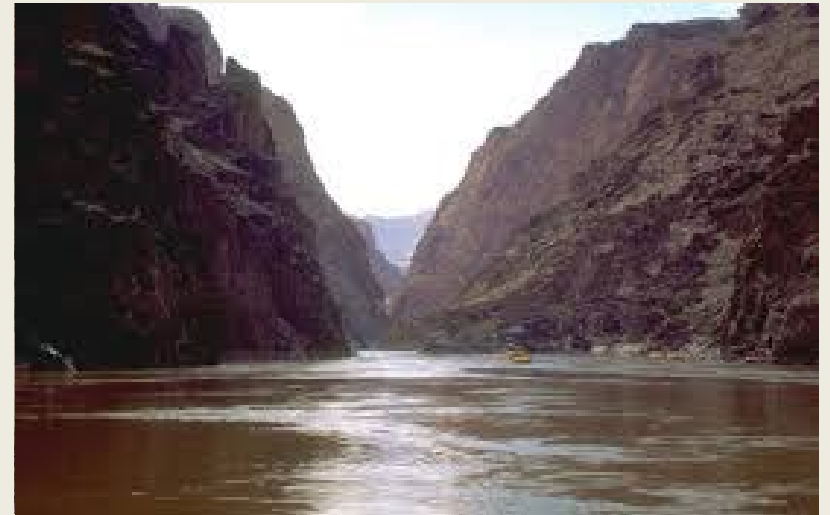
Critical Reaches = narrow sections of canyon, limited number of campsites

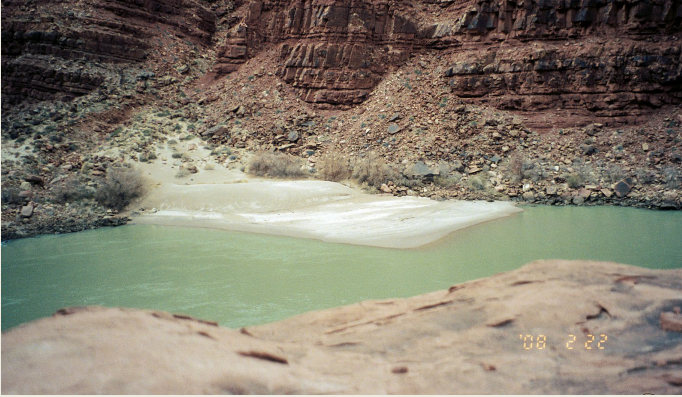
Lateral Cutbank Retreat

Pre-2008 Controlled Flood

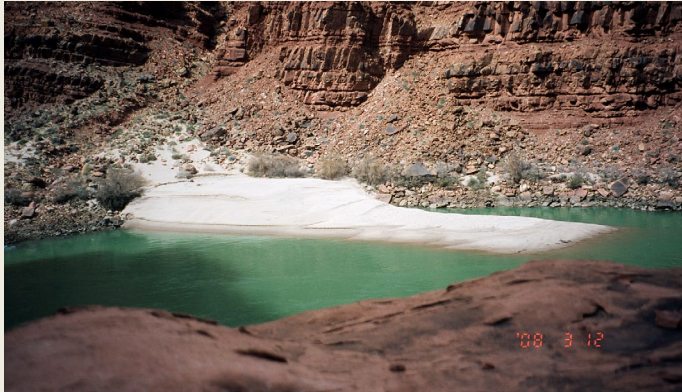
Post-2008 Controlled Flood

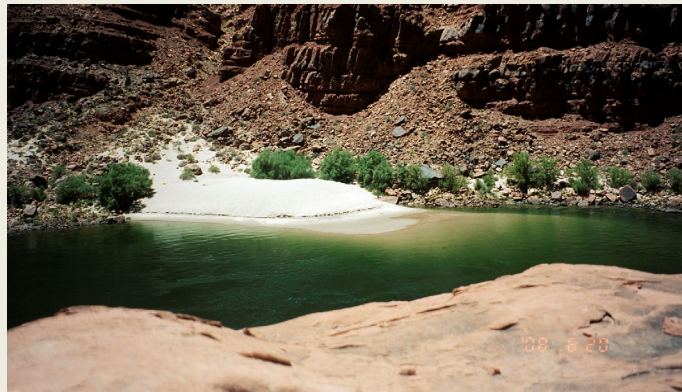
3 months after 2008 Controlled Flood

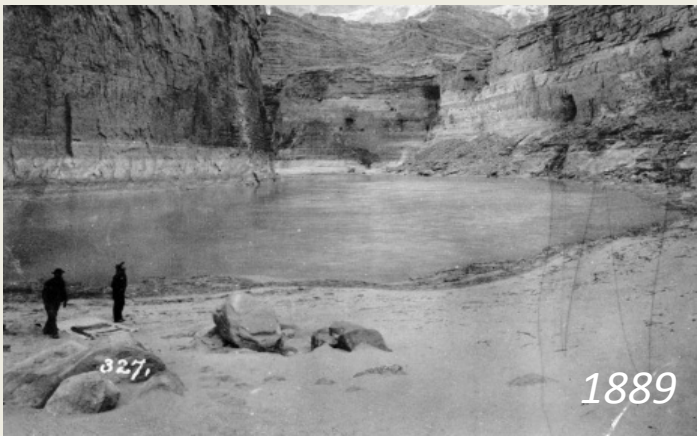
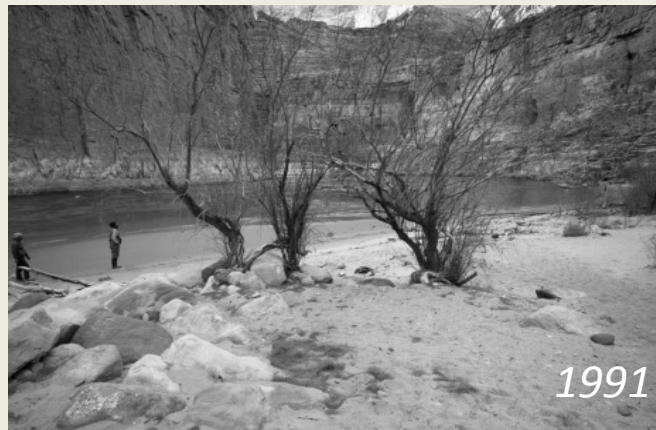
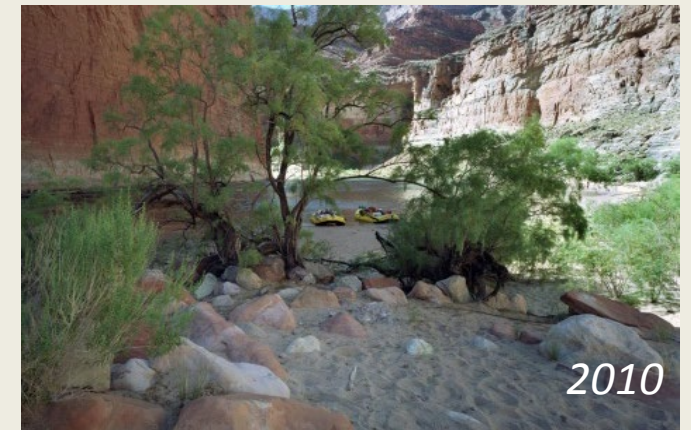
South Canyon RM 32.2, looking downstream

- Native and non-native vegetation continues to expand
- Gains from controlled floods often short-lived due to fluvial mainstem erosion (daily fluctuating dam releases)
