Kelley Stand Road

KELLEY STAND ROAD REHABILITATION

TOWN HIGHWAY No. 3 FOREST HIGHWAY No. 6

Post-Irene Investigation and Design

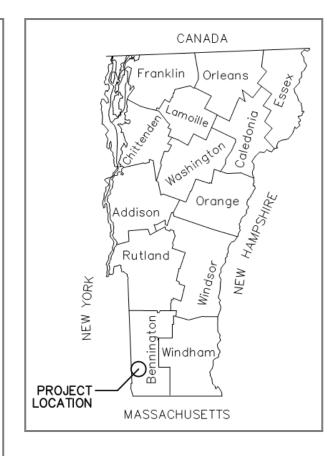
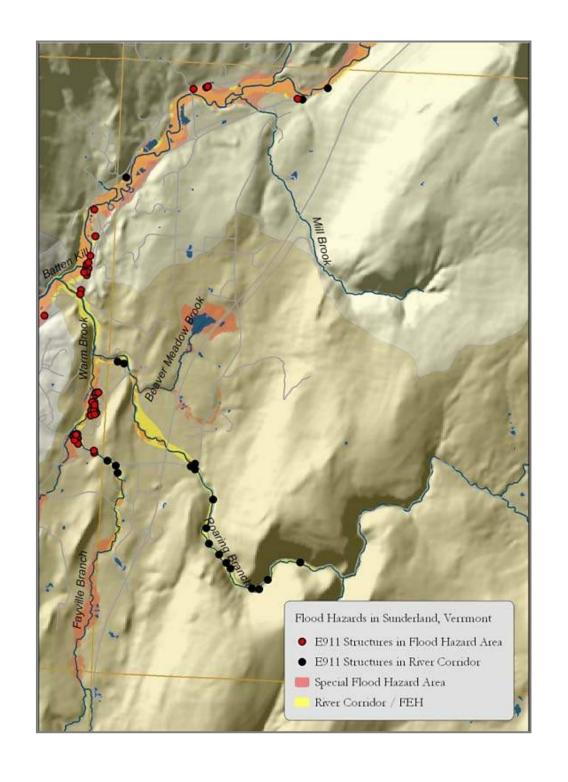
WORK TO BE PERFORMED UNDER THIS PROJECT INCLUDES ROADWAY REPAIRS AND RECONSTRUCTION, STREAMBANK ARMORING, BRIDGE REHABILITATION, AND BRIDGE

LENGTH OF ROADWAY:
LENGTH OF BRIDGE 16:
G3 FEET
LENGTH OF PROJECT:
4.55 MILES

BEGIN PROJECT STA. 18+50

END PROJECT STA. 259+50

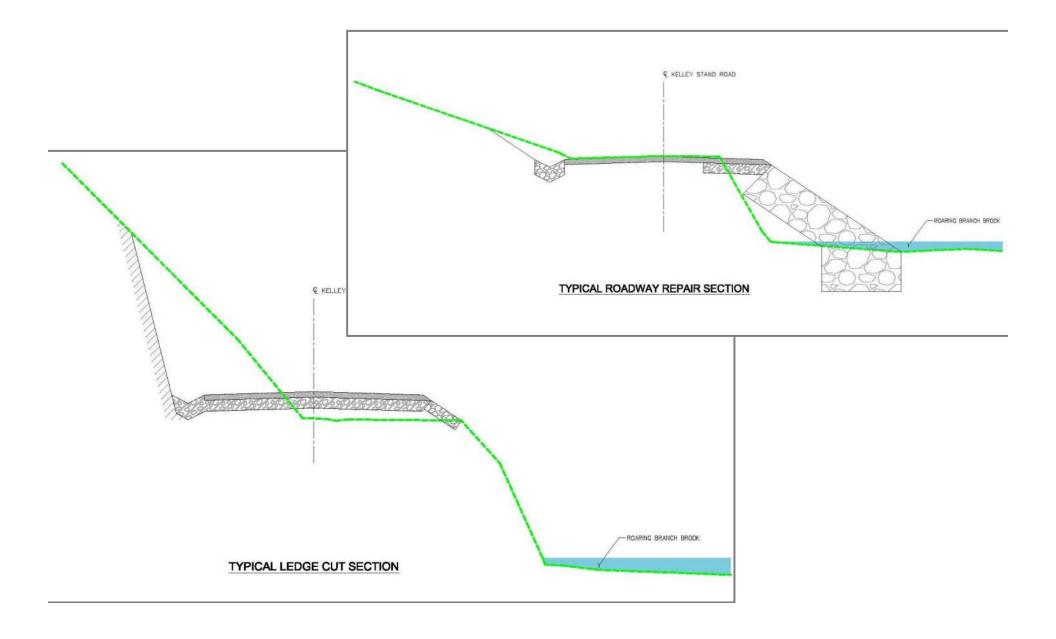
Idealized Cross Sections

- Relocate road where feasible and pull back to unerodable section for road bed
- Stacked boulder detail with pinned and grouted boulders to make vertical banks (6 to 8 feet high in some locations)
- Provide stable foundation for roadway, stable streambank for future events, flood bench where feasible
- Provide additional material for construction
- Crusher on-site to process in-place
- Brought-in crushed aggregate for roadway
- Woody debris added into site for grubbing materials woody debris left in place
