Use and Evaluation of the Critical-Depth Method for Estimating Peak Discharges in Mountain Streams

Robert D. Jarrett, Ph.D.

Flood and Paleoflood Science, LLC

GSA Rocky Mountain and Cordilleran

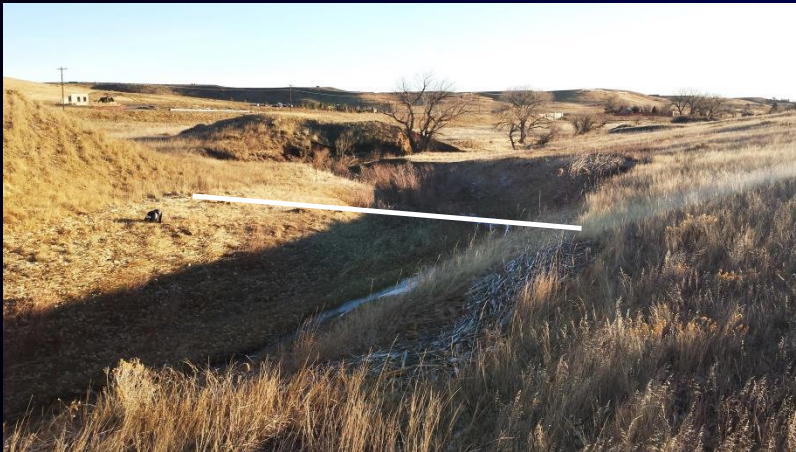
Leyden Creek

For stream slopes ≥ 0.01 ft/ft = 0.01 m/m

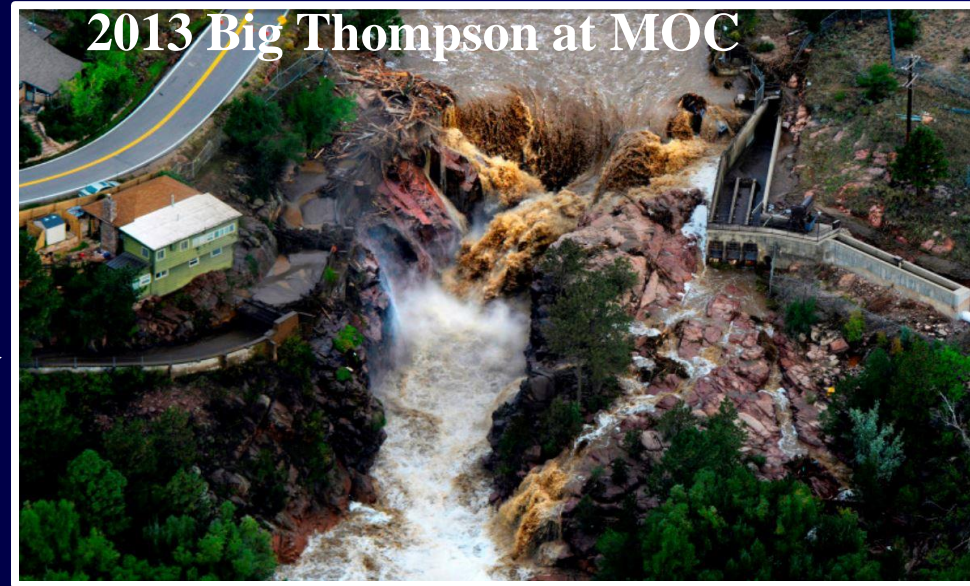
Critical-Depth Sites For Discharge

- Flow-over-road
- Weir/flumes
- Drops
- Waterfalls

Excellent controls for
stage-discharge relationships

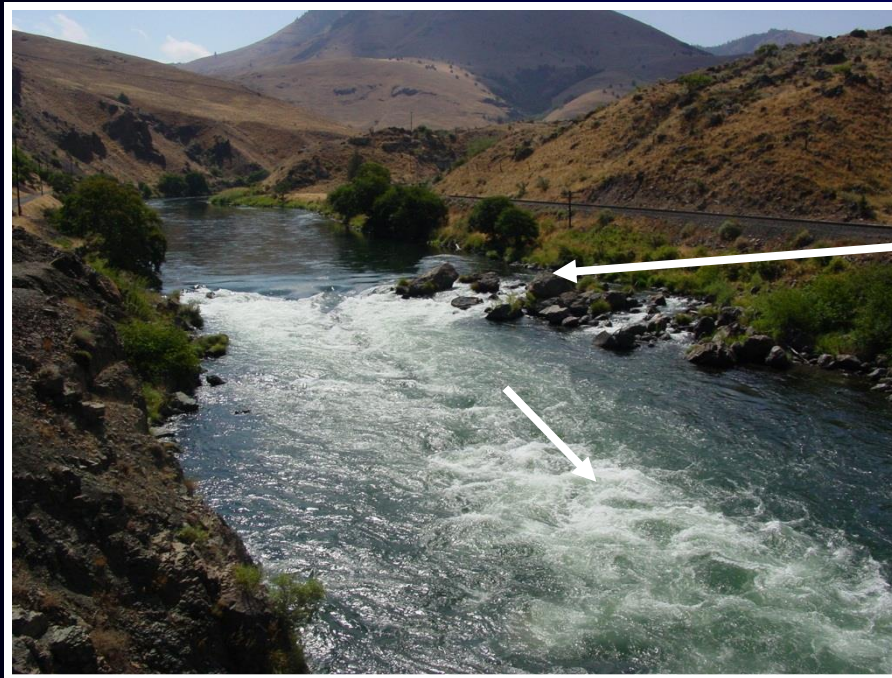
Critical depth - bedrock control

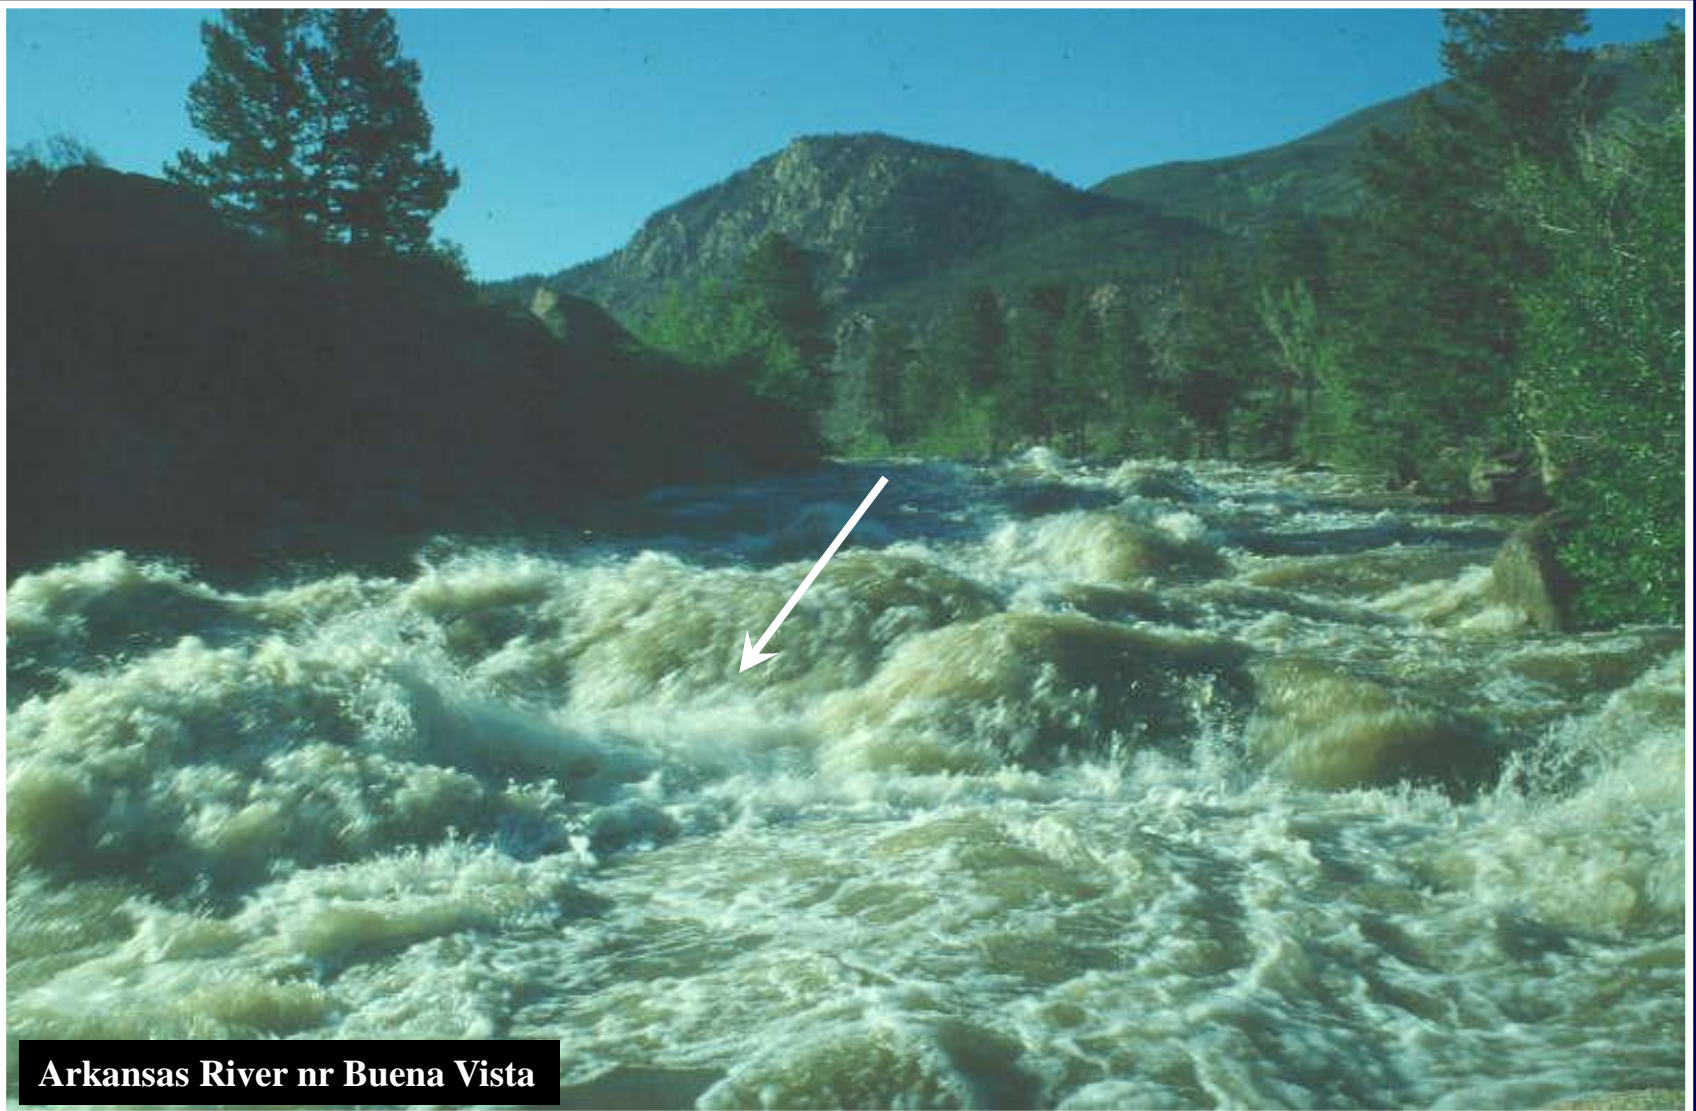
Arkansas River nr Buena Vista

Value of Using Critical-Depth Method

Long reaches of near critical flow; Froude No. ~ 1 (Jarrett, 1984)

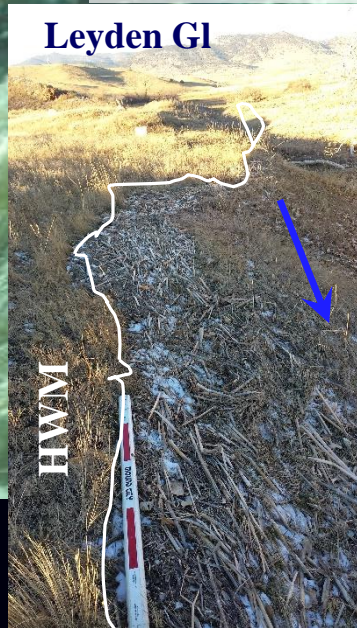
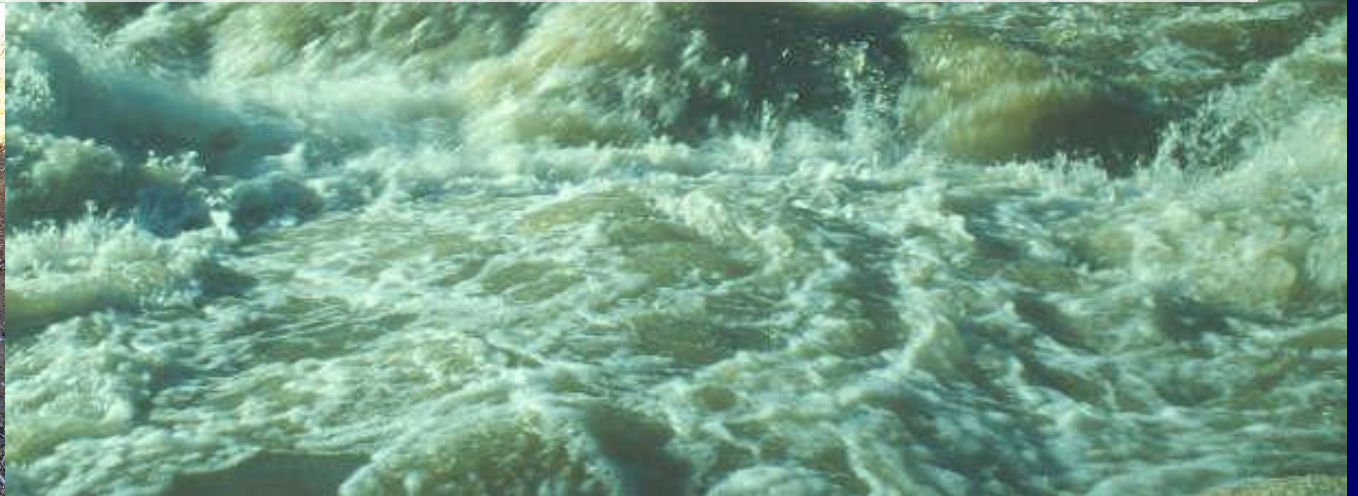
Little Thompson River (site 59B)

Attributes of a Flood Reach for Peak Discharge Estimation

1. Stream slope greater than ~ 0.01 m/m
2. Relatively straight channel (~ 15 m)
3. Relatively uniform width
4. Reach is stable or
5. Minor channel change can be evaluated
6. Minimal obstructions (debris, boulders, trees)
7. Good high-water marks

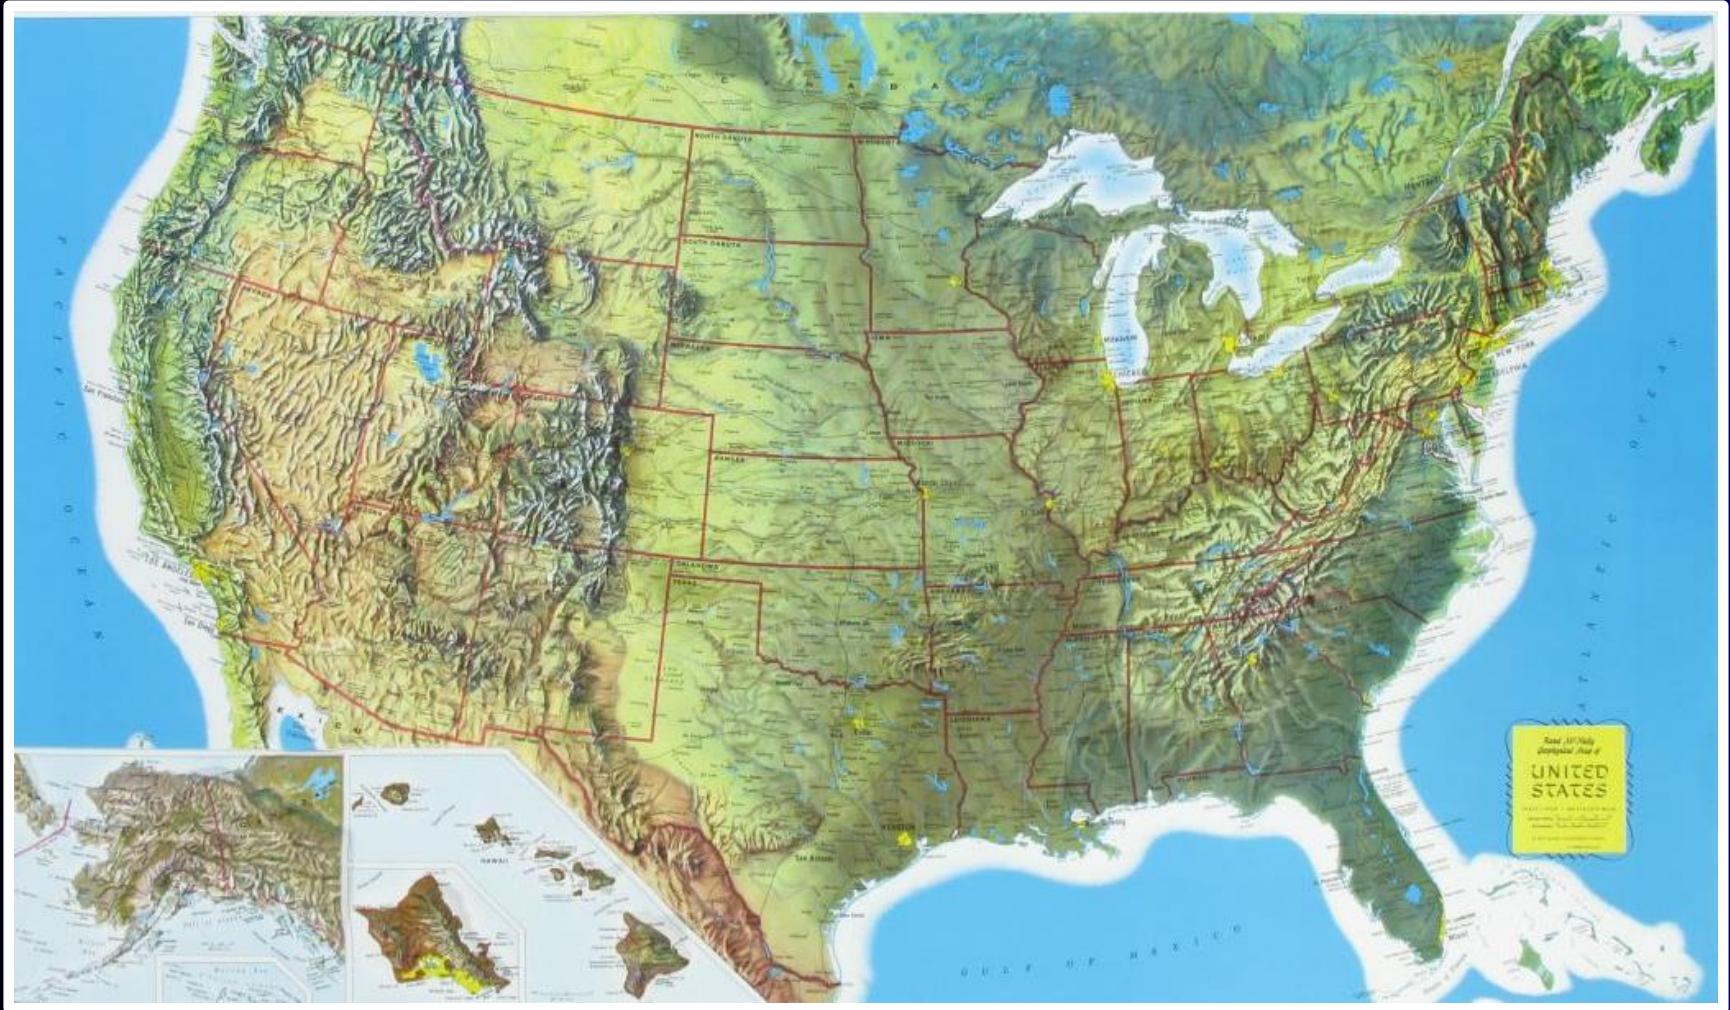
Mountain streams ($S \geq 0.01$ m/m) comprise about 25 % of United States

Thus, they are amenable for use of the critical-depth method

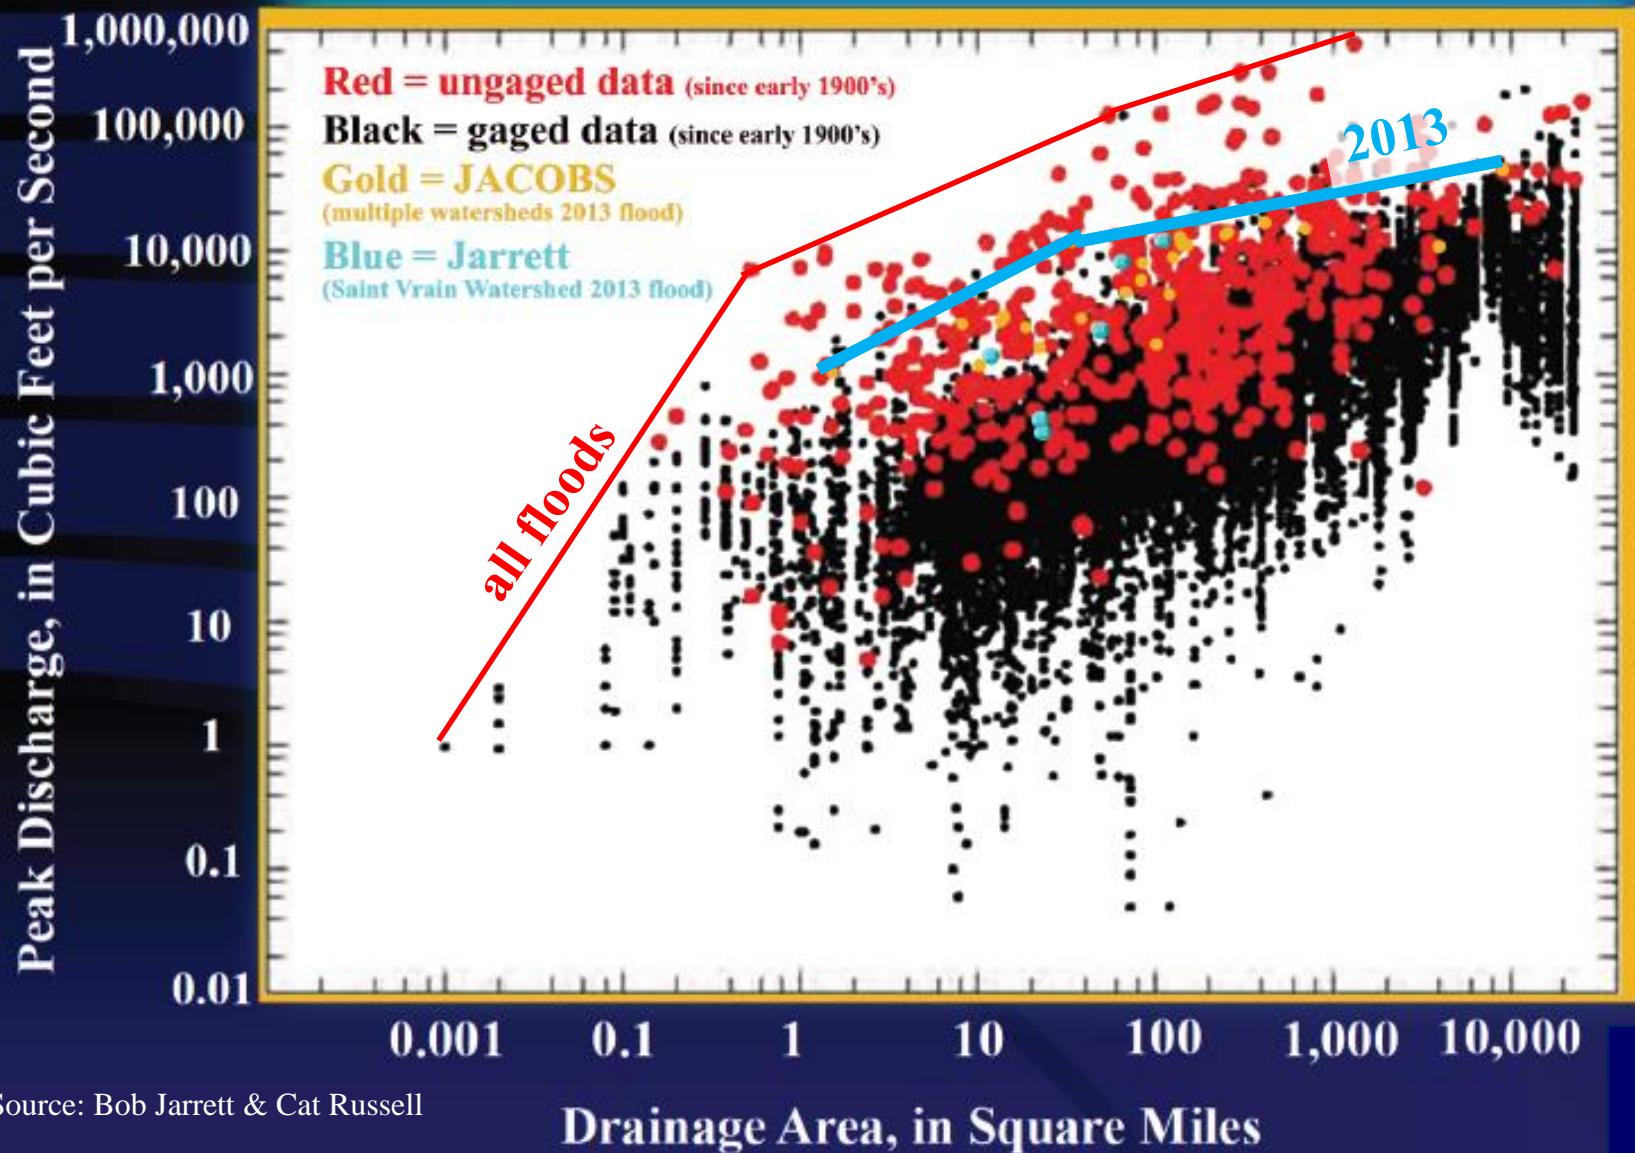
2013 Floods in Perspective of Other Colorado Floods vs Saint Vrain Creek basin 2013 Floods
