A BACI study of river restoration with large-wood additions using PIT-tagged tracer particles to access bed-sediment mobility on the Narraguagus River, Maine

Narraguagus River, Maine USA: Atlantic salmon restoration

BACI: Before, After Control, Impact

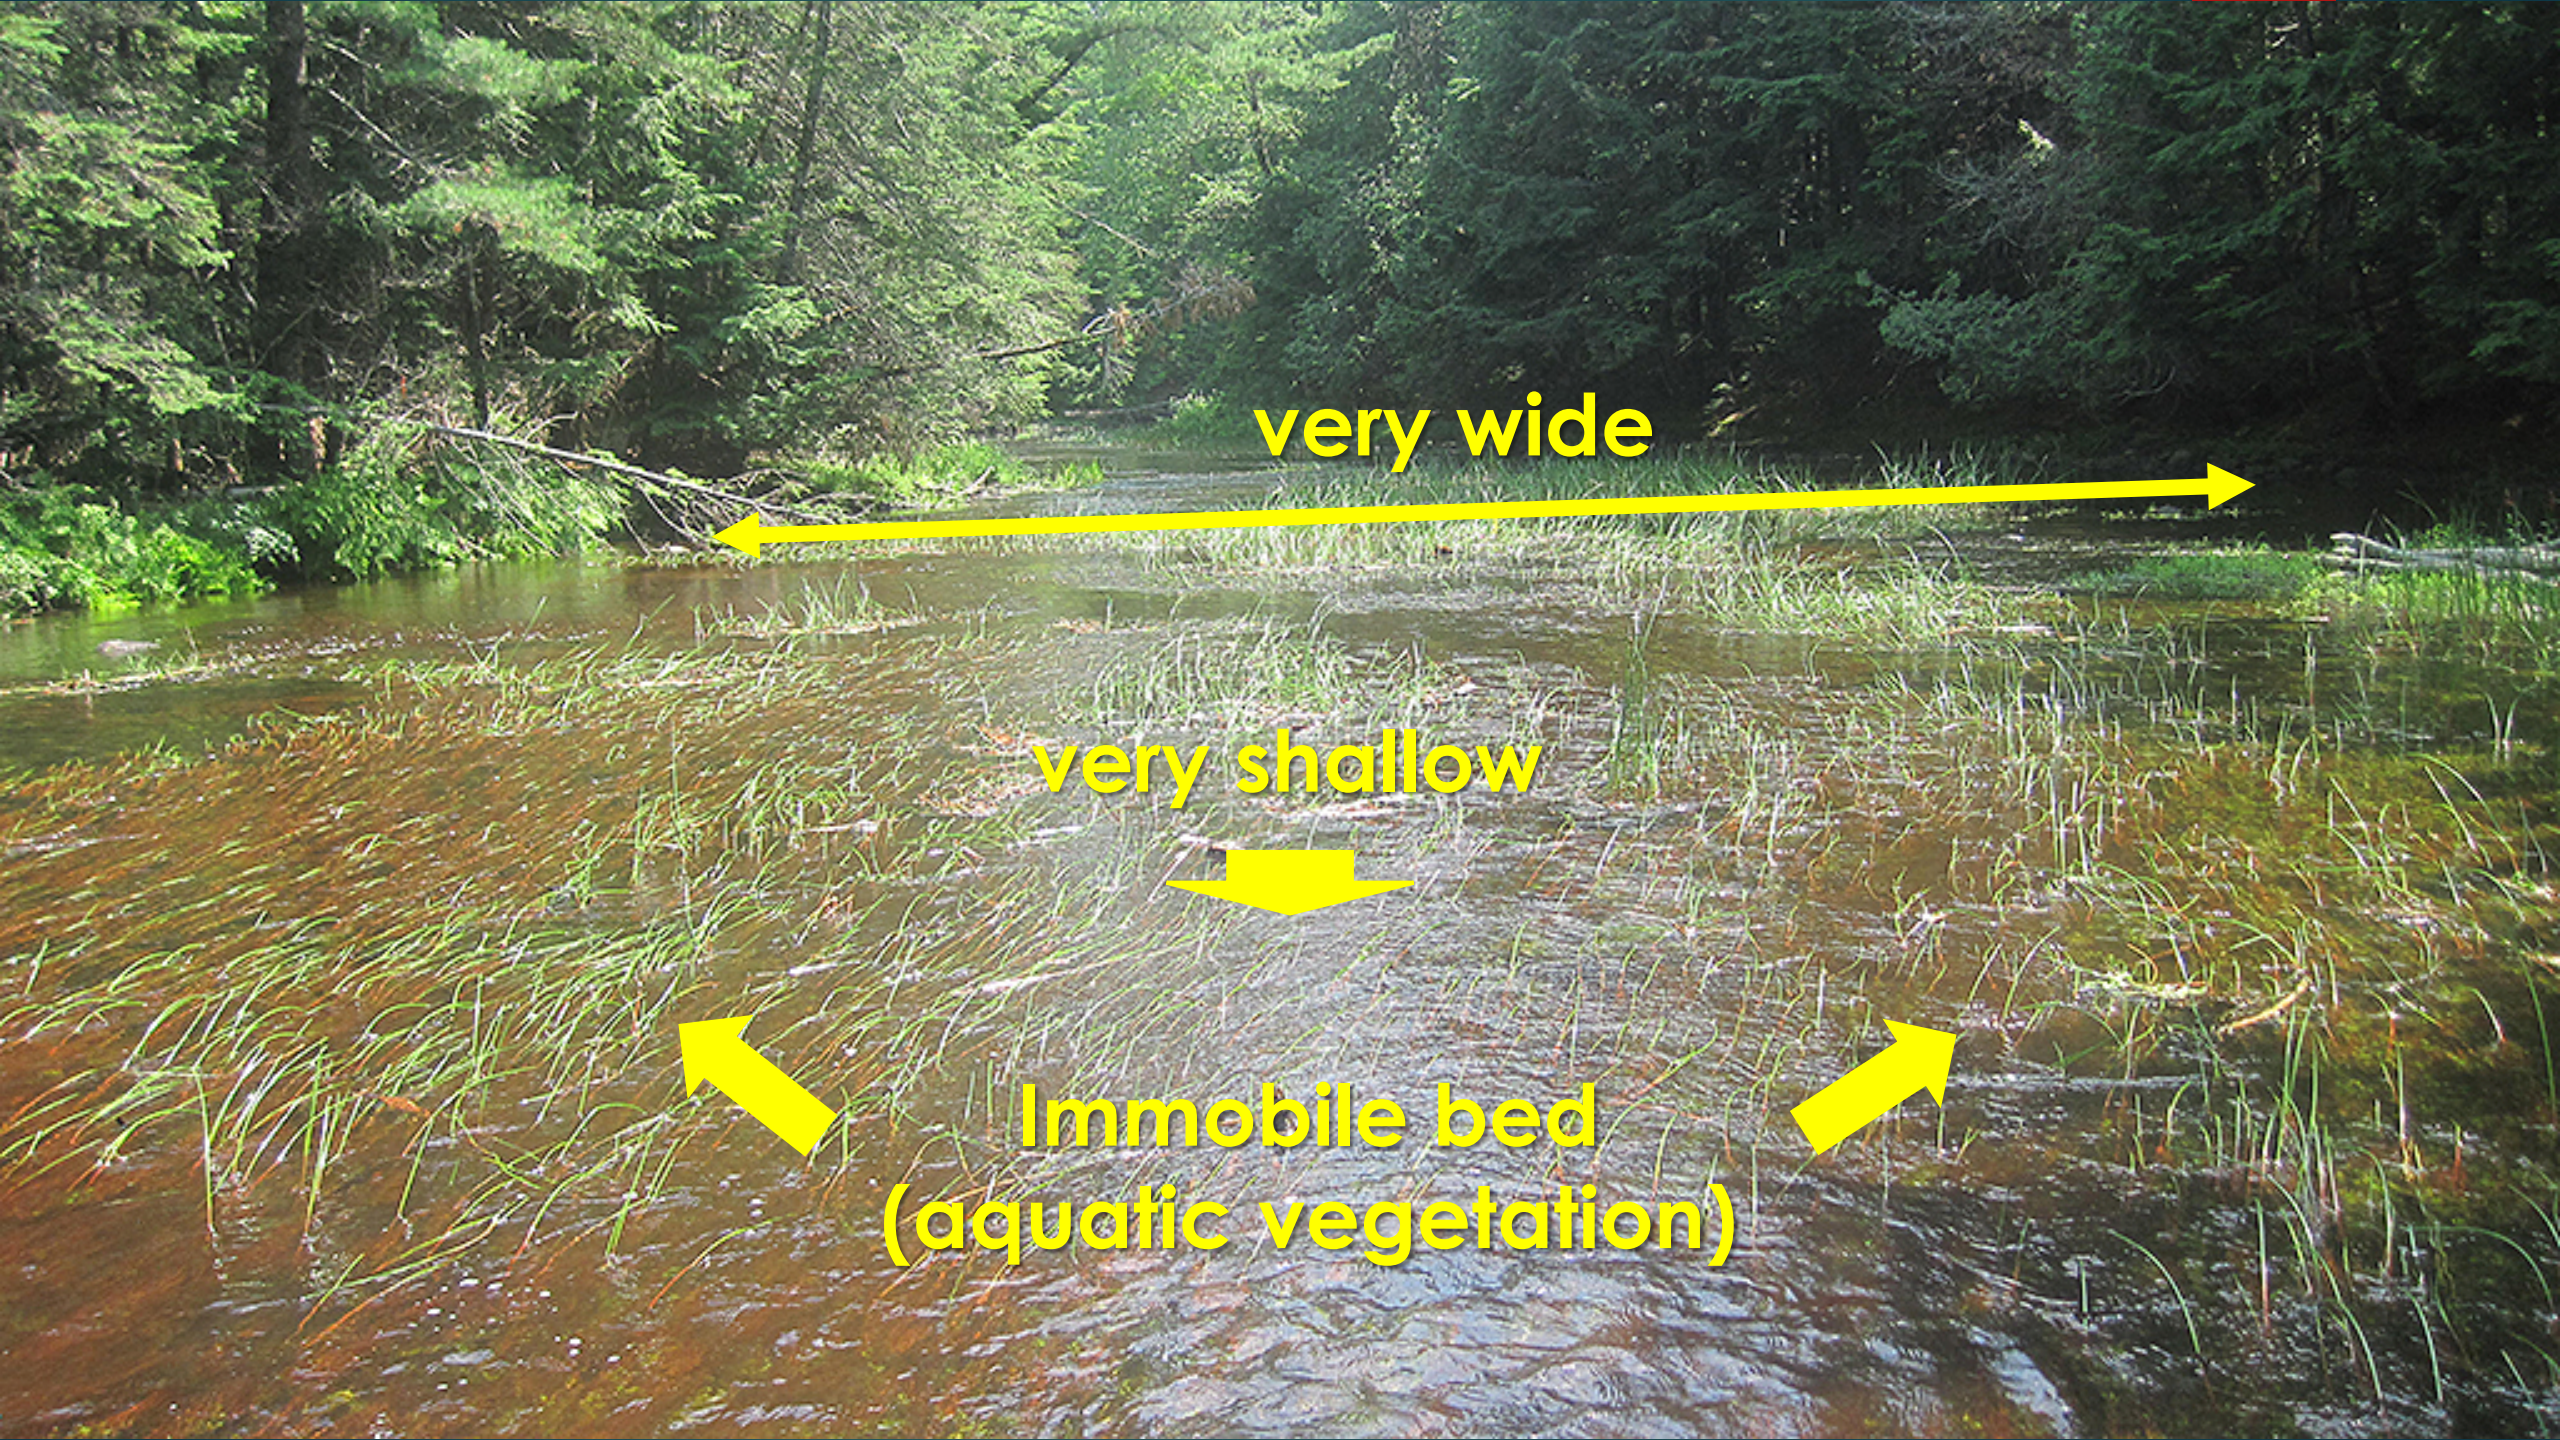
very wide

very shallow

Immobile bed
(aquatic vegetation)

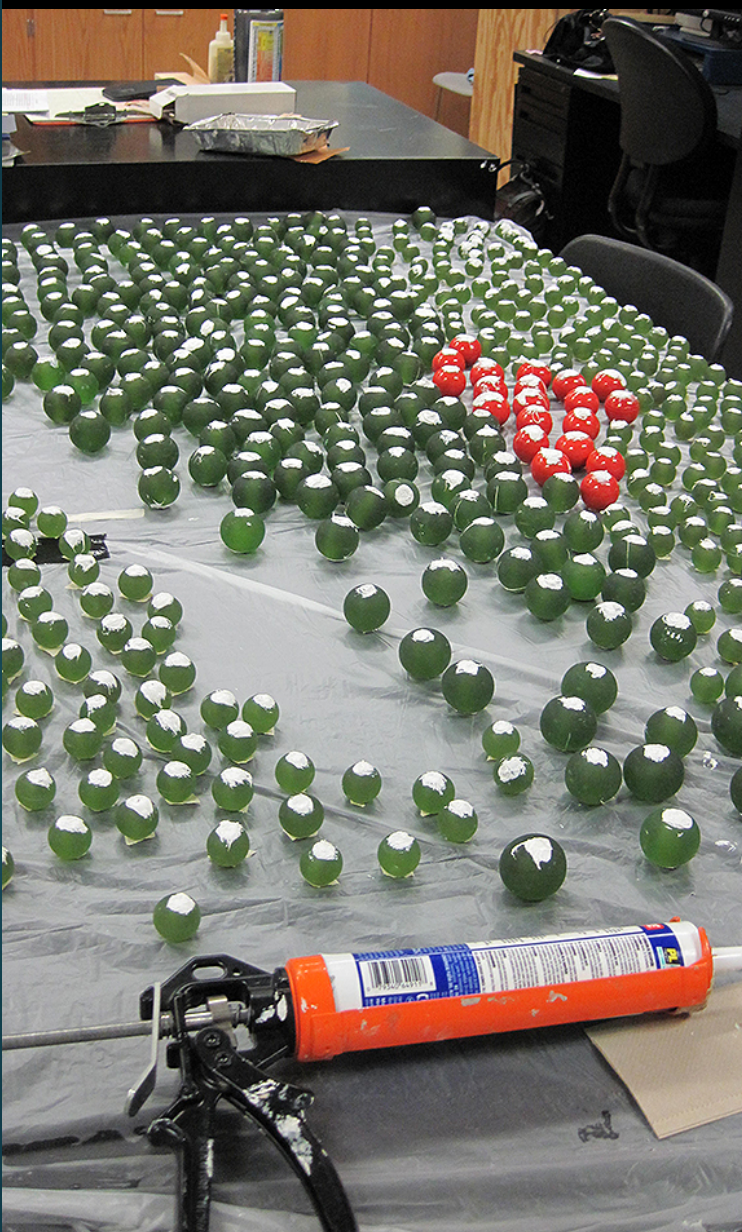
PIT Tag Tracer Particles

June-July 2016

- 10 cross-sections with 20 particles/cross-section
- Alternate 28-mm and 40-mm PIT-tagged particles
- Cross-section elevation surveys
- Embeddedness estimates along cross-sections

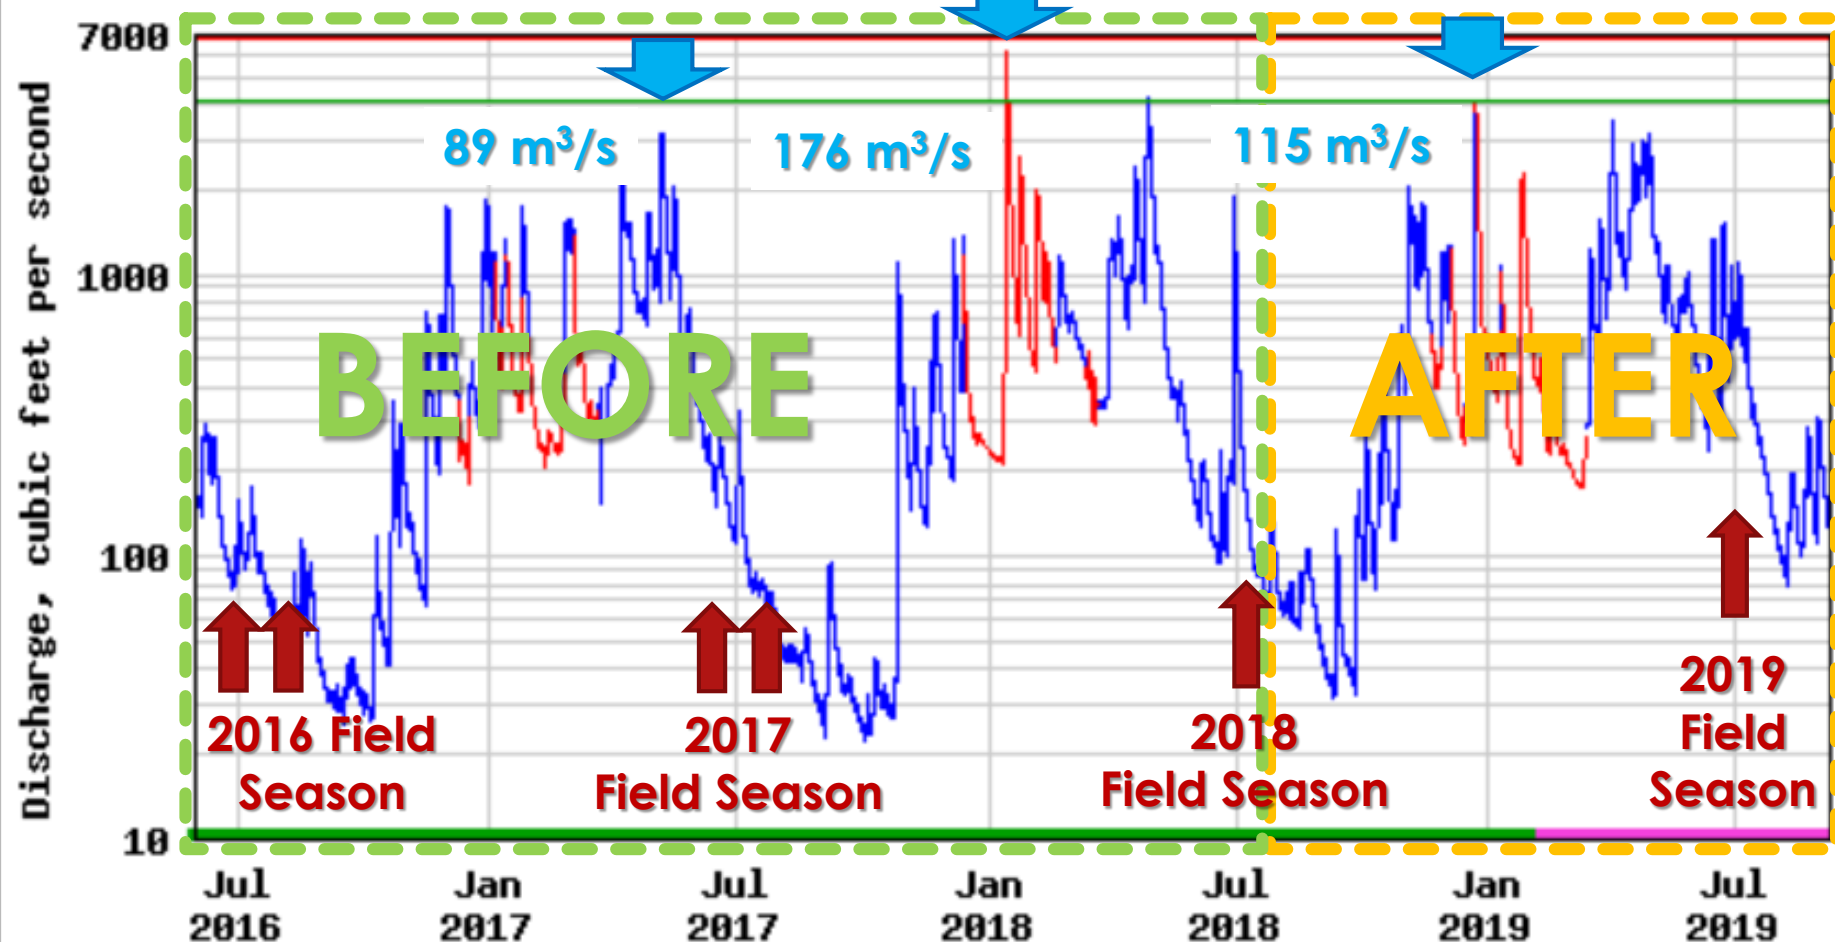
USGS 01022500 Narraguagus River at Cherryfield, Maine

- Discharge
- Estimated discharge
- Period of approved data
- Period of provisional data
- 10 Year Peak Flow *
- 2 Year Peak Flow *

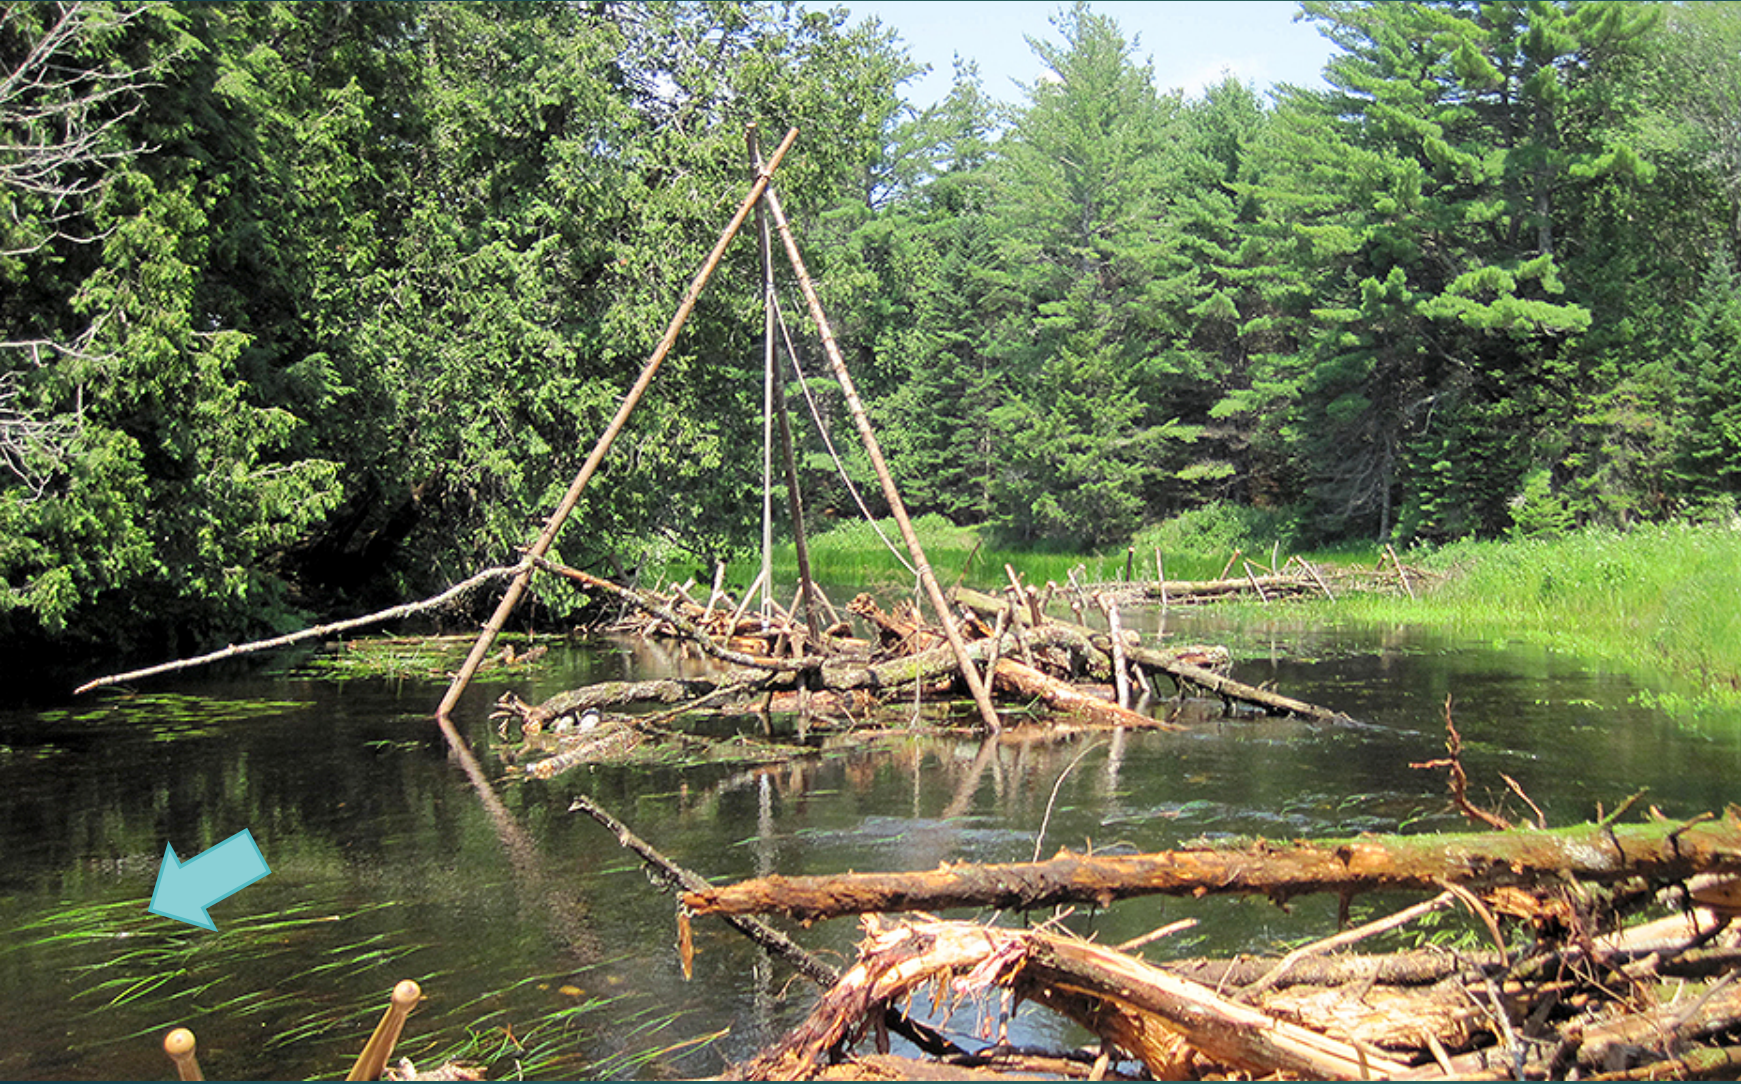
Treatment (IMPACT): July 2018

Post-Assisted Log Structures (PALS)

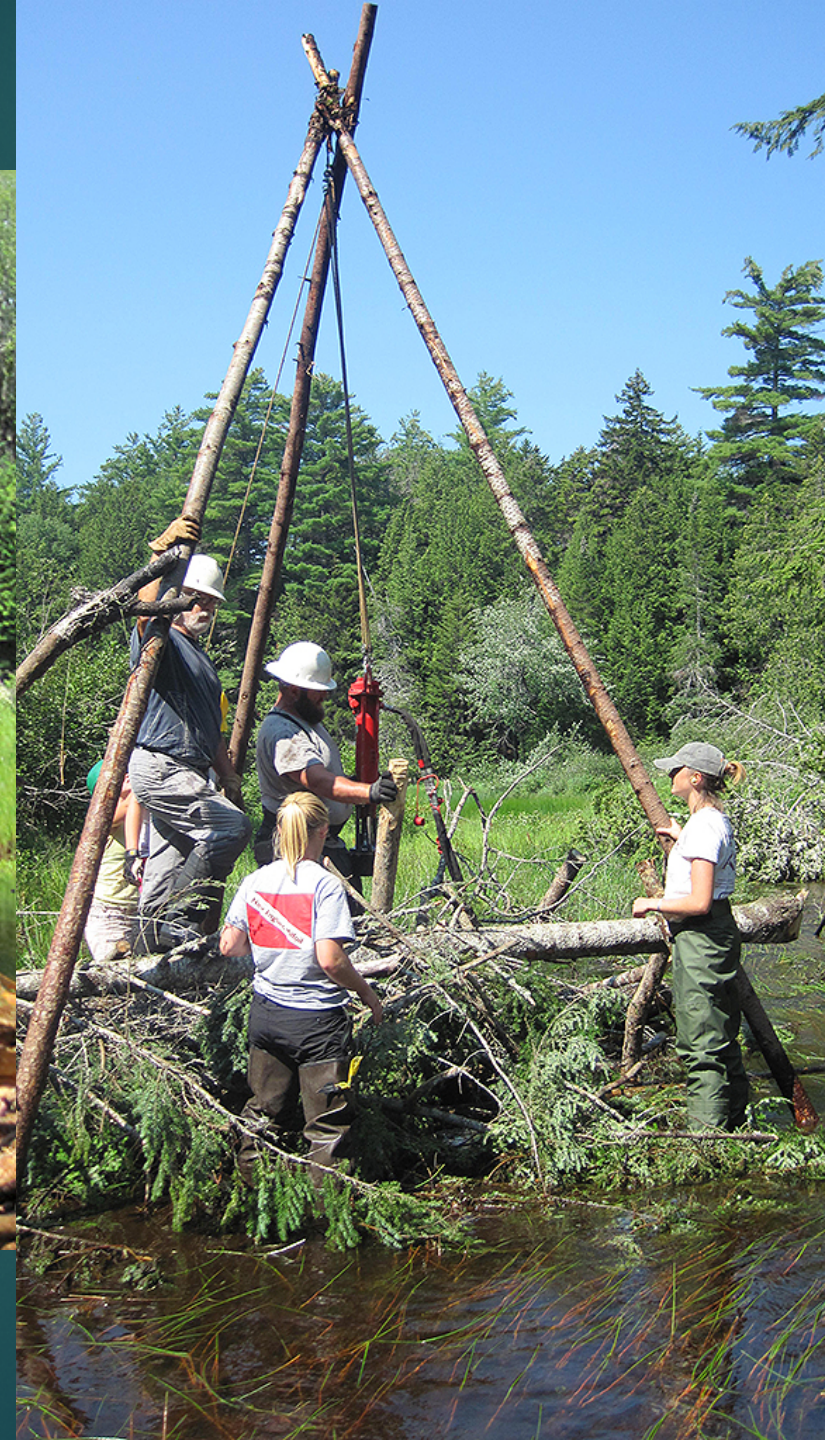
Treatment (IMPACT): July 2018

- The Narraguagus River is overly wide and shallow due to past logging activities
- Particle mobility is limited even during a large flood
- Particle entrainment rates between 28 mm and 40 mm particles are similar (equal mobility?)
- PALS additions did NOT impact entrainment rates, but DID increase particle step lengths in the treatment reach
