USE OF CONTINUOUS WATER QUALITY SENSORS TO EXAMINE HEADWATER RESPONSE TO SNOWMELT: JEMEZ RIVER, JEMEZ MOUNTAINS, NM

AXNESS, Abigail, CROSSEY, Laura J., MCGIBBON, Chris, SMITH, Kent, ALBONICO, Micael, PARMENTER, Robert R. and COMPTON, T. Scott, (1)
Department of Earth & Planetary Sciences, University of New Mexico, Albuquerque, NM (2) Valles Caldera National Preserve, Jemez Springs, NM

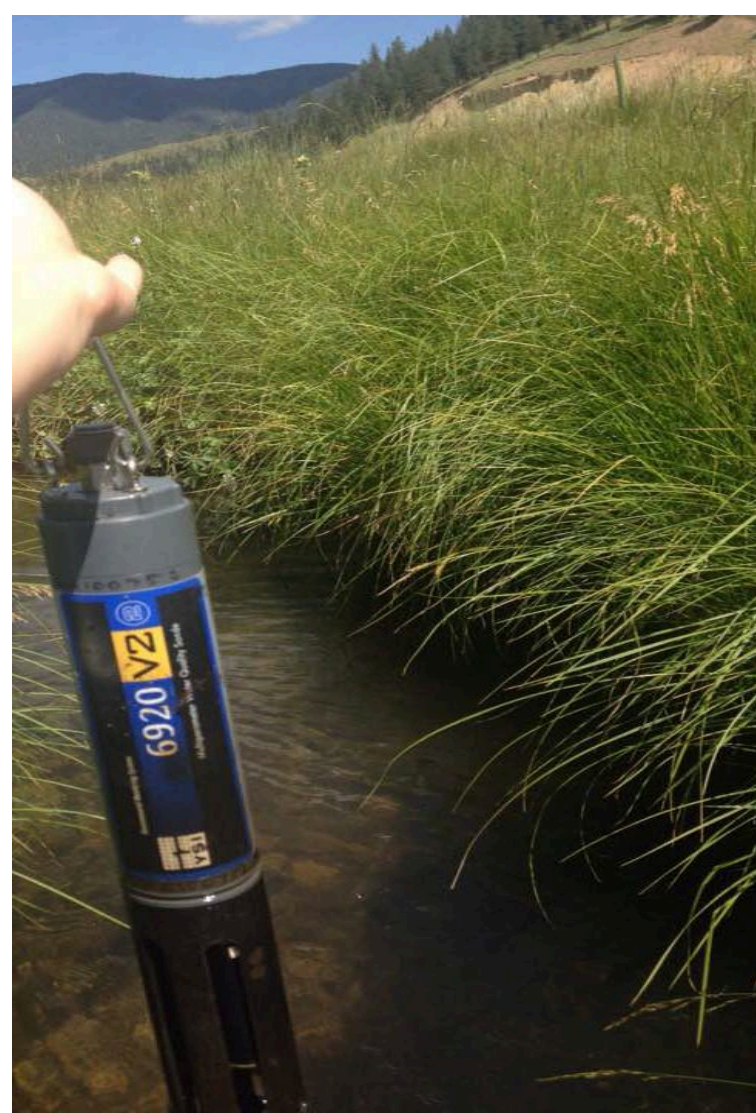
Fig 3. Yellow Springs Instrument (sonde).

- Measurements of temperature, dissolved oxygen (DO), pH, and turbidity were taken using Yellow Springs Instruments continuous monitoring sensors (Figs 3 & 4).
- We report on two consecutive years at 15 minute intervals between May and October in 2018 and 2019.
- Autonomous sensors are calibrated and maintained every three weeks.
- Analysis performed using the AQUARIUS (Aquatic Informatics), Excel, and MATLAB data platform.

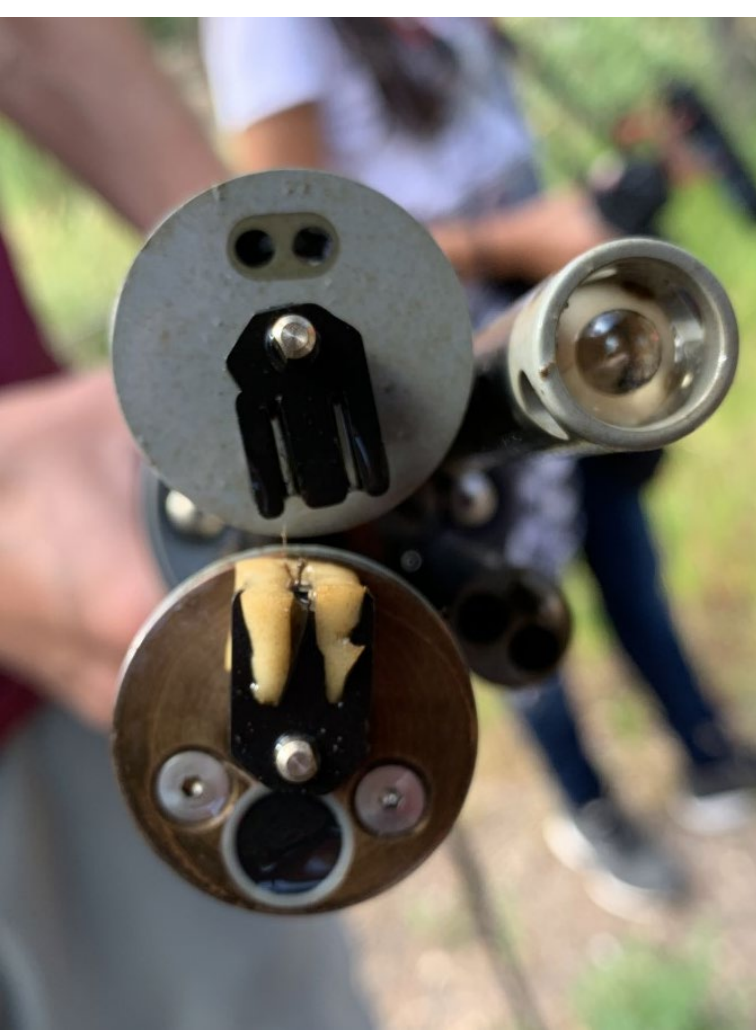
Fig 4. Bottom view, wipers that periodically clear the sensors.
