Soil Profiles in Bioswales: Implications on Soil Development and Bioswale Management

**LABIB S. SAMALI¹, Zhongqi Cheng¹, Kaitlin McLaughlin¹, Kohinoor Begum¹,
Peter Groffman¹, David Seidemann¹, Salvatore Engel-Dimauro², Olga Vargas³,
Richard Shaw¹**

1. Brooklyn College of The City University of New York
2. SUNY New Paltz
3. USDA NRCS

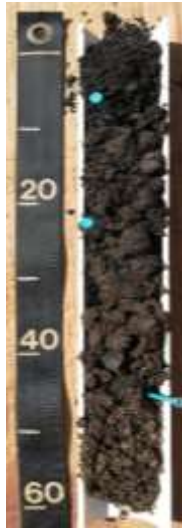
Union ETP

(extracted soils using an auger, field described)
