Electrical Resistivity Imaging (ERI) beneath Sinkholes and Suspect Sinks: Implications for Karst Risk Assessment in Clark County, Ohio

Michael J. Zaleha & Cole S. Benning

Department of Geology, Wittenberg University, Springfield, Ohio 45501-0720
mzaleha@wittenberg.edu

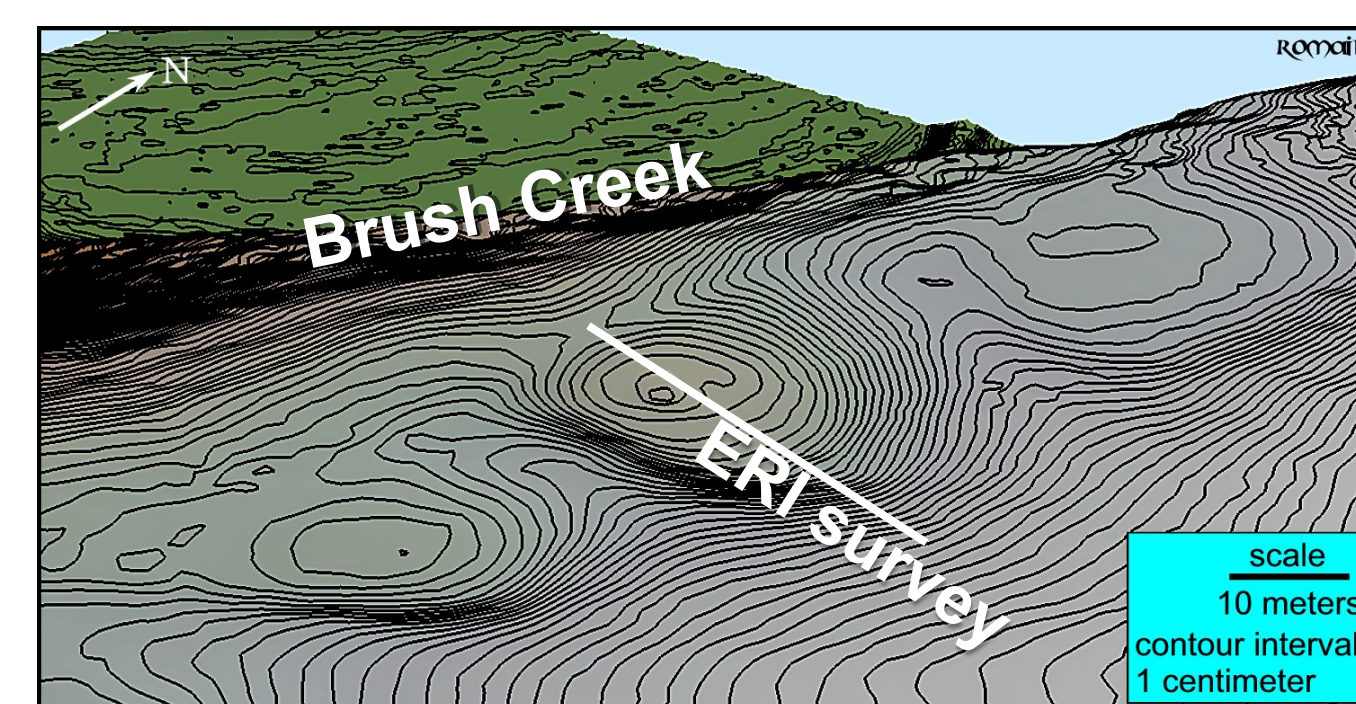
Zaleha and Romain (2014) conducted a prior study that examined suspect **sinkholes in Adams County**, Ohio (see Ohio Karst Areas map above for location). **Left. Topographic map** of the area showing the three **depressions** examined. Map was constructed from LiDAR data. **Below**, Example of **ERI results** which show an anomaly in the bedrock beneath one depression indicating that it is likely a **collapse sinkhole**. Bedrock is the Peebles Dolomite, equivalent to the Cedarville Dolomite that underlies the study areas in Clark County. Development of the initial void that resulted in sinkhole formation was likely related to the evolution of Brush Creek and its associated subsurface hydrology.

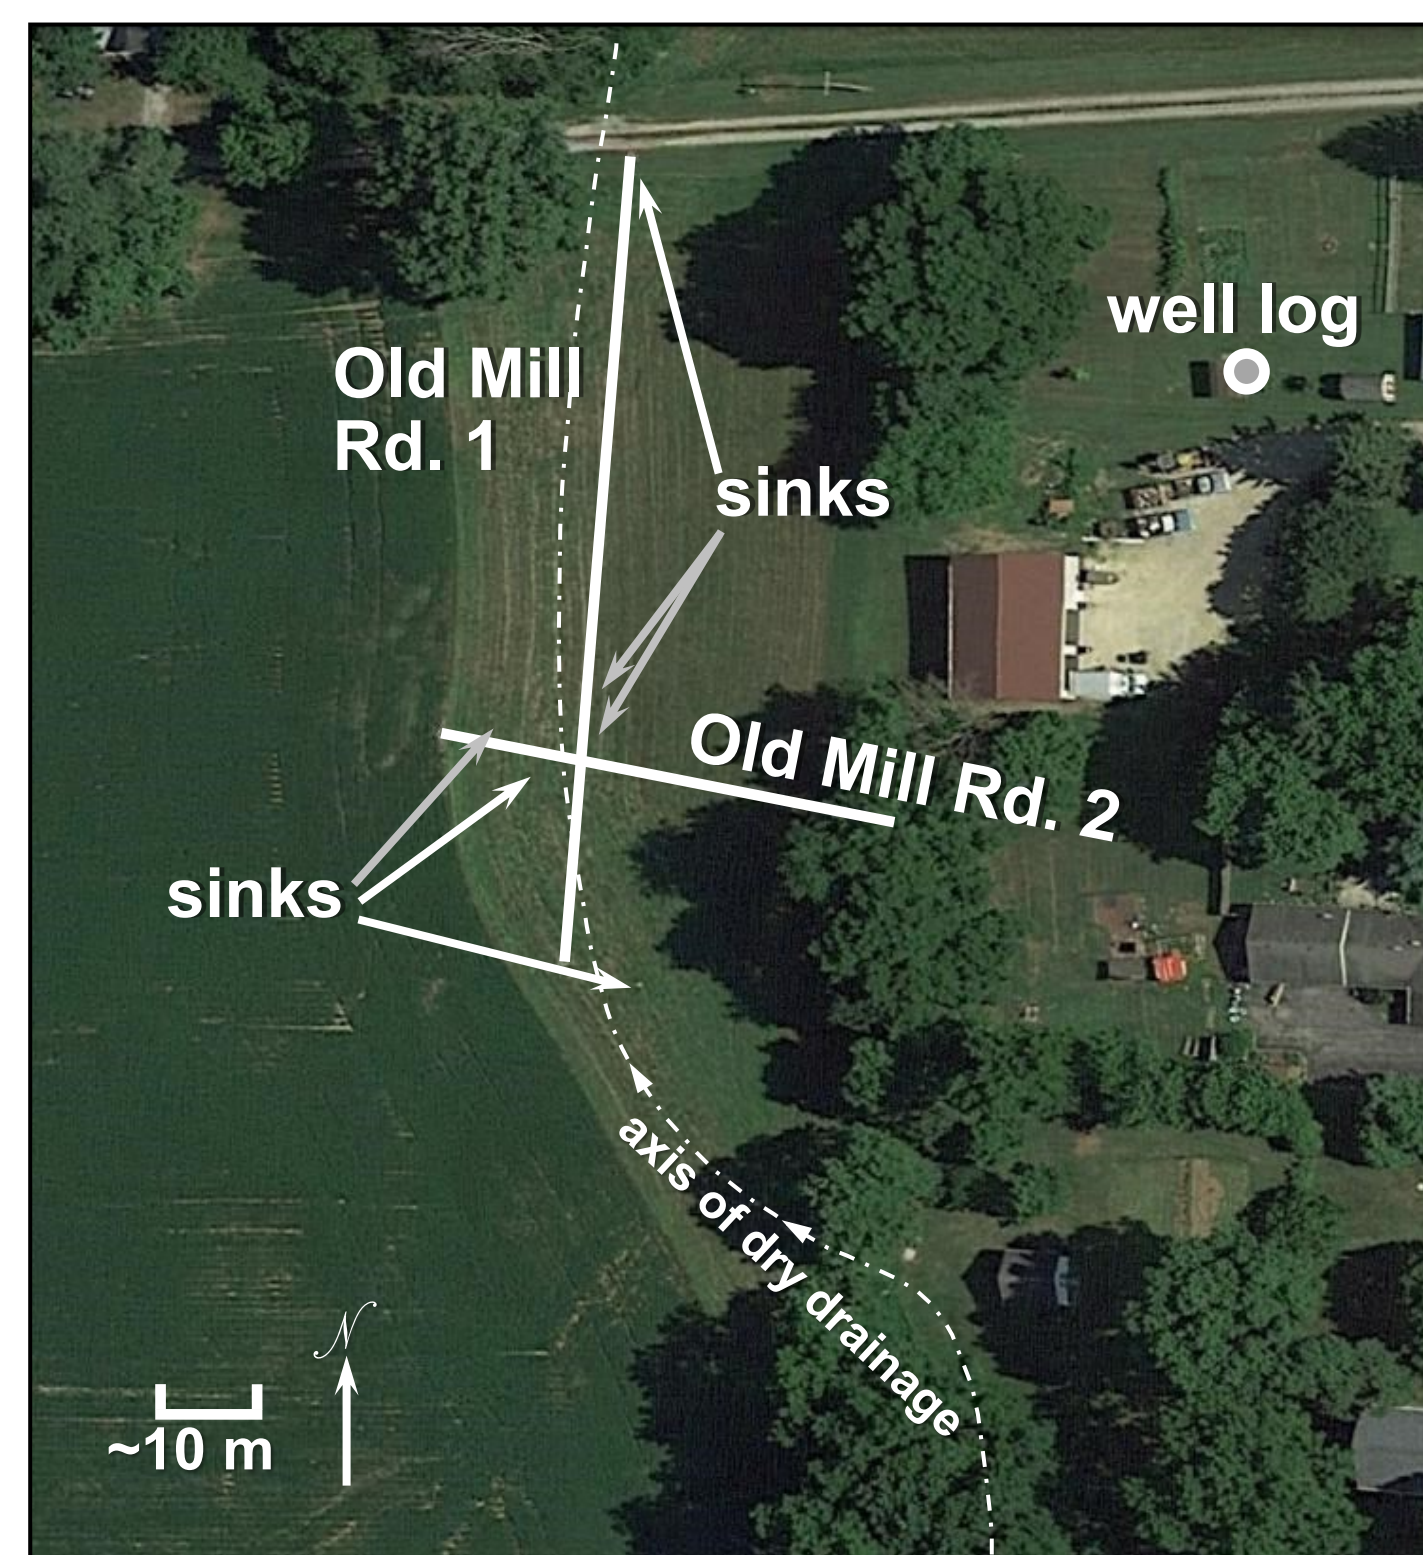
Aerial photo of the Old Mill Road site showing locations of **ERI surveys, sinkholes**, axis of the **dry drainage** and a nearby **well log**. Sinkholes identified in the Division of Geological Survey report are shown with white arrows. Sinkholes that developed since the report was published are shown with gray arrows. Image from Google Earth.

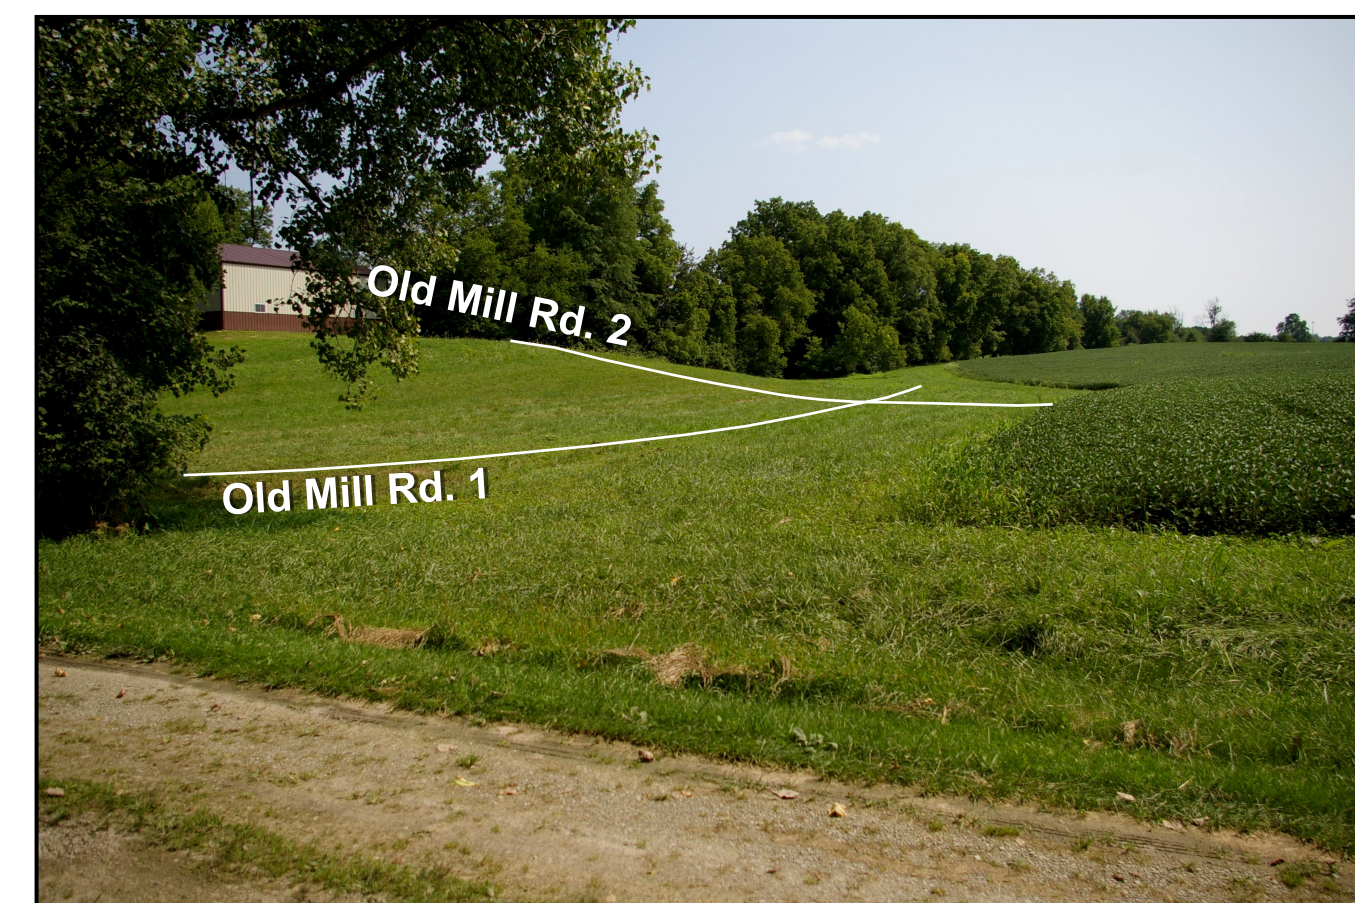
The **Old Mill Road site** showing approximate locations of the ERI surveys. View to the south-southeast looking up the dry drainage.

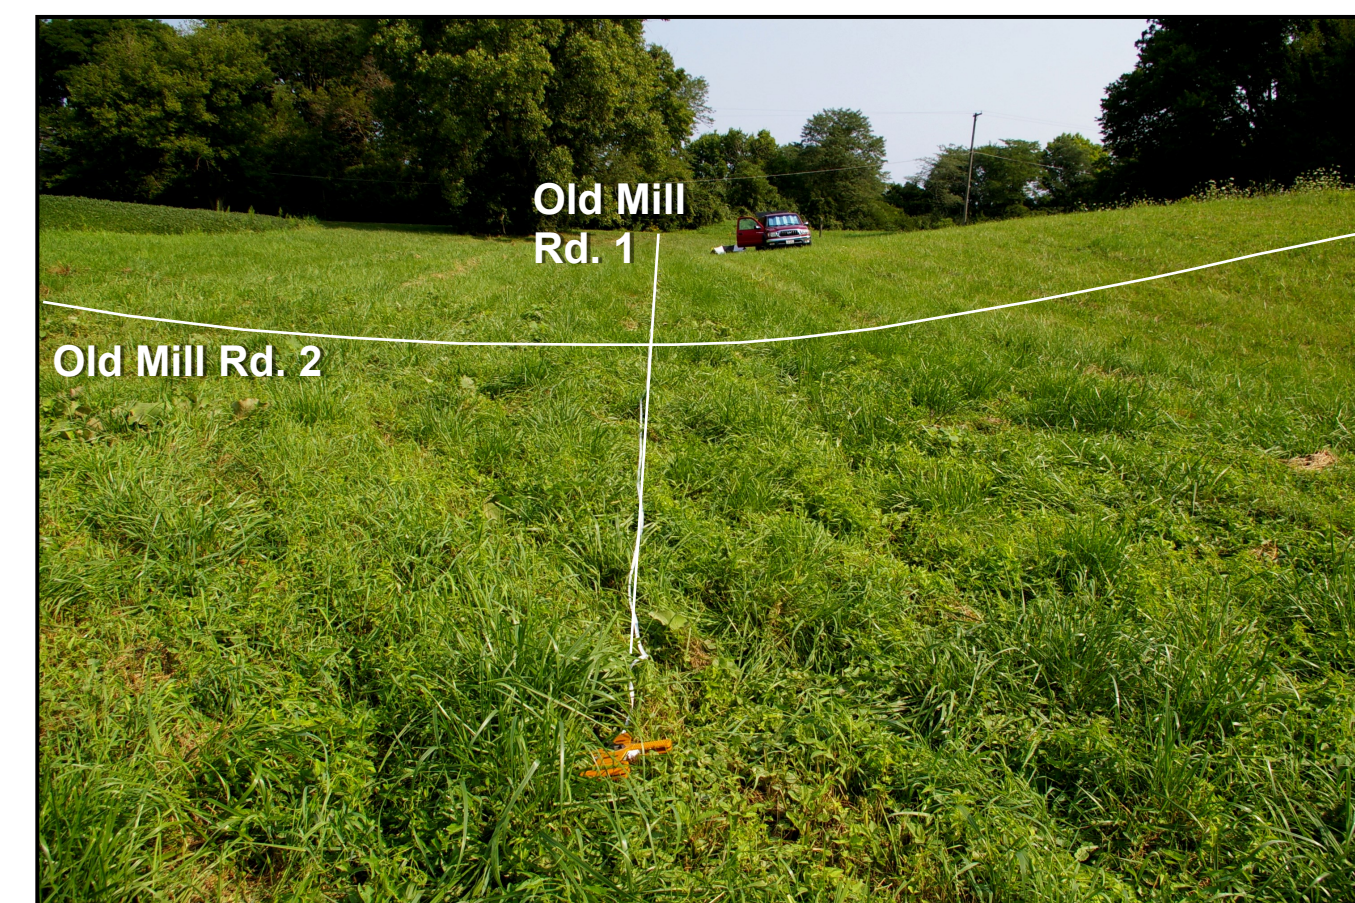
The **Old Mill Road site** showing approximate locations of ERI surveys. View is to the north looking down the dry drainage and corresponds with that of the ERI figure below.

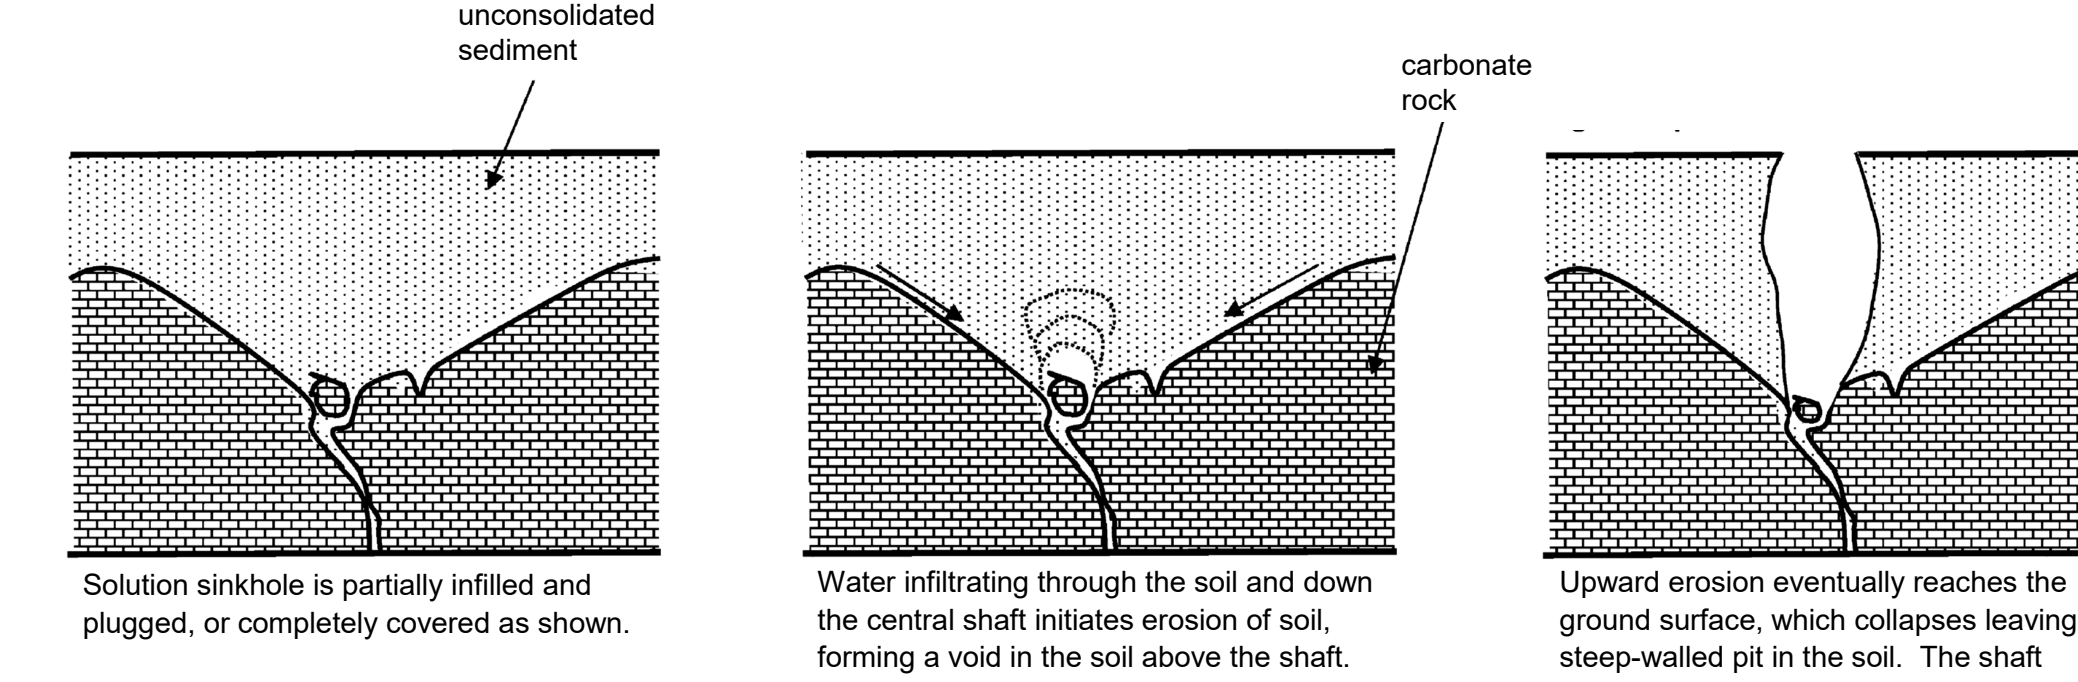
Sinkholes at the Old Mill Road site are likely **cover-collapse sinkholes**, formed by the above process (from Zhou et al., 2002), associated with subsurface water flow confined by bedrock topography of the dry drainage.

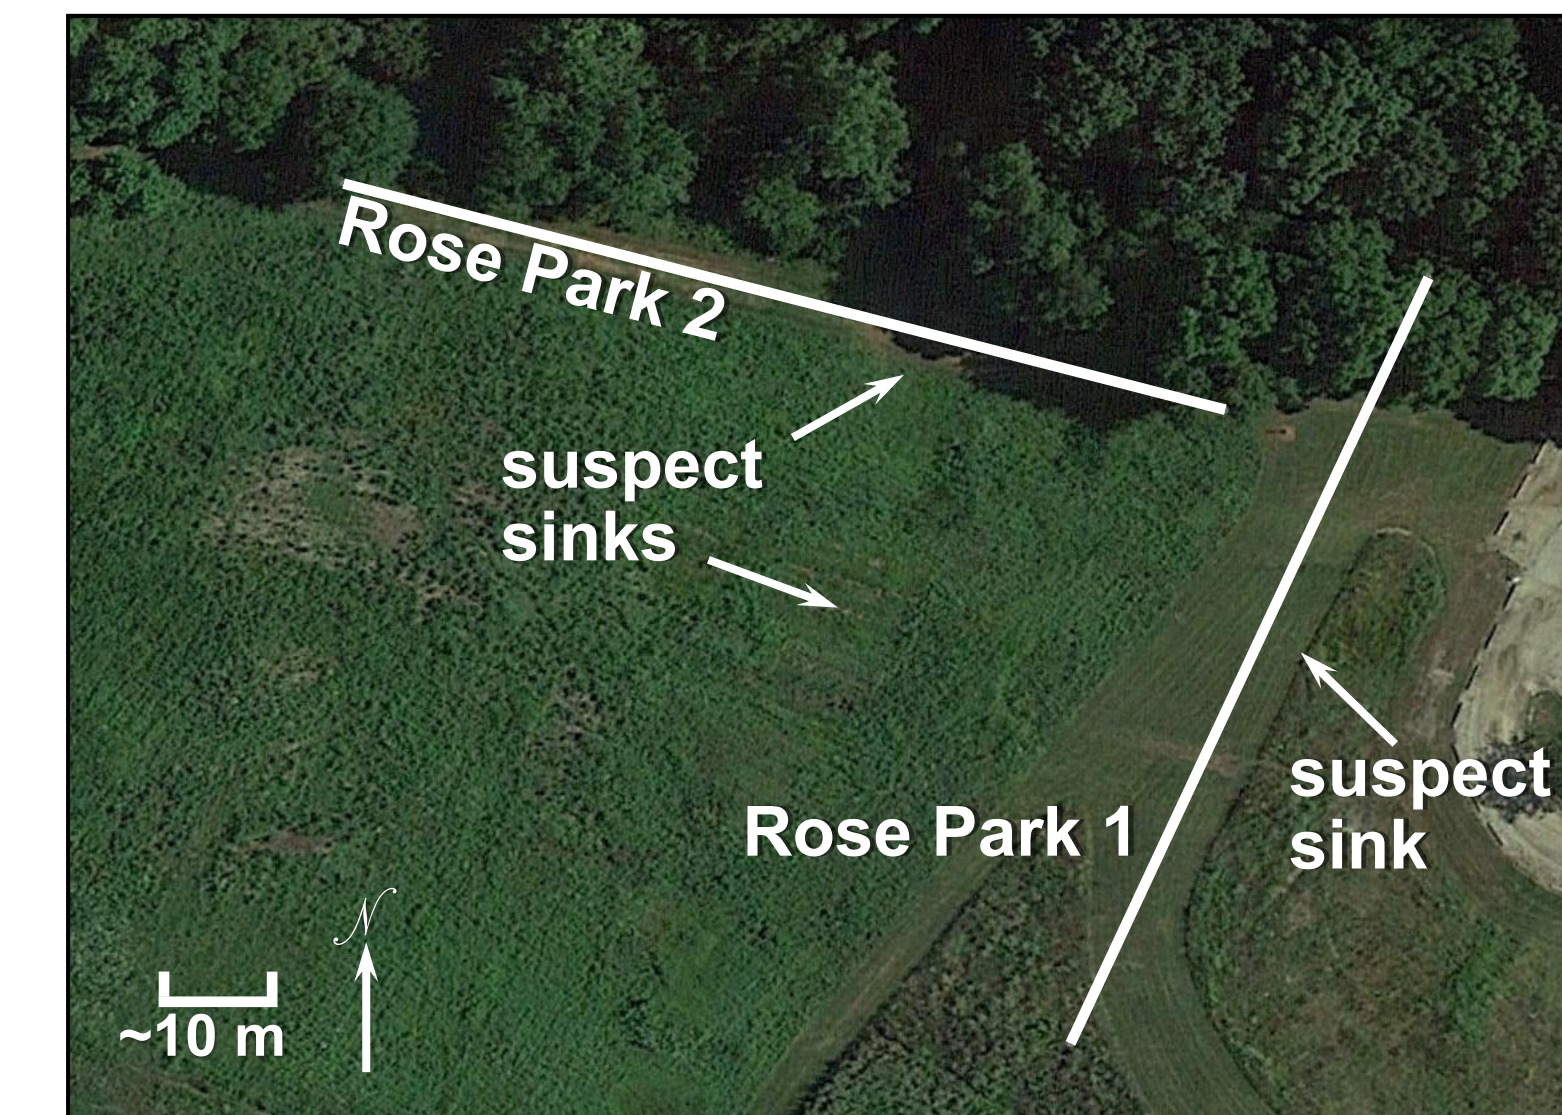
Aerial photo of the Rose Park site showing locations of **ERI surveys** and **suspect sinkholes**.

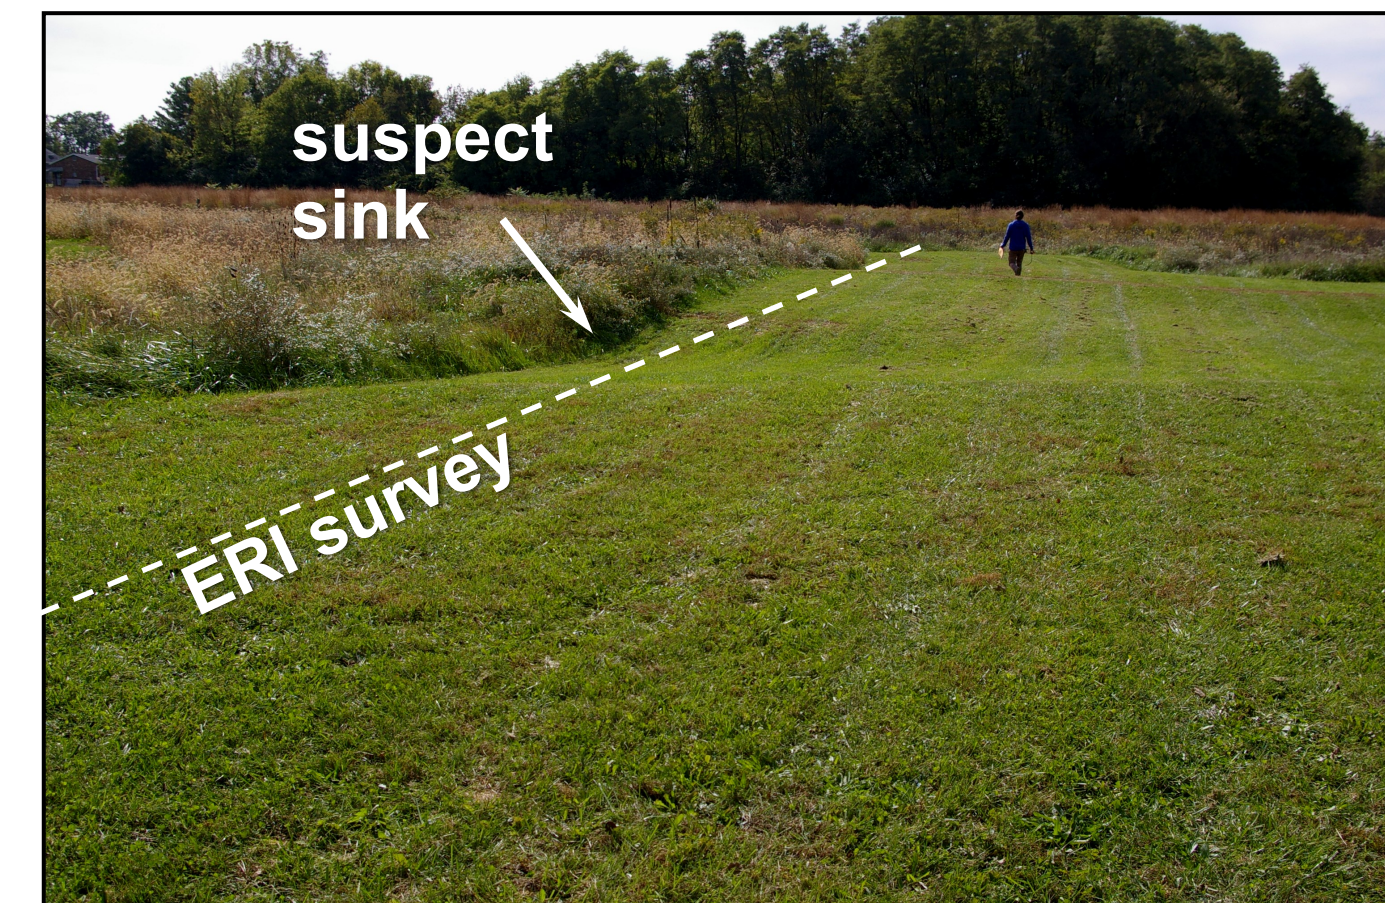
The site of **Survey: Rose Park 1** showing location of survey line and suspect sink. View is to the south.

Bedrock was not intercepted in this survey, consistent with nearby well logs which indicate depth-to-bedrock in this area ≥ 18 m. Most karst features in Clark County occur where depth-to-bedrock is ≤ 8 m. It is unlikely that the **suspect sink** is related to any bedrock feature and, hence, is **not a sinkhole**. The depression does correspond with a change in the underlying sediment and may be the result of differential compaction or, more likely, a cultural feature (see historical aerial photo, below-right). Depth of water table is from a nearby well log.

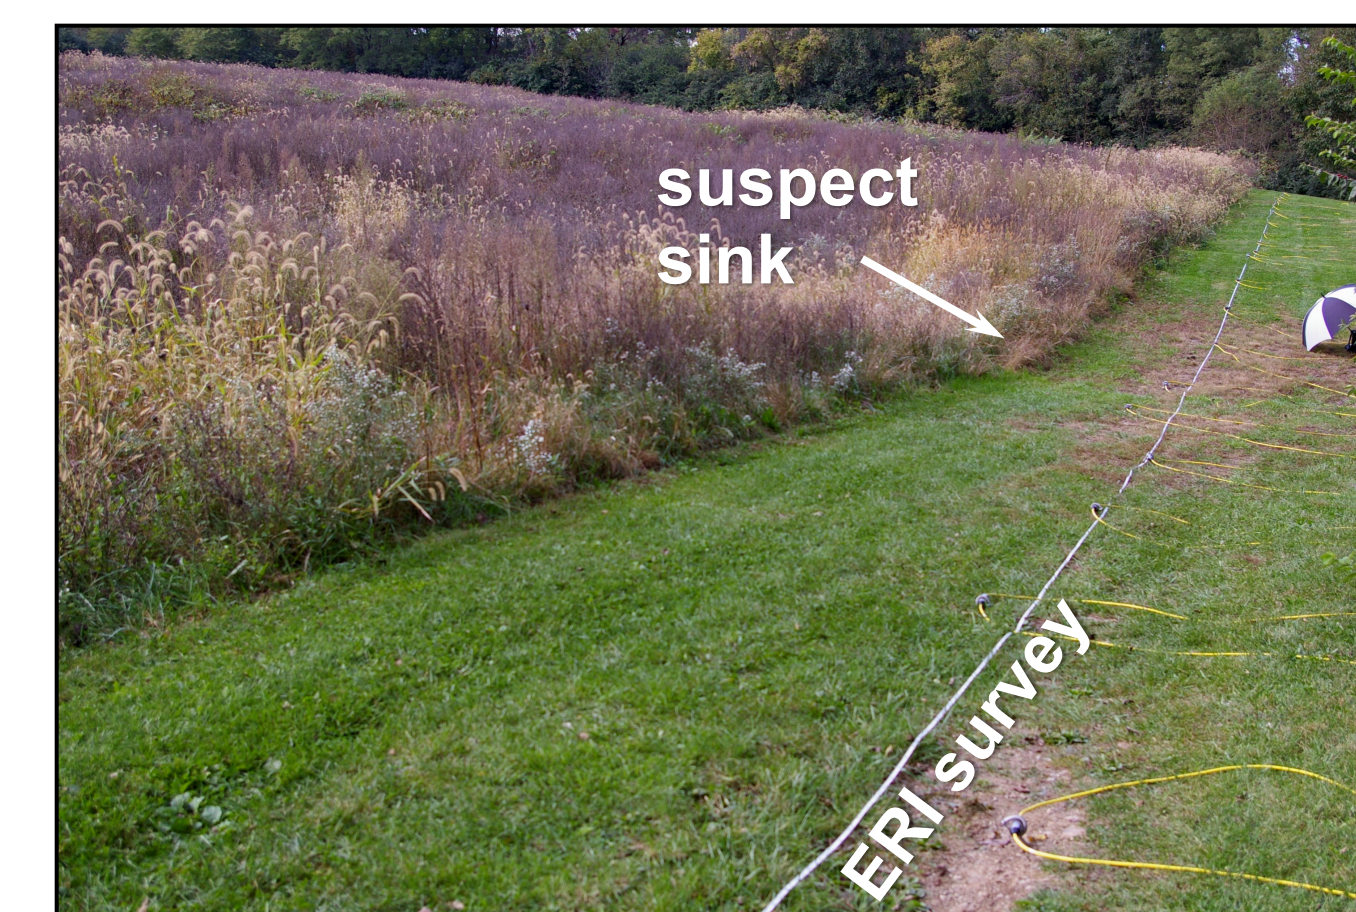
The site of **Survey: Rose Park 2** showing location of survey line and suspect sink. View is to the west.
