# ENGINEERING GEOLOGY'S ROLE IN REOPENING VERMONT'S TRANSPORTATION INFRASTRUCTURE IN RESPONSE TO CLIMATE CHANGE

*JAY R. SMEREKANICZ, P.G., C.P.G.  
SENIOR ENGINEERING GEOLOGIST  
SCARPTEC, INC.  
MONUMENT BEACH, MASSACHUSETTS  
[JAY@SCARPTEC.COM](mailto:JAY@SCARPTEC.COM)*

*VERMONT AGENCY OF TRANSPORTATION (VTRANS)  
HIGHWAY DIVISION | CONSTRUCTION & MATERIALS BUREAU  
GEOTECHNICAL ENGINEERING SECTION | GEOLOGY UNIT*

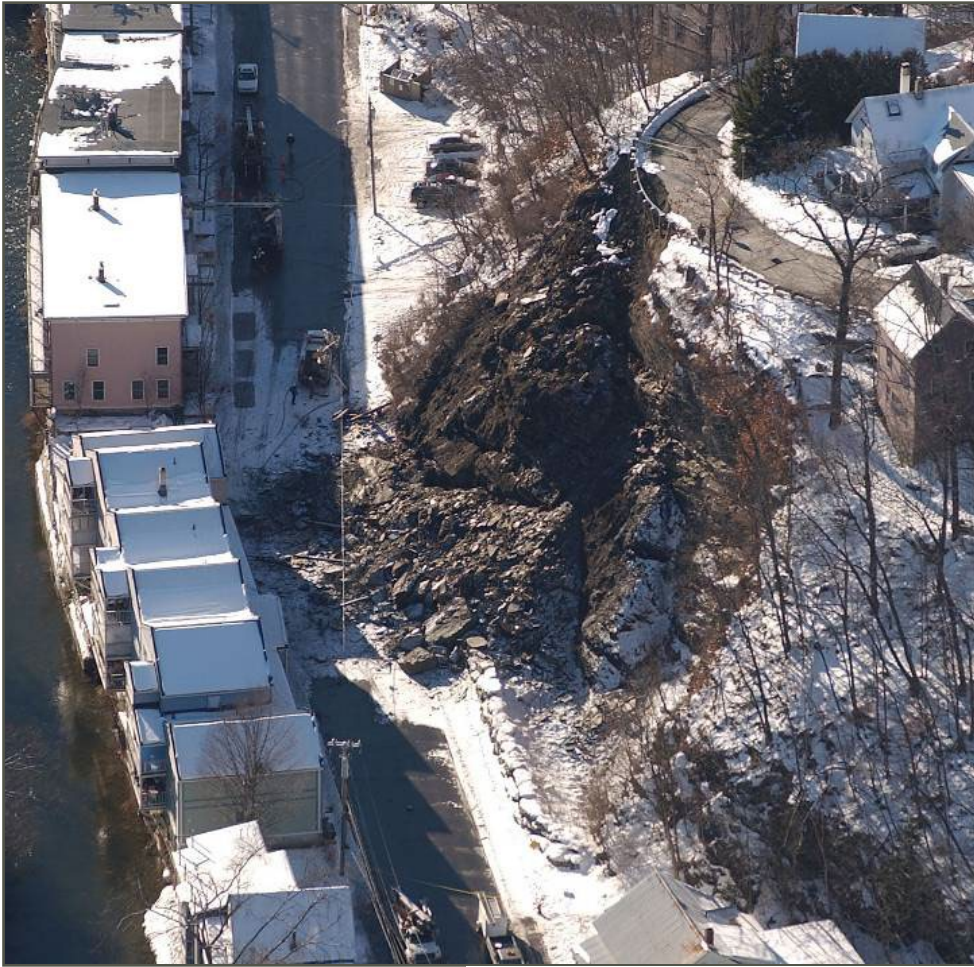
*Elm St. Rockslide, Montpelier,  
December 2005 (VTrans)*

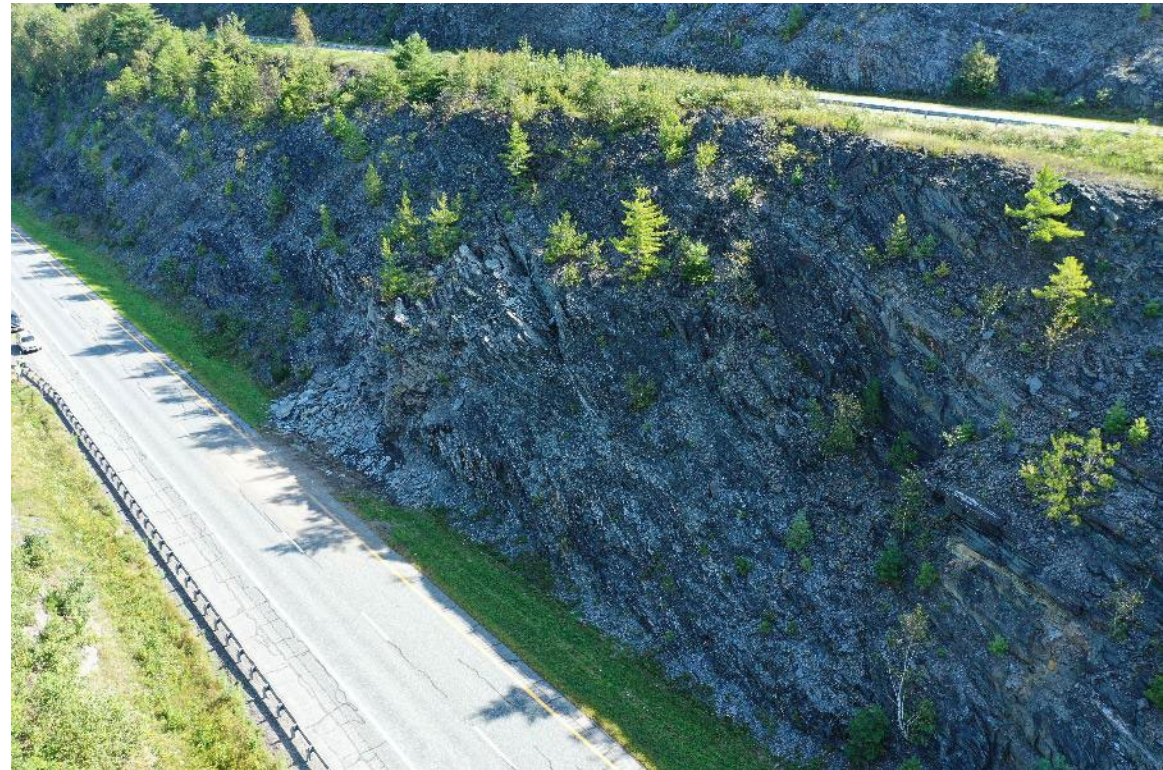
*I-91 SB, Fairlee, August 2023 (VTrans)*

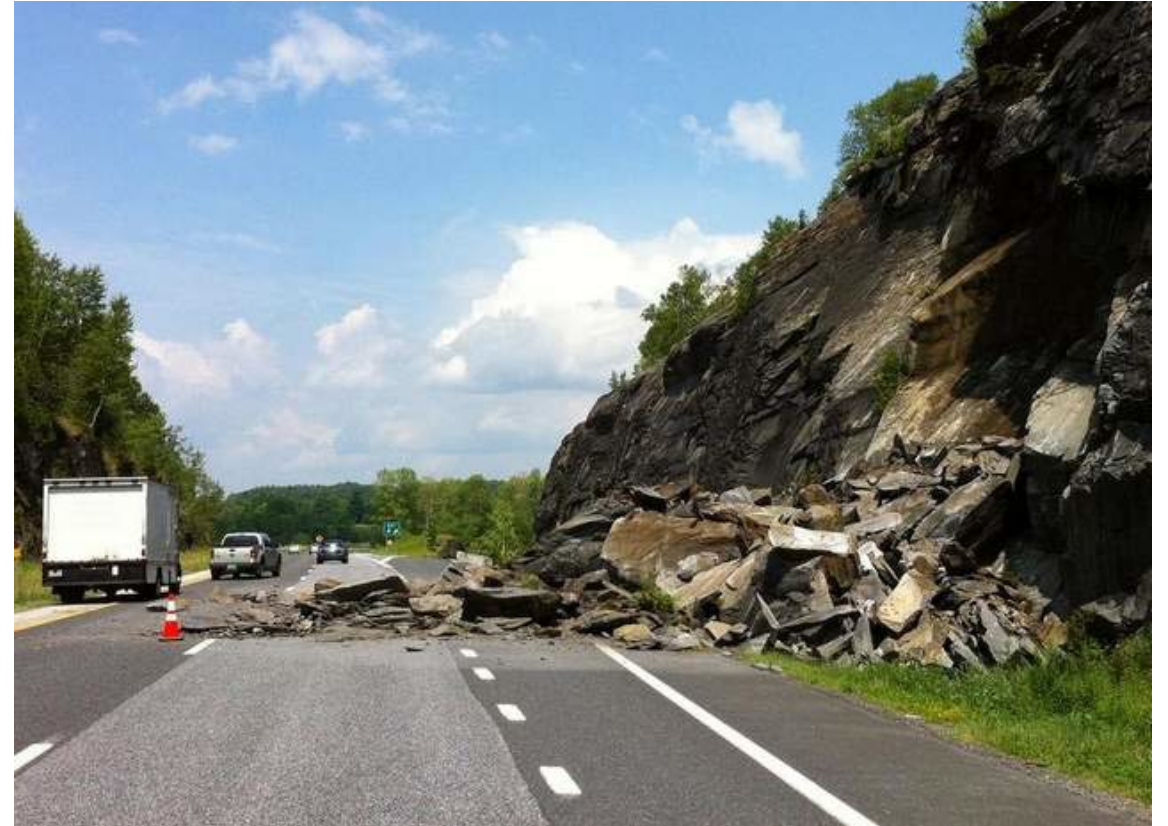
*I-89 NB, Berlin, July 2012 (VTrans)*

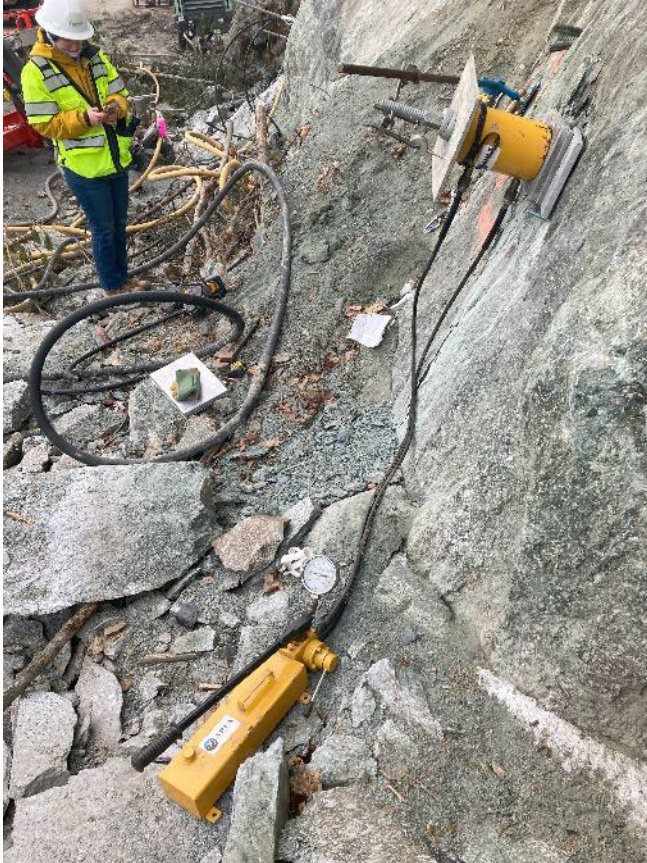
*Rock dowel pull testing, Fairlee (Scarptec, 2024)*

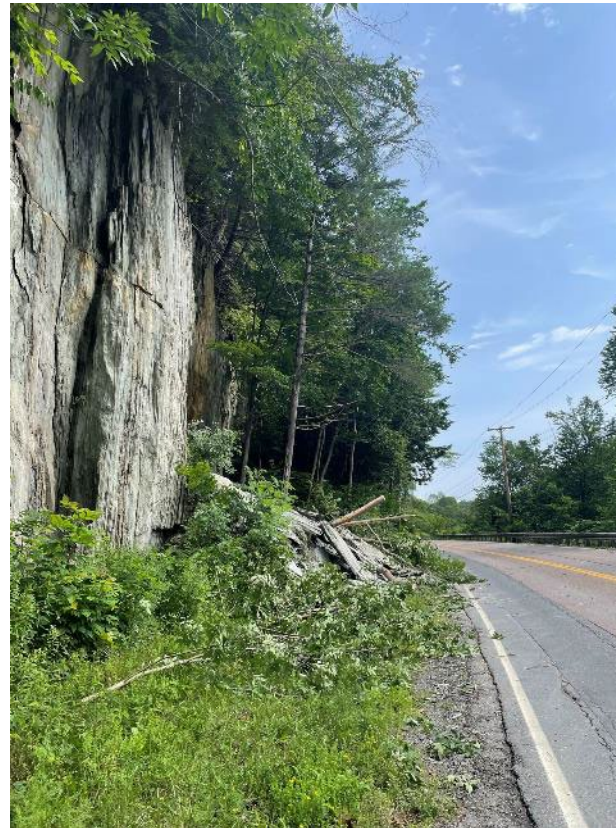
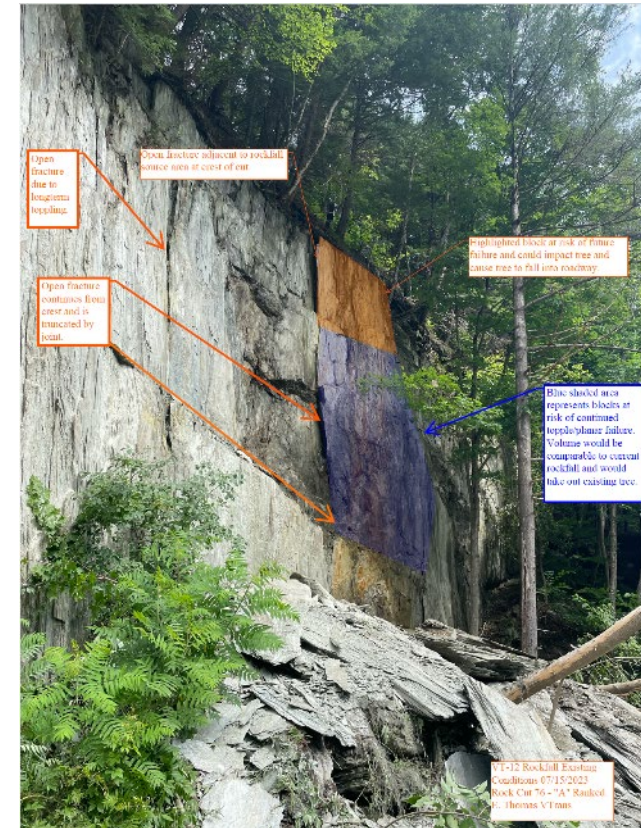
VTrans, 2023

- July 10-11, 2023 rainfall event, ~5 in.
- Geology: Devonian-Silurian Northfield Fm, quartz-sericite slate/phyllite

- Cause = Nearly vertical foliation on strike with roadway saturated from intense rainfall, lead to toppling
- Fairly common in VT

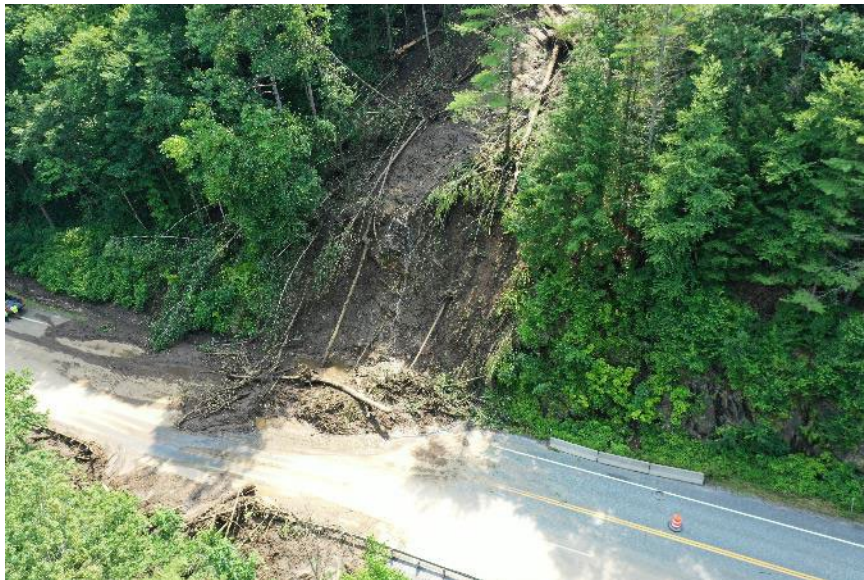
VTrans, 2023

- “Gulf” (deep valley), steep slopes of forested/protected land, 3-lane road, outside of VTrans right-of-way, ~1,000 ft runout starting at +40° headslope
- July 10-11, 2023 rainfall event
- Bedrock geology complex (slate, phyllite, schist, gneiss, amphibolite – Ordovician Missisquoi & Silurian-Devonian Northfield Fms), overlain by thin mantle of colluvium developed from glacial till

- Natural event (?), possibly influenced by past foresting activity, uprooted trees from prior storms
- Scars of past similar events evident (LiDAR)
- 100’s of similar steep slopes with thin colluvium over bedrock

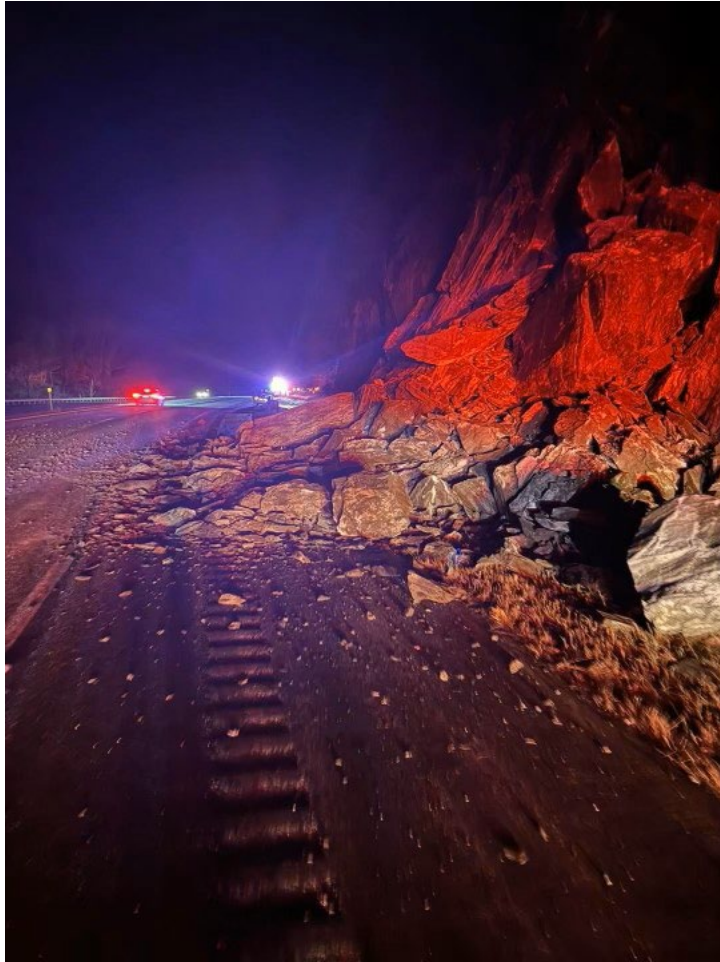
VTrans, 2023

- November 23, 2023 (Thanksgiving) evening
- At least 15 vehicles damaged
- Gile Mountain Fm metavolcanics (phyllite) with several discontinuity sets
- VTrans watching slope, programmed for additional mitigation but slide occurred first
- Limited resources to remediate before sliding occurs, very hard to predict when failure will occur

- Cause = wedge sliding due to ice-jacking
- Intersection of two joints, with line of intersection “daylighting” on rock face
- Emergency mitigation initiated to address large blocks in ditch and unstable overhang
- Mitigation = vegetation removal, scaling (removal of remaining loose rock), and securing overhang with rock dowels

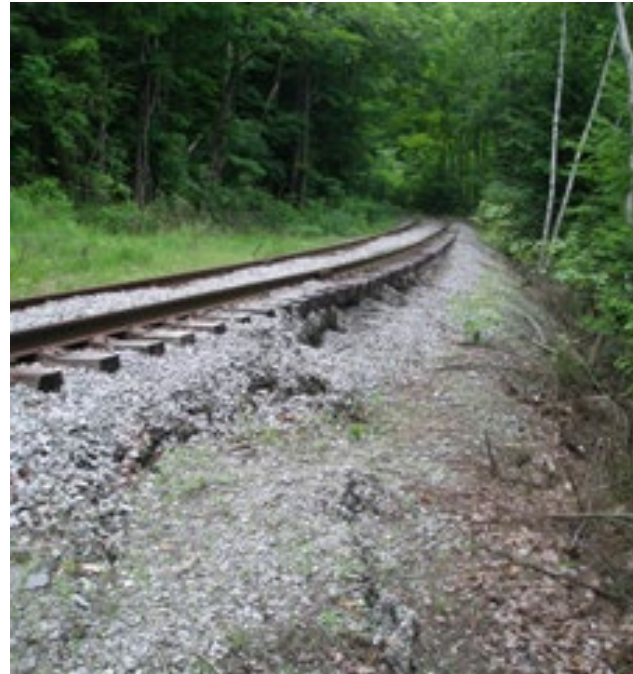
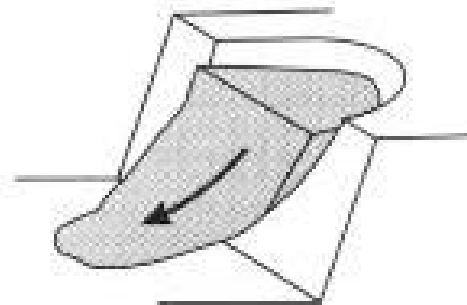
Wyllie, 2018

- State-owned railway servicing Rock of Ages granite quarry
- July 2011 heavy rains caused small landslide, with a small head scarp in railbed (~1 ft)
- Even a fraction of an inch movement will cause railways to shut down
- Geology consists of fill materials over glacial till/colluvium
- Cause = circular failure within unconsolidated materials

- Mitigation consisted of full slope repair, with tied-back retaining wall and rip rap slope armor (very \$\$\$)

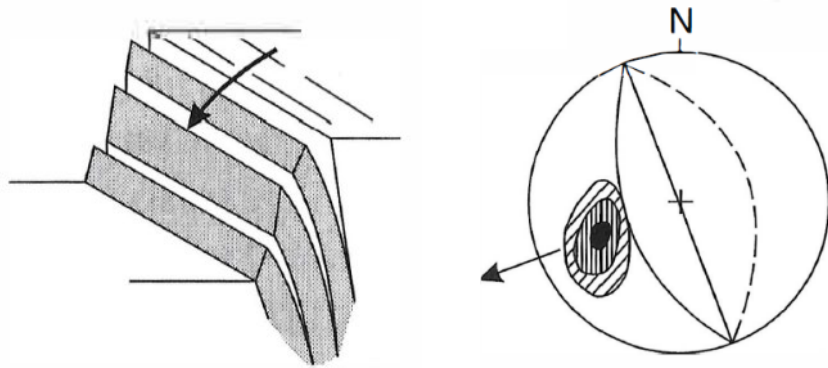
Wyllie, 2004

- Cause = toppling of large pillars, blocks and slabs exacerbated by melting of adfreeze (melting of ice acting as a temporary “glue” after ice jacking occurs)

- Emergency mitigation on going, consisting of scaling remaining loose rock and repair of draped mesh

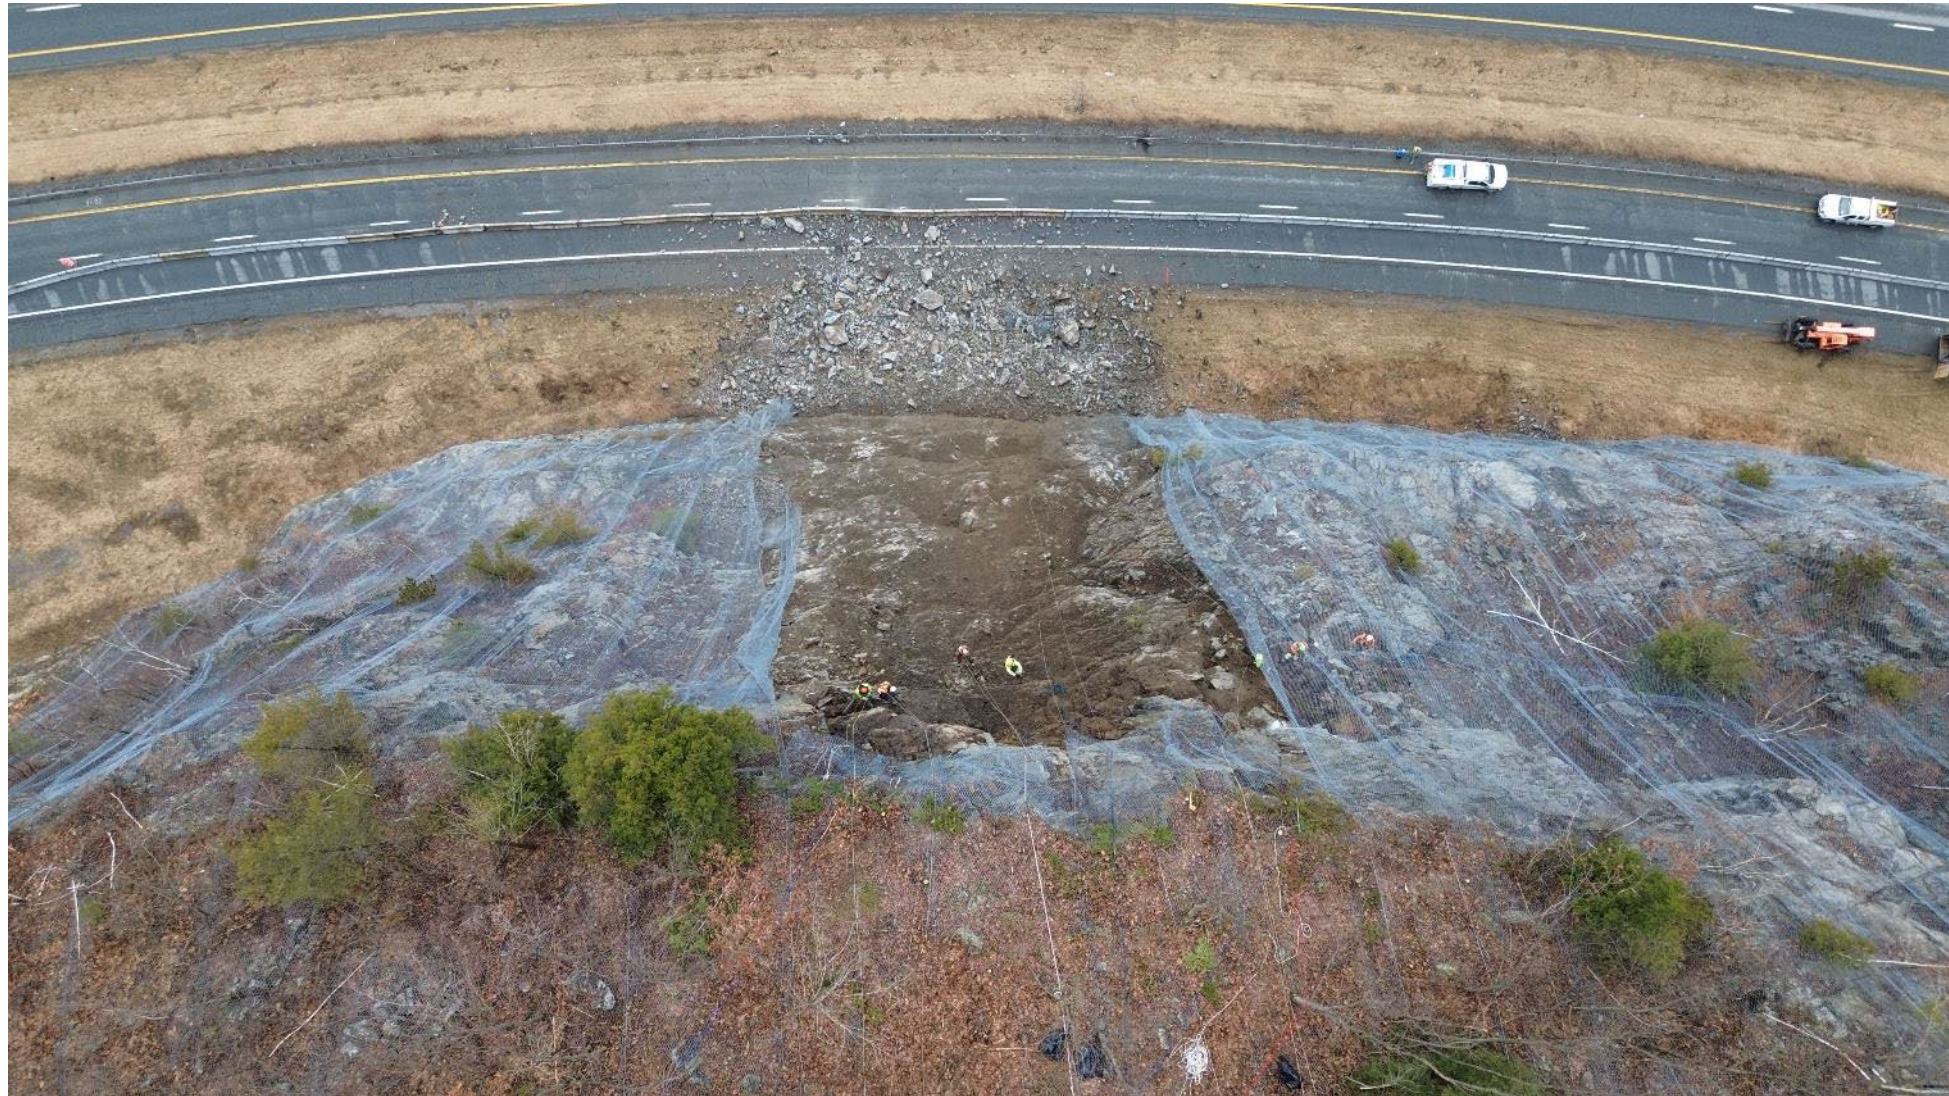
VTrans, 2024

- Numerous other areas identified behind mesh at risk of failing and overwhelm netting
- Intends to program and mitigate these 2025
