GEOLOGICAL CONSIDERATIONS FOR CONSTRUCTING A RAFTING AND KAYAKING COURSE ON THE CHATTAHOOCHEE RIVER, COLUMBUS, GEORGIA

Thomas Hanley, Department of Earth and Space Science,
Columbus State University

Edward Kinner, Uptown Columbus, Inc.

SEGSA, Asheville, NC
April 1, 2012

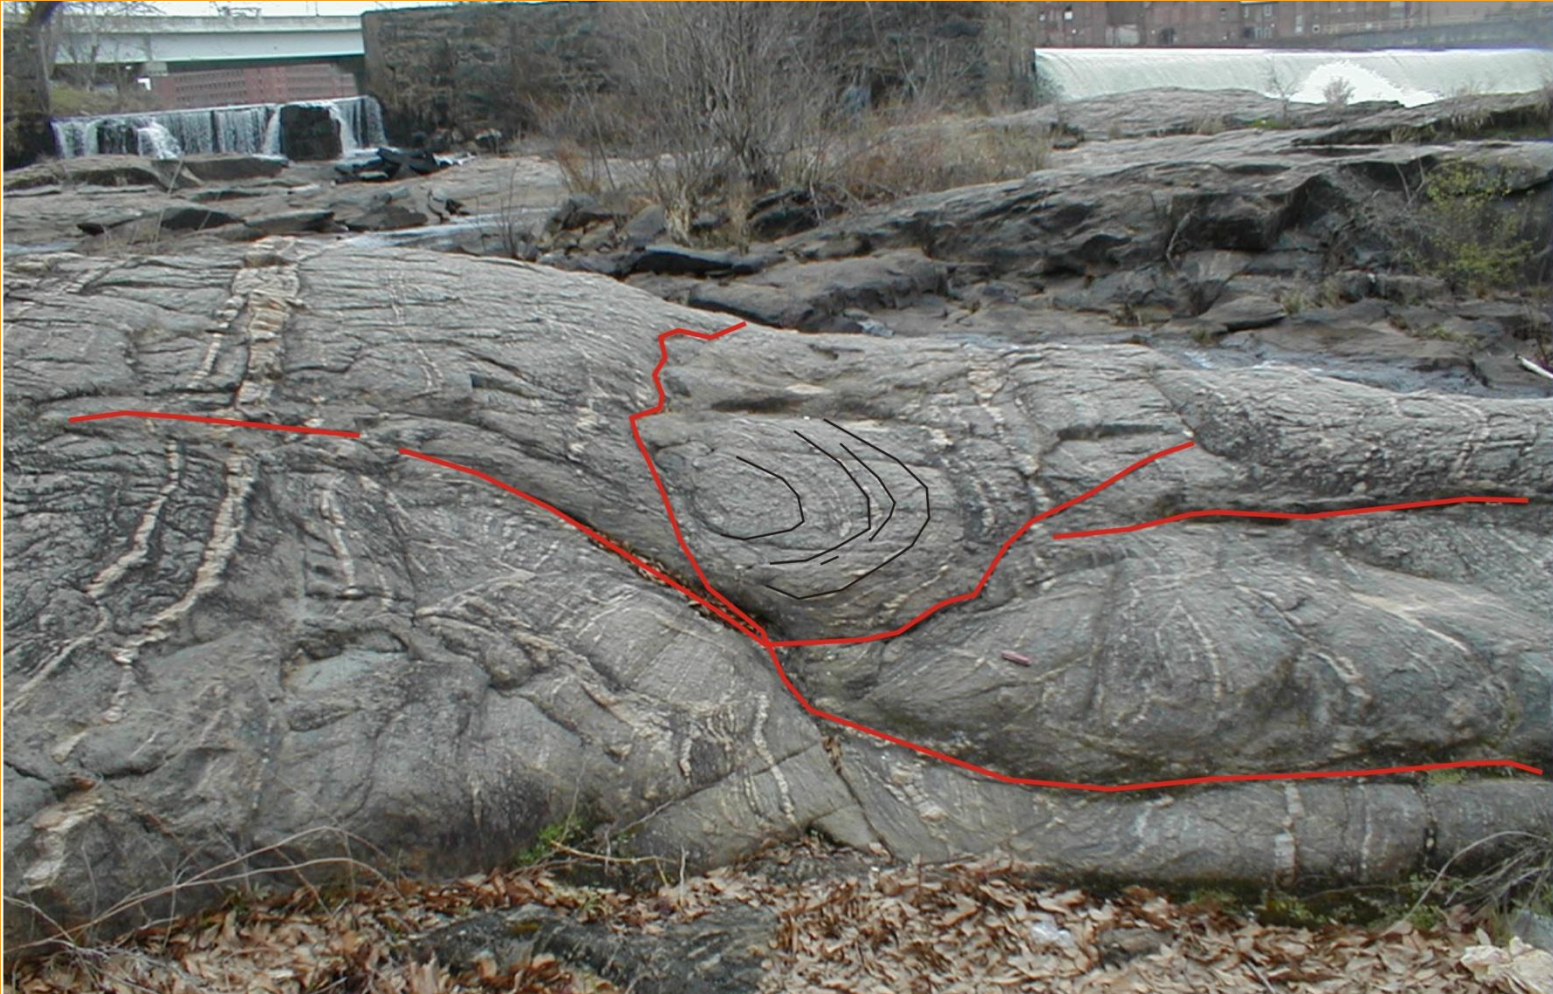
West-facing ledge west of Schamel's Rock channel. Hornblende gneiss has vertical layering enhanced by thin, light-colored granitoid layers that are nearly concordant to foliation in the gneiss. The gneiss is cut by irregular shallow-dipping slip surfaces (S2) shown by red. layers are offset near and within these slip zones. Folding in the middle of the photo seems related to S2. Axis of fold is nearly horizontal, but the axial surface is steep.

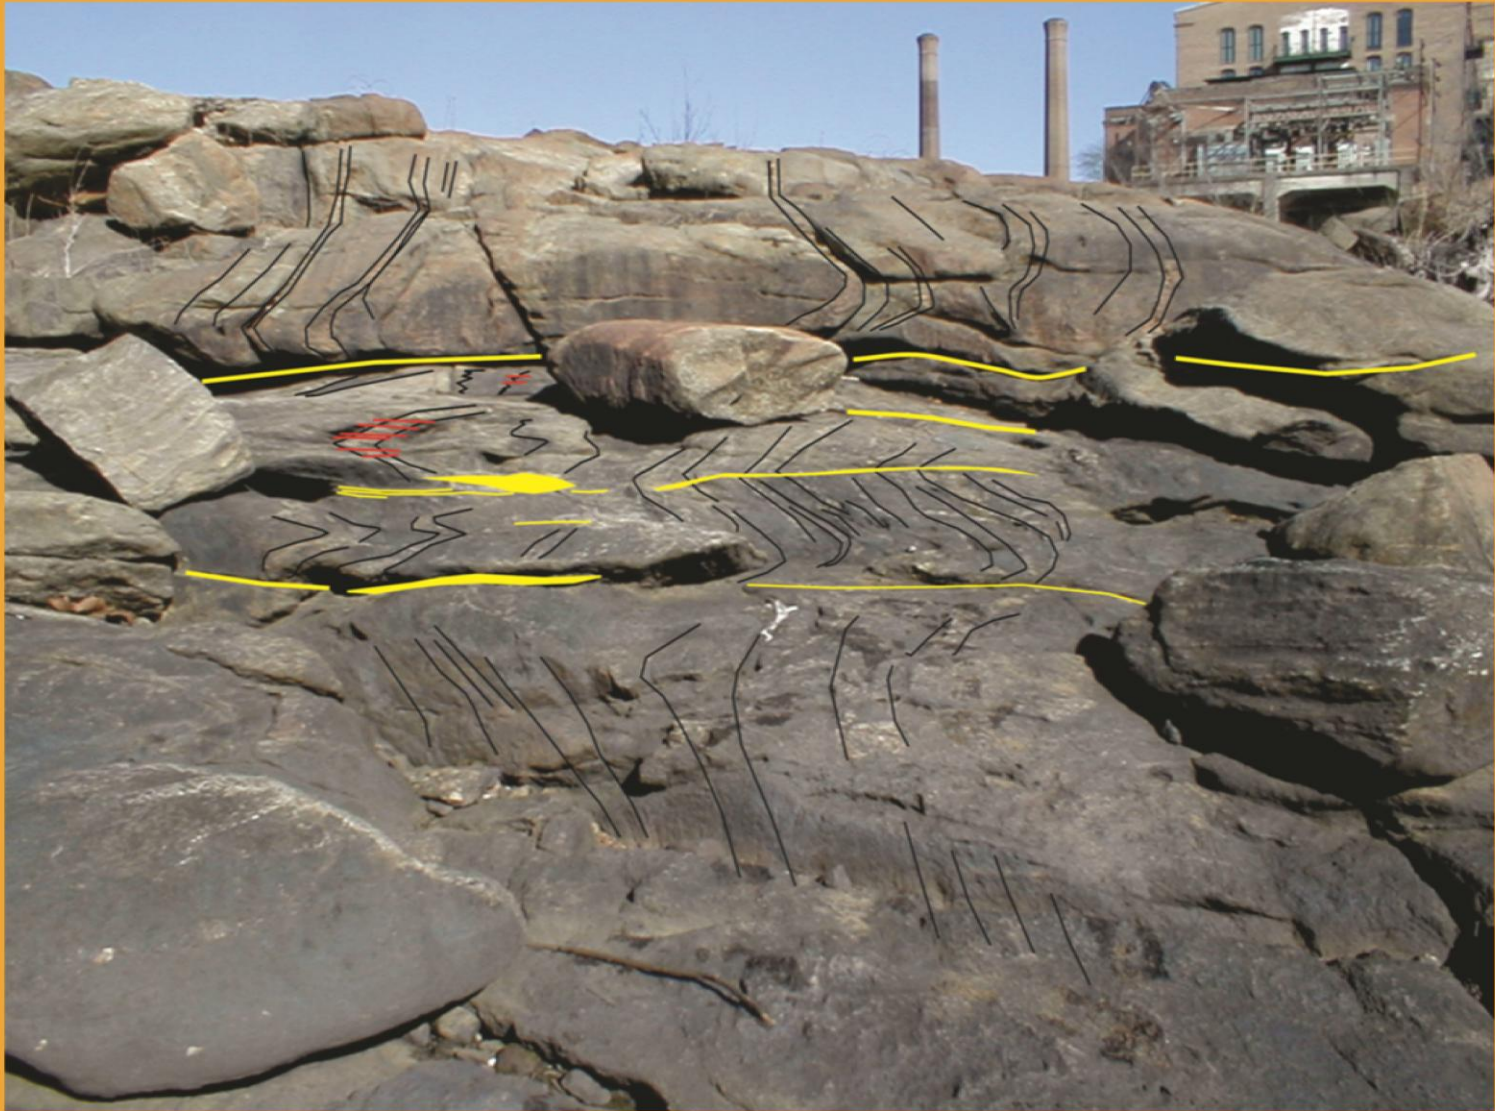
Middle Island beach looking northeast

Near vertical layering are actually, in many cases, limbs of isoclinal folds.

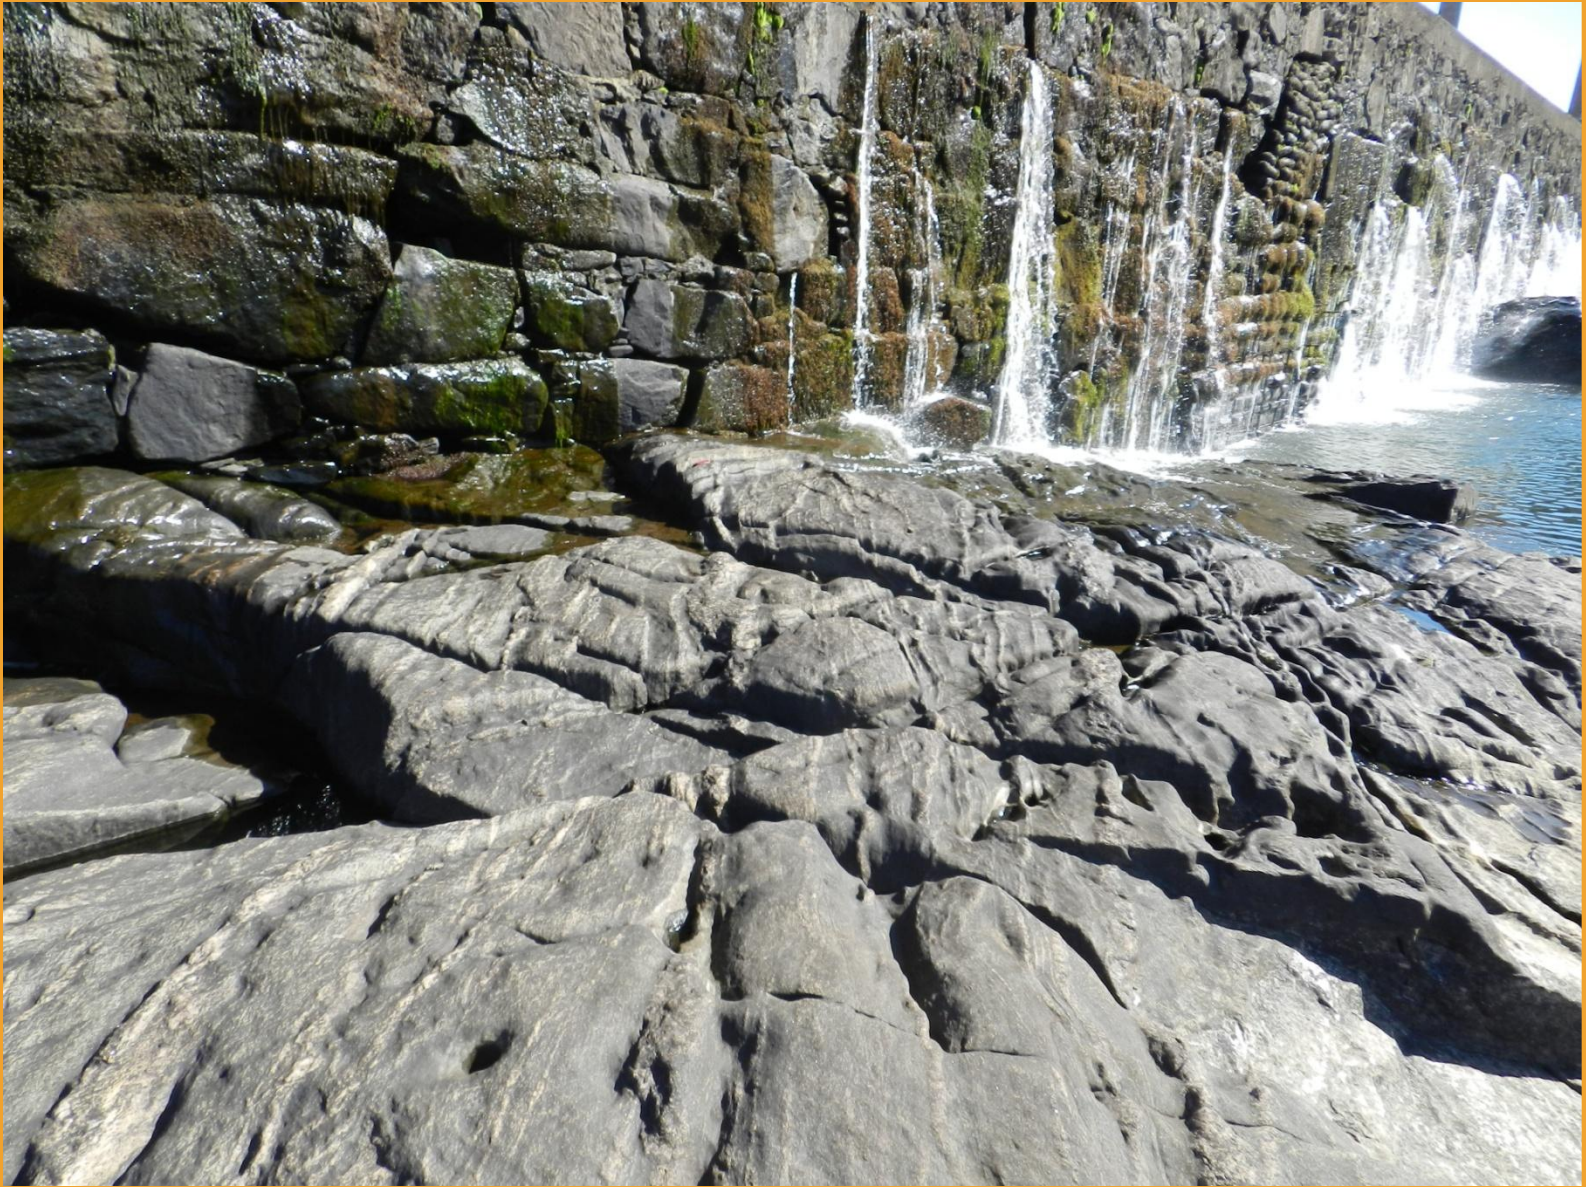
Intersecting joints and layering below the E&P Dam

Joints controlling pot holes.

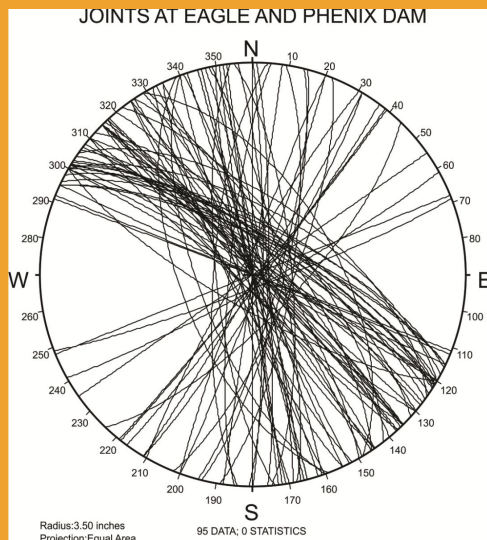
Foliations and joints, Eagle and Phenix dam

S0=S1 and S2

Structural summary:

- Foliations and joints intersect each other producing blocks
- The bedrock is solid and has a low permeability
- Joints and foliation are probably tight at depth

joints

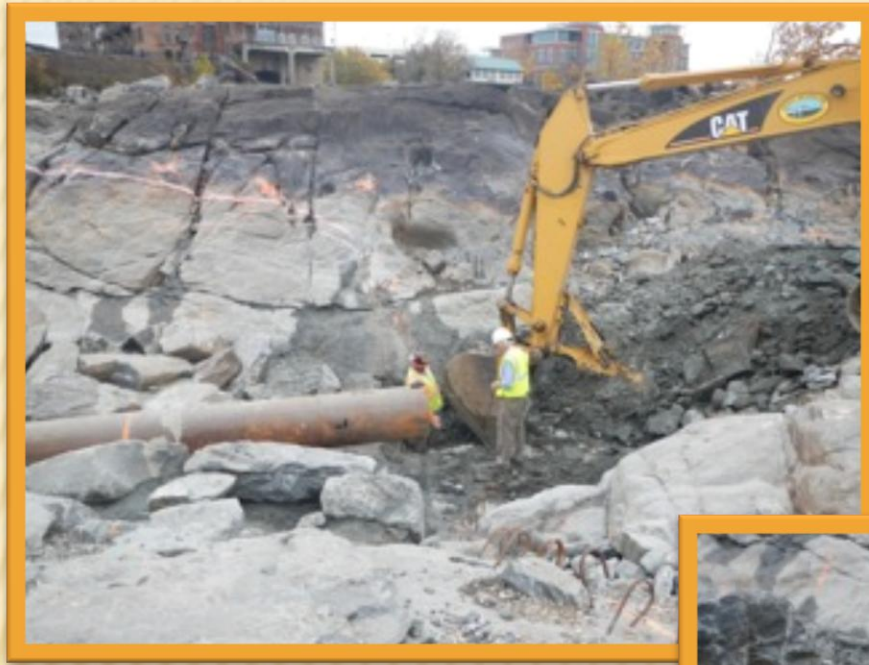
Bottom of dry Alabama channel, looking east. Cofferdam at head of Alabama channel has allowed draining of the Alabama channel.

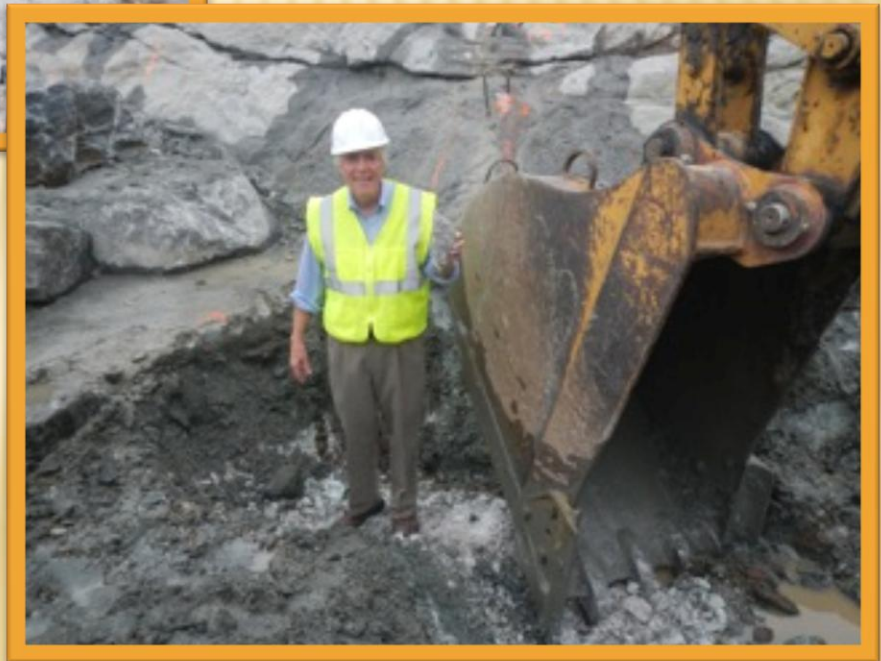
Excavation of Alabama channel led to discovery of a white mass dominated by quartz.

Close-up of “angle plated” quartz in fracture zone.

1. Host rock is brittley fractured.
2. Quartz deposited hydrothermally(?) in fractures
3. Host rock weathered to leave geometric arrangement of tabular quartz, and in this case
4. Calcite deposited in open space.

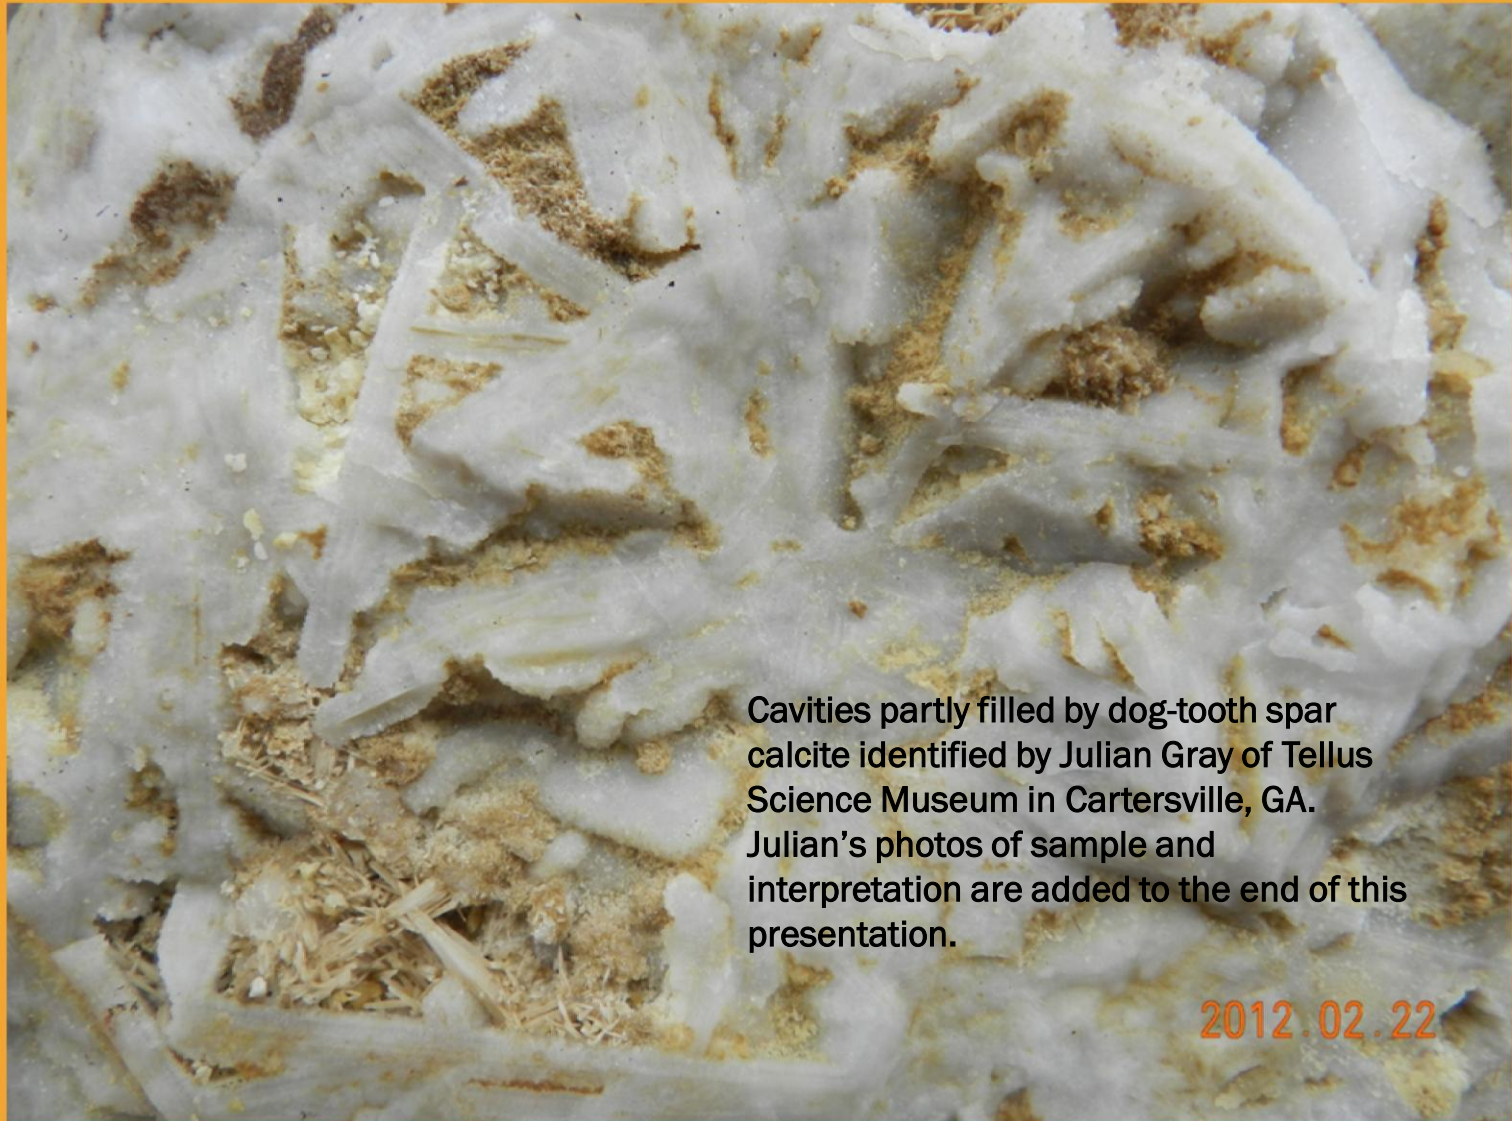
Cavities partly filled by dog-tooth spar calcite identified by Julian Gray of Tellus Science Museum in Cartersville, GA. Julian's photos of sample and interpretation are added to the end of this presentation.

The crystals are elongated, acicular and tapered to a sharp point; a common habit of calcite, but not zeolite. It effervesces in dilute HCl, has high birefringence, and rhombic cleavage. To nail it, I did a cursory check of lowest n_D and found it is close to 1.480. Easy! Most of the calcite was dirty with inclusions, but I found a large, clean piece for the optical work.

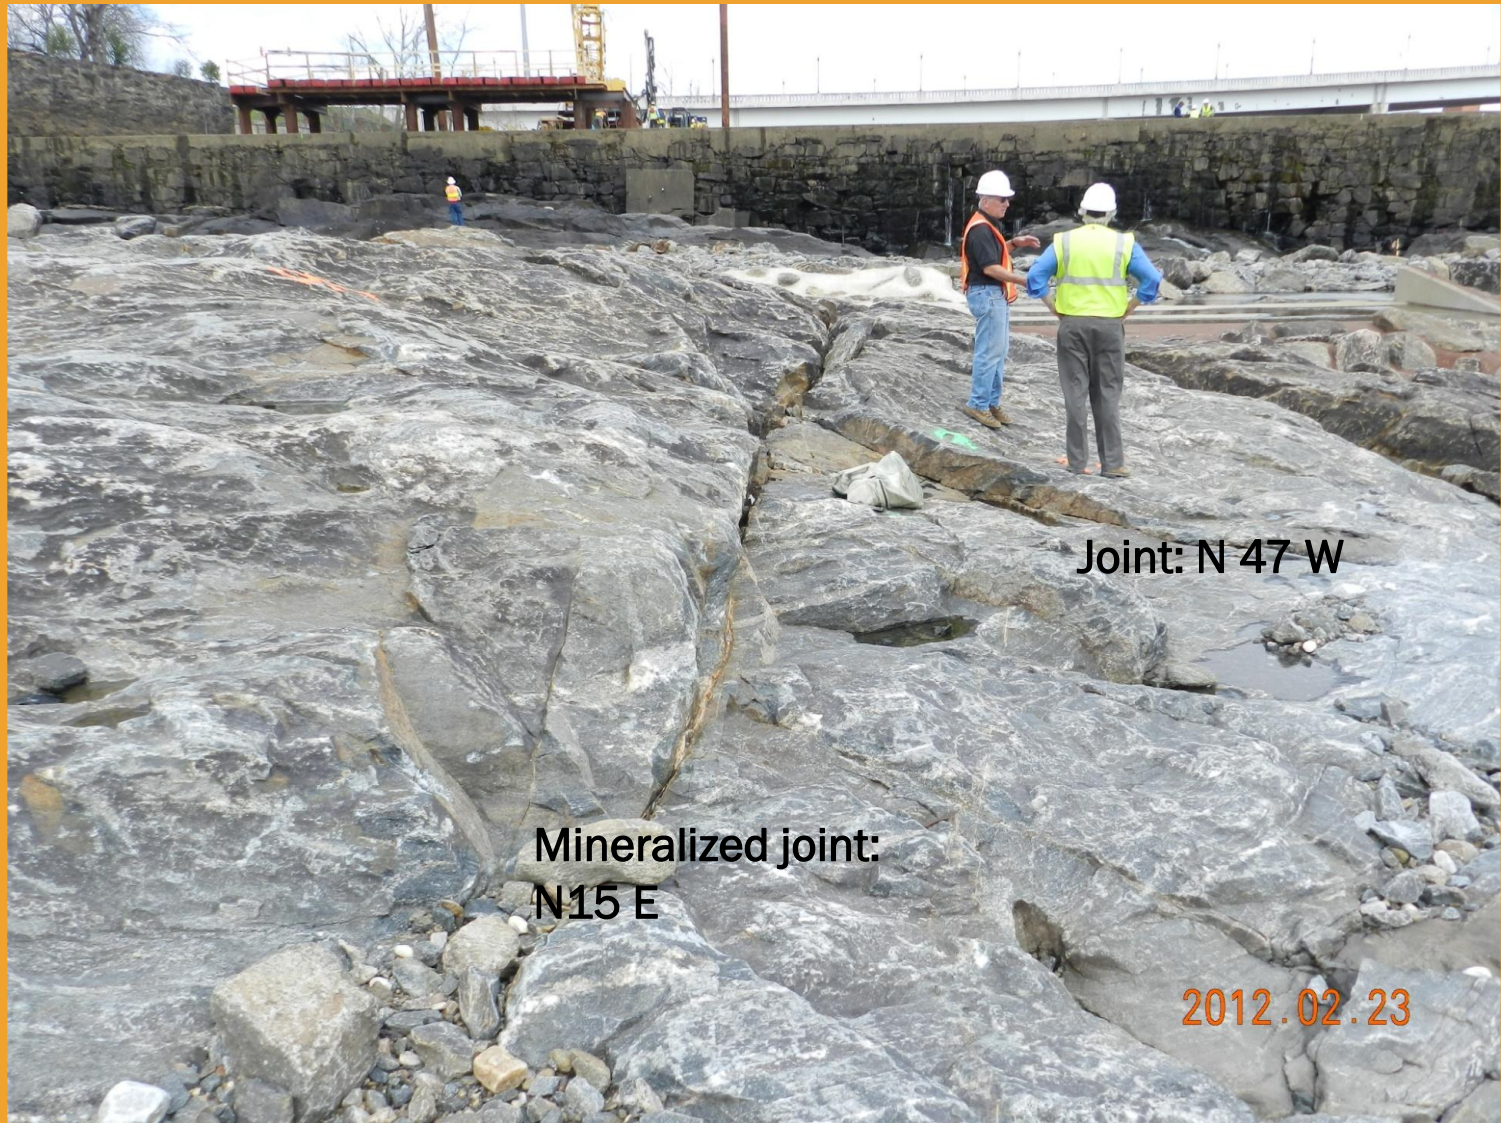
Mineralized fracture sub parallel and adjacent to the Alabama channel

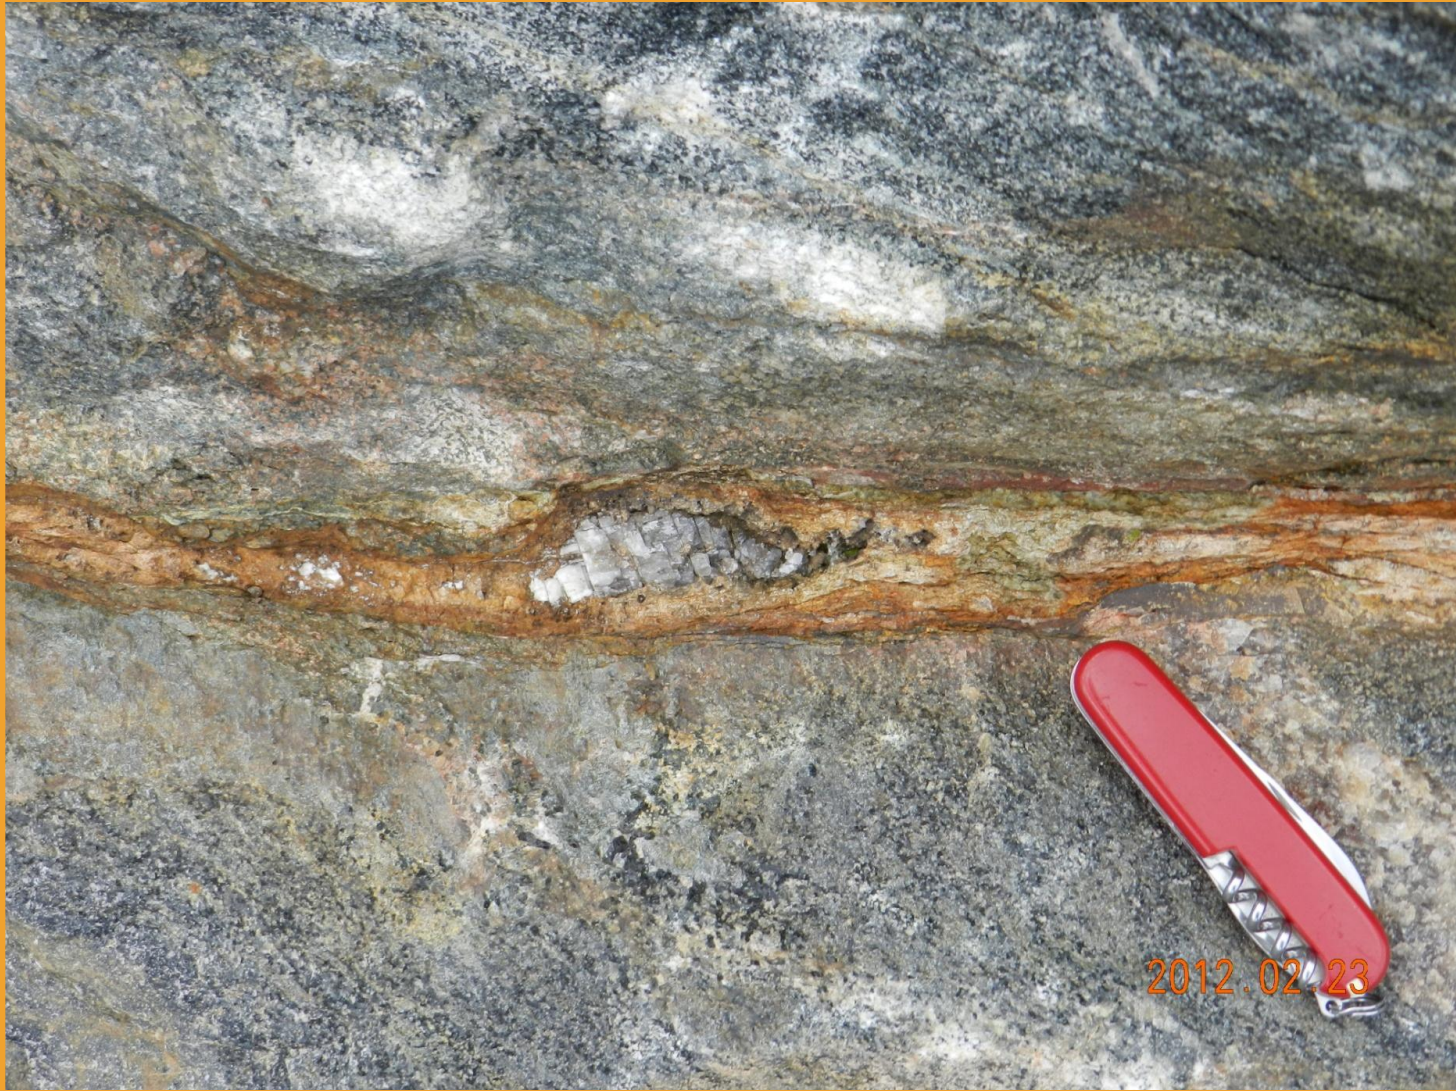
Gray calcite + ?

Note foliation in the orange joint-fill material indicating movement; west is towards top of photo.

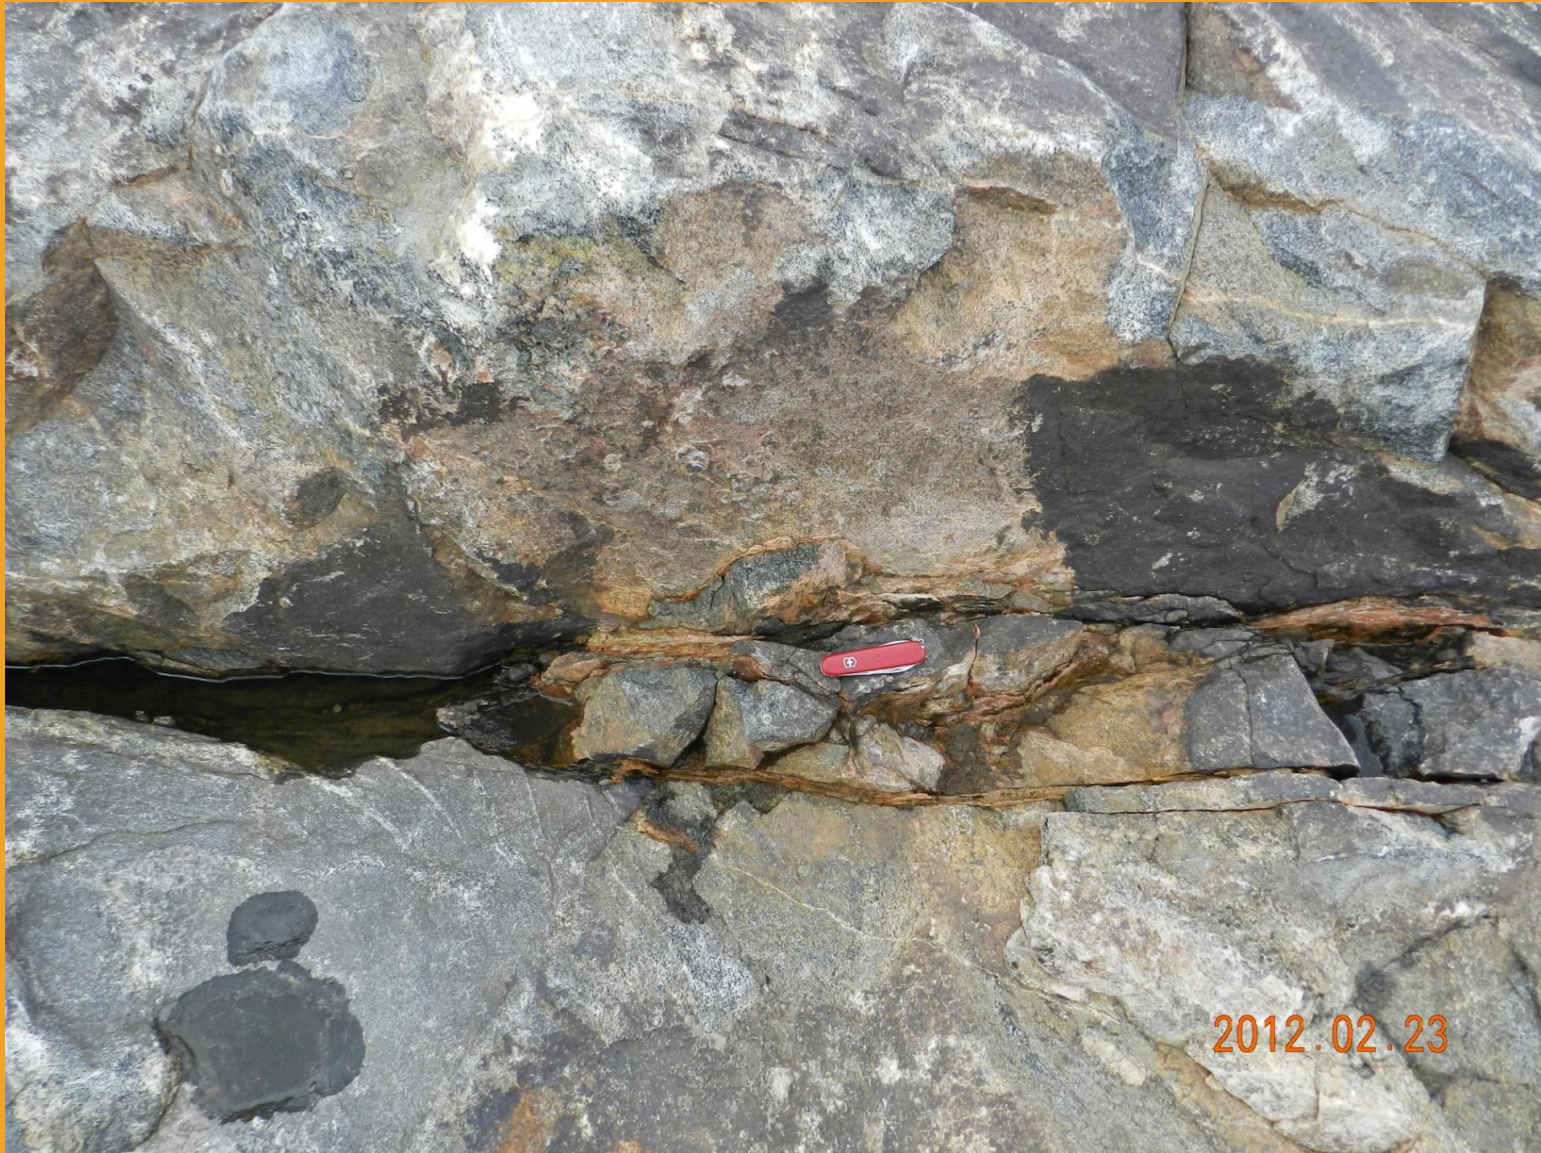
Broken gneiss where fracture bifurcates

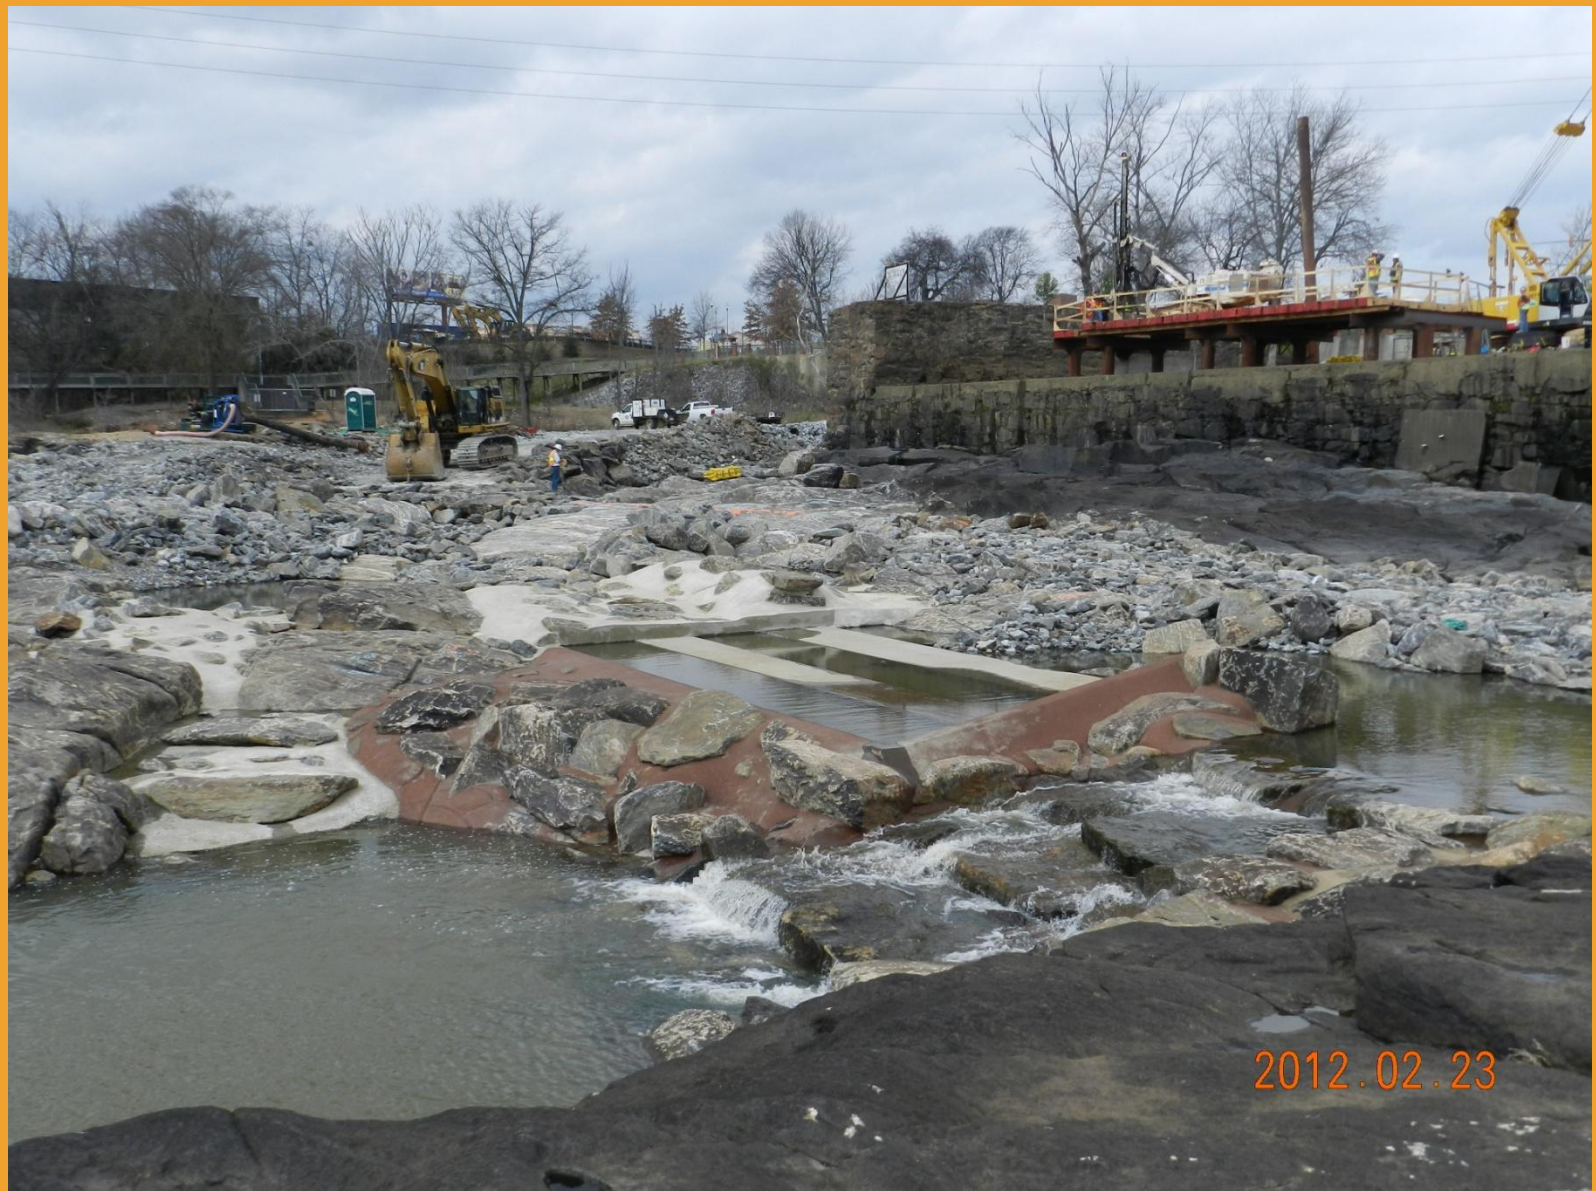
Nearly complete entry gate for Alabama Channel; note big stone slab steps

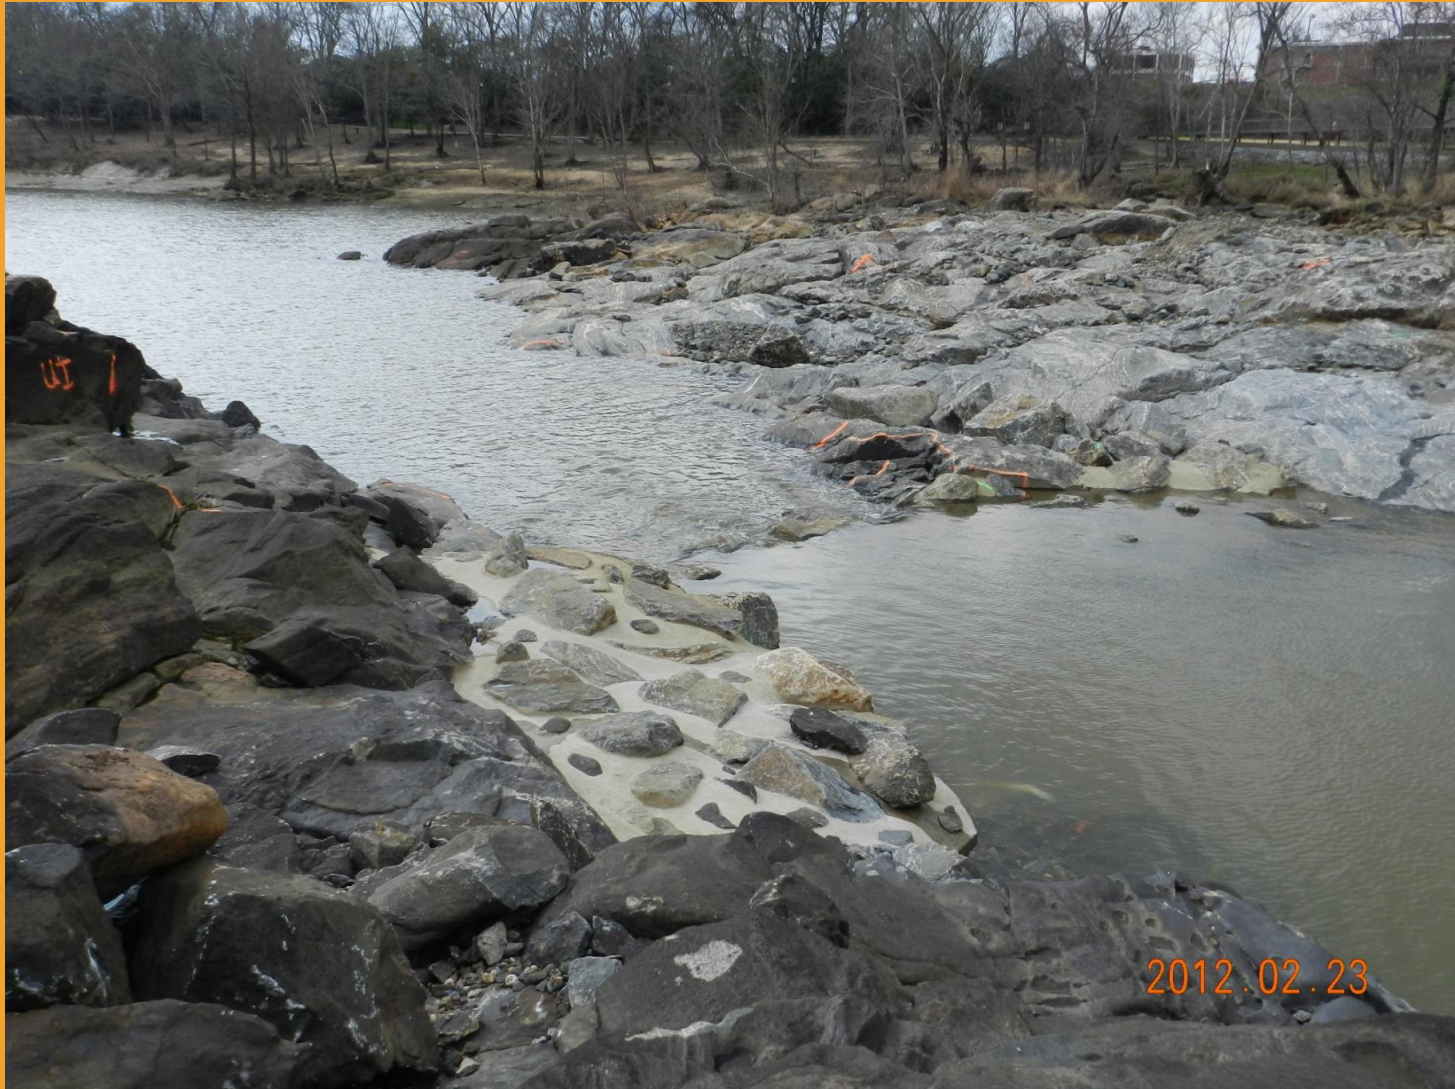
Alabama Channel, upper invert sill.

Intersecting joints and S2 facilitated widening and deepening of channel.

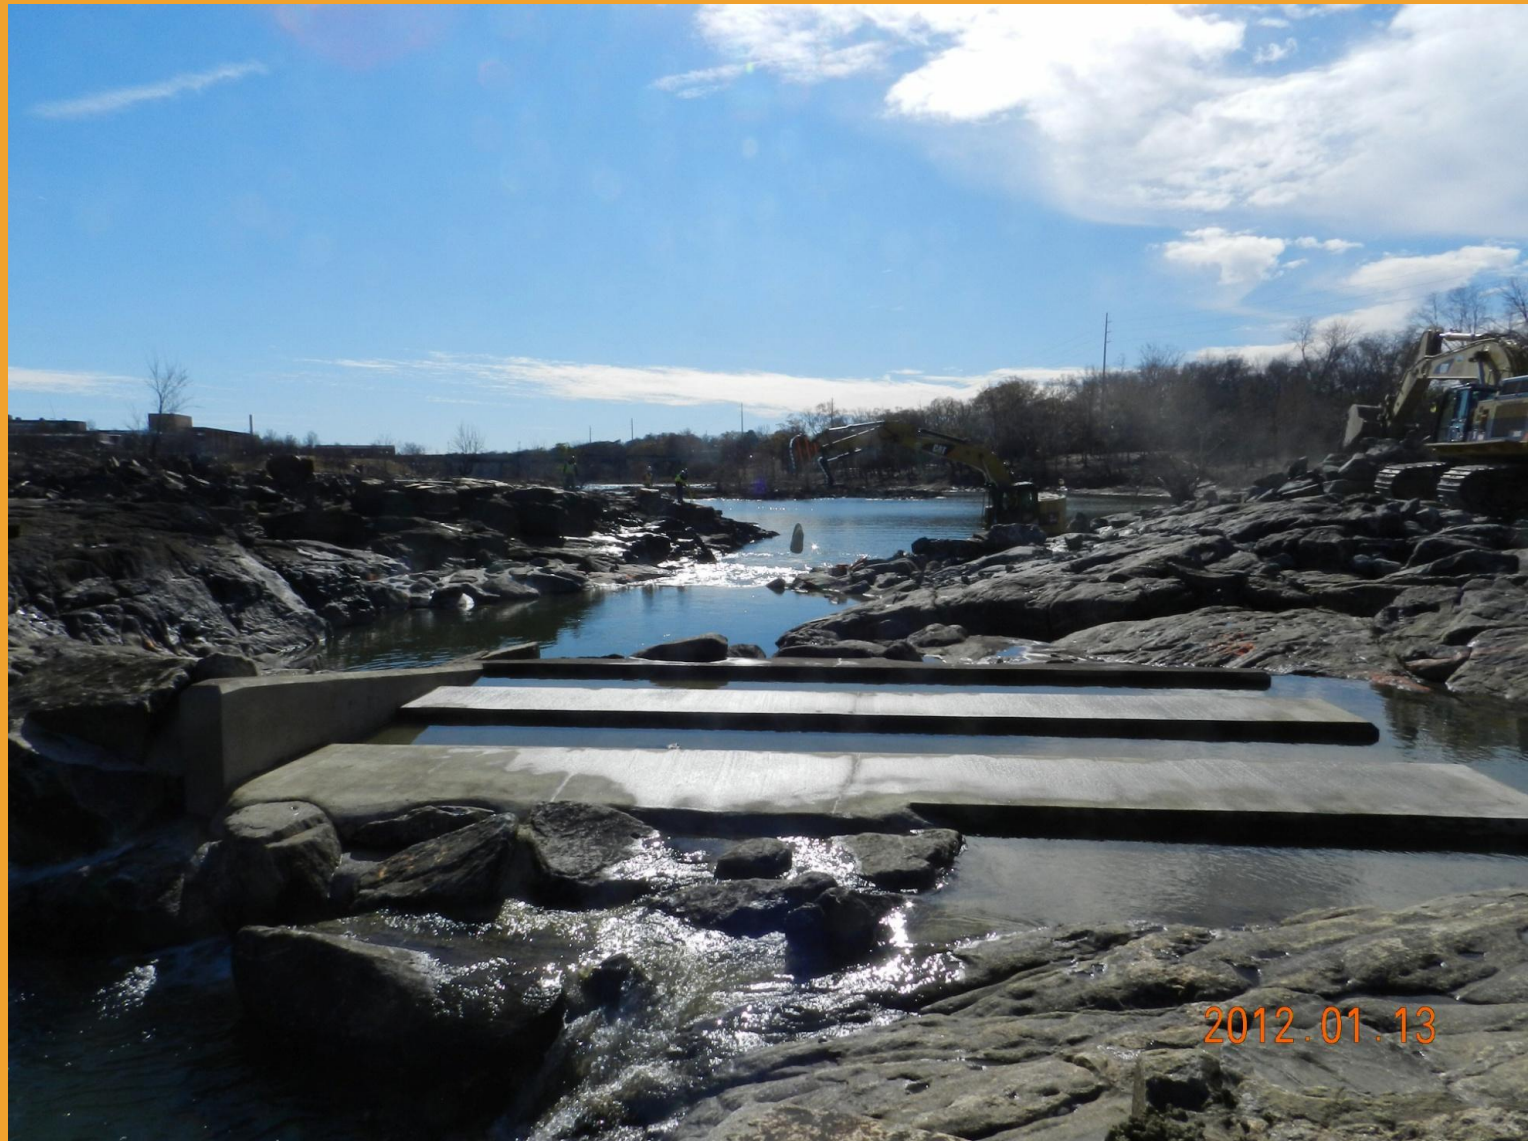
Placing boulders in Alabama Channel for lower invert sill.

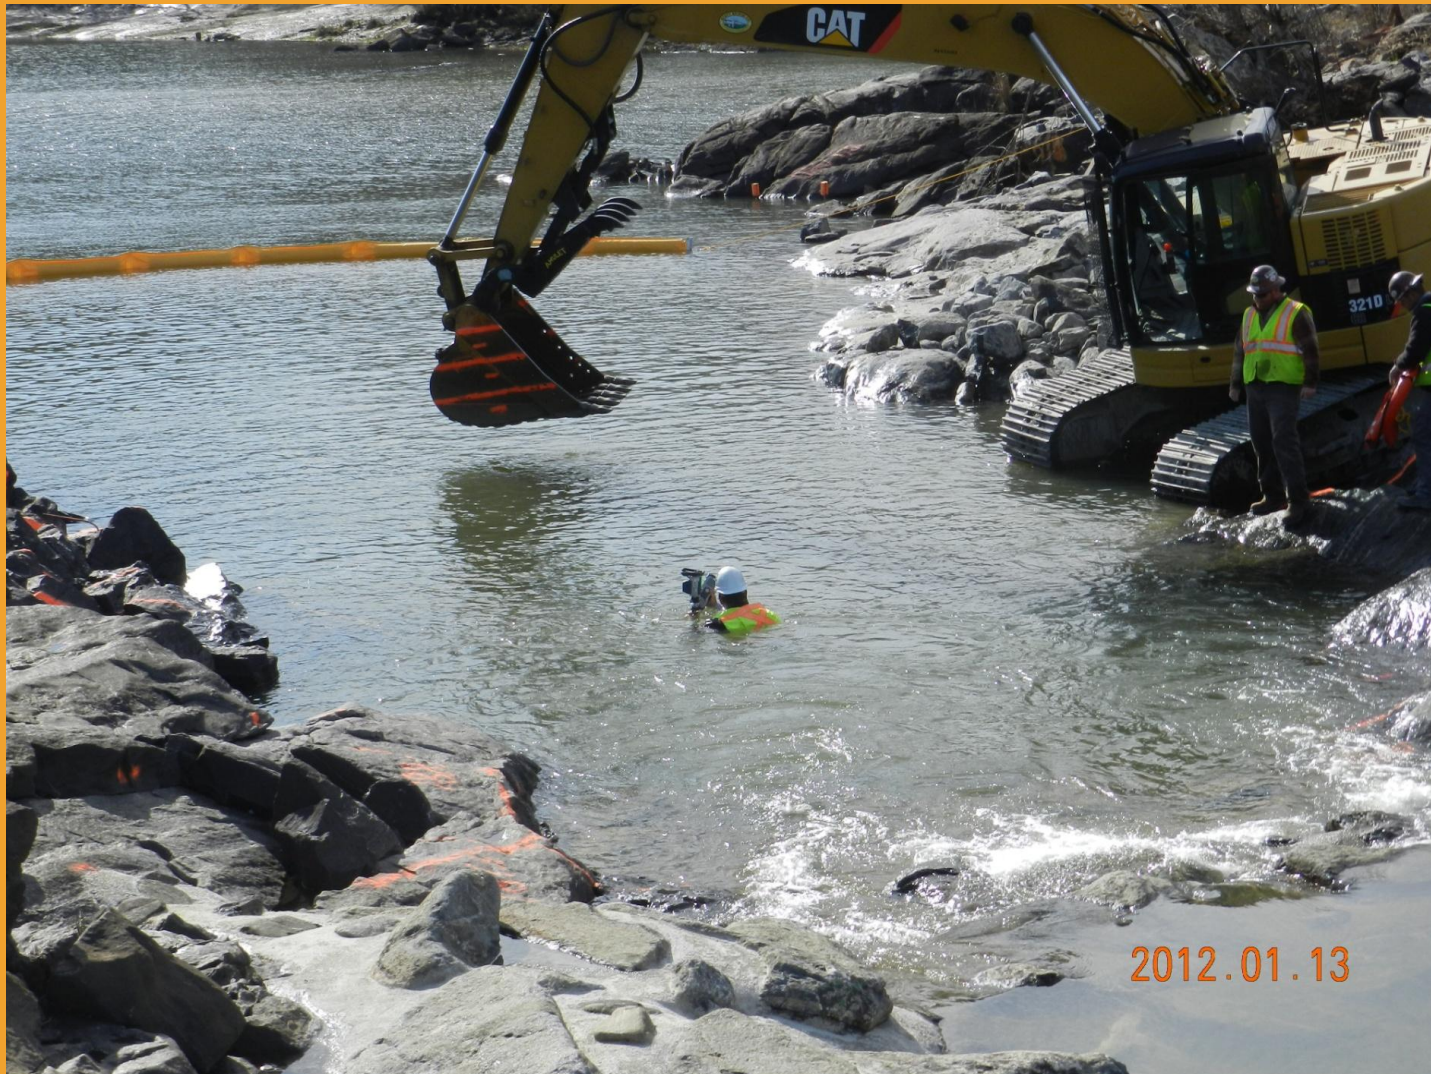
Watch your head! Engineer checking bottom topography for lower invert sill.

Upper invert sill in foreground.

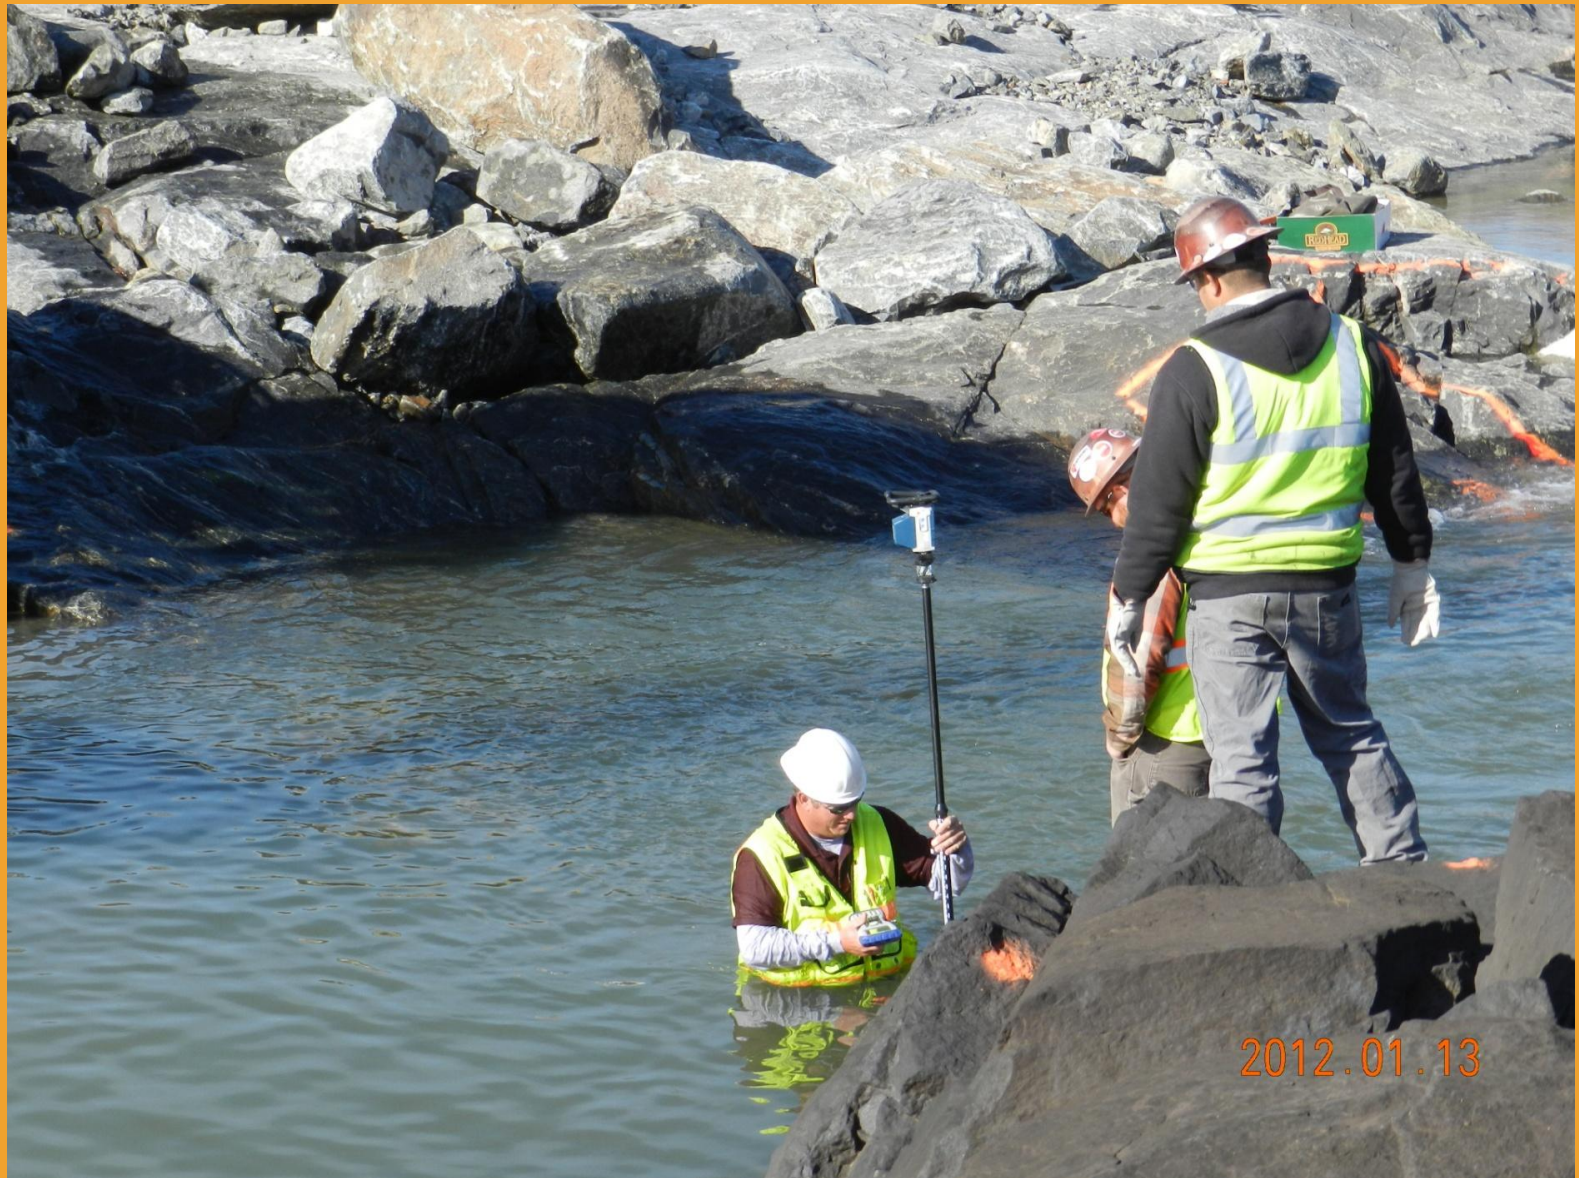
Surveying channel bottom, lower invert sill.
