GEOLOGICAL CONSIDERATIONS FOR CONSTRUCTING A RAFTING AND KAYAKING COURSE ON THE CHATTAHOOCHEE RIVER, COLUMBUS, GEORGIA

Thomas Hanley, Department of Earth and Space Science,
Columbus State University

Edward Kinner, Uptown Columbus, Inc.

SEGSA, Asheville, NC
April 1, 2012

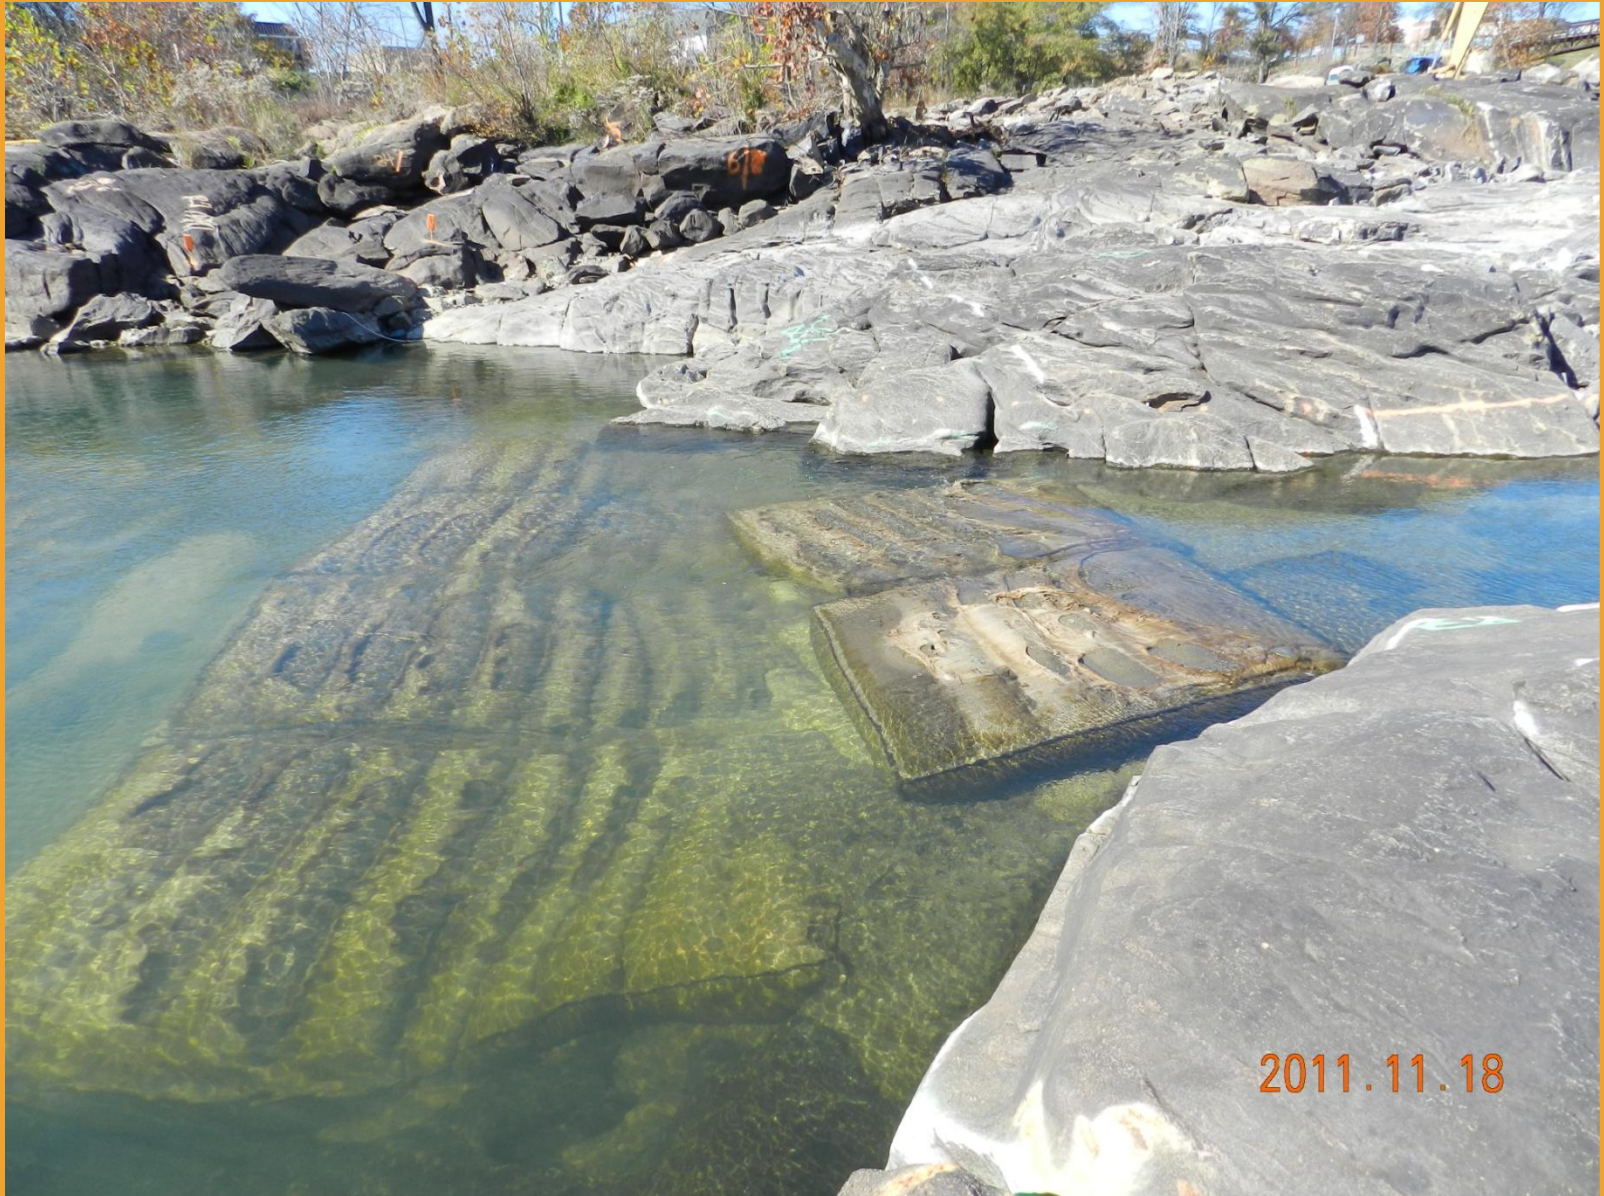
Grout mattresses at end of Alabama Channel: the whitewater sill.

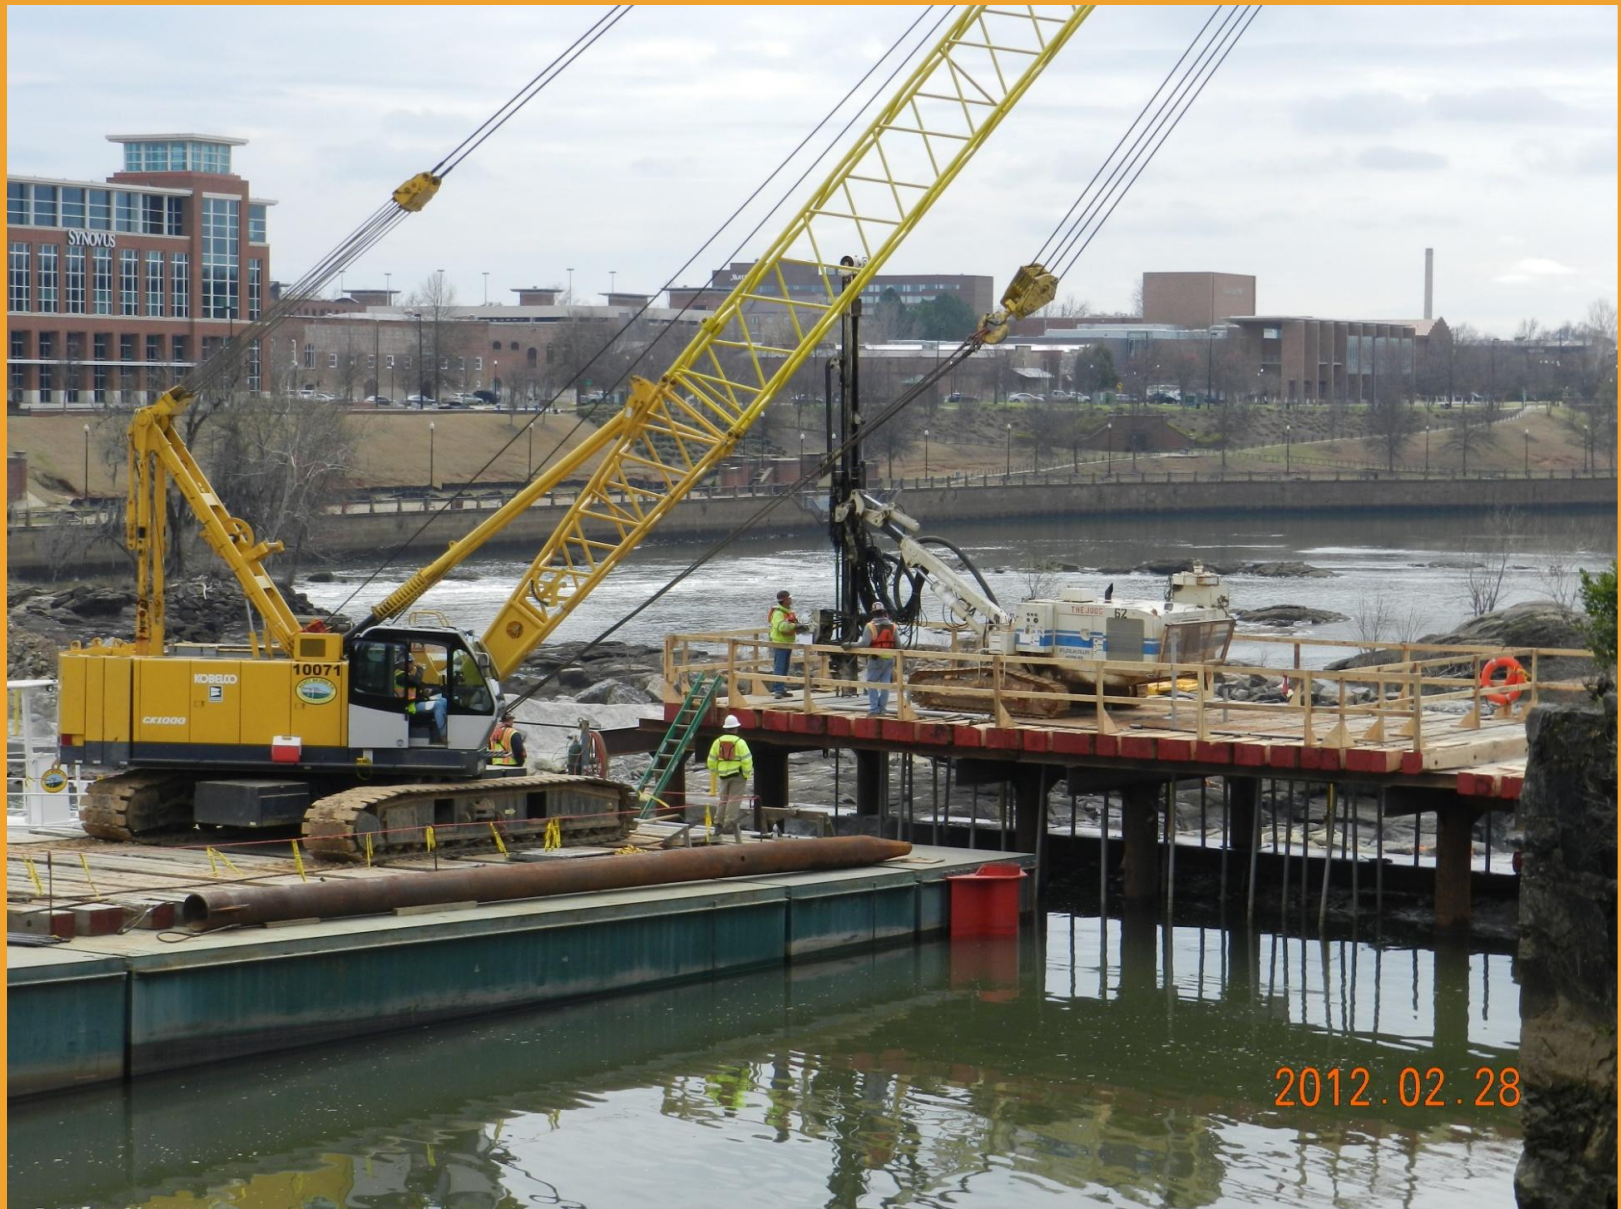
Dam is being drilled for placing charges.

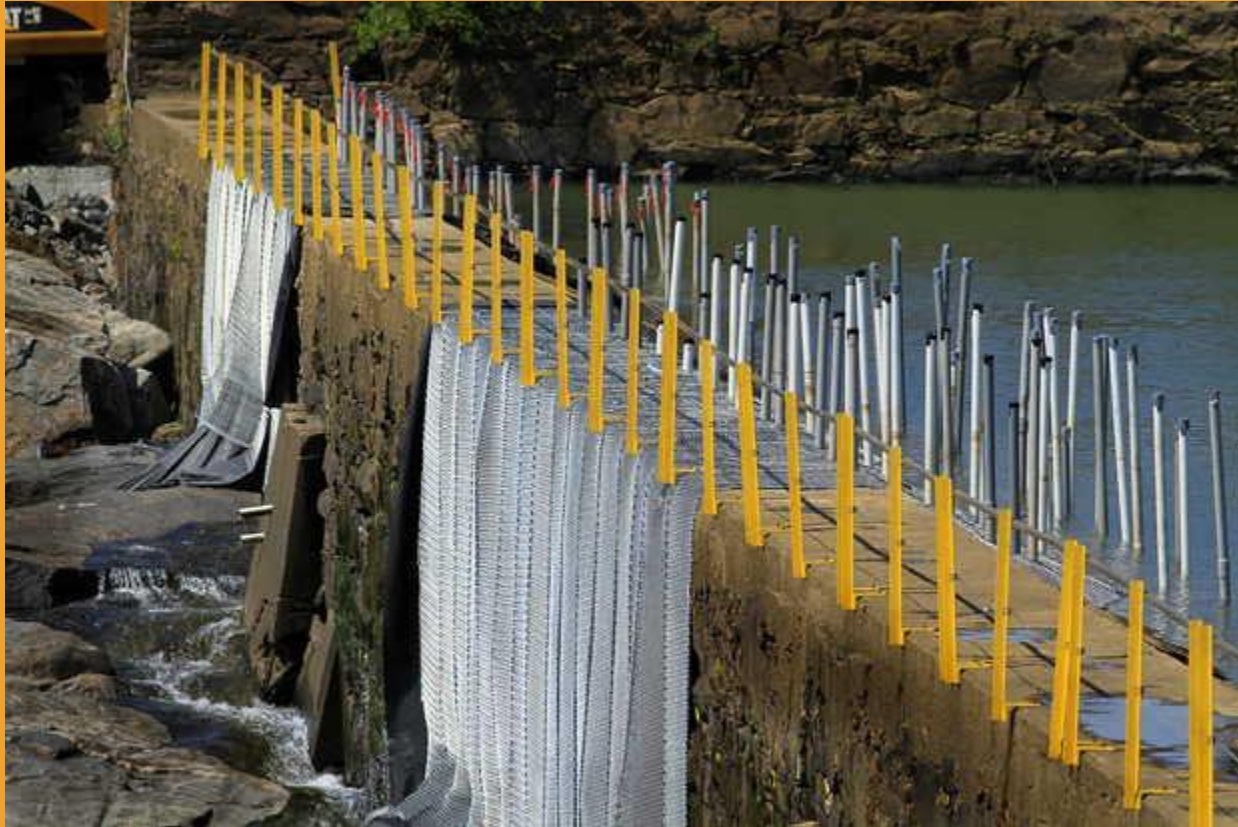
**Chain link drapes to control blast on west side of the TDS;
Metal pipes are drill hole locations for charges.**

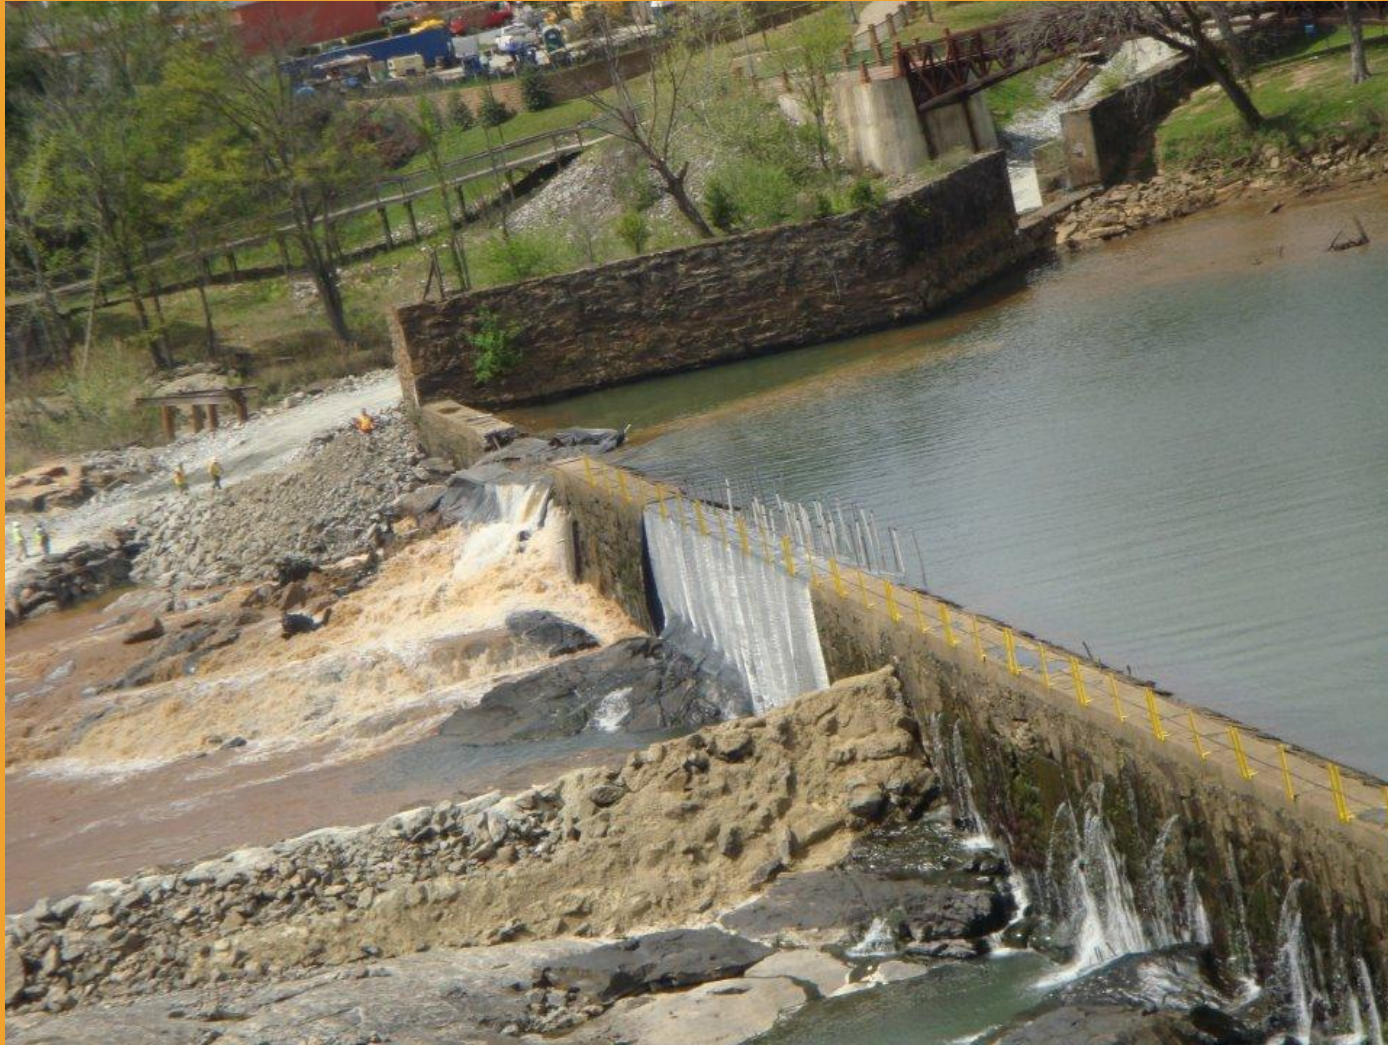
Post-blast; western wall broken, one more to go.

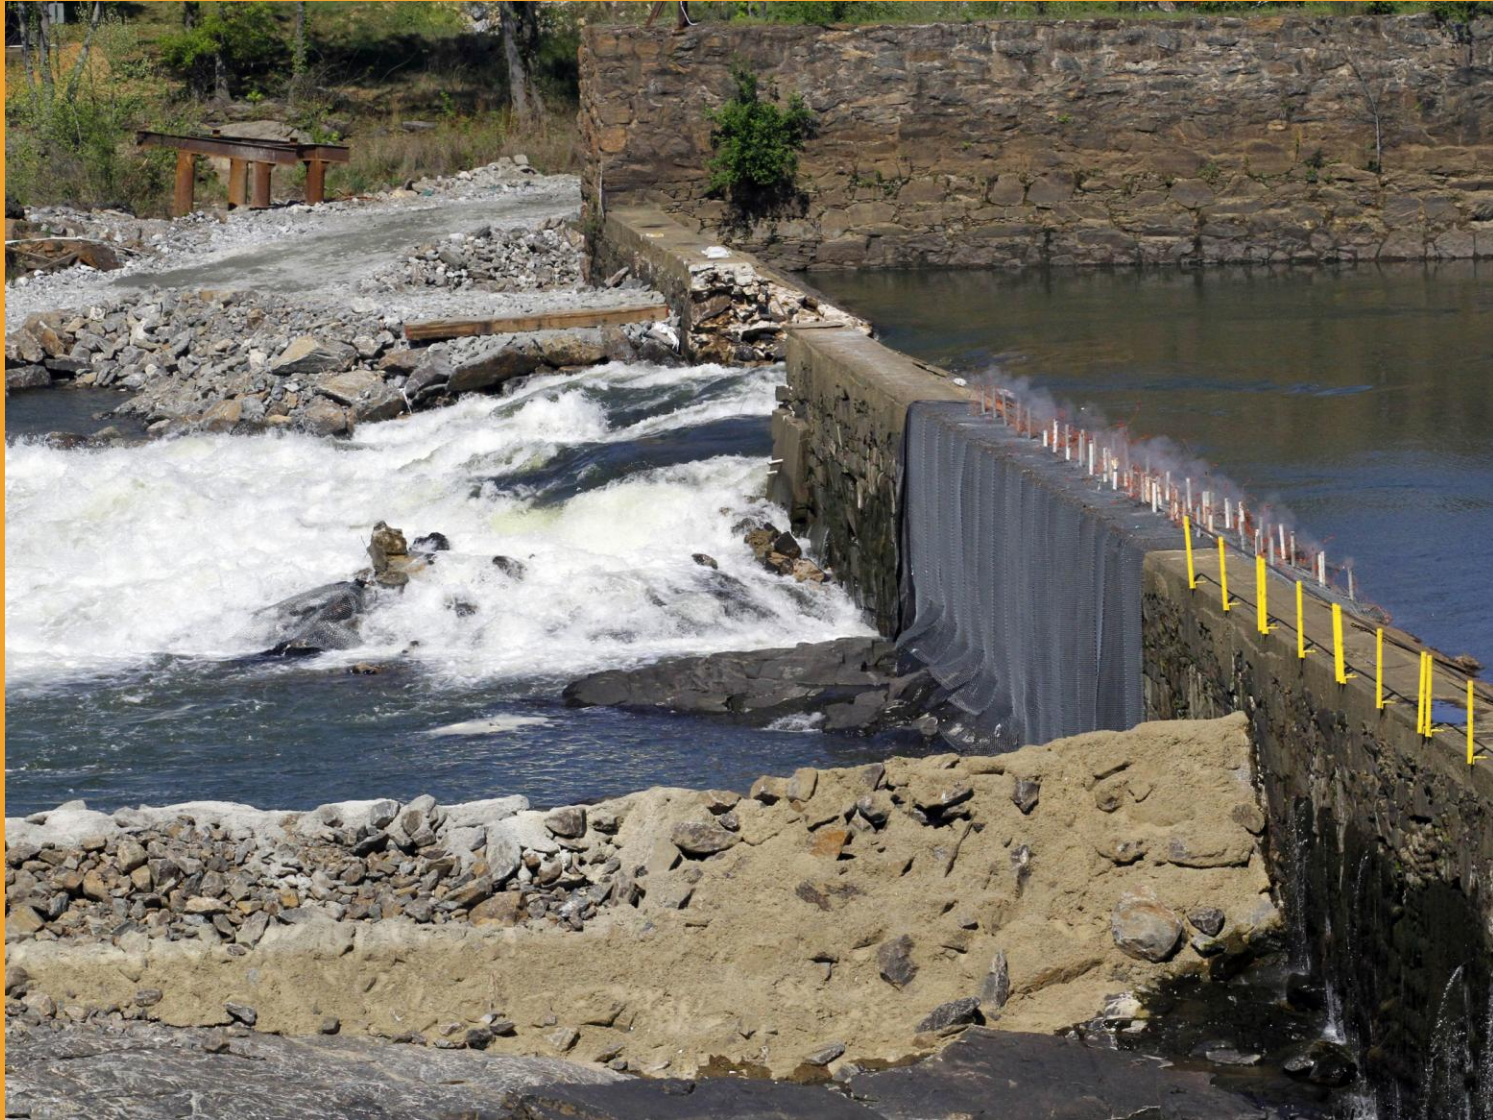
Second breach, Sunday, March 25, 2012

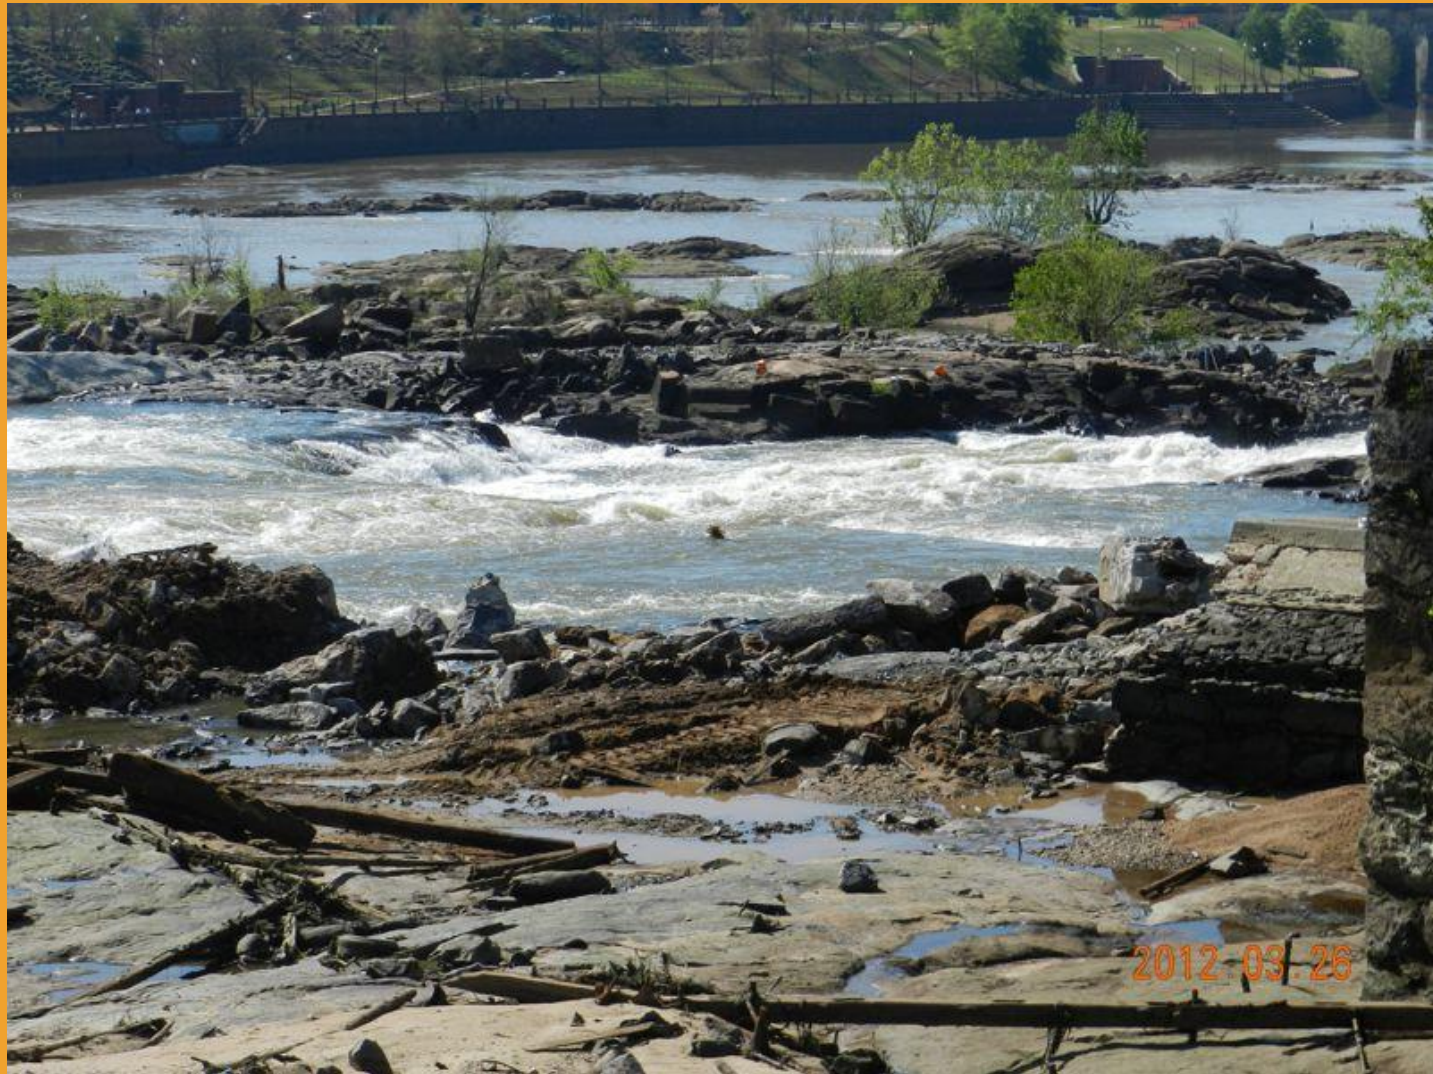
Entry gate is seen as the low fall in left side of photo.

Looking down the main channel to the breach and the Alabama channel beyond.

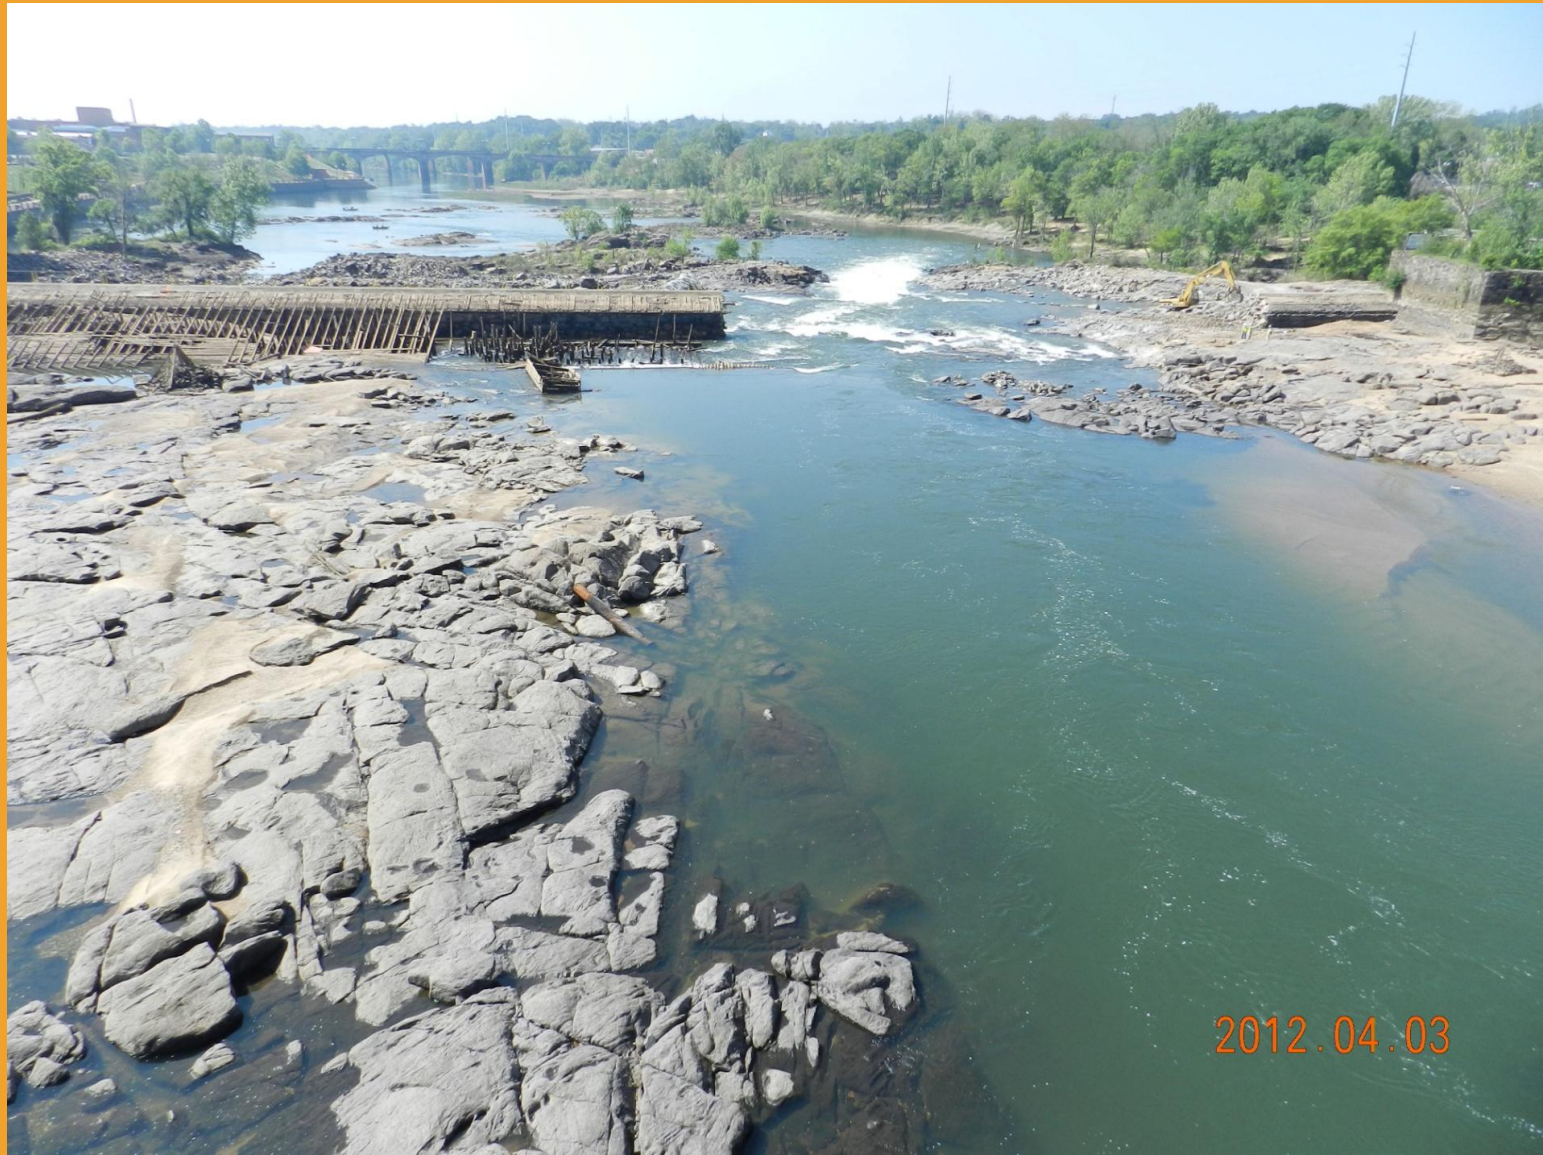
East edge of steep-walled channel at the N12W reading.

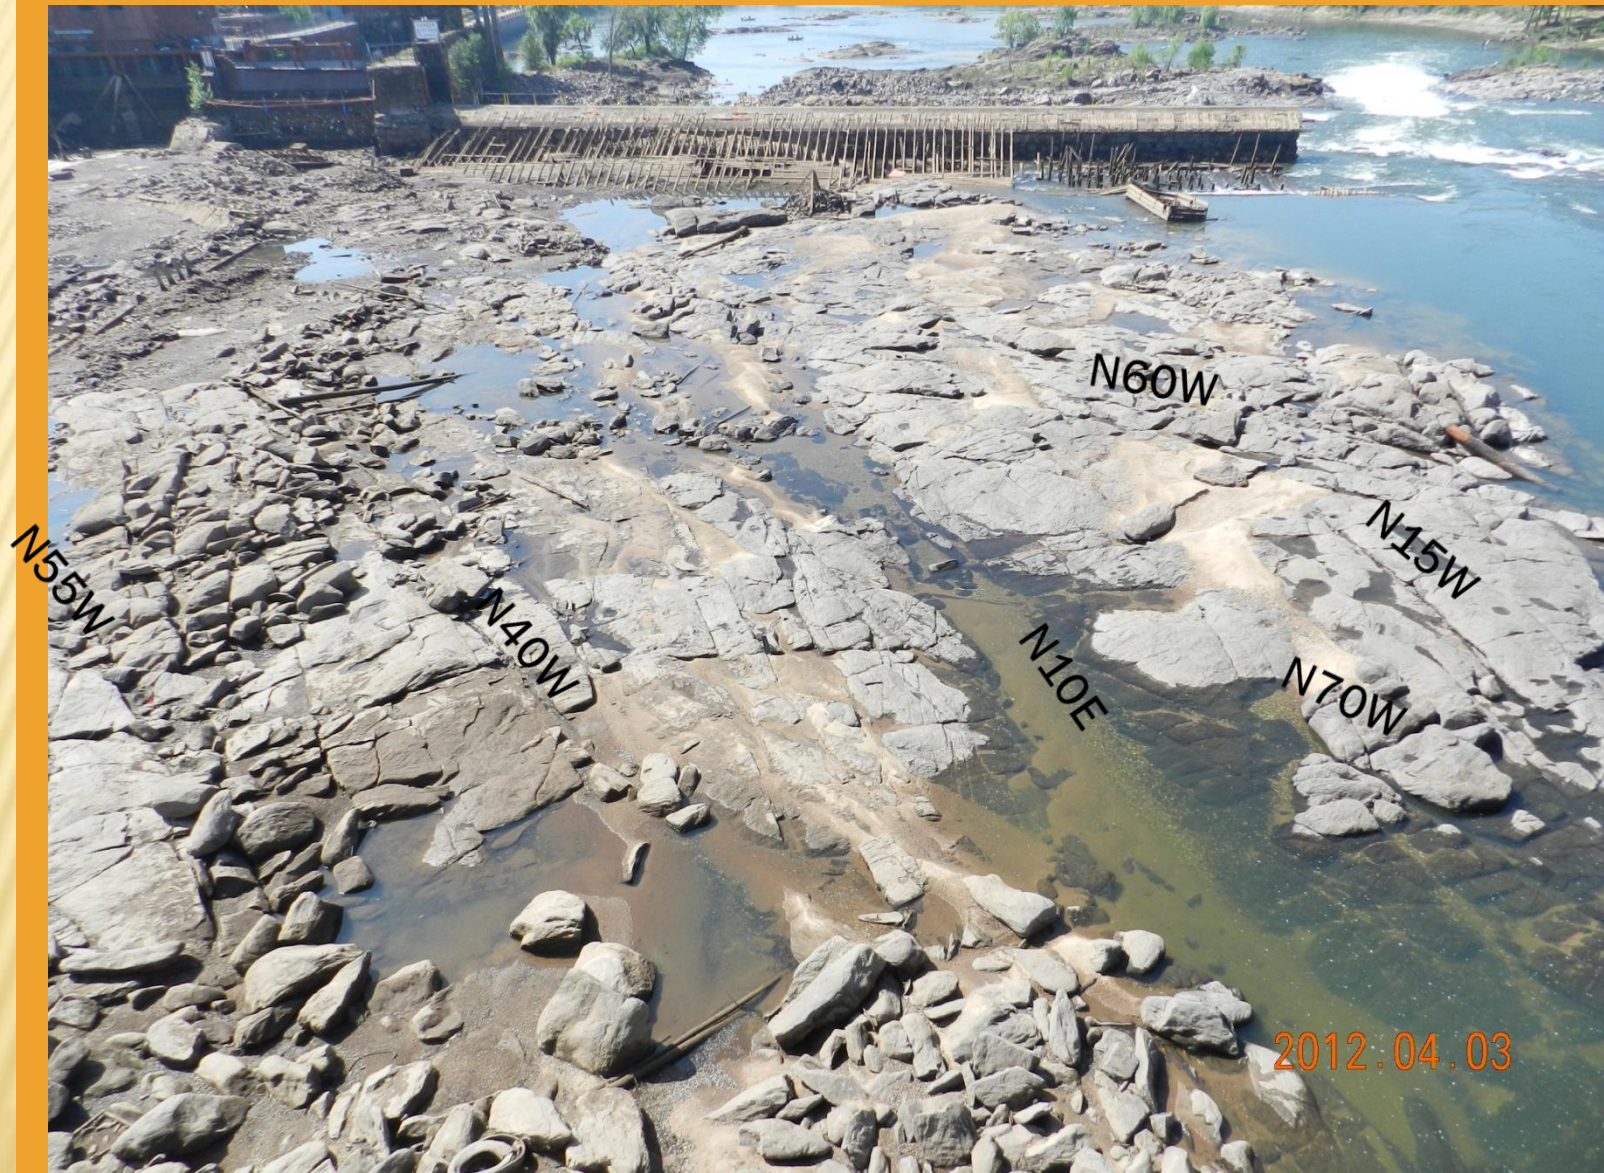
Joints in outcrop above dam: eyeballed from 13th Street bridge.

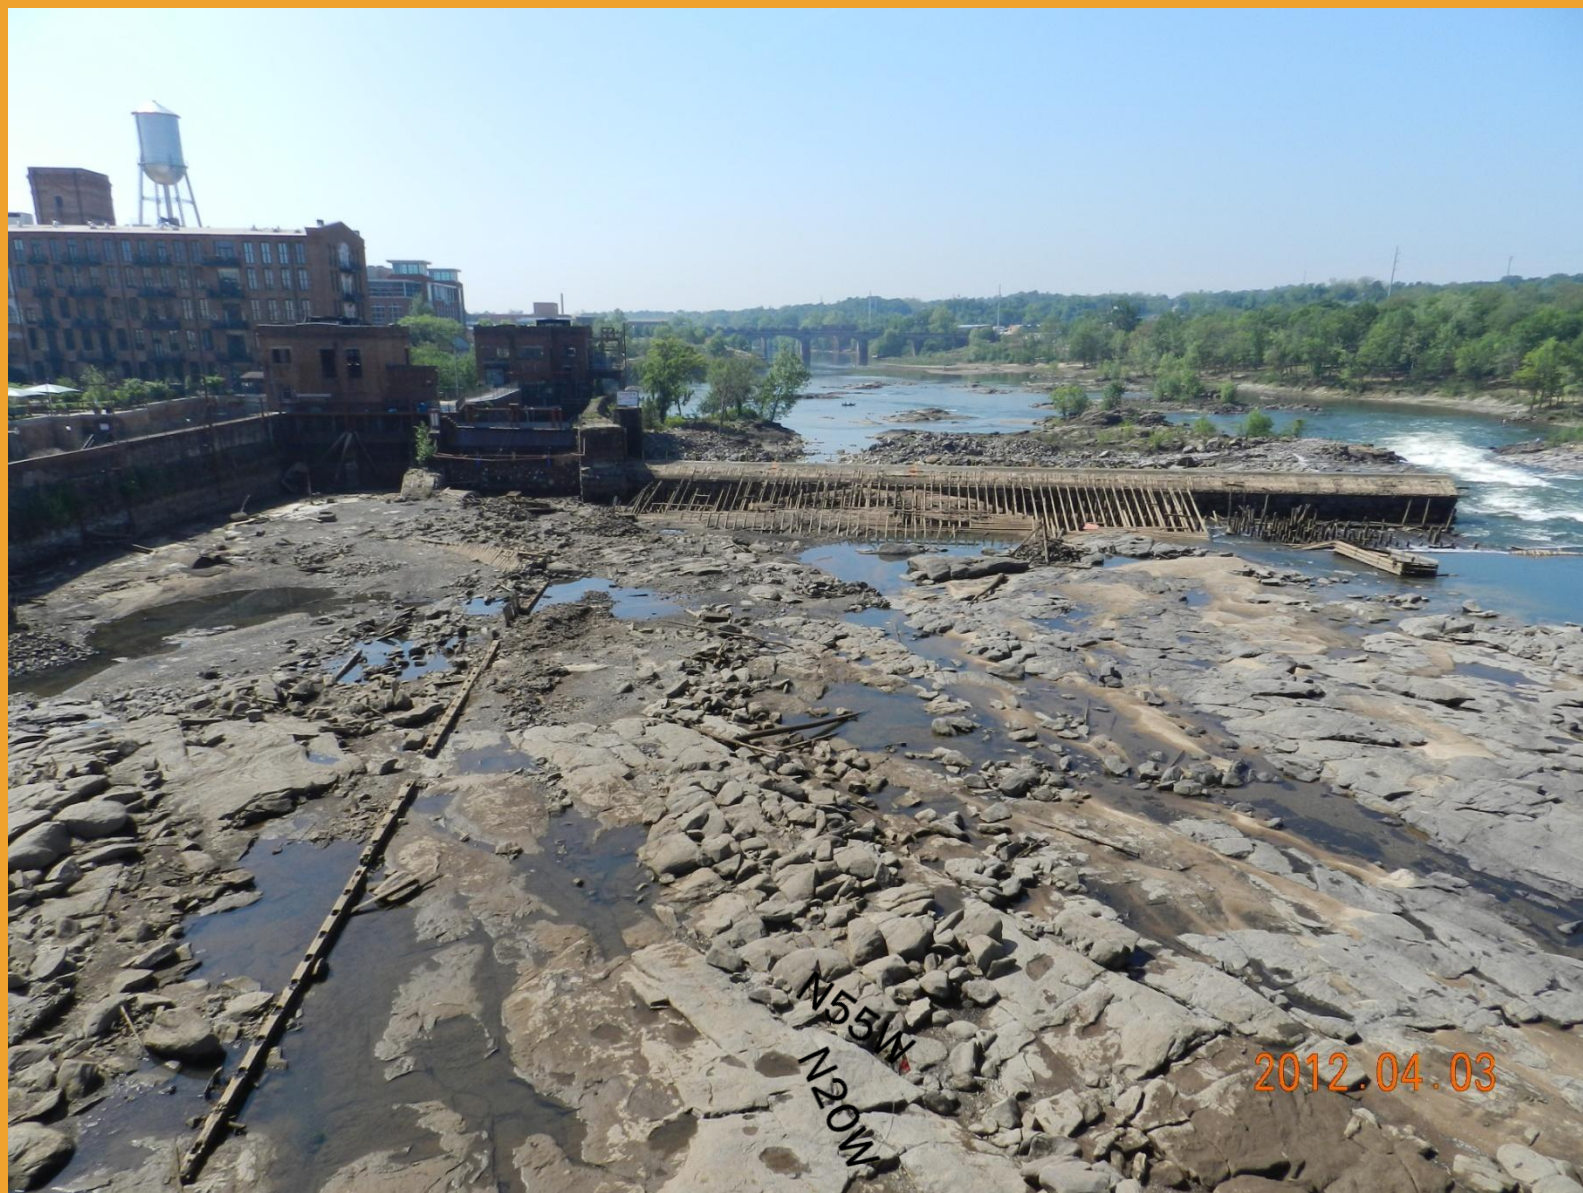
Joints eyeballed from 13th Street bridge.

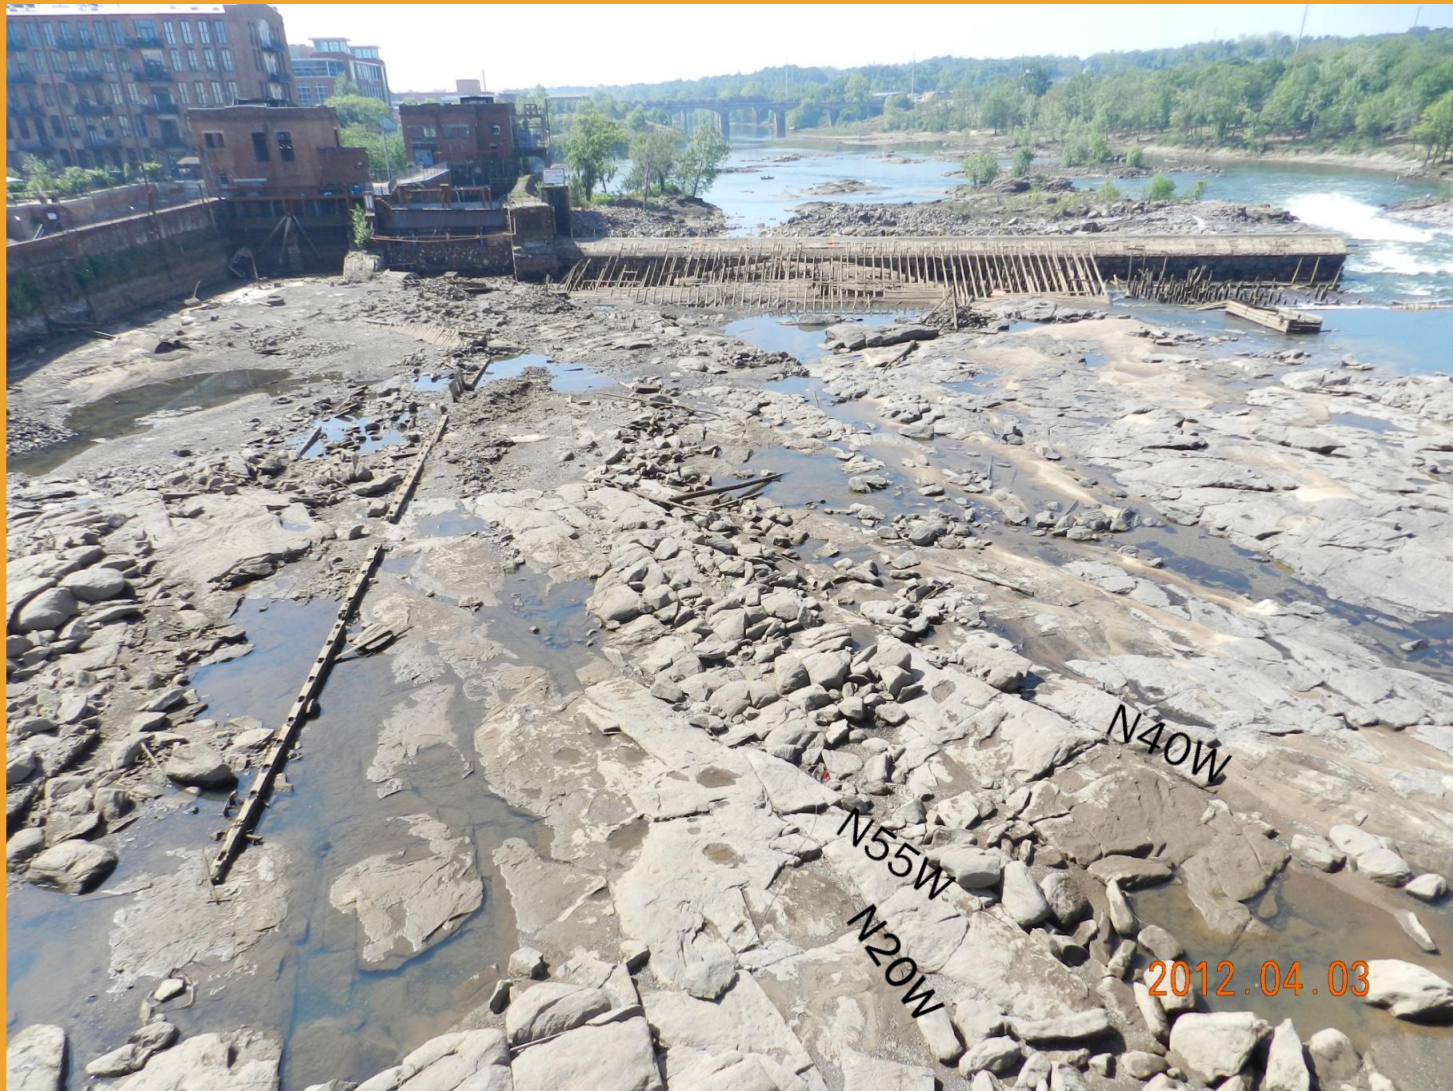
Powerhouse on left seems to have a boat ramp; linear structure may have directed water towards powerhouse.

Looking northwest towards 14th Street bridge from 13th Street bridge

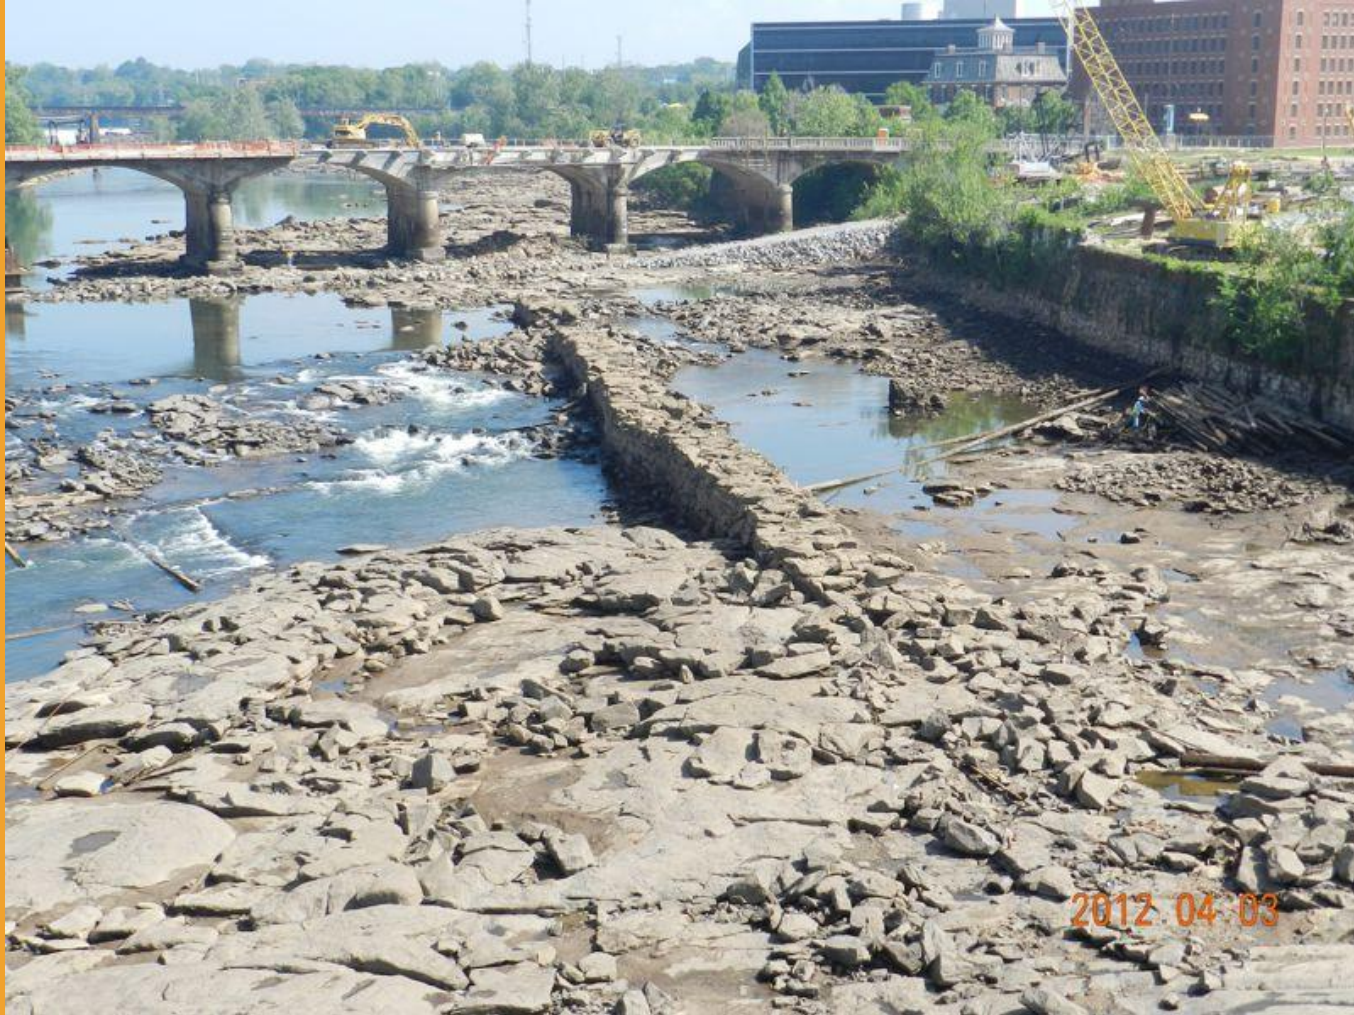
Bedrock above 13th Street bridge; old wall apparently directed water to E&P powerhouse. 14th Street bridge is being repaired for use by pedestrians. Railroad bridge and City Mills dam lies beyond. TSYS campus with first Columbus library building is upper right.

Jointed bedrock on north side of 13th Street bridge.

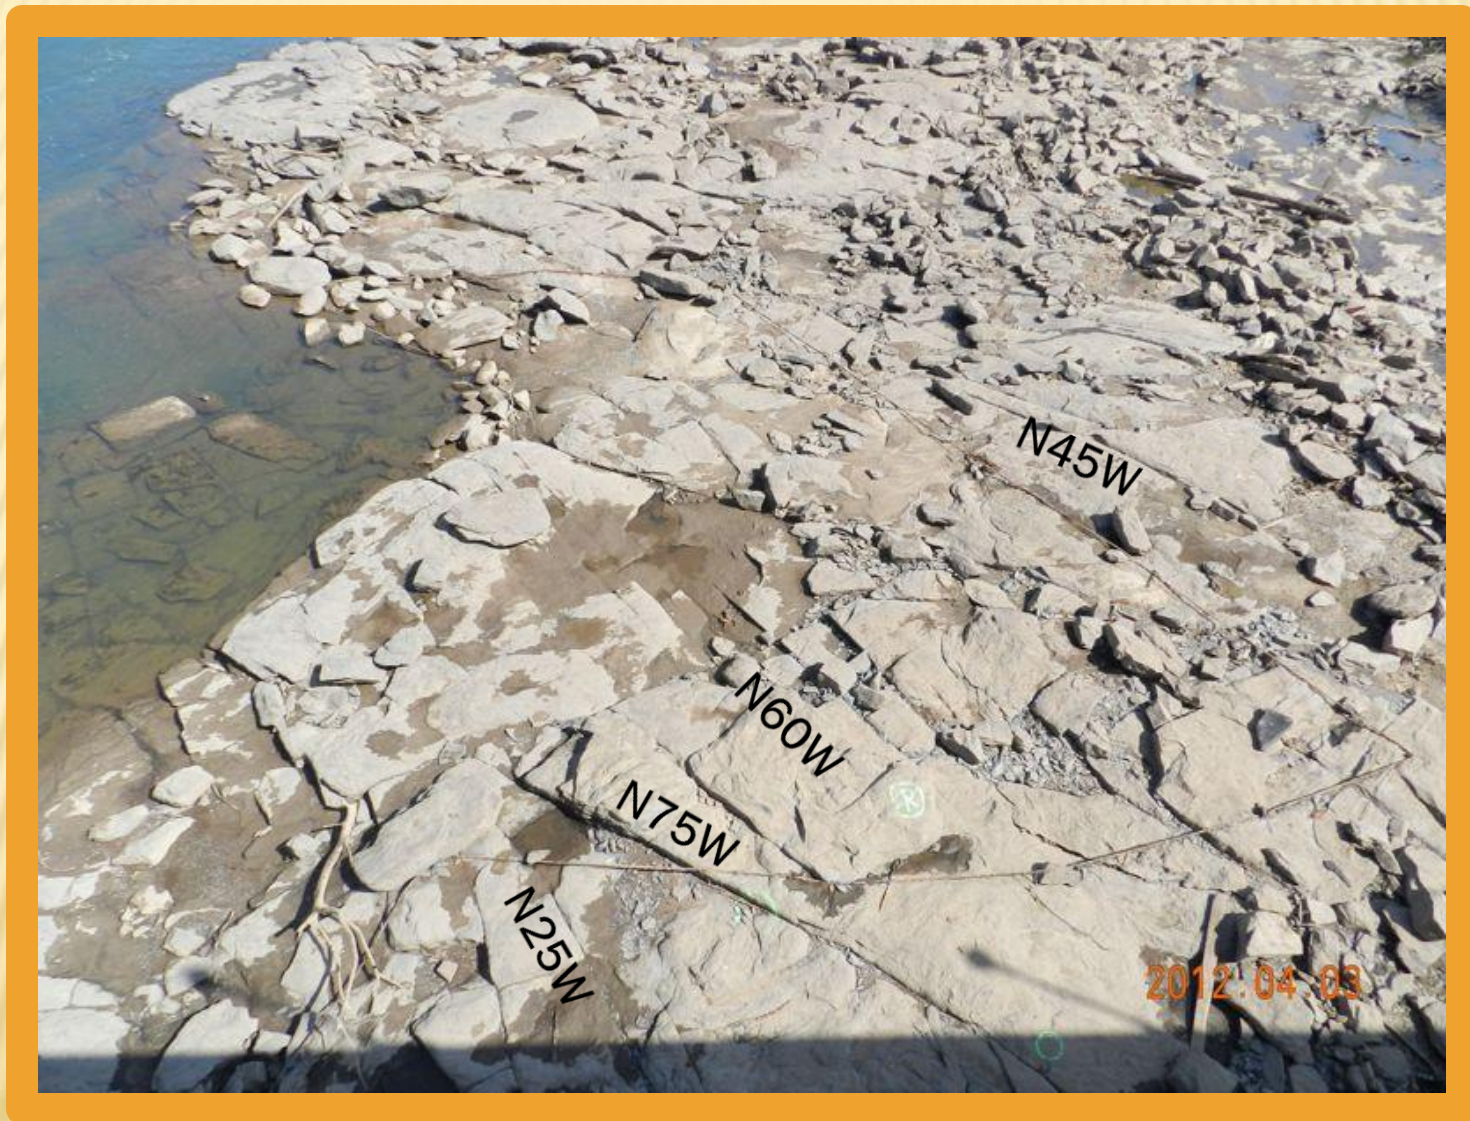
Strikes of joints eyeballed from 13th Street bridge.

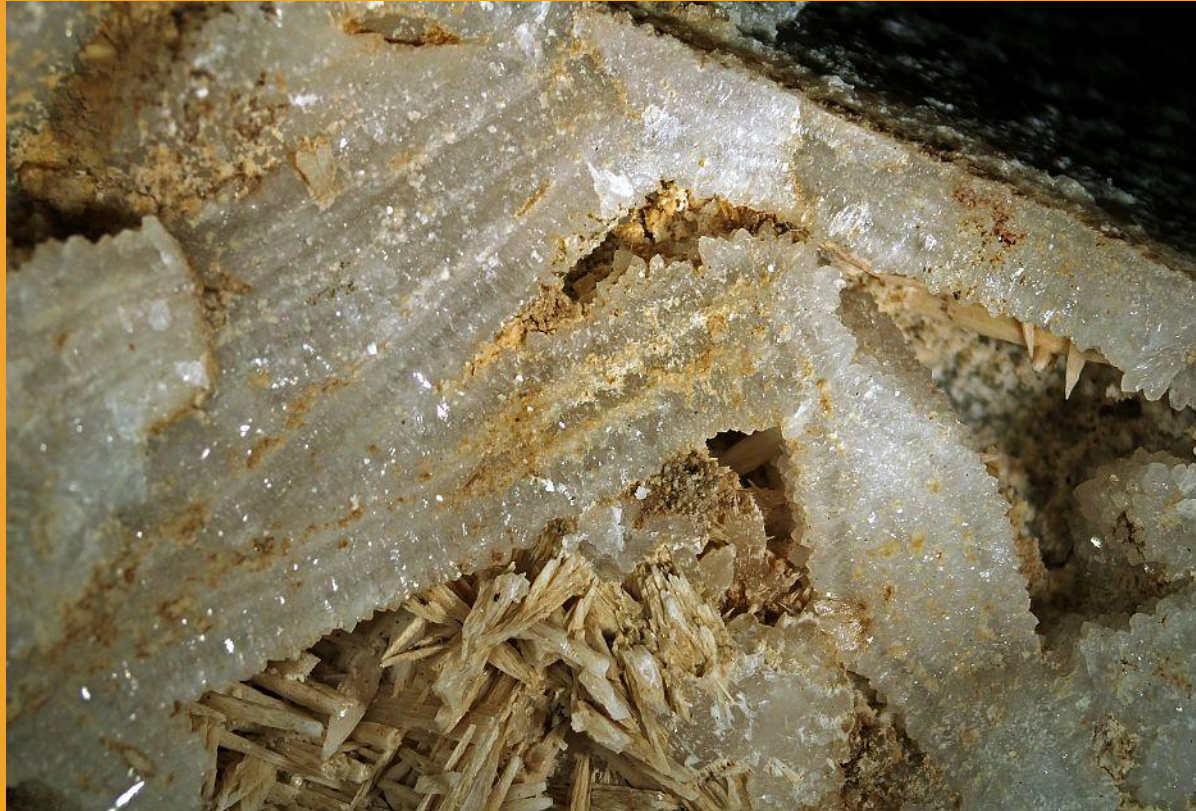
Angle-plated quartz with dog-tooth spar calcite filling voids: photo and id by Julian Gray, Tellus Science Museum, Cartersville, GA.

Photo by Julian Gray at Tellus Science Museum; magnification is 6.5X , field of view is 24mm.

1. Host rock is brittley fractured.
2. Quartz deposited hydrothermally(?) in fractures
3. Host rock weathered to leave geometric arrangement of tabular quartz, and in this case
4. Calcite deposited in open space.

So what I observed is a later stage growth of drusy quartz on tabular hydrothermal quartz; quartz crystal terminations growing into the open space, away from the hydrothermal quartz. Furthermore, in at least one instance one tablet ended in an open space and drusy quartz completely surrounded the plate. This is probably easily to explain in this paragenesis:

1. Host rock is brittley fractured.
2. Quartz deposited hydrothermally(?) in the fractures
3. Host rock weathered to leave geometric arrangement of tabular quartz (some ending in open space)
4. Tabular quartz overgrown by drusy quartz
5. Calcite deposited in the open space.

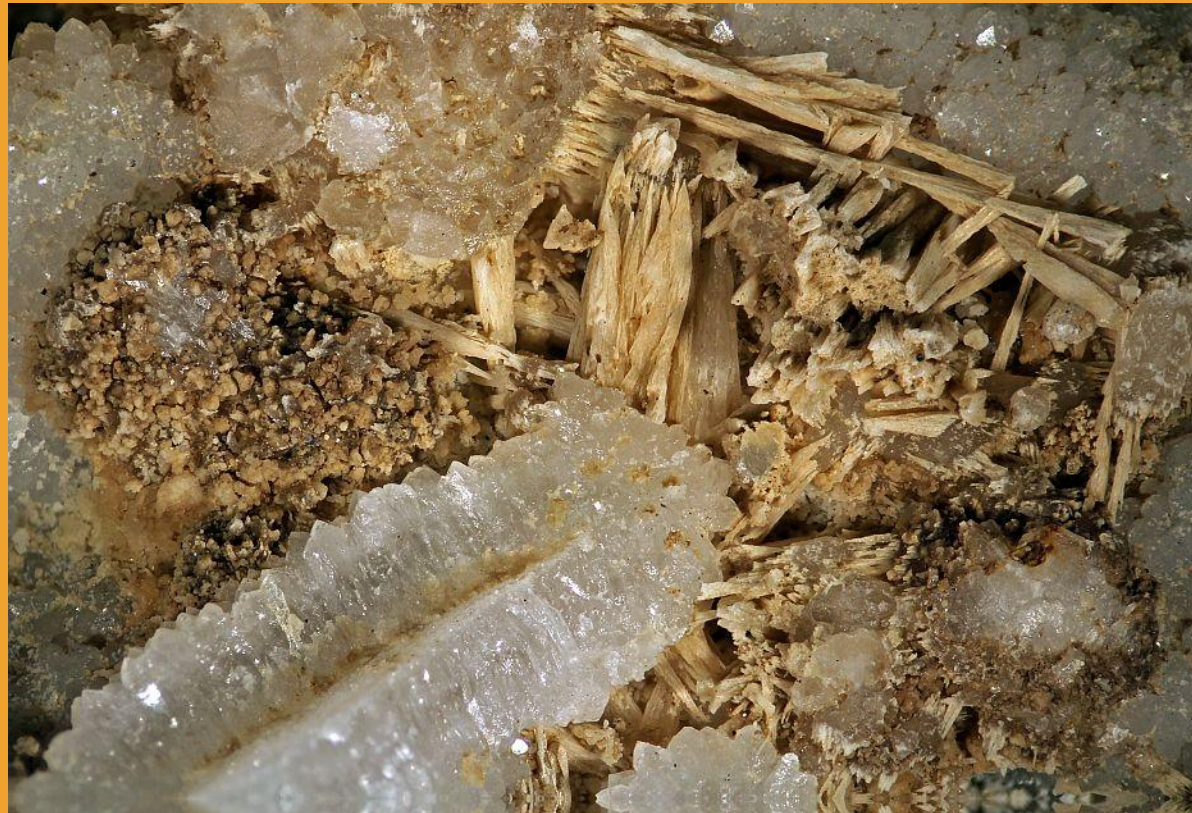
Angle-plated quartz covered by drusy quartz; dog-tooth spar calcite fills voids: photo and id by Julian Gray, Tellus Science Museum, Cartersville, GA.

Photo by Julian Gray of Tellus Science Museum; magnification is 12.5X, field of view is 12 mm.
