GEOLOGICAL CONSIDERATIONS FOR CONSTRUCTING A RAFTING AND KAYAKING COURSE ON THE CHATTAHOOCHEE RIVER, COLUMBUS, GEORGIA

Thomas Hanley, Department of Earth and Space Science,
Columbus State University

Edward Kinner, Uptown Columbus, Inc.

SEGSA, Asheville, NC
April 1, 2012

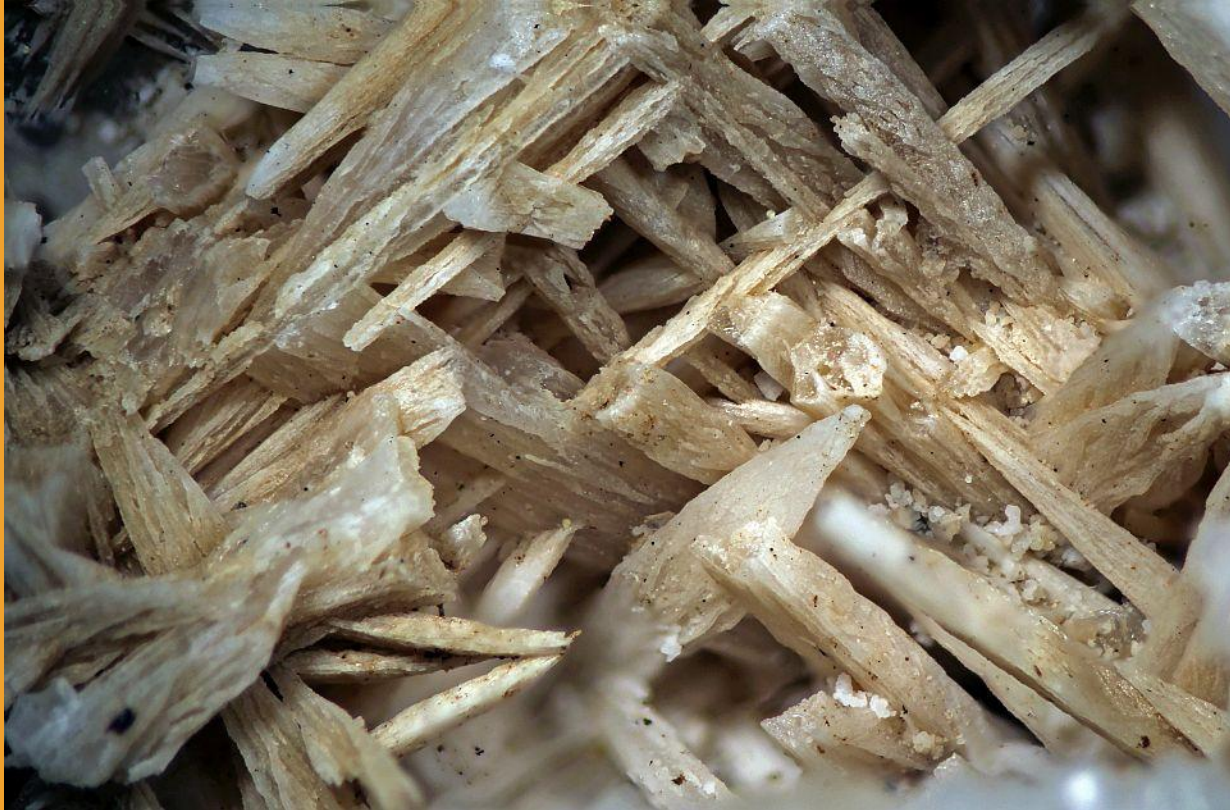
Dog tooth spar calcite in voids between angle-plated quartz ; photo and id by Julian Gray, Tellus Science Museum, Cartersville, GA.

Photo by Julian Gray of Tellus Science Museum; magnification is 20x, field of view is 7.5 mm.

The crystals are elongated, acicular and tapered to a sharp point; a common habit of calcite, but not zeolite. It effervesces in dilute HCl, has high birefringence, and rhombic cleavage. To nail it, I did a cursory check of lowest n_D and found it is close to 1.480. Easy! Most of the calcite was dirty with inclusions, but I found a large, clean piece for the optical work.
