Restoration Design Evaluation of the East Branch of the Beaver River, Silver Bay, Minnesota: A Student-led Investigation Comparing Two Designs

Capstone Course for Stream Restoration Science & Engineering Graduate Program

Margaret Upton^{1*}, Elizabeth Brown¹, Nolan LaBonne¹, Stephen Labuz², Larissa Scott², Kate Sinner³, Andrew Strasser³, Ian Treat¹, Thomas Voigt¹, Karen Gran¹
(1) Earth and Environmental Sciences, (2) Civil Engineering, (3) Water Resources Science, University of Minnesota Duluth, *upton040@d.umn.edu

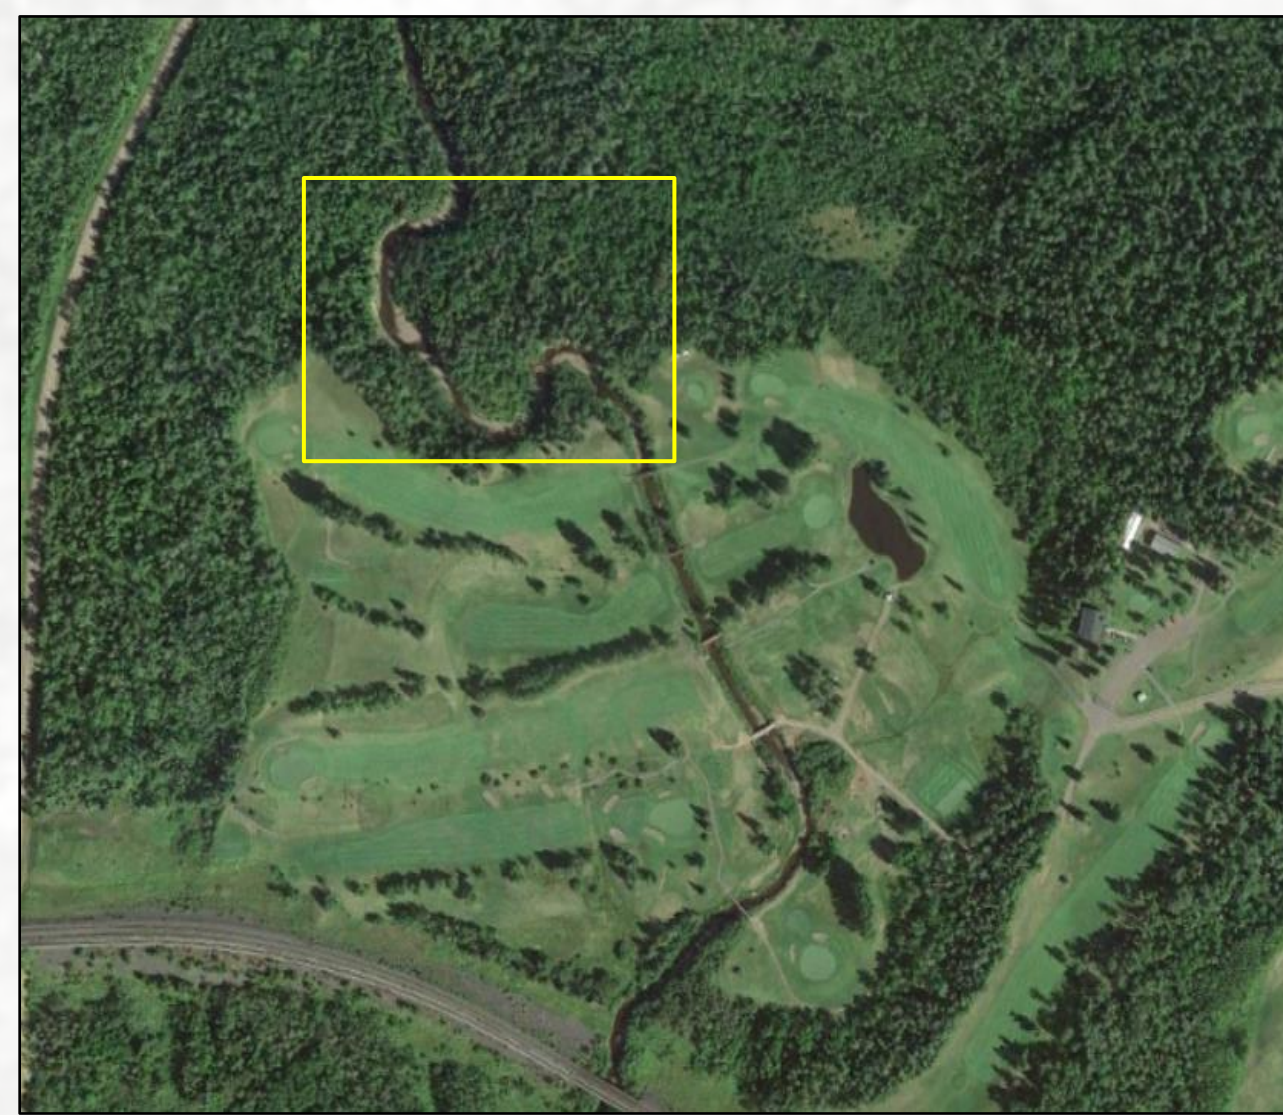
The establishment of the Silver Bay Gold Course has drastically modified the channel flow and form. The East Beaver River has been channelized within the golf course. A historic photo (right) is from 1939, showing a large floodplain with a meandering river.

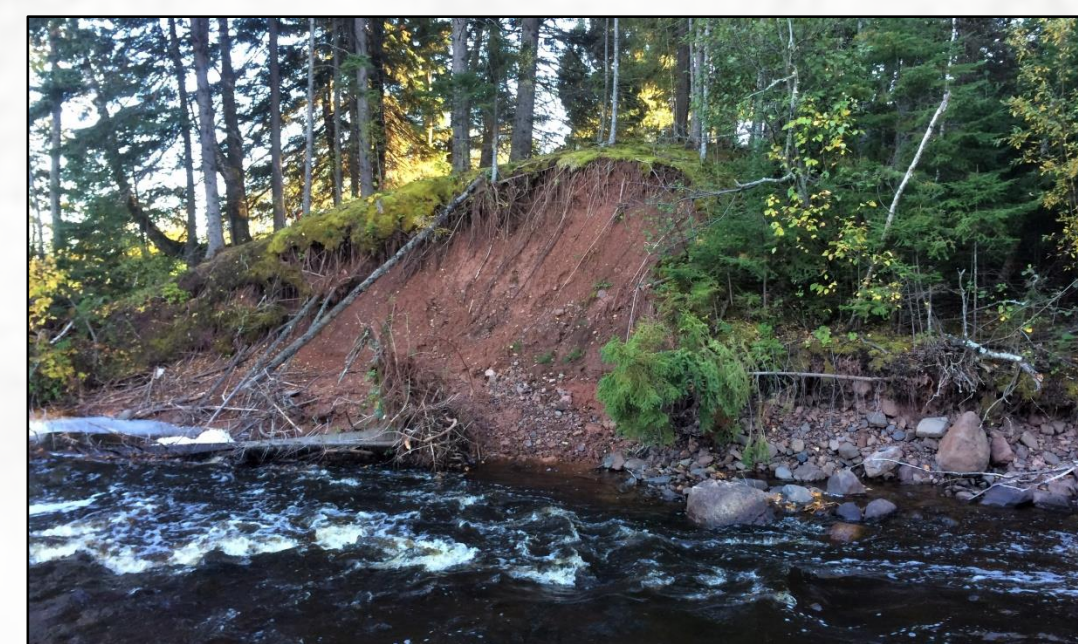
One of the eroding till banks of concern to golf course and DNR.

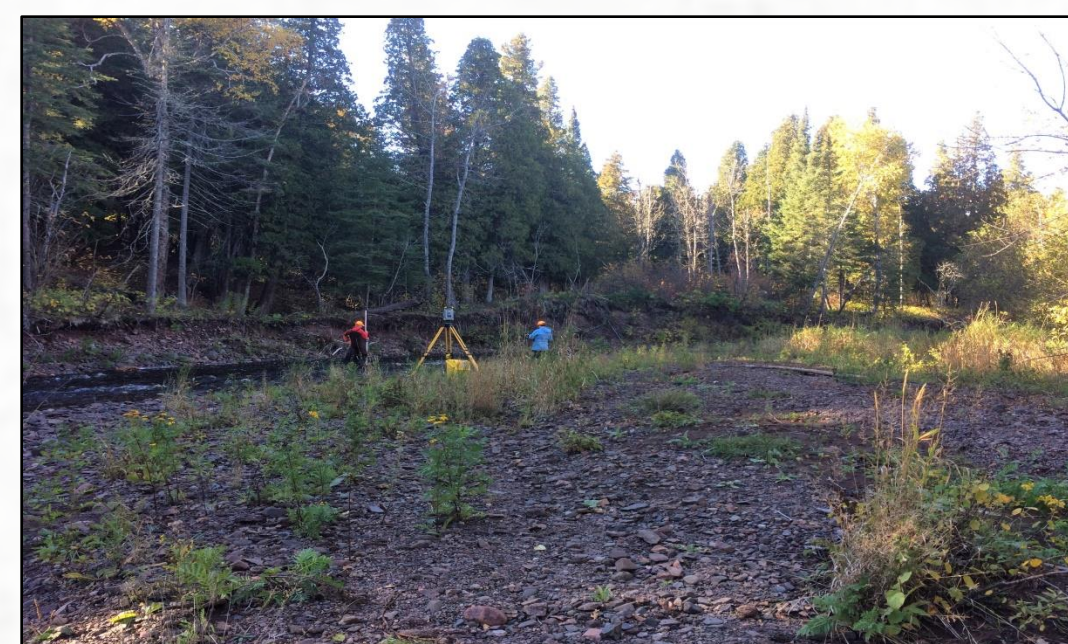
Project reach is depositional currently with large gravel bars.

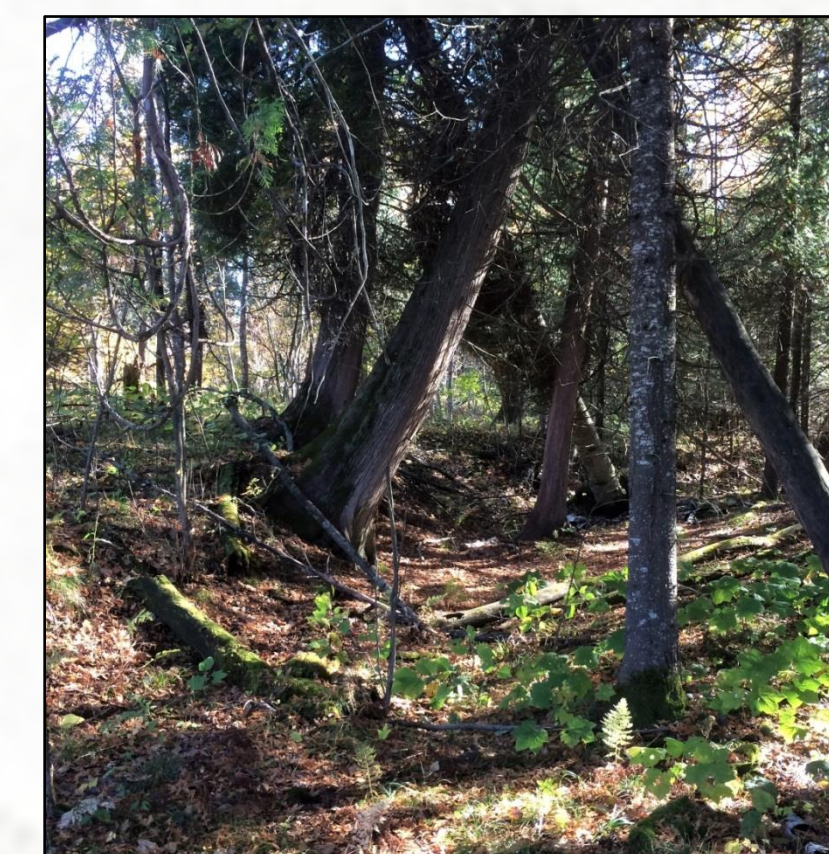
Mature trees in paleochannel on terrace shown on right.

Care was taken to protect mature trees, and vegetation designs incorporated more mature trees to help improve survival.
