The Role of Channel Armoring with Gabions on Channel Adjustments on the Zealand River, New Hampshire

Douglas M. Thompson, Leah S.
Puklin and Anna E. Marshall

Connecticut College

2014 Gabion Assessment

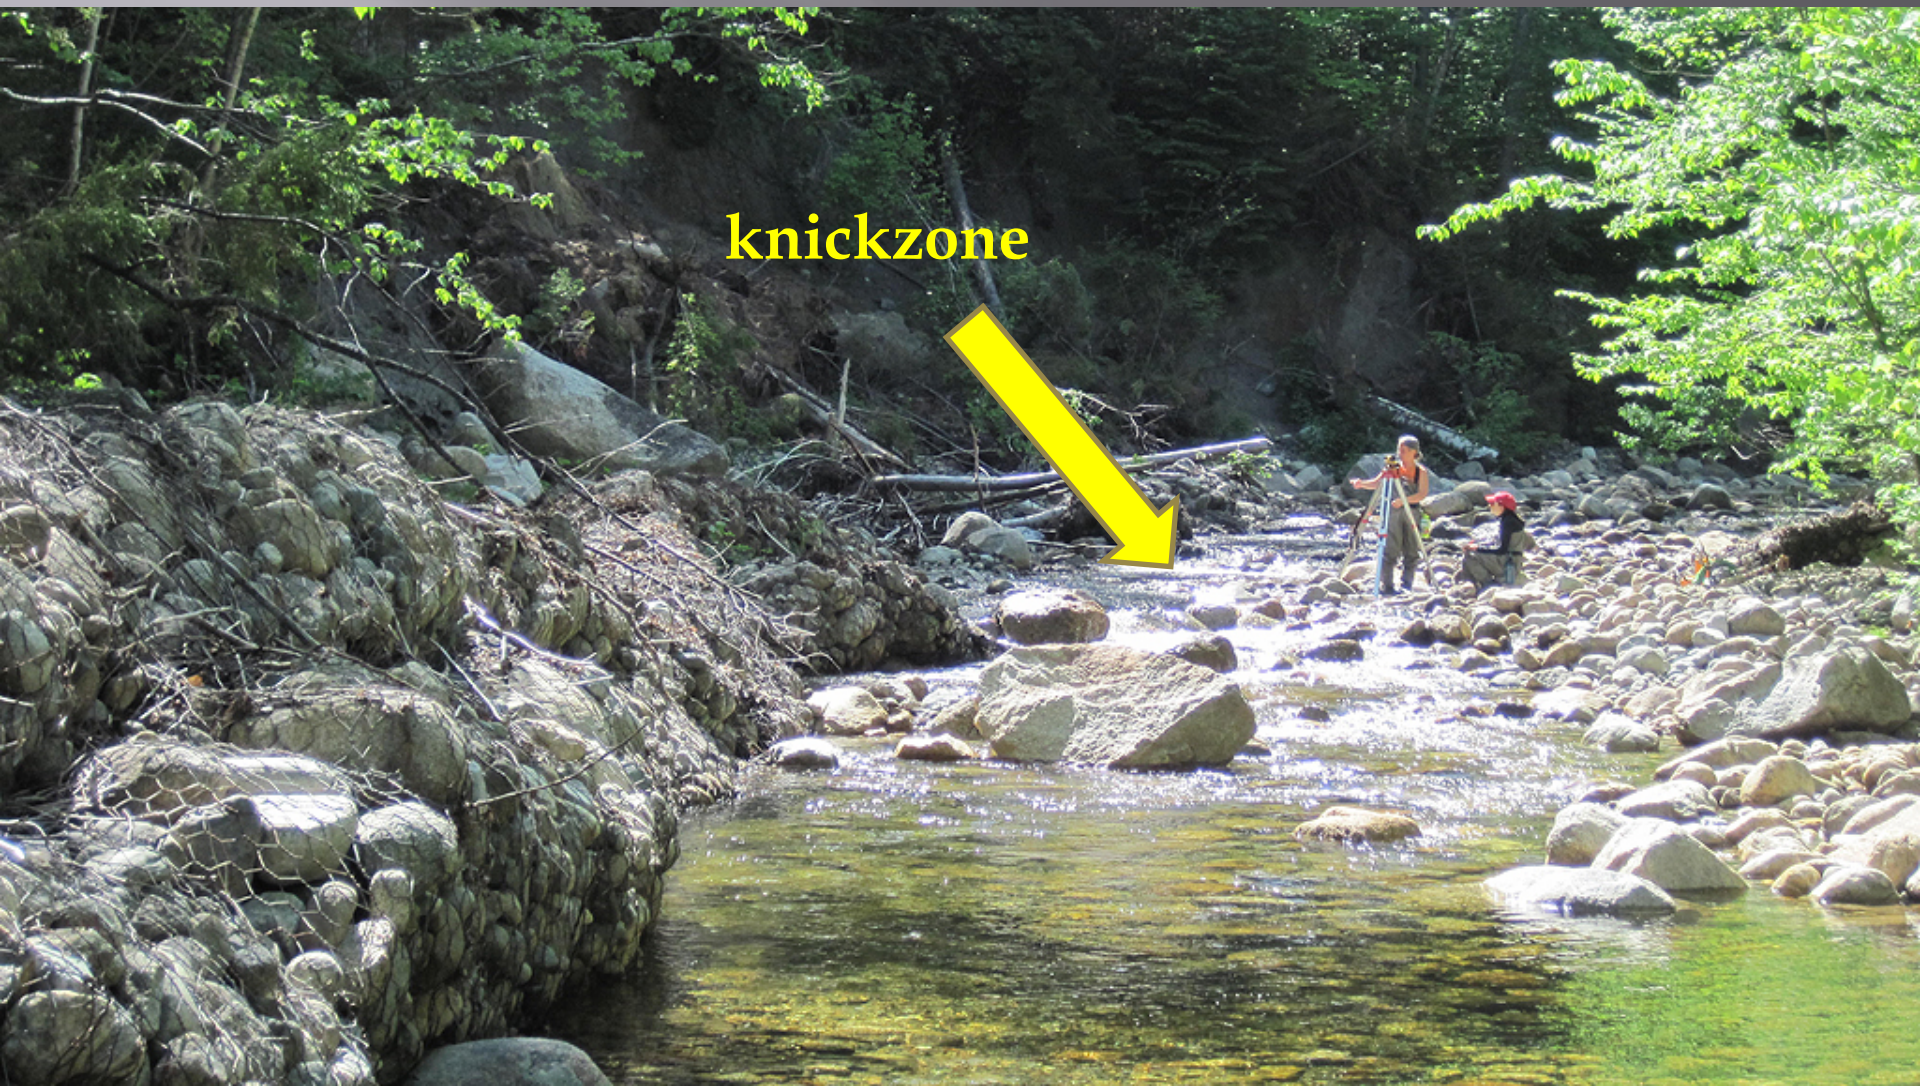
Middle Reach Gabion Wall 13a

Channel Narrowing = Increased Stream Power
